Bradshaw Gass & Hope LLP  
21 Silverwell Street  
Bolton  
BL1 1PR

Rochdale Borough Council  
Floor 2  
Number One Riverside  
Smith Street  
Rochdale  
OL16 1XU

**RE: 2215.52 Edgar Wood Trough**

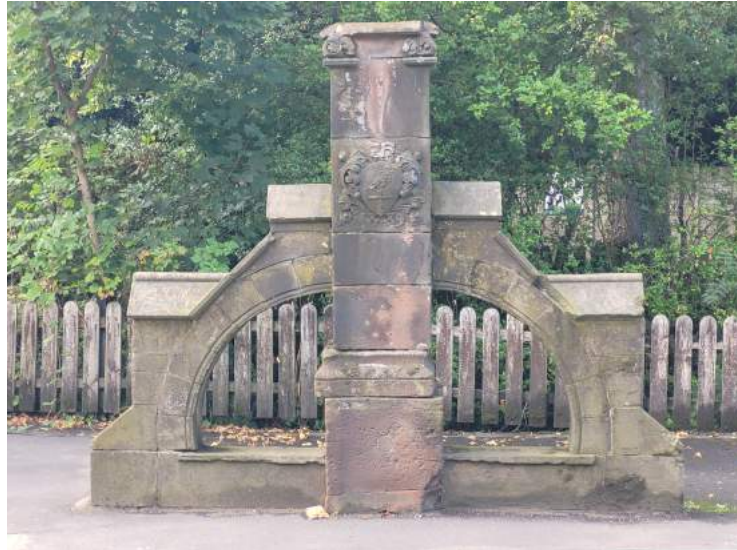
**Elevation on Fountain from Heywood Old Road**

The structure is understood to be a former fountain and horse water trough. It was designed by the Architect Edgar Wood who was an Architect of note and practised at the turn of the 20<sup>th</sup> century. A stone carving to the front elevation indicates a date of construction of 1889.

The structure is formed from a central stone masonry pillar, with 2 number half arches which frame in to either side. (Please see elevation photo above).

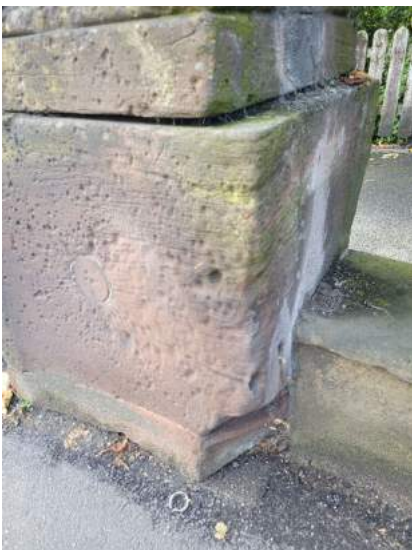
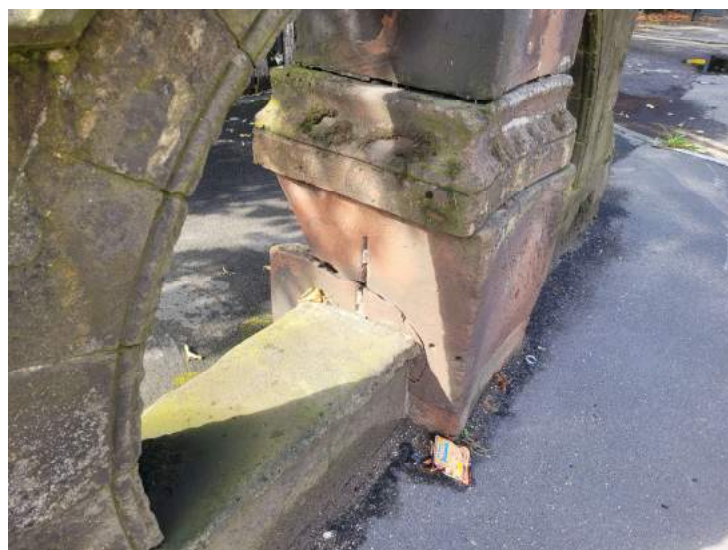
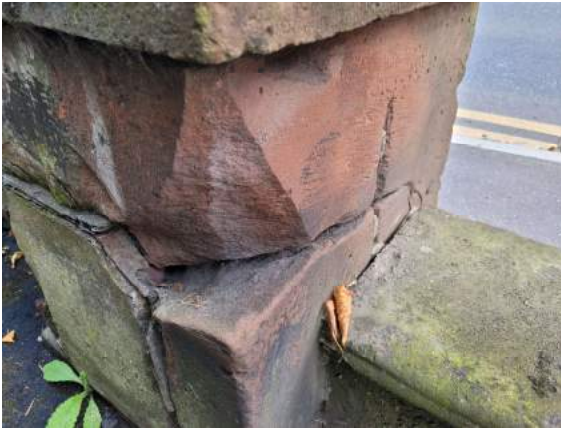
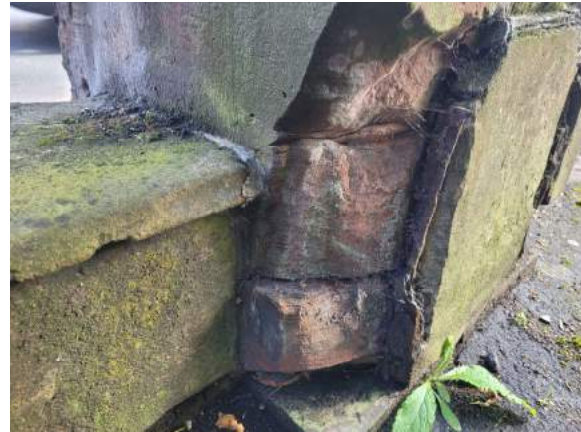
The central pillar especially displays heavy damage and displacement to the stone units. The stone base plinth has lost a portion of its section at the corners in addition to a number of severe cracks (See Photographs Below).

The most severe damage is shown to the plinth of the stone pillar and we believe this has failed. By its heavily loaded nature this is the most critical element of the structure. We would suggest it is only the tying nature of the 2 stone arches which has prevented collapse of the pillar.

It is our opinion a severe winter or further vehicle impact will likely cause the structure to collapse. We would recommend remedial works are carried out to the fountain as soon as possible. With a specialist stone mason carrying out the repairs to the base plinth.

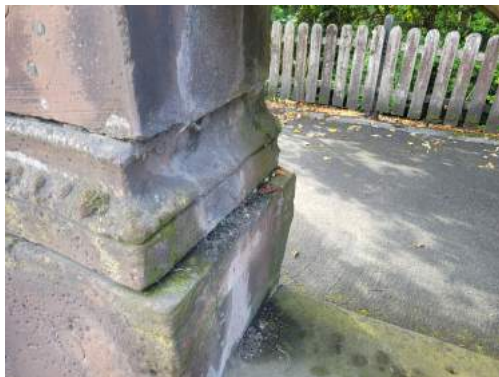
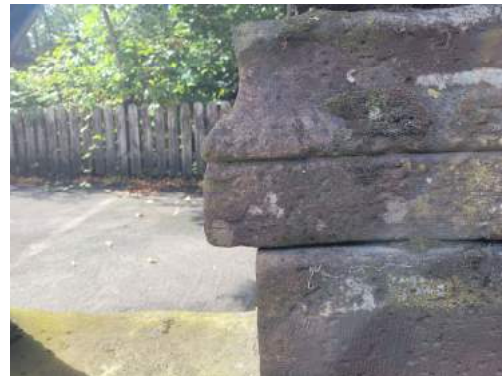
The fillet stone above the plinth shows a significant displacement of approximately 50mm. (Refer to Photographs below)

A typical form of construction of a stone pillar of this type would have a number of internal iron tie bars concealed within the bed joints of the units. Although no intrusive investigation has been carried out. The severe displacement of the fillet stone above the plinth would suggest these tie bars have sheared, possibly due to vehicle impact.

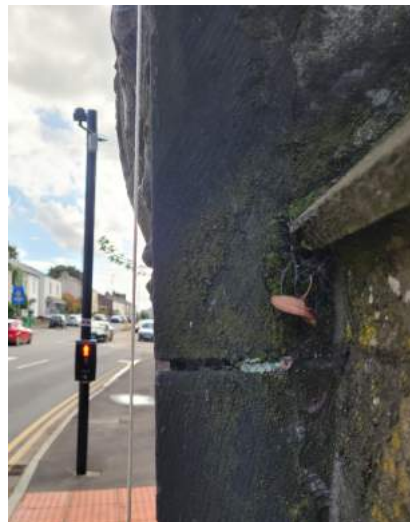
The stone shaft above does not display significant displacement of the stone units. However the pillar displays a lean of approximately  $2^\circ$  towards Heywood old road (Refer to Photograph below).

The lean of the structure towards Heywood Road is concerning as this is beyond what would be considered acceptable or safe.

The most likely cause of this lean is the damage to the base plinth, however it may be a symptom of an issue with the foundation.

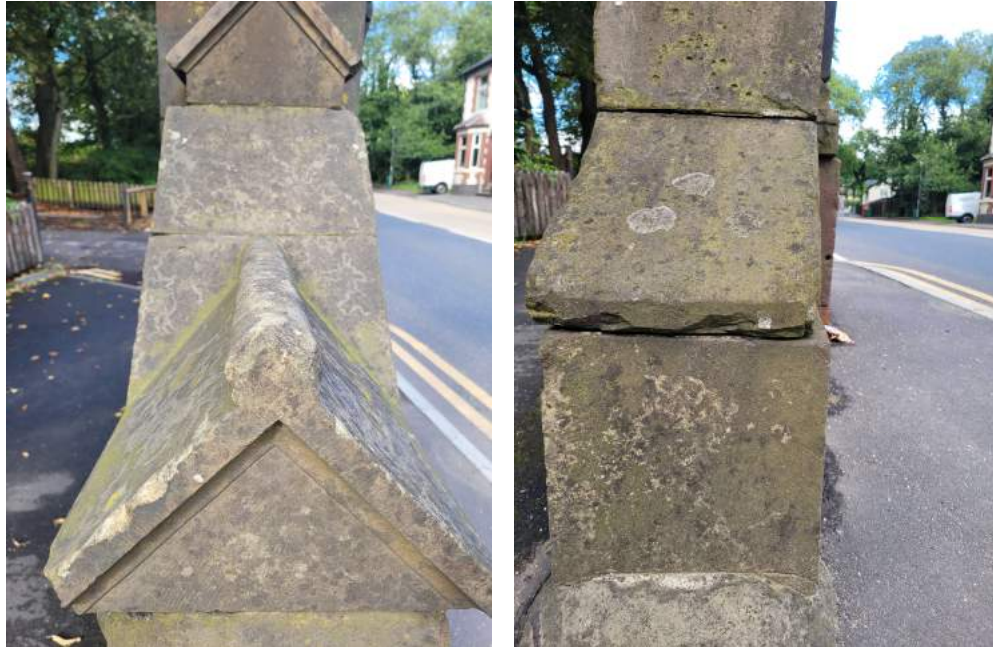
The stone half arches to either side of the pillar display chips to their edges, displacement of units and also a similar lean to the main pillar (see photograph below).
