# LYONS STONEMASONRY

## Stone survey report

Edgar Wood Trough

Heywood Old Rd

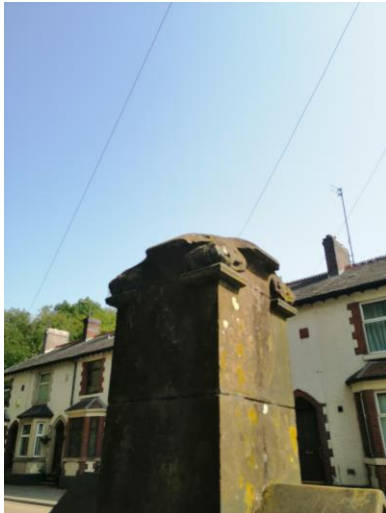
**Stone number 1-** Missing mouldings no work required.

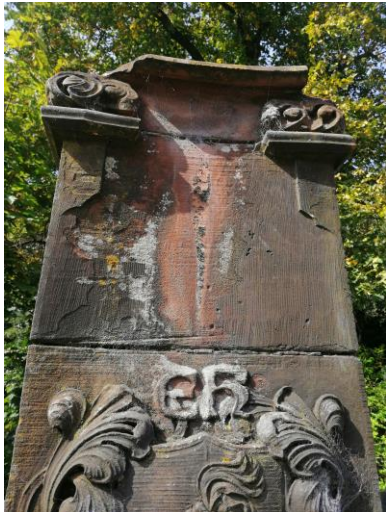
**Stone number 2-** Radius profile to front face, corner mouldings. No work required.

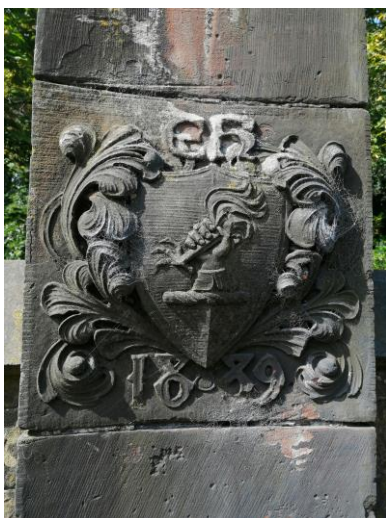
**Stone number 3-** Radius profile to front face with coat of arms. No work required.

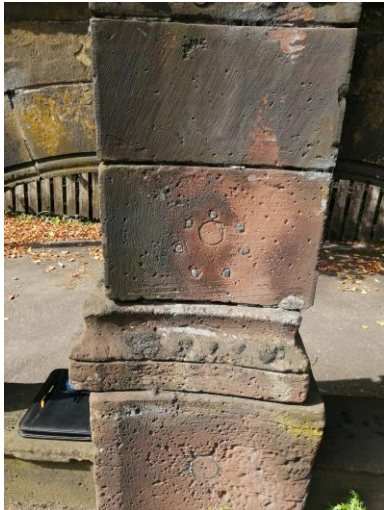
**Stones 4&5**- Radius profile to front face. No work required.

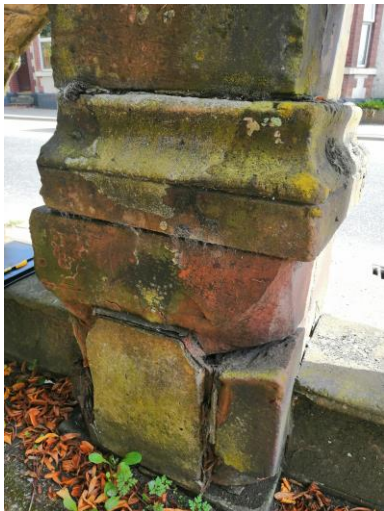
**Stone number 6**- Plinth dislodged. Moulded profile. No work required.

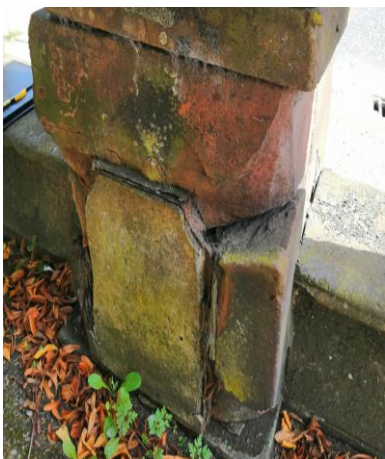
The majority of the stones have small sections of stone missing which are not structural, there is only one number stone that requires replacing in full due to the structural integrity of the unit. One number stone requires indenting due to the location becoming a water trap.

**Stone number 7**- Radius profile to front face. Multiple fractures to rear face and sides. Replace stone like for like 600x 600 x 640.

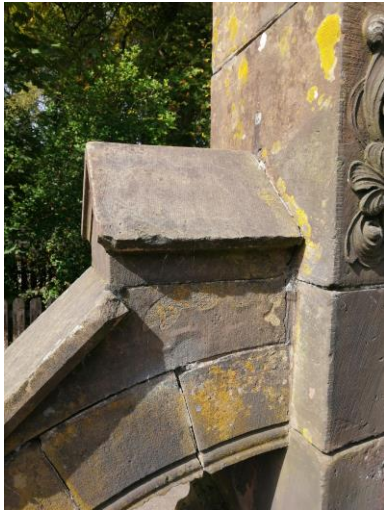
**Stone number 8** – Coping stone with moulded profiles to 3 faces. No work required.

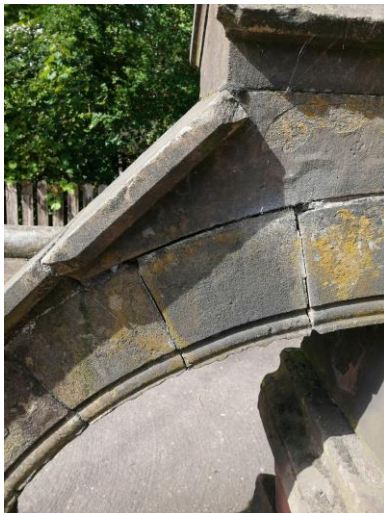
**Stone number 9 & 11** – Coping with moulded detail on 2 faces incorporating radius ashlar. No work required.

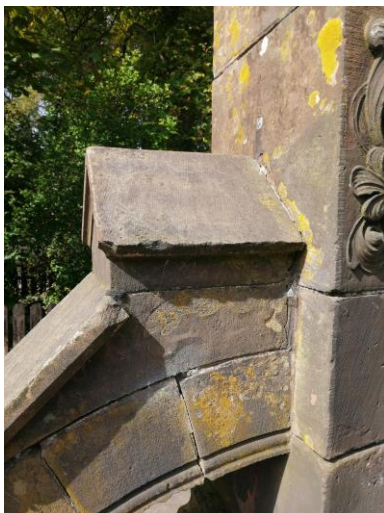
**Stones numbered 10 & 12** – Voussoir stones profiled on 2 faces. No work required.

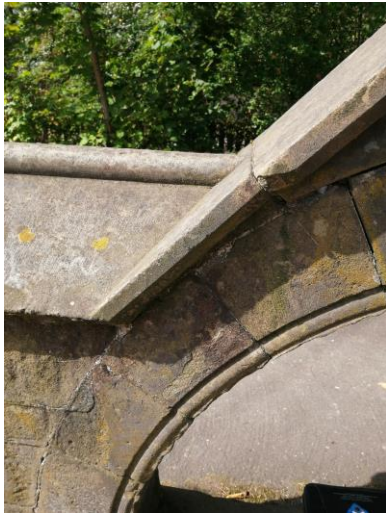
**Stones numbers 13, 14 & 16-**Voussoir stones profiled on 2 faces. No work required.

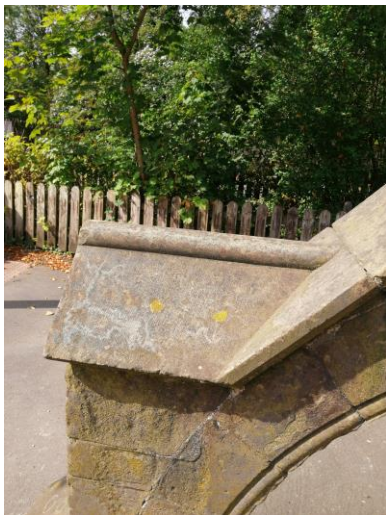
**Stone number 15 –** Kneeler stone profiled on 3 faces. No work required

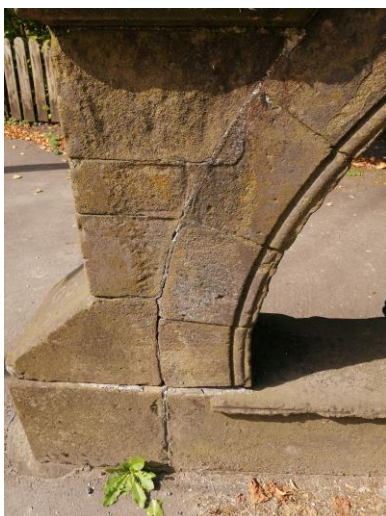
**Stone numbers 17 &18-** Voussoir stones profiled on 2 faces. No work required.

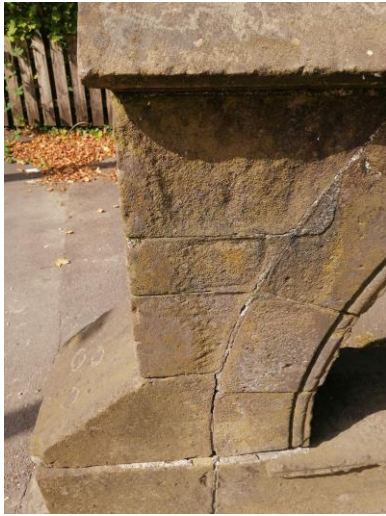
**Stone numbers 19&20-** Ashlar return stones. No work required.

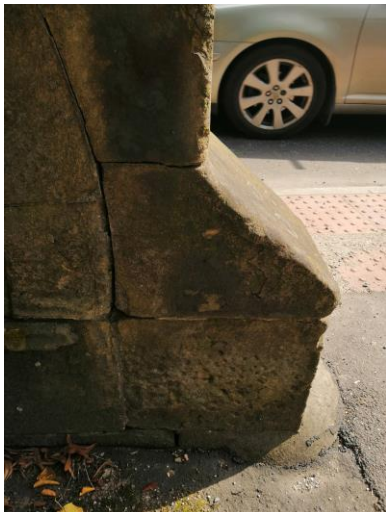
**Stone number 21** – Kneeler stone profiled to 1 face. No work required.

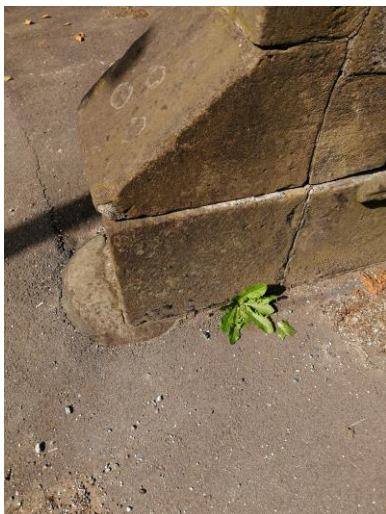
**Stone number 22-** Ashlar return. No work required.

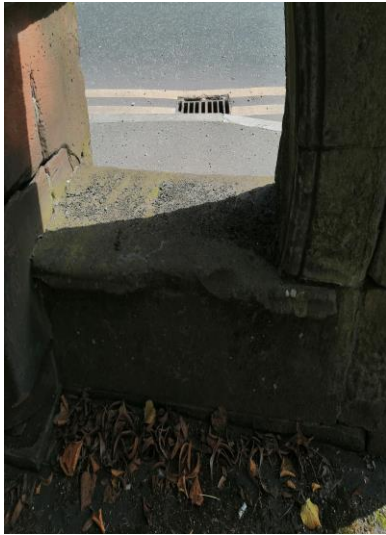
**Stone number23-** Plinth stone profiles missing on 2 faces. No work required.

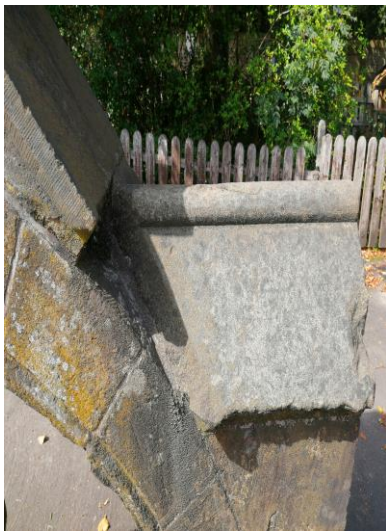
**Stone number 24-** Kneeler stone profiled on 2 faces. Angled section missing. Indent section 280 x 180x50

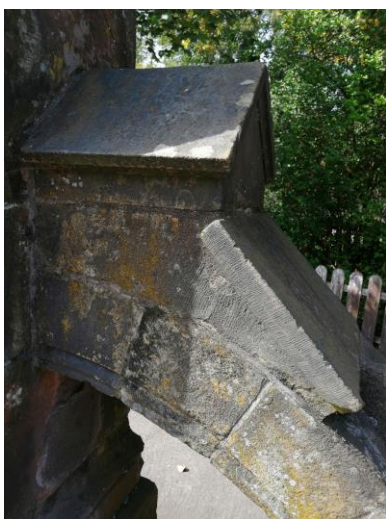
**Stone number 25-** Coping with moulded detail on 2 faces incorporating radius ashlar. No work

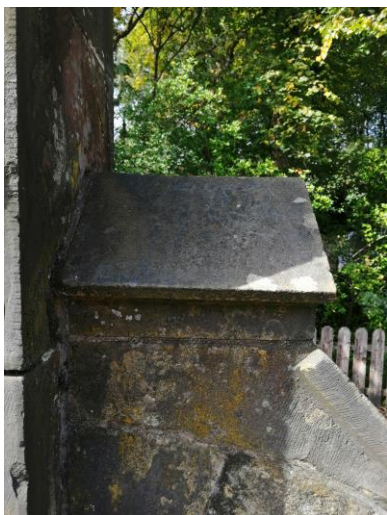
**Stone number 26**— Coping stone with moulded profiles to 3 faces. No work required.

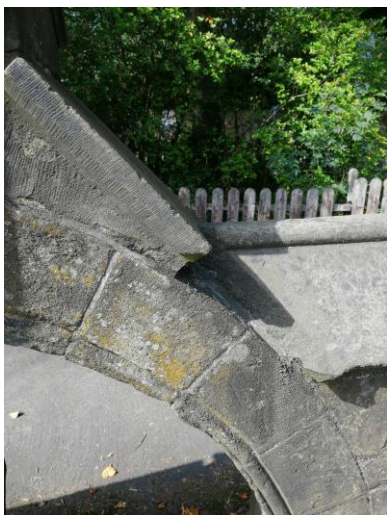
**Stones numbered 27-30** - Voussoir stones profiled on 2 faces. No work required.

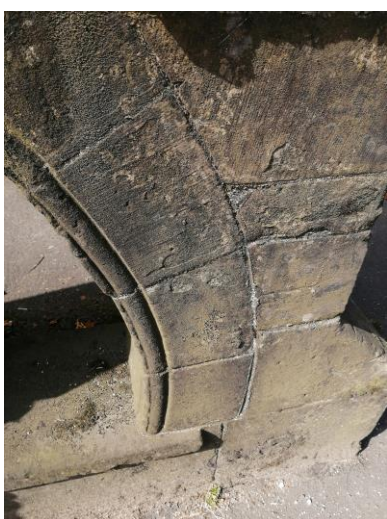
**Stones numbered 31-33** - Voussoir stones profiled on 2 faces. No work required.

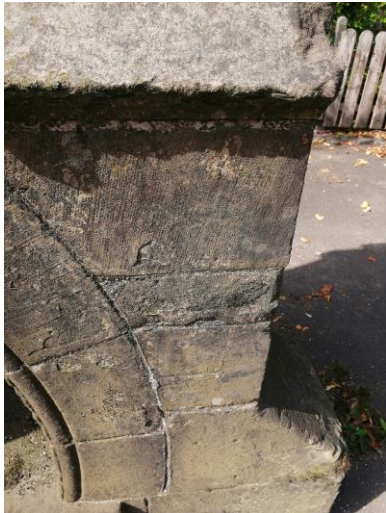
**Stones numbered 34-35-** Ashlar return stones. No work required.

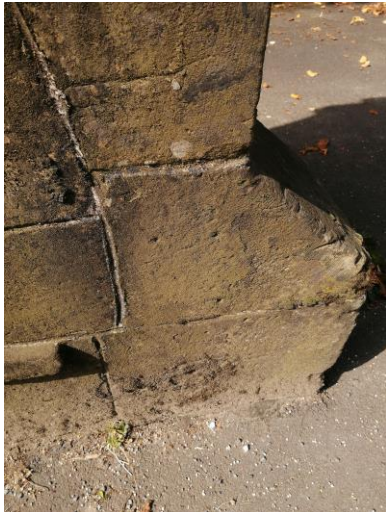
**Stone number 36 -** Kneeler stone profiled to 1 face. No work required.

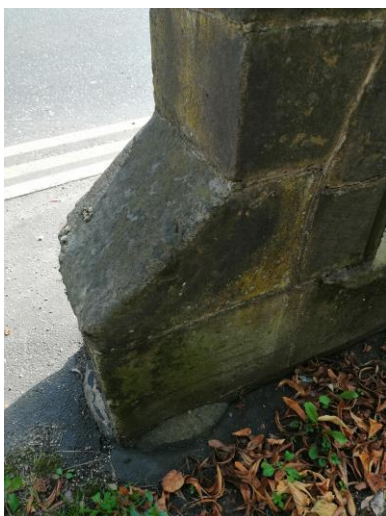
**Stone number 37- -** Ashlar return. No work required.

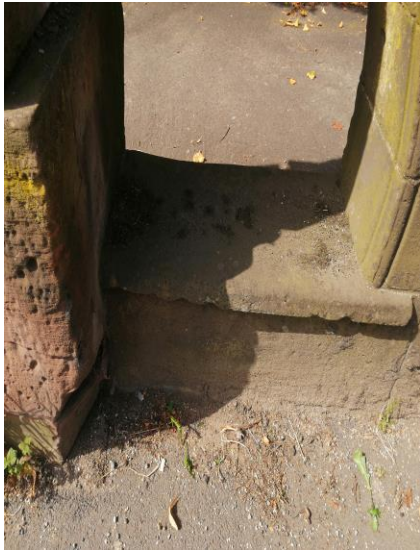
Stone numbered 38- Plinth stone profiles missing on 2 faces. No work required
