Existing Vent Photographs  
Photographs - January 2024

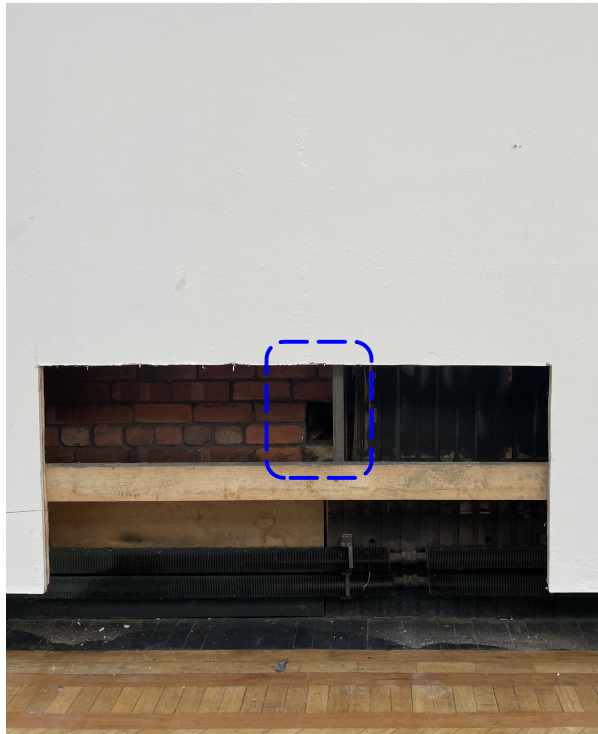
Image 01/04 -  
Section of Exhibition boarding removed to reveal locaton of typical vent (gallery 04).

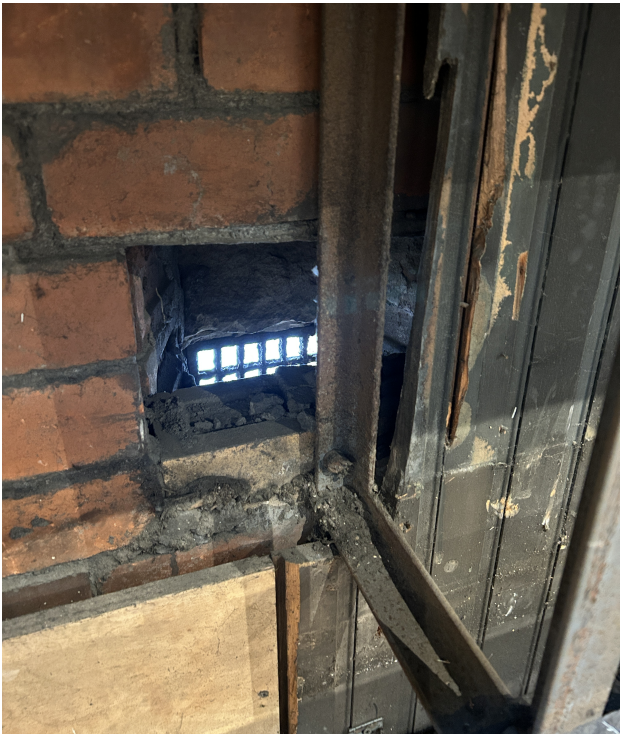
Image 02/04 -  
Closer look at vent position, brickwork opening and grille height. Grille sits directly behind existing brickwork meaning (cold) air needs to rise in order to enter space. S/o in brickwork for air movement is located at a higher level to external grille.

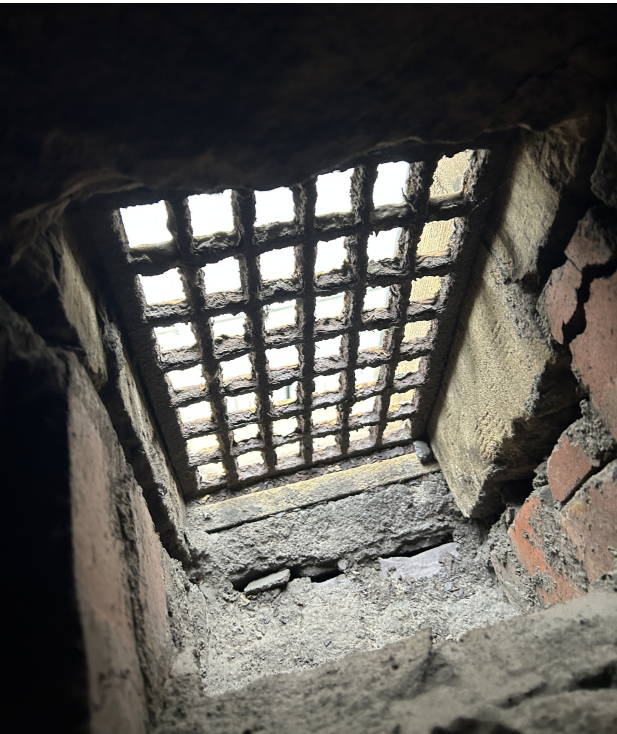
Image 03/04 -  
Photograph from within cavity looking at ventilation grille.

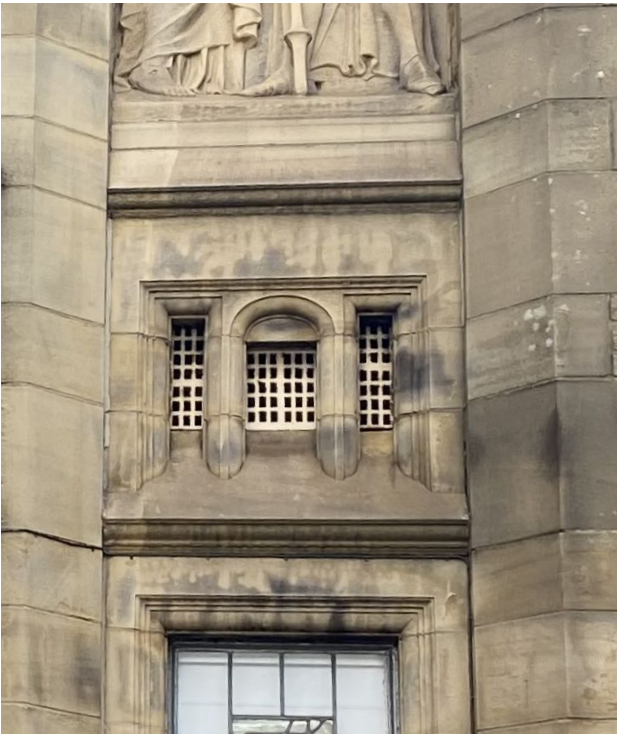
Image 04/04 -  
External photograph looking at a typical ventilation grille condition.
