21314

BRANCH ROAD FARM, BRANCH ROAD  
LITTLEBOROUGH – OL15 0AB

Revised: 24<sup>th</sup> June 2022

# REPORT ON STRUCTURE

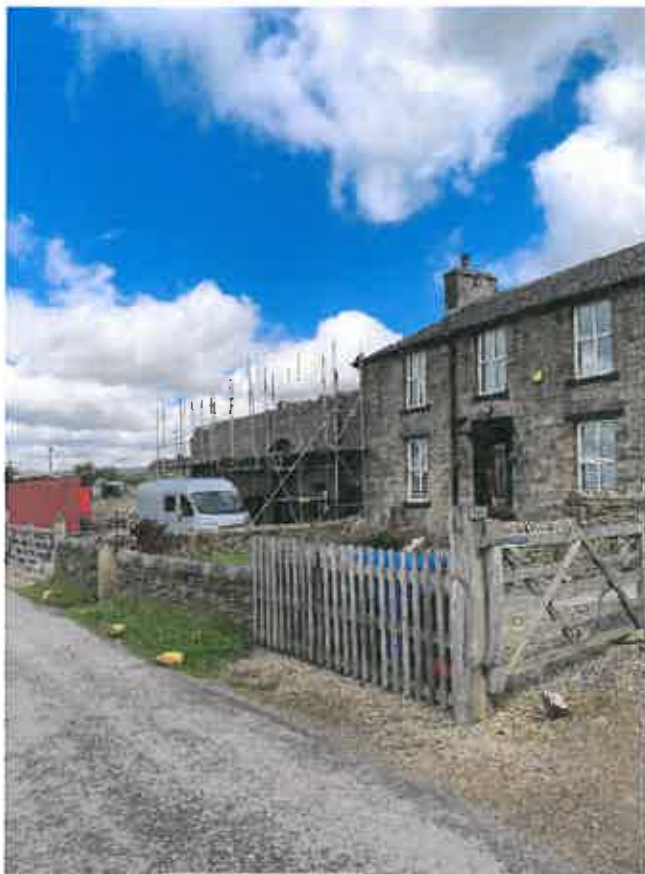
*Photograph 1*

- 1.01** We were requested by Mr Wildman to carry out a survey and to provide a report on the structure of the property known as The Barn, Branch Road Farm, Littleborough. See photograph 1.

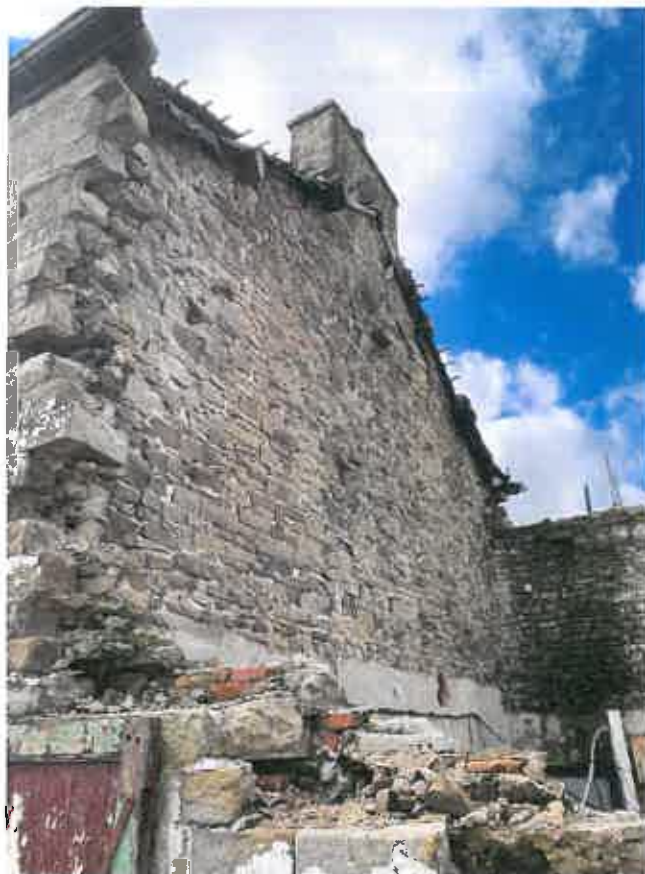
*Photograph 2*

The party wall, with the farmhouse, is to remain as a party wall in the new development. See photograph 2.

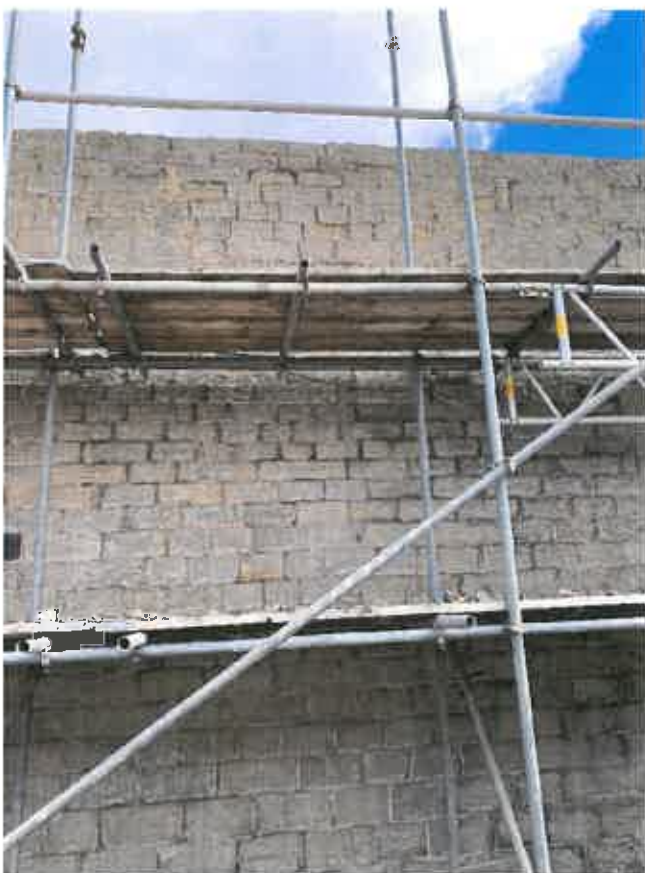
*Photograph 3*

**2.04** The remaining barn walls are faced with a coursed local stone with narrow beds joints. See photograph 3. The inner leaf is of random stone and there is a poor, loose rubble fill. See photograph 4.

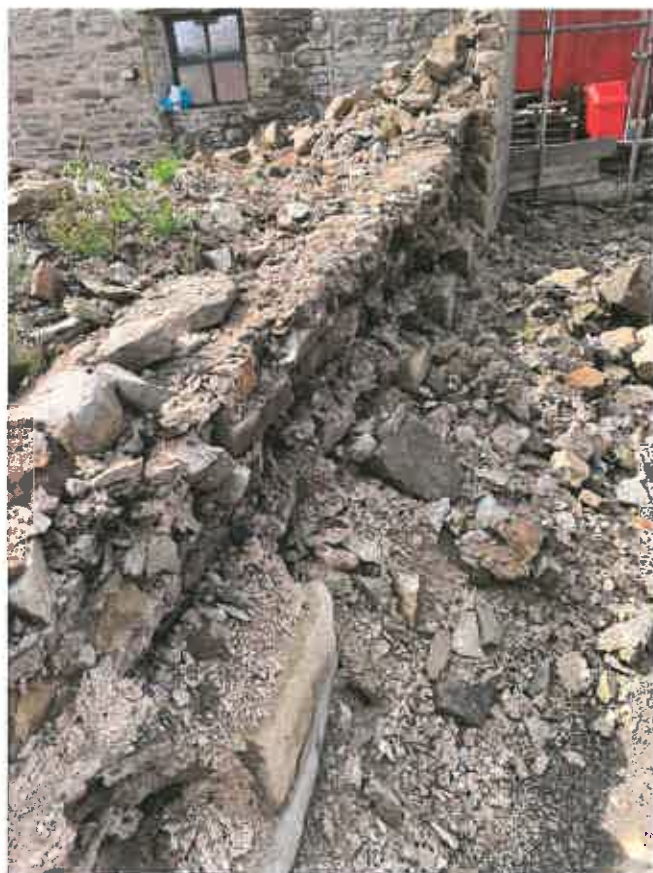
*Photograph 4*

The inner face is of random stone set in a relatively poor, lime mortar matrix. With local patch re-pointing in a lime mortar the inner leaf is deemed to be capable of being retained. In order to help stabilise the wall and avoid any further collapse, it is intended to carefully remove any loose mortar from the inner face and patch point as described.

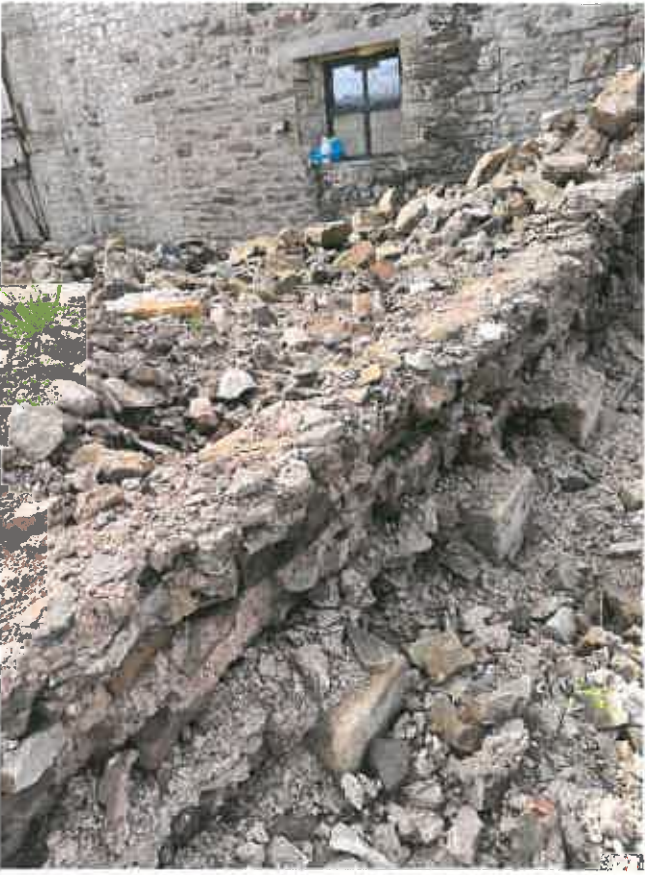
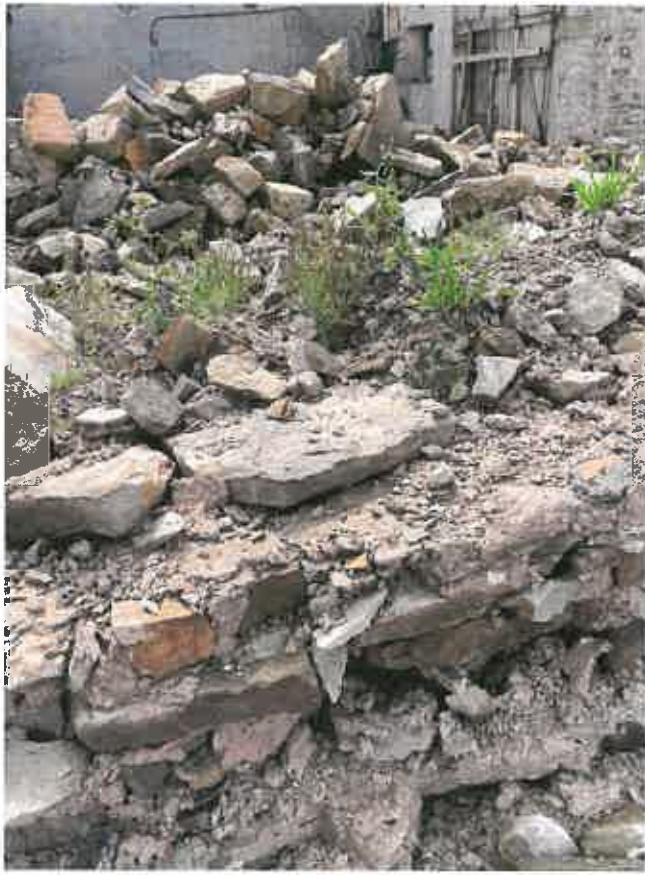
- 4.01** We believe the collapse of the left-hand side and the rear elevation was inevitable given the condition of the walls and the poor quality of the inner leaf matrix and the loose rubble fill. See photographs 15 & 16. The loss of lateral restraint due to the removal of the roof was also a contributing factor.

- 4.06** Given the nature of the remaining wall construction, it is in our opinion that the collapse was unfortunate but inevitable.

- 4.02** To this end, we have recommended action that will stabilise the remaining elements prior to any further work being undertaken.

The elevations to be rebuilt will be backed up with a blockwork inner leaf. This will need to step around areas of the external wall that remain standing.
