Validation Report  
Land off Don Street, Middleton

Reference: 14-554-R8-2  
Date: November 2024

# REMEDIATION AND ENABLING WORKS VALIDATION

Land off Don Street  
Middleton  
Greater Manchester  
M24 2DB

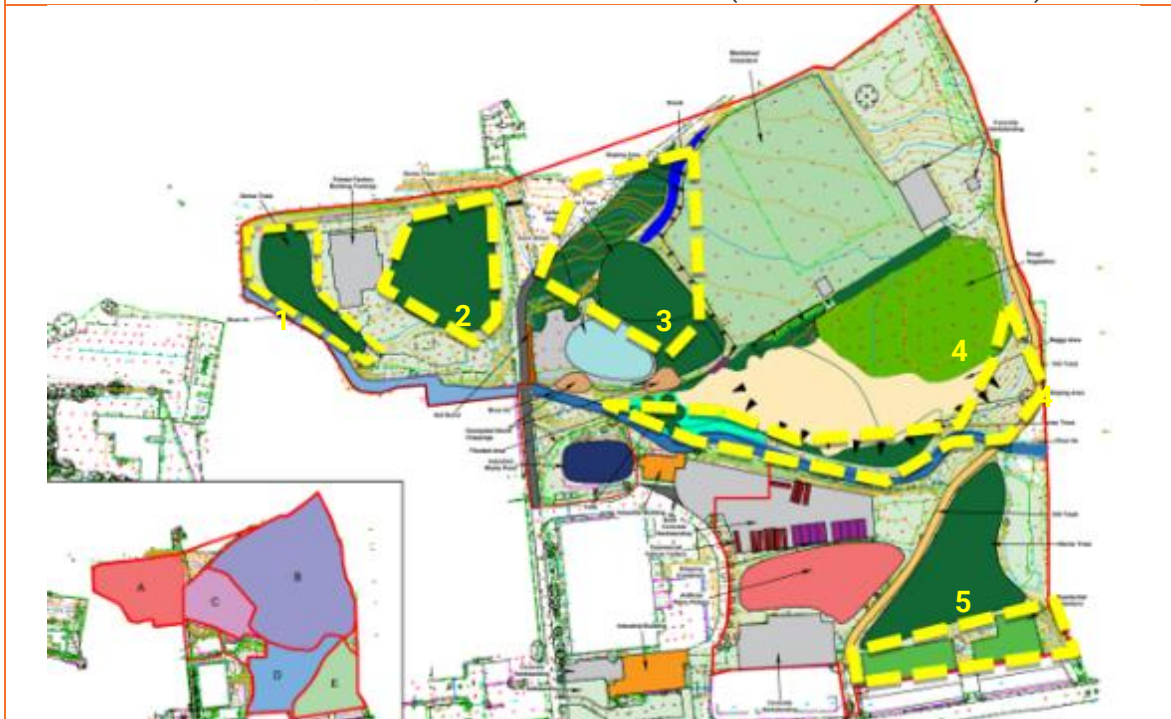
FIGURE 4.1 – AREAS REQUIRING FURTHER INVESTIGATION (YELLOW DASHED AREAS)

| Within Areas 1-4, as shown on Figure 4.1 overleaf, multiple phases of supplementary trial pitting were undertaken on the 8 <sup>th</sup> and 9 <sup>th</sup> of February 2022, 8 <sup>th</sup> of March 2022 and 10 <sup>th</sup> May 2022 to record ground conditions and obtain geotechnical and geochemical samples. Additional investigation of potential peat deposits in Area 3 (Phase 2A) were undertaken within these phases of supplementary trial pitting. The further investigation did not identify any true peat deposits, only very soft to soft clays with a shear strength value (Cu) of less than 30 kN/m <sup>2</sup> , the material is not suitable for vibro stone columns and requires removal with granular replacement during remedial works in this area. |

Granular replacement of soft organic clays in Area 3 (Phase 2A) was completed in January and February 2023.

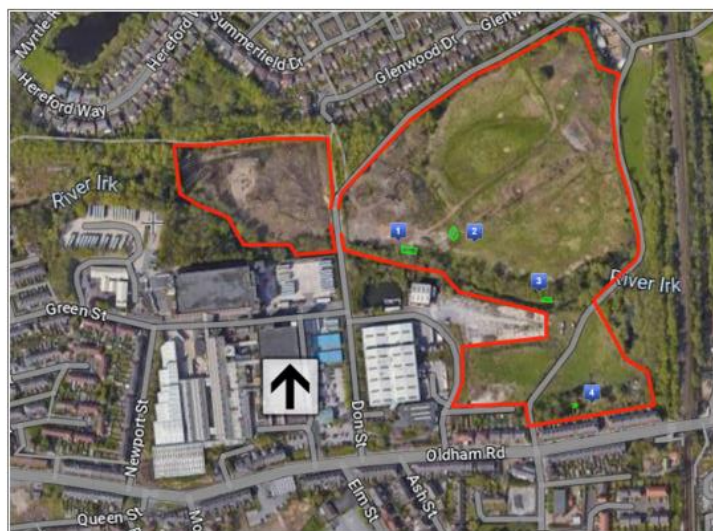
FIGURE 4.3 – JAPANESE KNOTWEED LOCATIONS

Japanese Knotweed impacted materials were excavated under the supervision of Knotweed Eradication in April and May 2023. Material excavated in April 2023 was placed in a temporary stockpile area on visqueen sheeting, tested by E3P, and subsequently removed from site. Impacted material excavated in May 2023 was placed directly into wagons and removed from site. A validation report was prepared by Knotweed Eradication (IWMP2255A, dated October 2023) that is available upon request to Kellen Homes or Urban Regen.

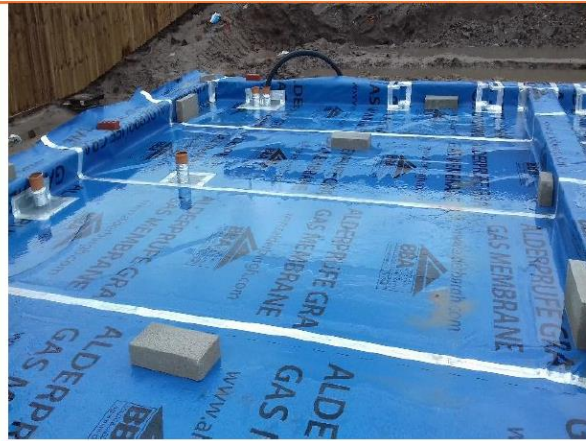
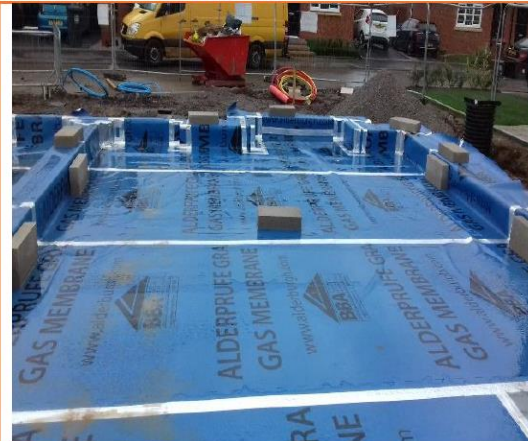
Plot – 236

General Condition of Membrane-Good Condition

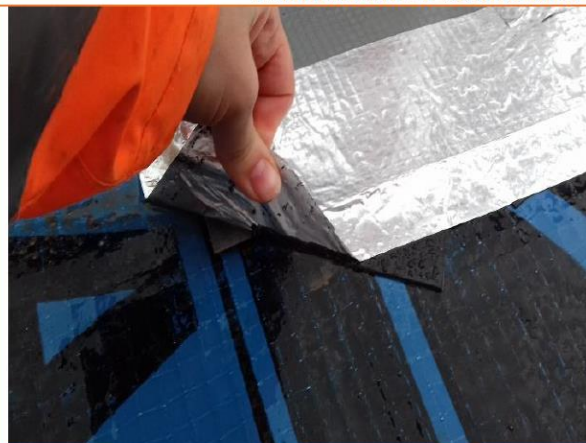
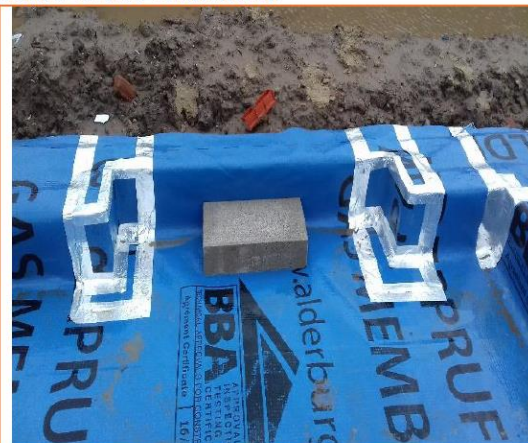
Verification of Joints and Seals-Good Condition

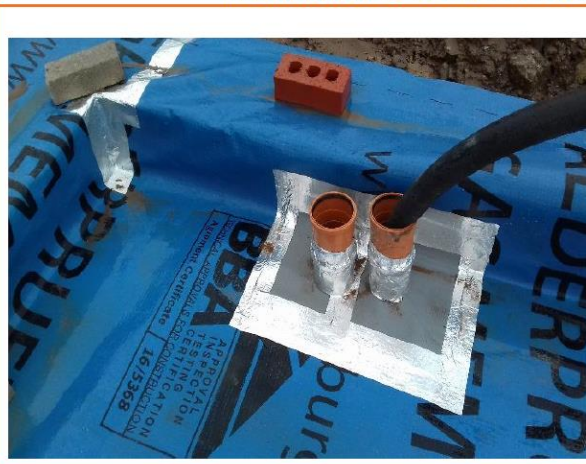
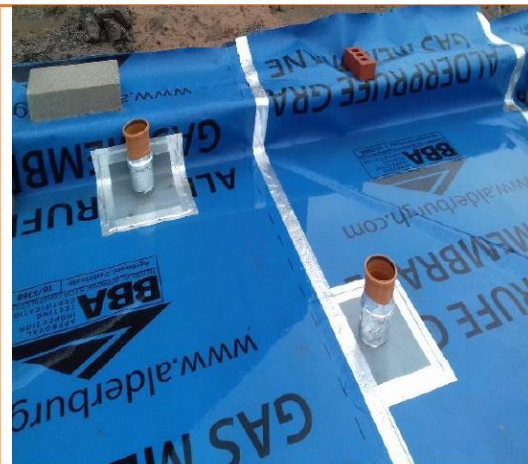
Verification of Service Penetrations-Good Condition
