**Project****Project Name:** 2023-07-20641 Kellen Homes Castleton Manchester OL11 3BX**Project Date:** 07/08/2023**Inspection Standard:** MSCC5 Sewers & Drainage GB (SRM5 Scoring)

## Section Inspection - 03/08/2023 - MH2X

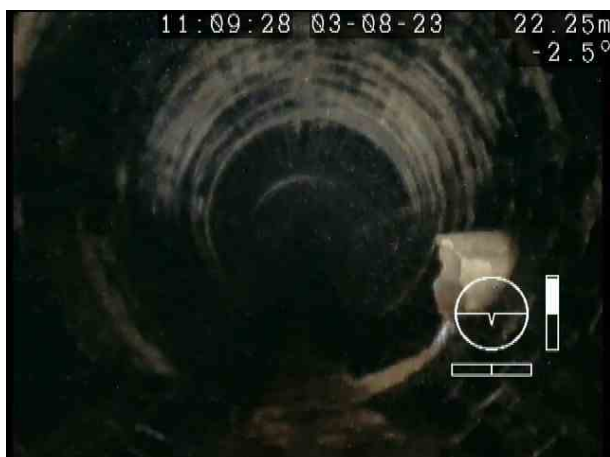
| Scale: 1:561 | Position [m] | Code | Observation | MPEG | Photo | Grade |
|---|---|---|---|---|---|---|
| | 22.25 | CN | Connection other than junction at 02 o'clock, 255mm dia | 00:01:46 | MH2X_0ce<br>11f09-7e9<br>3-46ff-b01 | |

MH2X\_0ce11f09-7e93-46ff-b017-77710b23b2b6\_20230807\_143823\_705.jpg, 00:01:46, 22.25 m  
 Connection other than junction at 02 o'clock, 255mm dia

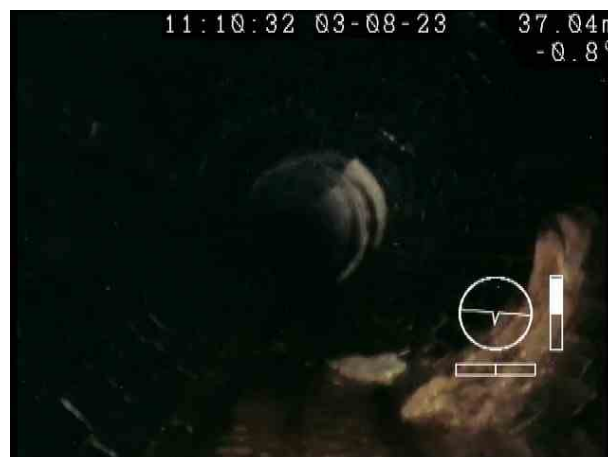
| Scale: 1:561 | Position [m] | Code | Observation | MPEG | Photo | Grade |
|---|---|---|---|---|---|---|
| | 37.04 | CN | Connection other than junction at 03 o'clock, 225mm dia | 00:02:51 | MH2X_ed<br>12cab5-16<br>6a-4e04-9 | |

MH2X\_ed12cab5-166a-4e04-9059-7607abf8a7c8\_20230807\_143902\_719.jpg, 00:02:51, 37.04 m  
 Connection other than junction at 03 o'clock, 225mm dia

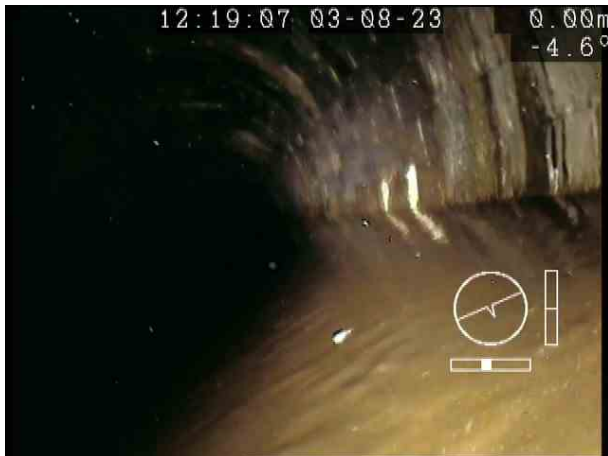
| Scale: | 1:50 | Position [m] | Code | Observation | MPEG | Photo | Grade |
|---|---|---|---|---|---|---|---|
| | | 0.50 | DES | Settled deposits, fine, 25% cross-sectional area loss | 00:00:30 | MH3X_19<br>79f13f-2ce<br>f-4281-873 | 4 |
| | | 0.50 | SA | Survey abandoned: tyoo much silt in pipe | 00:00:30 | | |

MH3X\_1979f13f-2cef-4281-873c-6da0f7b91a3c\_20230807\_1  
 44220\_784.jpg, 00:00:30, 0.50 m  
 Settled deposits, fine, 25% cross-sectional area loss
