R3347

SYKE HOUSE FARM – SYKE ROAD, LITTLEBOROUGH,  
OL15 0AH

# REPORT ON STRUCTURE

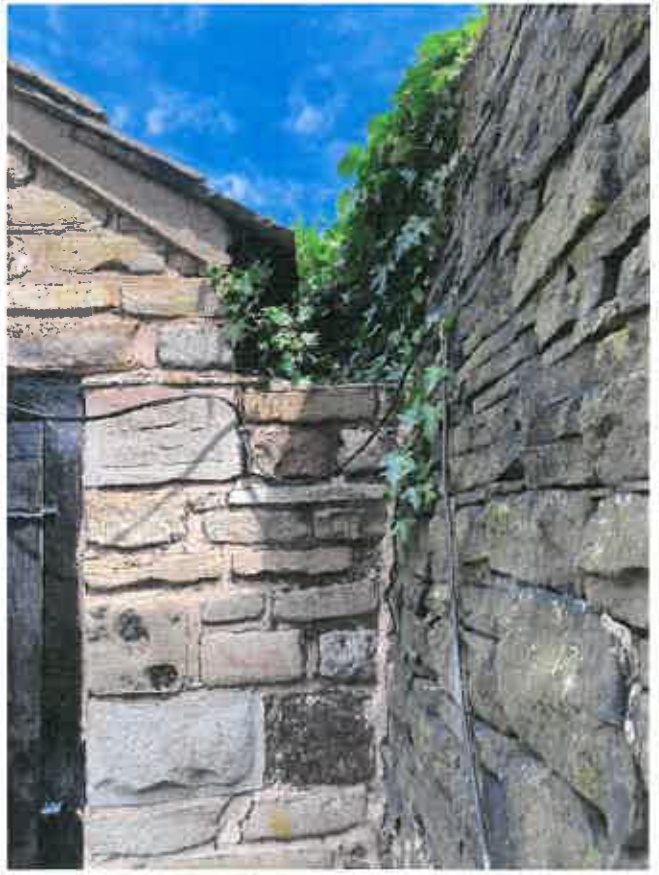
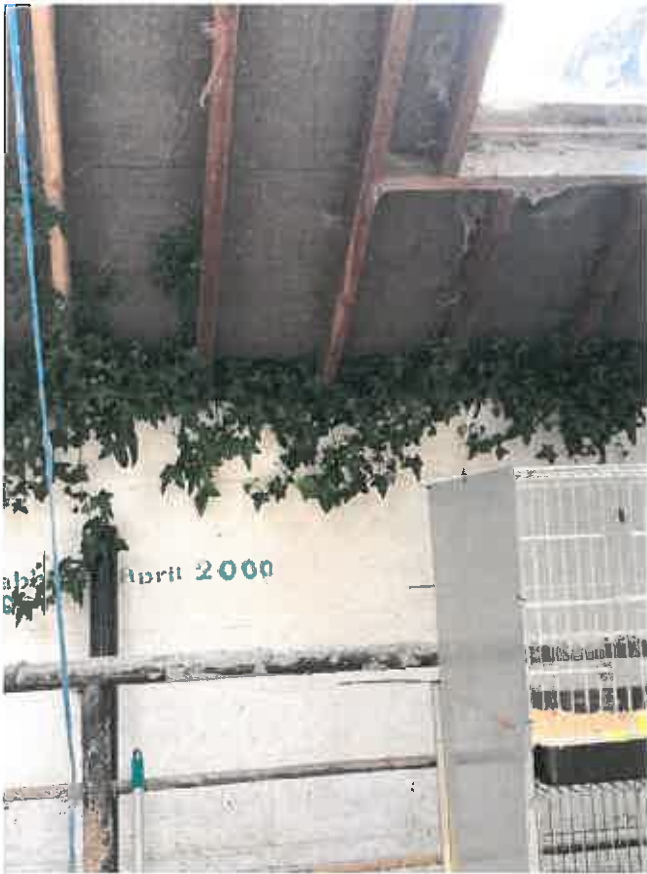
The gutter and the area to the rear of the left-hand wall is filled with plant growth, some of which has extended into the rear of the cow shed. Photographs 8 & 9. This will need to be cleaned and removed.

- 4.01** The Cow Shed is considered to be in a good structural condition and is deemed fit for purpose.
- 4.02** The rear gutter area should be cleaned, and the vegetation should be removed. No further remedial action is required to the Cow Shed.

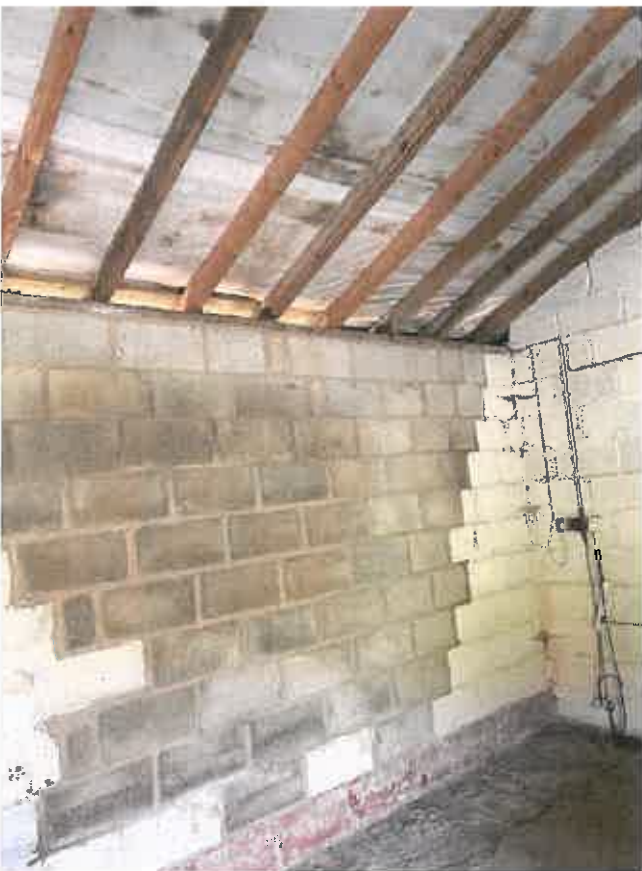
*Photograph 19*

The property has previously suffered damage from a falling tree. This caused damage to the rear elevation. The area of damage can be seen as being repaired with new blockwork, photograph 19.

We understand the above repair works were undertaken as an insurance claim.

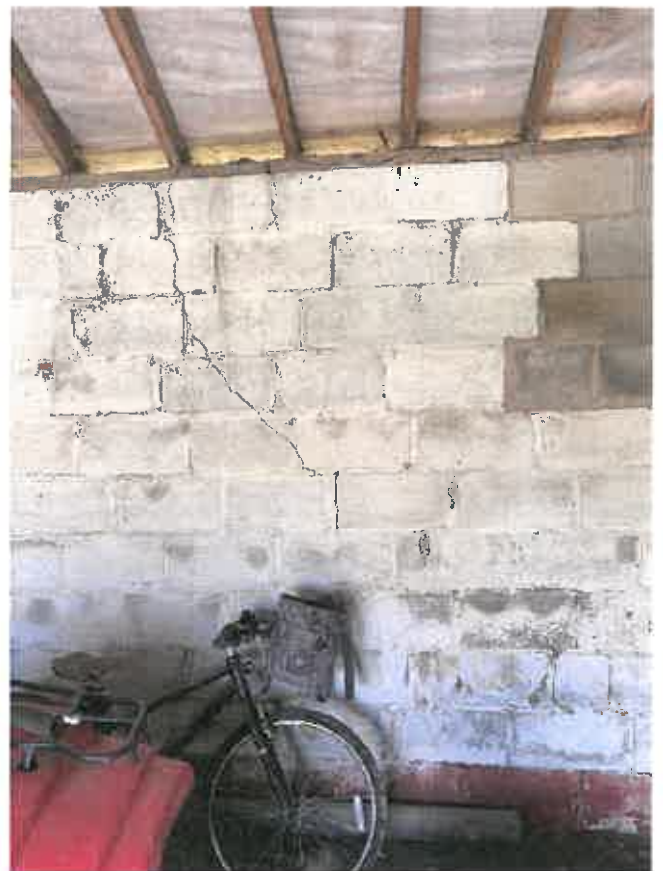
*Photograph 20*

On the rear elevation there is cracking in the original inner leaf to the left of this new blockwork. Photograph 20. The crack is considered to be a remnant of the original damage and is not due to any recent movement.

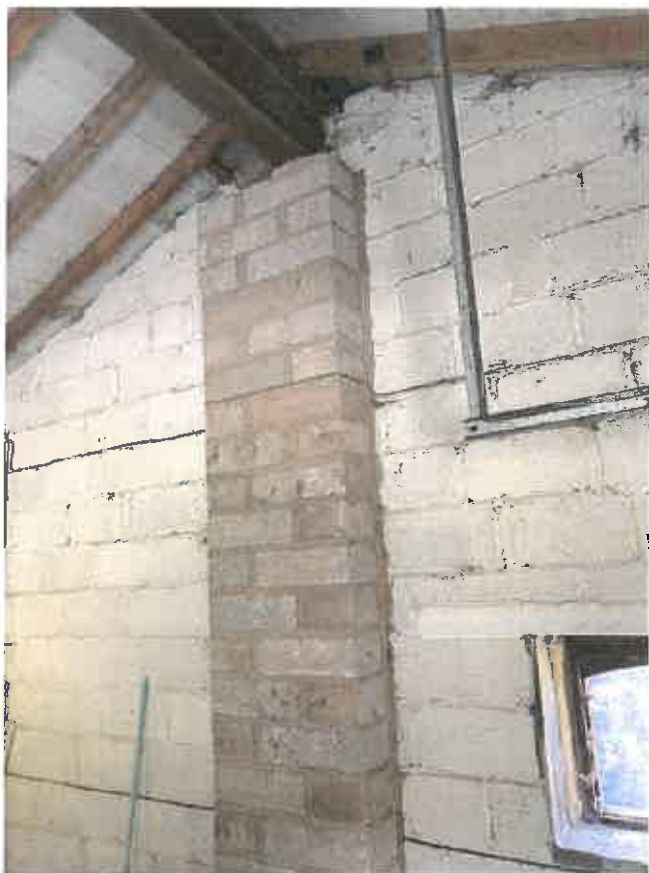
Photograph 21

As part of this claim, an internal blockwork pier was built centrally on the right-hand gable to provide additional support to the steel ridge beam. Photograph 21. This is serving its intended purpose.

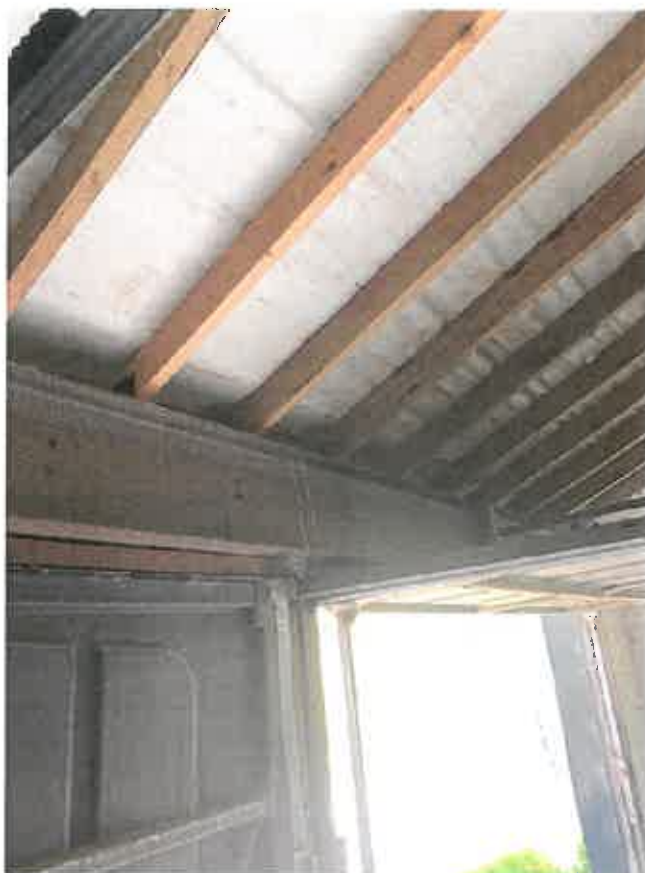
Photograph 22

There is a large steel beam spanning the opening for the two doors. This is of significant proportions and is well over designed for the span and load. Photograph 22.

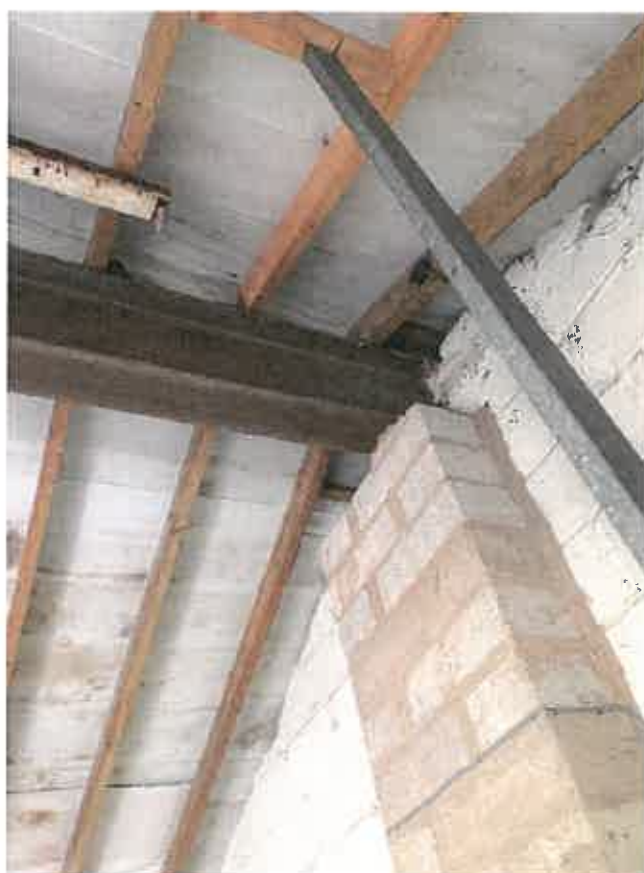
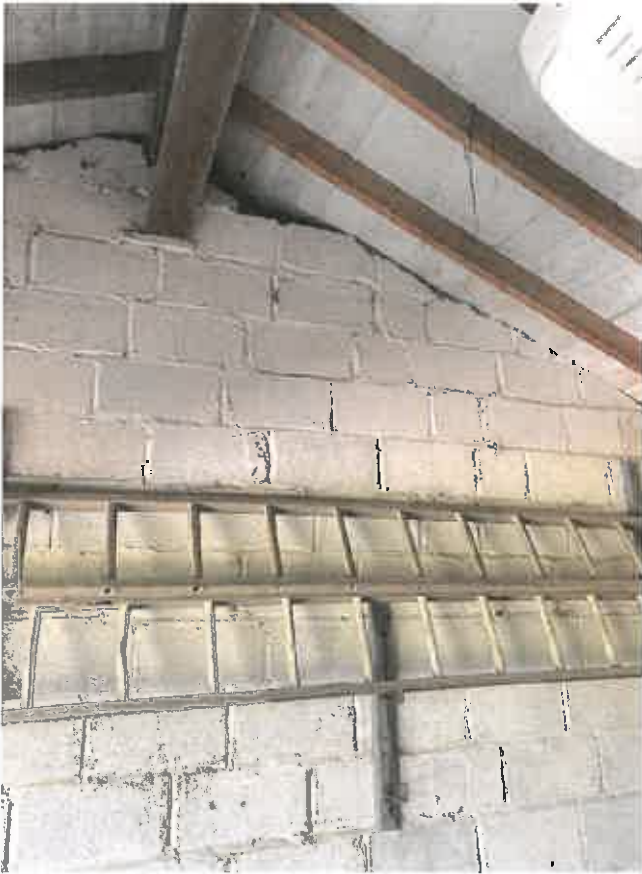
The ridge beam is also of significant proportions and although there are no padstones at each end of the beam, we do not believe this to be a significant structural issue. Photographs 24 & 25.

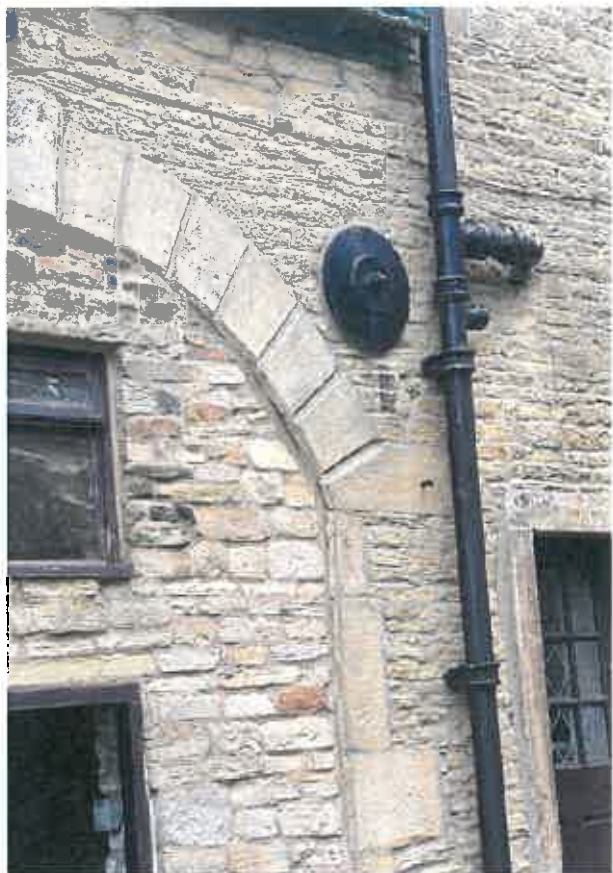
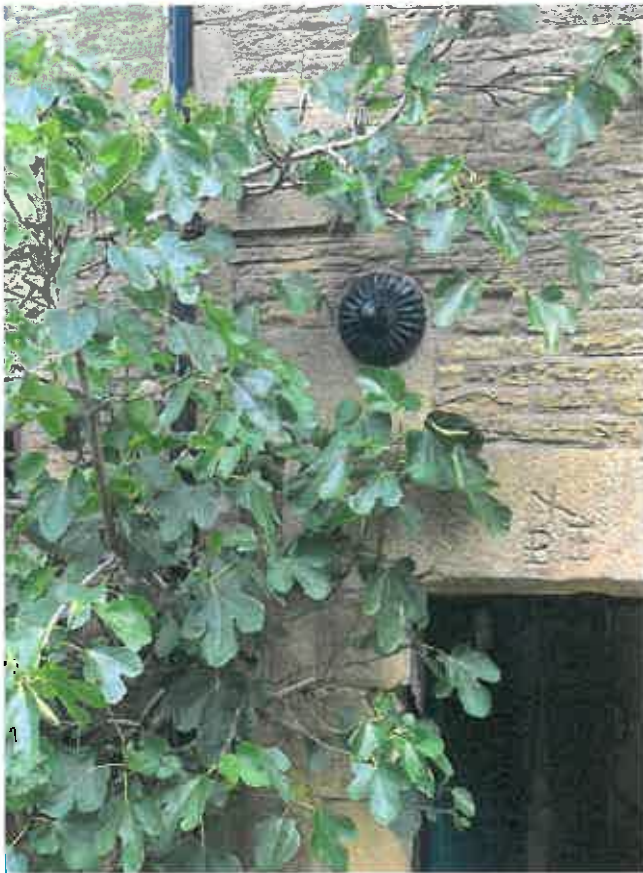
On the rear elevation of this section. The cart arch has been infilled with a door and a window. To the right of this is a further small arch window and a door mirroring that at the front. Photograph 32. There is a straight joint between this and the next part of the property. There are tie bars and pattresses on the rear elevation of this section. Photographs 33 & 34.

The rear elevation is more out of plumb, hence the need for the tie bars and pattress.

The rear elevation has also bulged in places causing the need to introduce tie bars and pattresses. There is no evidence of any current movement associated with the above.

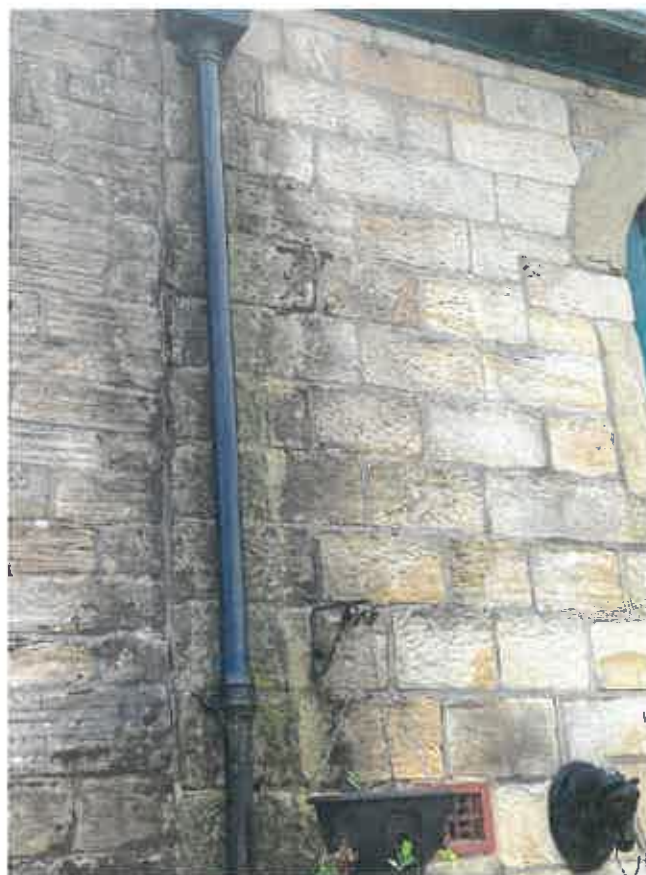
Photograph 50

There is slight movement at the junction of the separate builds, but this is considered to be well within acceptable tolerances and does not give cause for concern. No remedial action is required. Photograph 50.

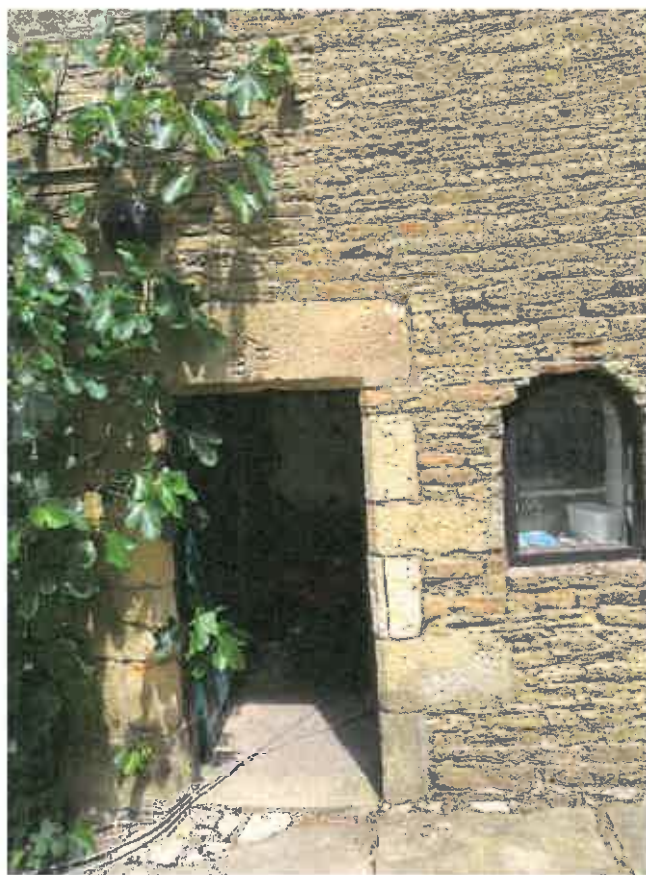
Photograph 52

There has been past movement over the right-hand door into the tool store. The lintel in this, falls towards the left. This is clearly old and longstanding and does not give cause for concern. Photograph 52.

- 4.04** The main barn has not suffered from any significant subsidence or settlement. There has been past settlement noted in the rear door over the tool room. This is old and longstanding and does not give cause for concern. Movement to this property is mainly of a lateral nature where the trusses have rotated towards the right.

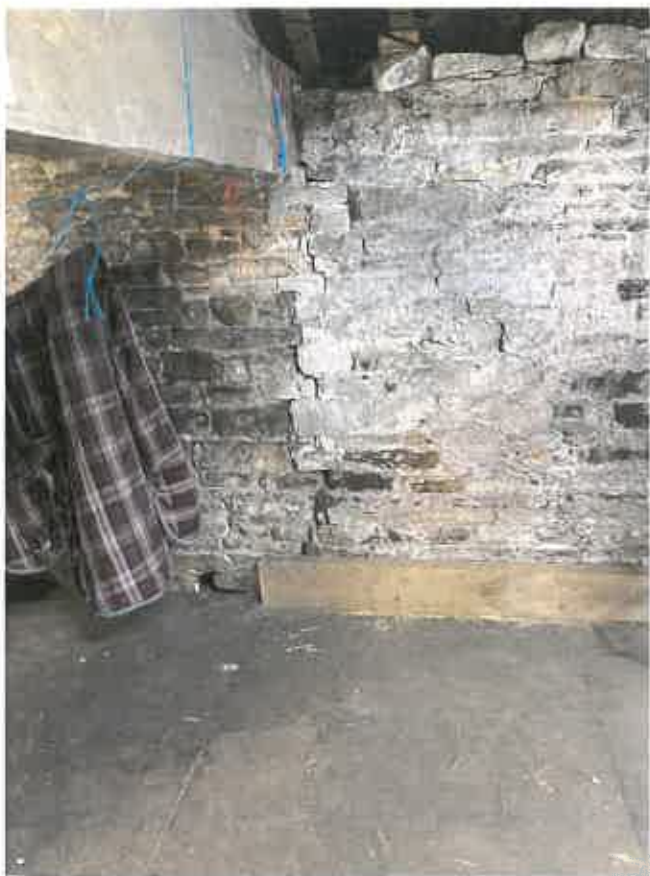
*Photograph 53*

Internally there are nominal cracks under the truss on the front left. These should be stitched with helical bar. Photograph 53. See attached data sheet CS01.

- 4.06** There are nominal cracks in the masonry both internally and externally. These can be stitched with a helical bar or similar. A data sheet explaining this has been added to the rear of this report.

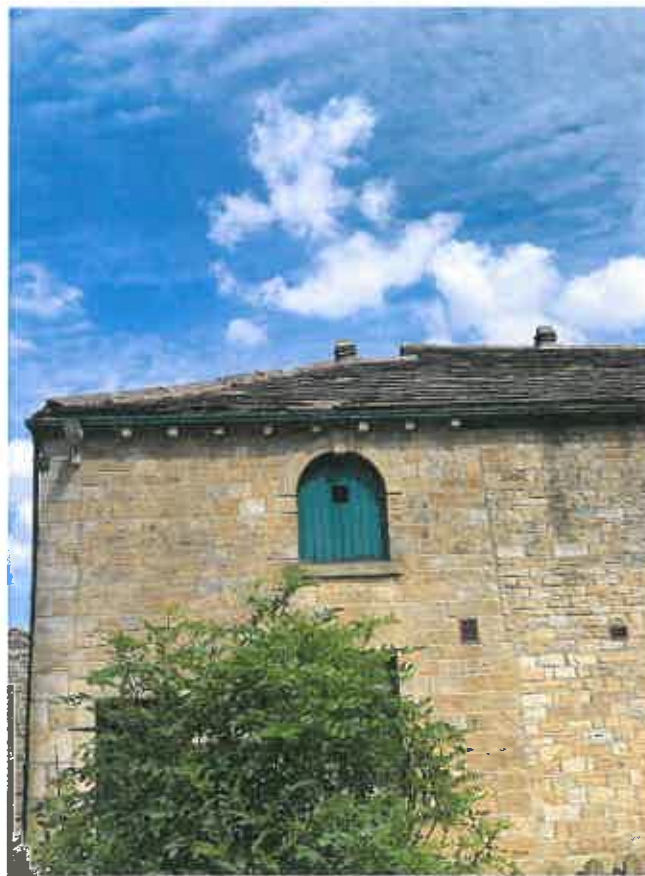
*Photograph 54*

The whole roof is covered with a heavy stone slate. The main roof line when viewed externally is uneven on most parts of the property but considered to be within acceptable tolerances. The right-hand hipped roof is visually uneven, particularly on the rear hip, but seems to be serving its intended purpose at the time of our survey, photograph 54.

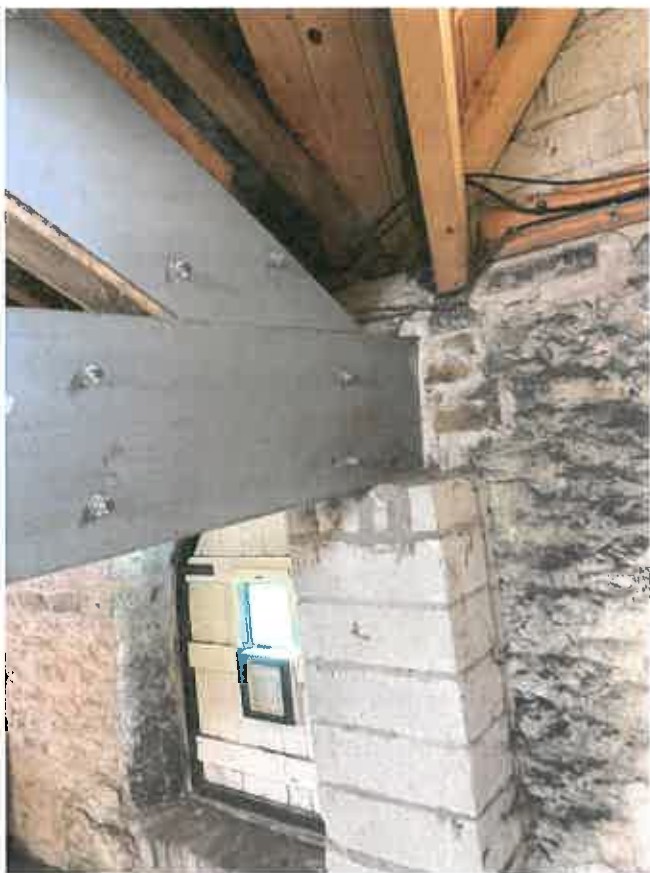
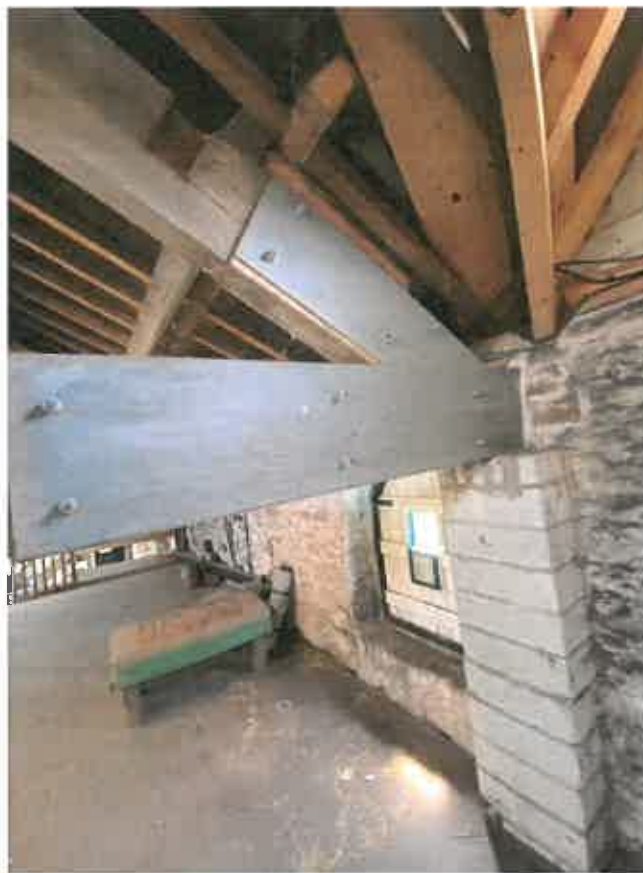
The property roof has leaned to the right at some point in the past, causing distress to the trusses.

The trusses have been strengthened and repaired in the past. There are steel plates and additional blockwork piers under the supports, Photographs 55 & 56.

- 4.05** The movement and the decay to the trusses has resulted in significant past repairs. At the time of our survey these were deemed to be generally satisfactory.

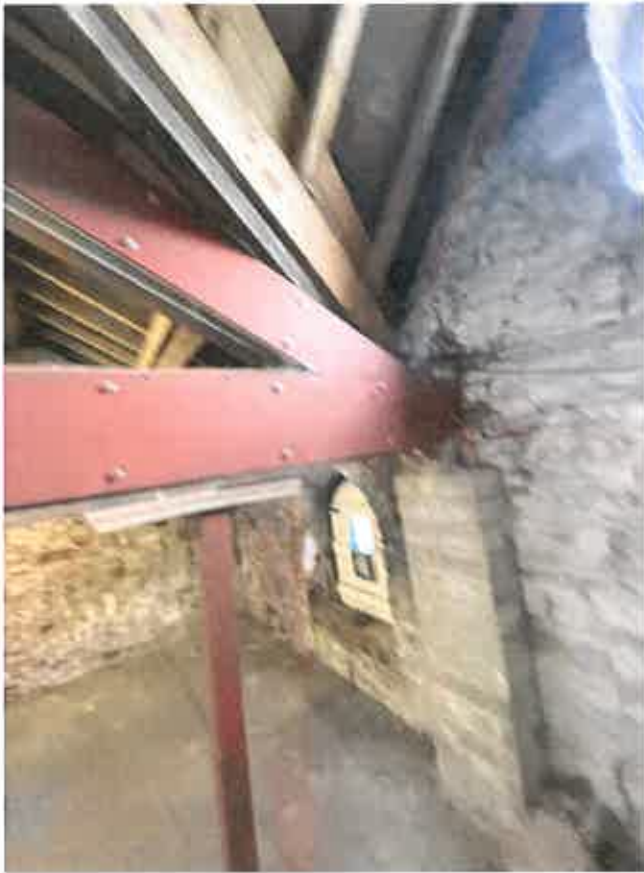
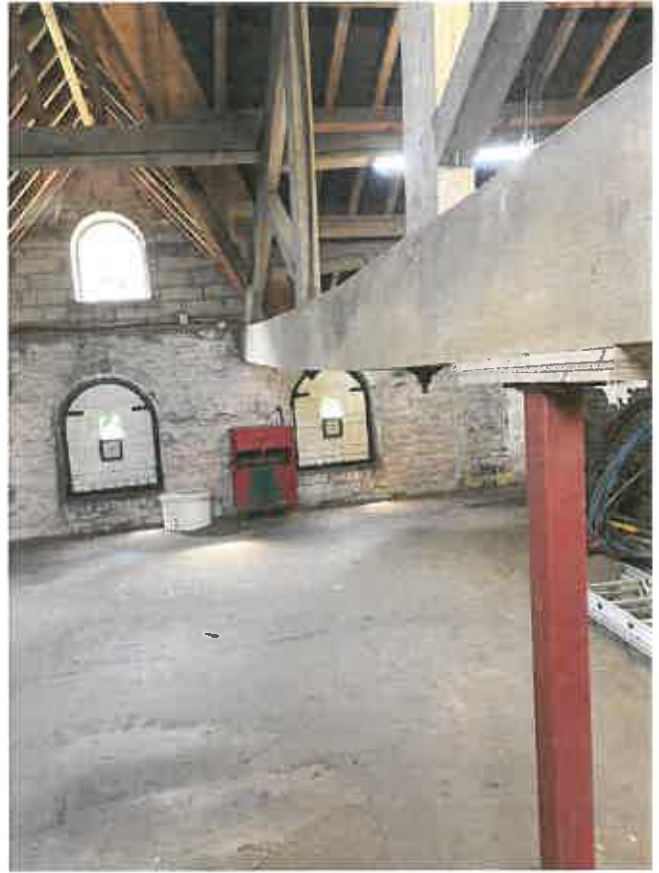
In the case of the fourth truss from the right, there are steel posts providing additional support. Photographs 57 & 58.

The support for the two steel posts providing the additional support to the fourth truss could not be determined. We believe the post nearest to the front elevation is propped directly off the hay loft floor and rear post is in line with one of the main wrought iron support beams.

There are no signs of any current movement. No remedial action is deemed necessary at this time.

Some of the areas of additional support are not structurally provable by calculations. There are props on the hay loft floor and there are areas where the new blockwork piers do not extend to ground level. Notwithstanding the above, there are no signs of any current distress, and no remedial action is deemed necessary at this time.

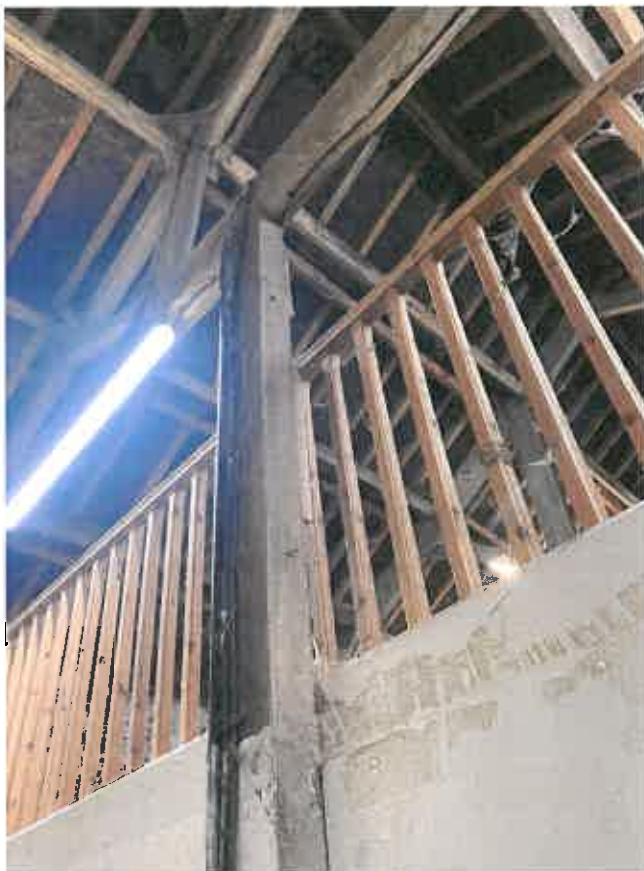
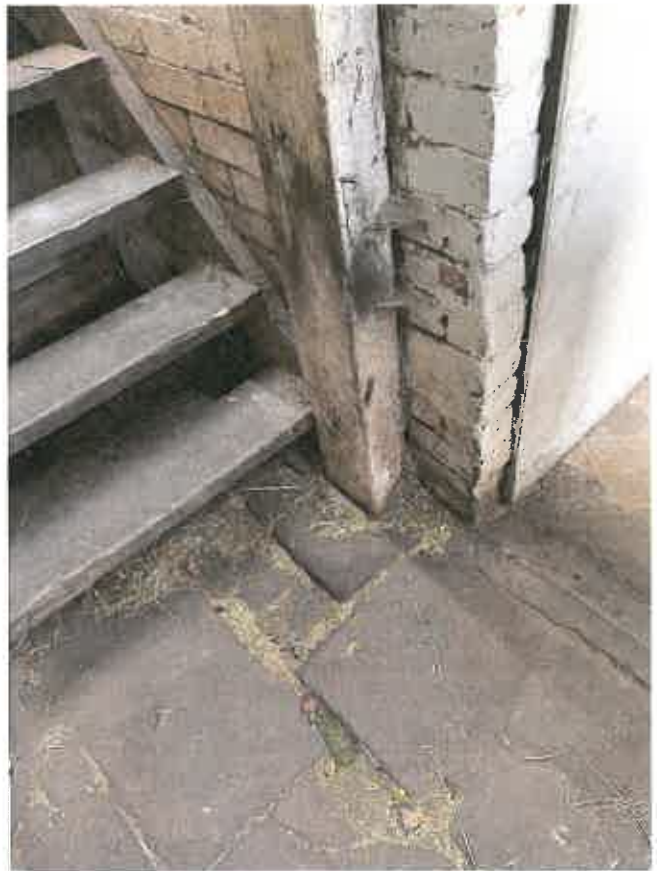
The first truss from the left is propped by a timber member but directly off the floor. Photographs 59 & 60.
