# Report regarding the Roofing Works at: The Lower Falinge Development, Rochdale

**Prepared for:** P. Casey & Company Ltd

**Date of Inspection:** Tuesday 12th March 2024

**Reference:** 3749 March 2024

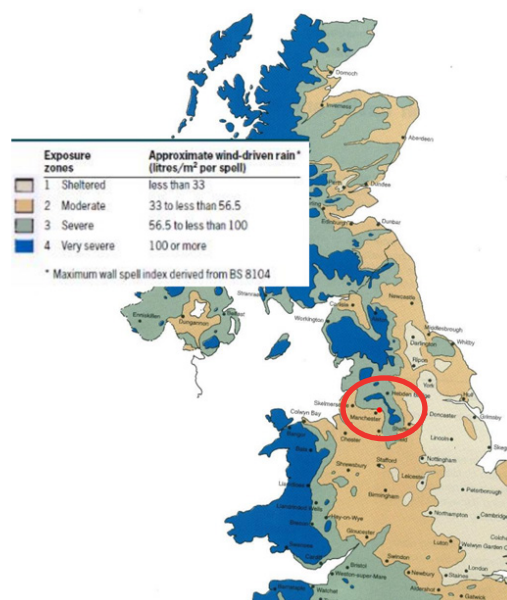
Figure 1: Map of UK exposure zones from BR 262, based on BS 8104 calculation methodology

Rochdale is approximately indicated by the red dot, it is in the moderate to severe Exposure Zones 2/3

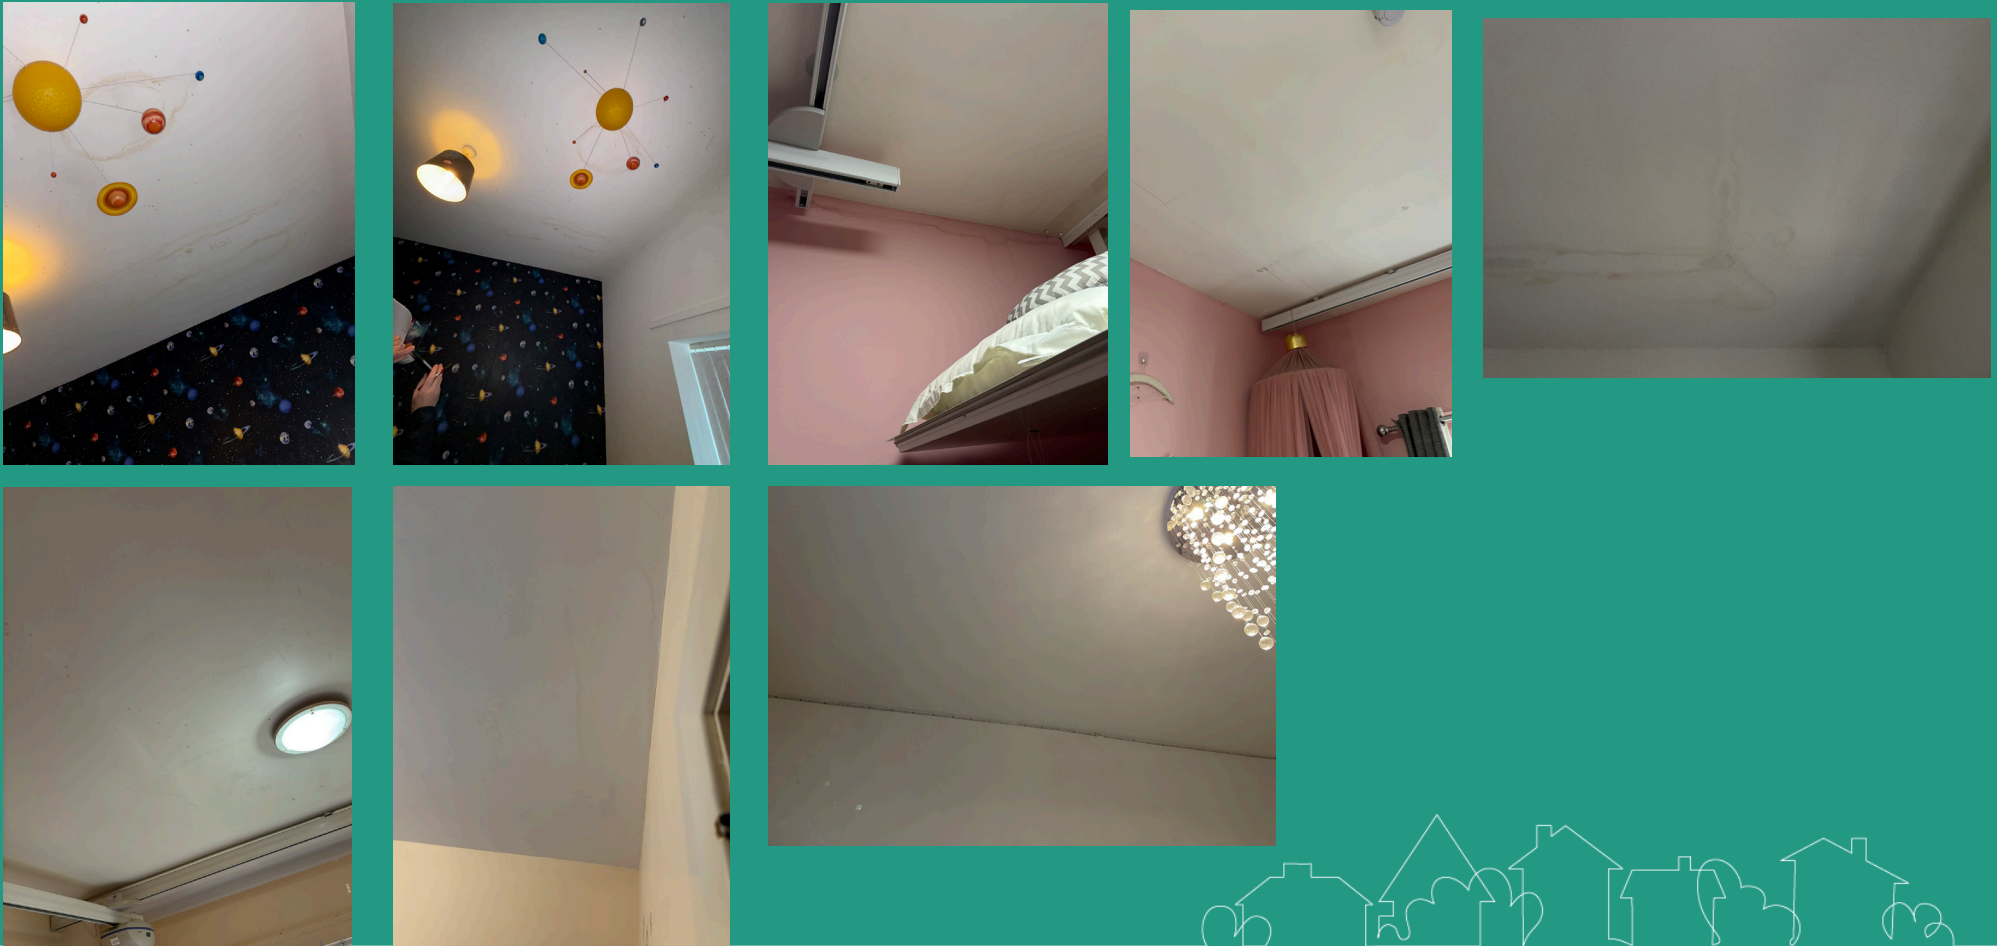
## Typical Examples of internal water ingress

Water ingress is occurring on the 17.5 degree pitched roofs and not occurring on the 35 degree roofs. Water staining is generally evident on plasterboard internally in the properties inspected, below the 17.5 degree roof and also at ceiling level junction with wall. Water ingress is evident in roof spaces too on the rafters in the lower third and white mould is evident on the underside of the felt on the 17.5 degree underside. On the box gutter junction between the 17.5 degree roof on the lower gutter, there is water ingress and damage to top layer of plywood.

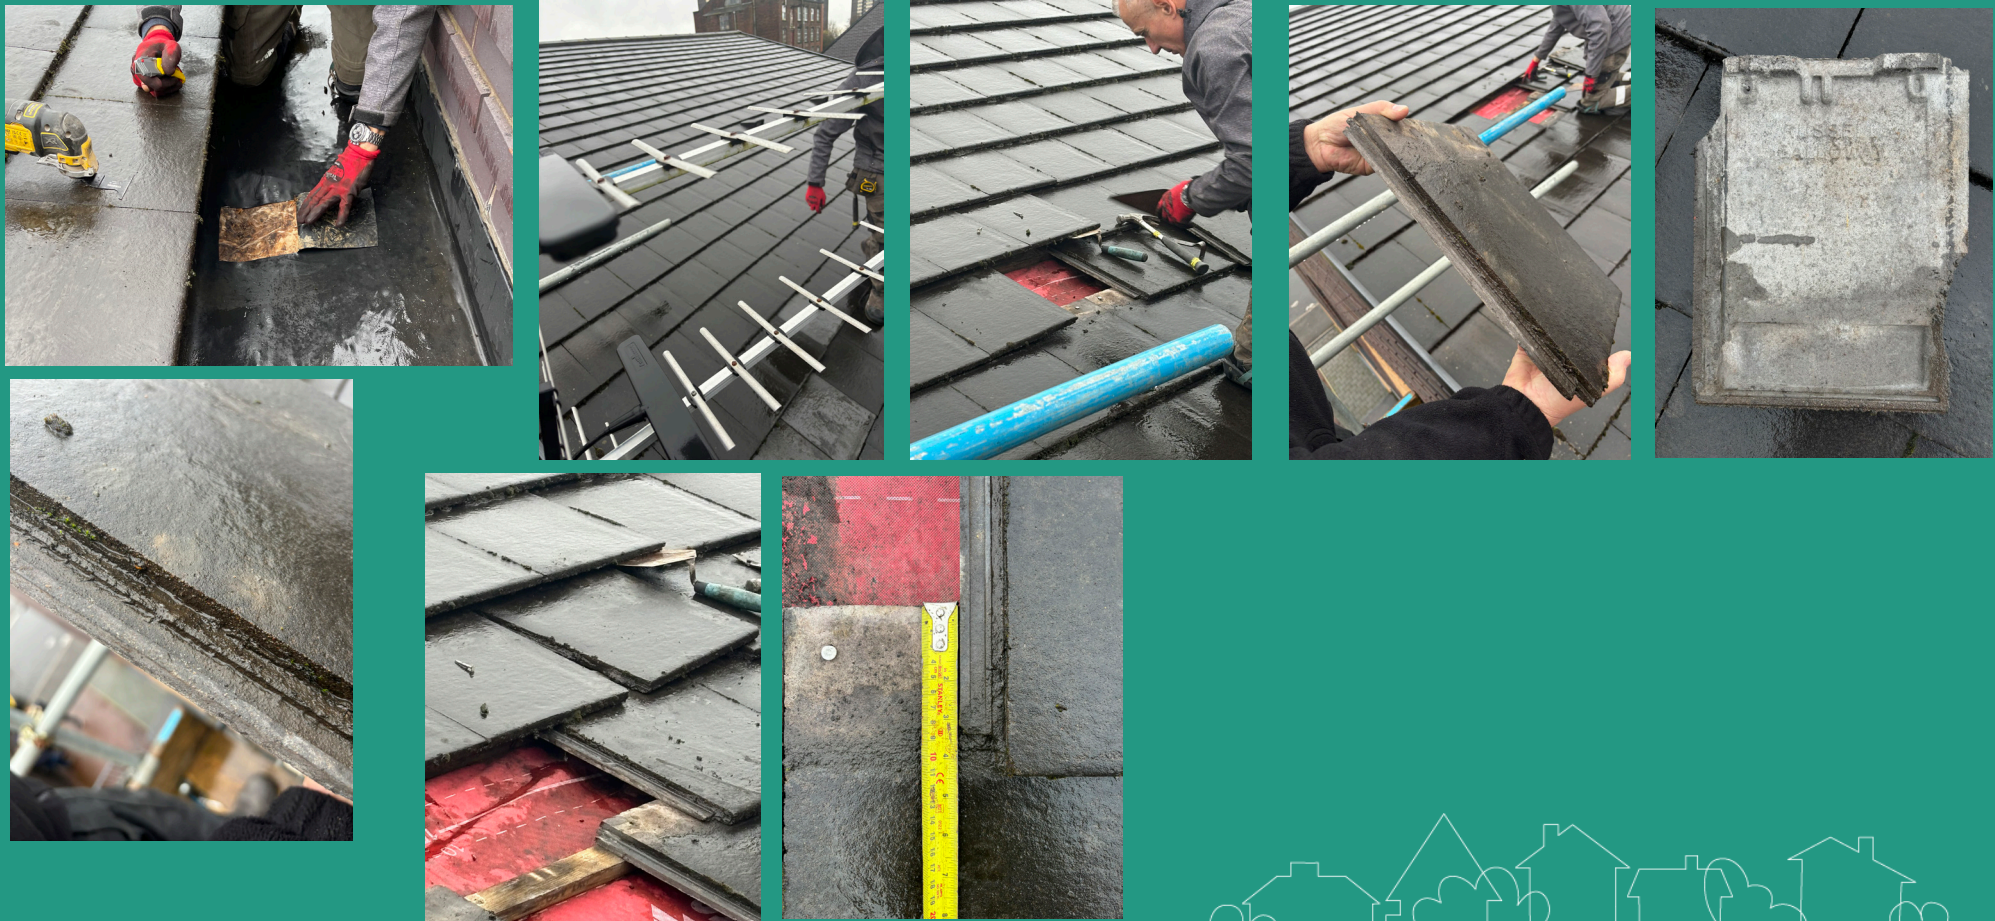
## External investigations

Externally a roofing contractor opened up an area of the 17.5 degree tiled roof at 6 Waterhouse Street. The roof tiles were stripped approx. 1m<sup>2</sup> and the gutter detail was opened approx. 150mm x 150mm. The opening up externally correlated to the internal water ingress evident on the ceiling in the property below. The area opened was an original tiled area circa 2016. Three Lidar scans were completed and 2 Endoscope surveys were taken.

The EPDM is laid loose onto 19mm Plywood. Under the outer plywood layer is a 50mm batten spacer followed by a second 19mm plywood layer with mineral wool below and foilbacked plasterboard. There is a lack of ventilation in the void between the 2 plywood layers and water ingress is evident at eaves tracking under the EPDM.

The black EPDM does not have any visible defects and looks intact and in reasonable condition. The plywood directly below has disintegrated for large parts for the lower gutter.

2. Replacing the box gutter arrangement to junctions of the 17.5 degree roof slopes with a traditional eaves gutter by extending the rafters to project beyond the face of the external walling at eaves level.

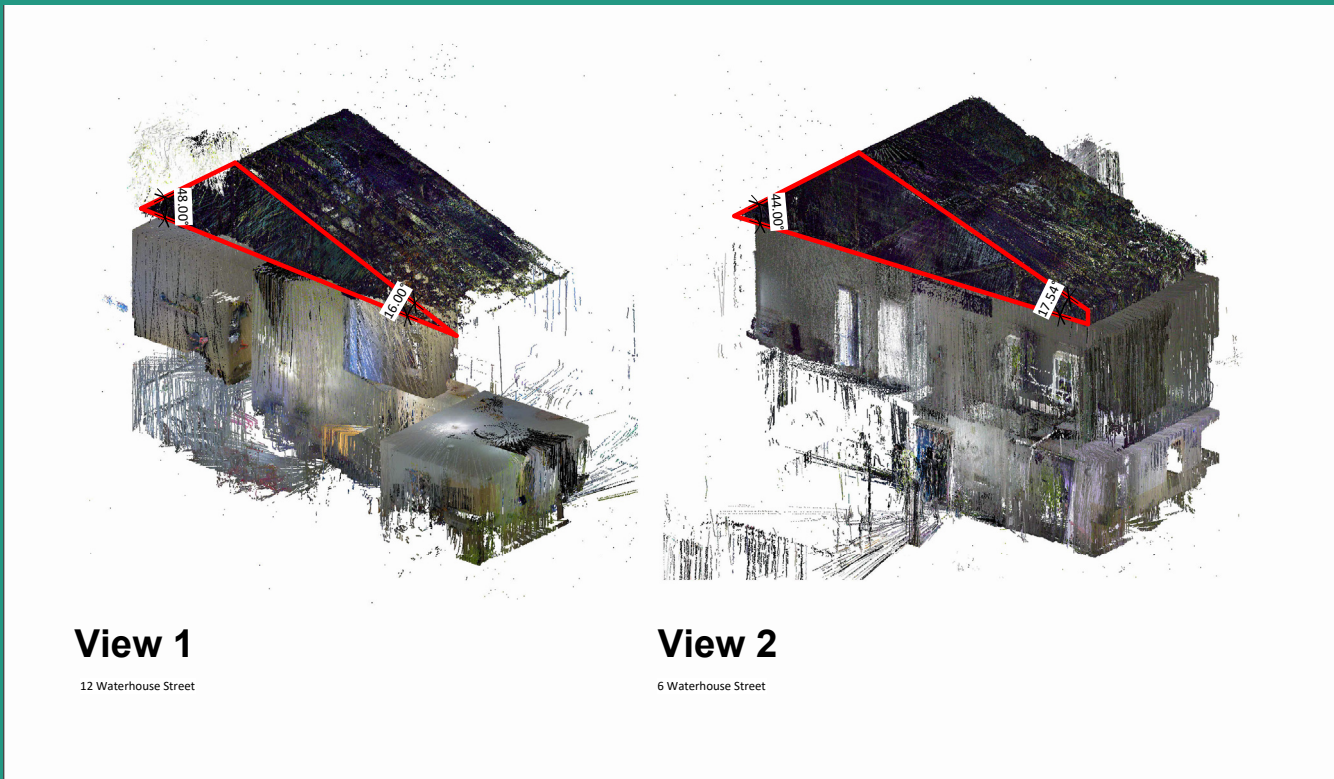
## 3D Views taken from Point Cloud

The rafter length is 6.7 metres on the 17.5 degree, measurements taken from the Lidar scan record 17.3 to 18 degrees pitch. The rafters are at 600mm centres. The maximum rafter length for the tile is 8 metres.
