### **Area 3 Works Overview**

# Manhole Record Card

| Job No | TS24-386 | Project | Stakehill Industrial Estate |

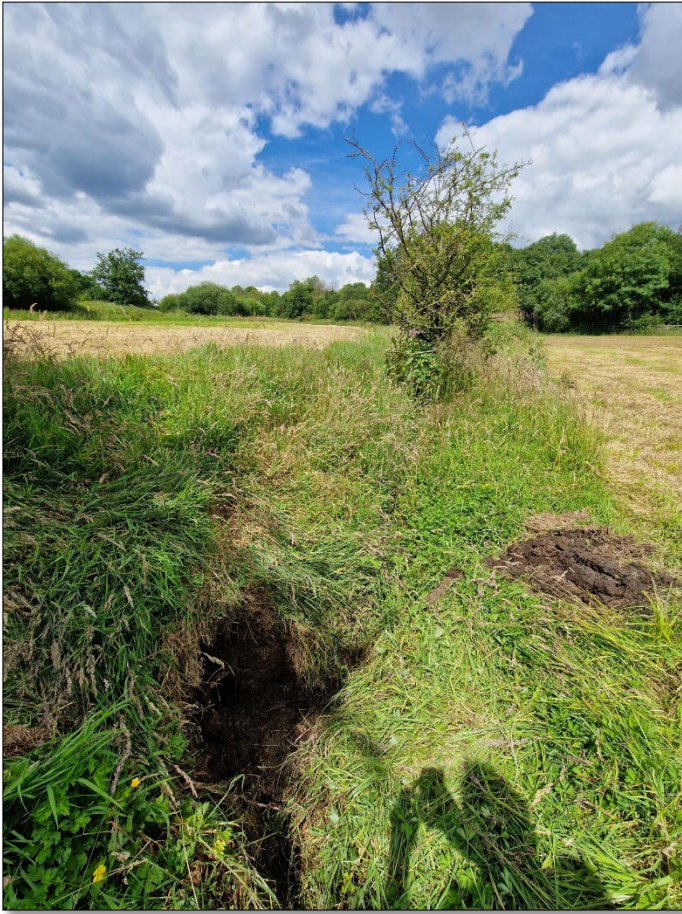
Undertook a visual survey to locate the open section of watercourse as detailed on the plan supplied and located the outfall which had become concealed with foliage and the collapsing bank.

**Watercourse Outfall Exposed for Access**

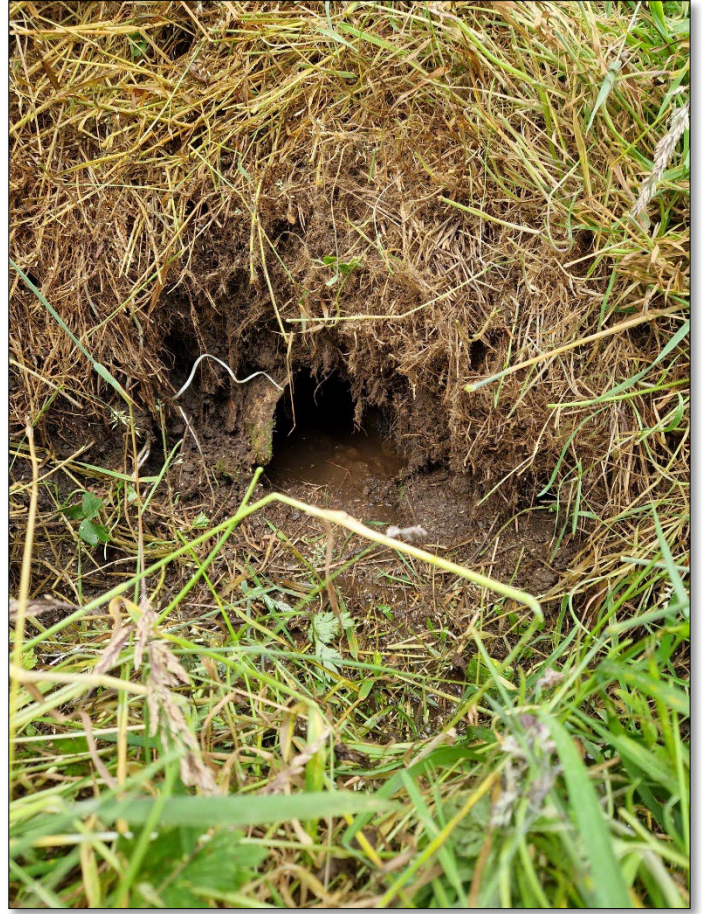
**Watercourse Outfall Location View**

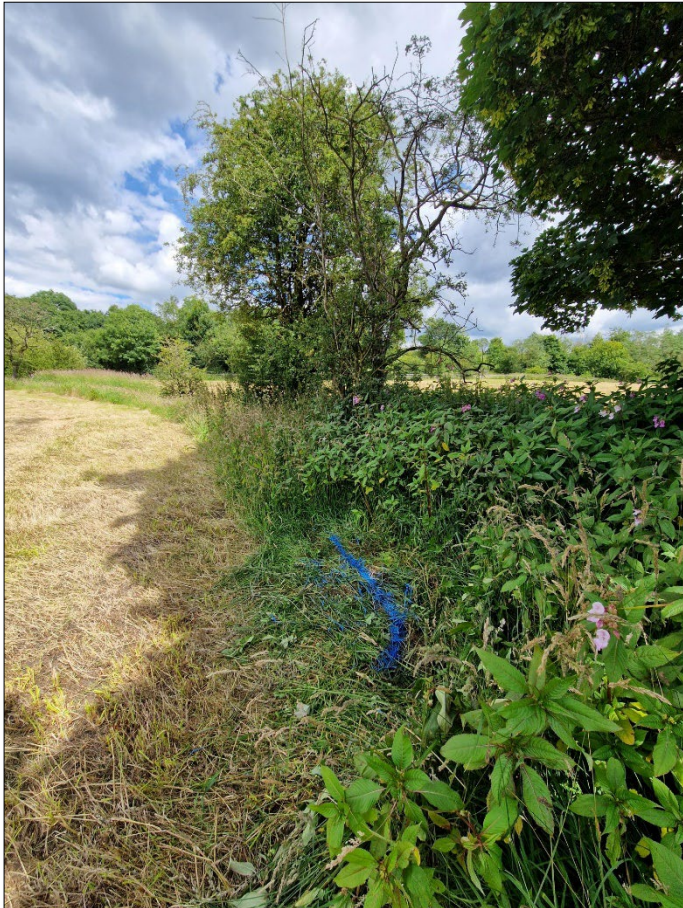
Exposed the pipe with hand tools to undertake electronic tracing of downstream line through to a possible stone built chamber/culvert.

Metal detected the area of line trace but were unable to pick up any positive signals for a potential manhole cover over a chamber.

**Pipe route and Location of Possible Chamber/Culvert**

- Excavate stone built chamber/culvert to access and determine its condition to enable further recommendations/requirements to continue survey.

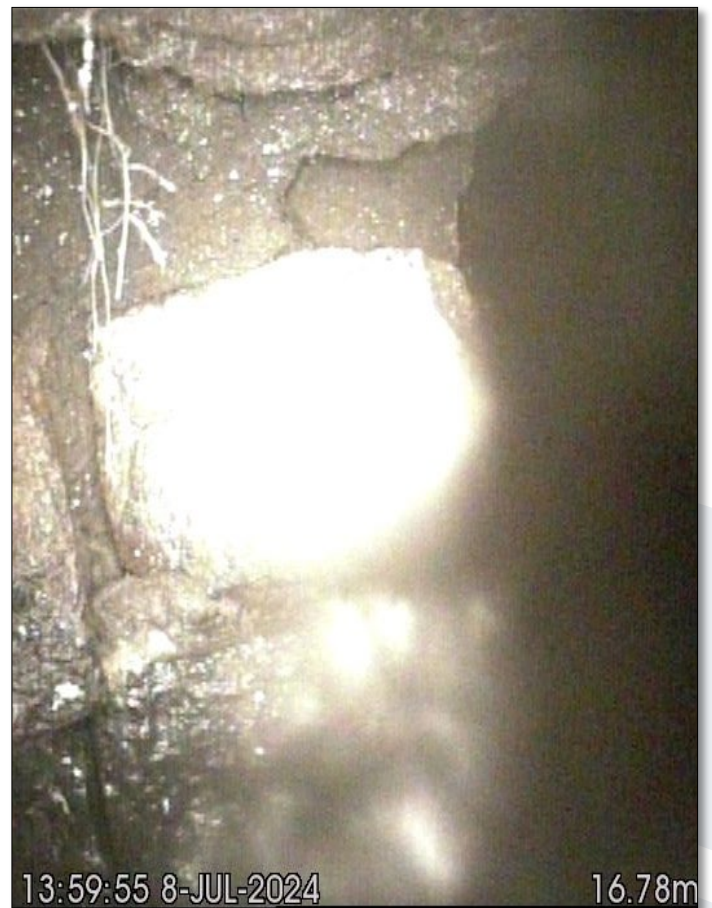
**Possible Chamber/Brick Culvert**

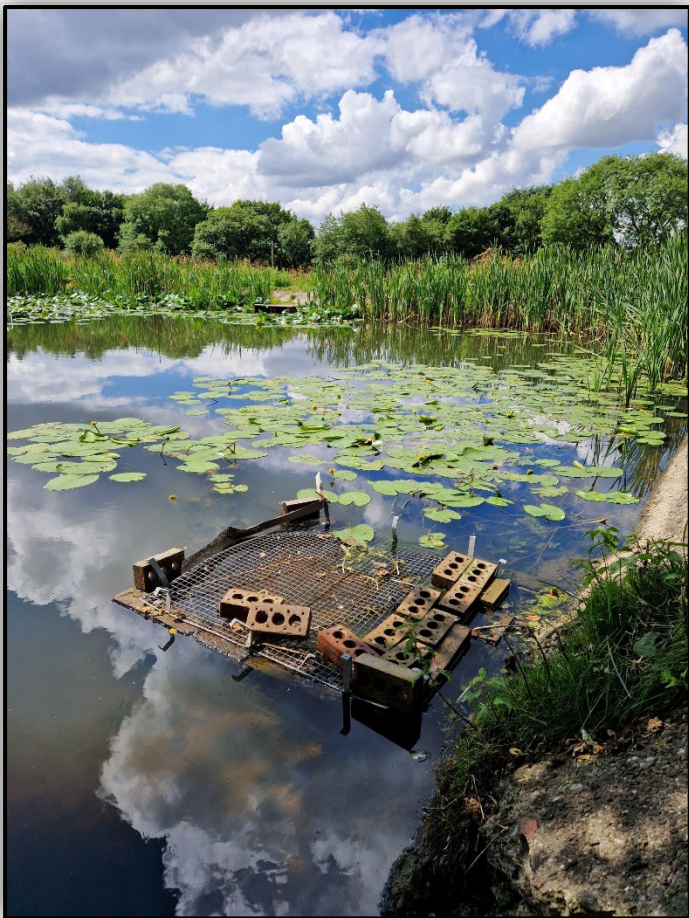
Arranged access with Fisheries contact to gain permission and access to the fishing lakes. A walkover survey confirmed the 5-tiered lakes to be fed via a watercourse running below the A627(M). The fishery lakes connect via linked pipework with water flowing to the bottom tier which contains a brick-built chamber and rising 150mm pipe which were confirmed to be surcharged and not flowing.

**Fishery Lake Outfall Location View**

- Combination Lorry Jetting Unit to attend site and draw down water level and HPWJ manhole MH1 (see Area 5) located in Stakehill Lane to investigate a possible connection with the fishing lake outlet/provide further recommendations to continue survey.

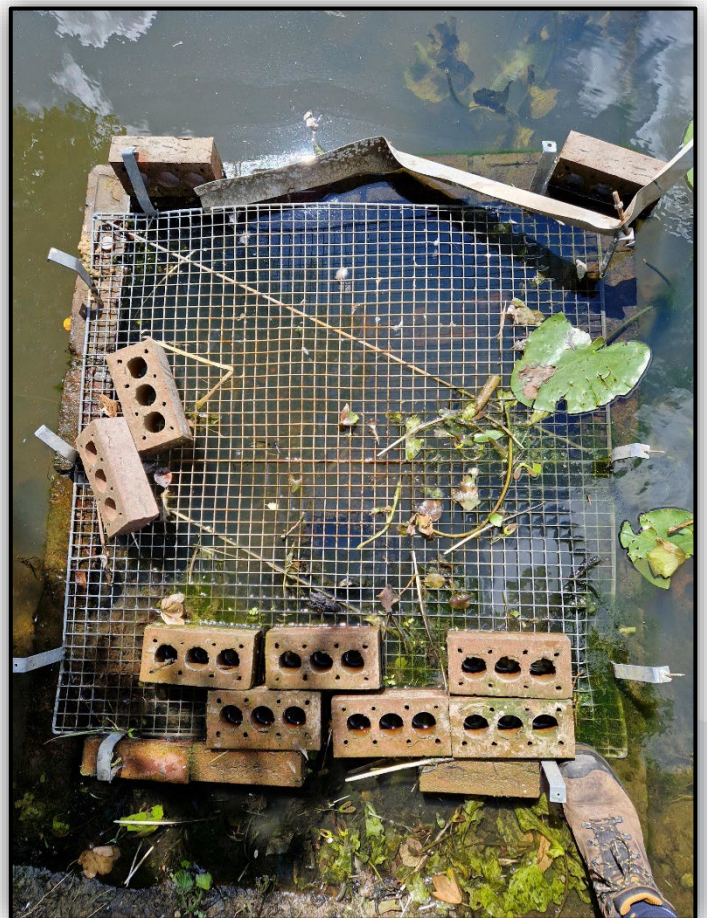
**Fishery Lake Outfall Chamber & Pipe View**

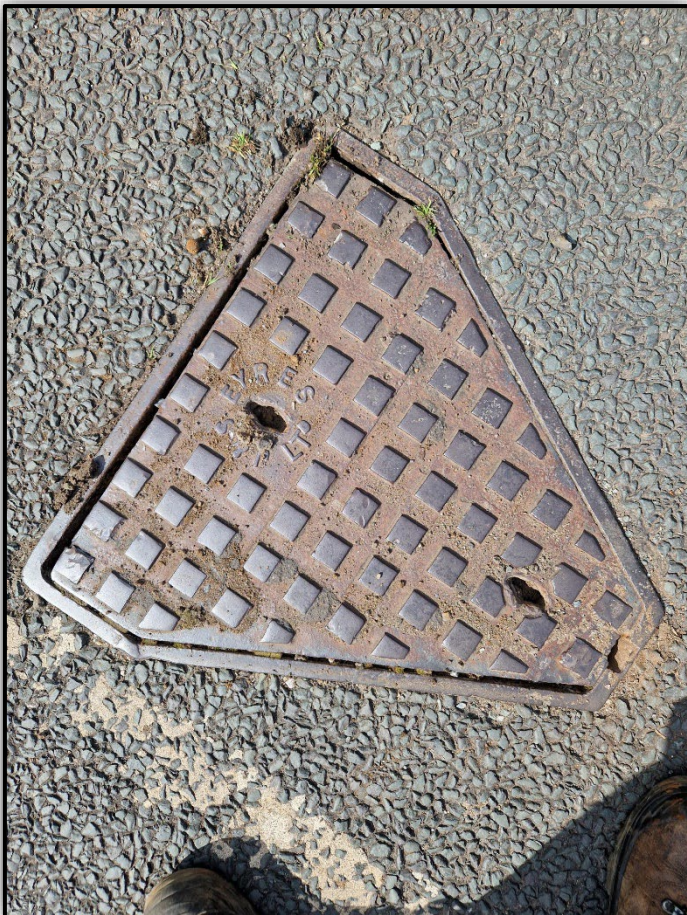
Manhole S2 has become compressed into its frame and could not be lifted after repeated attempts to free it with hand tools and a mechanical lifter.

**S2 Seized Manhole Cover**

- Combination Lorry Jetting Unit to attend site to empty and HPWJ manhole MH1 and undertake further investigation/CCTV survey of any accessible connecting sections.
- Break out and replace seized manholes S2 & C5 to survey manhole chambers and verify connectivity

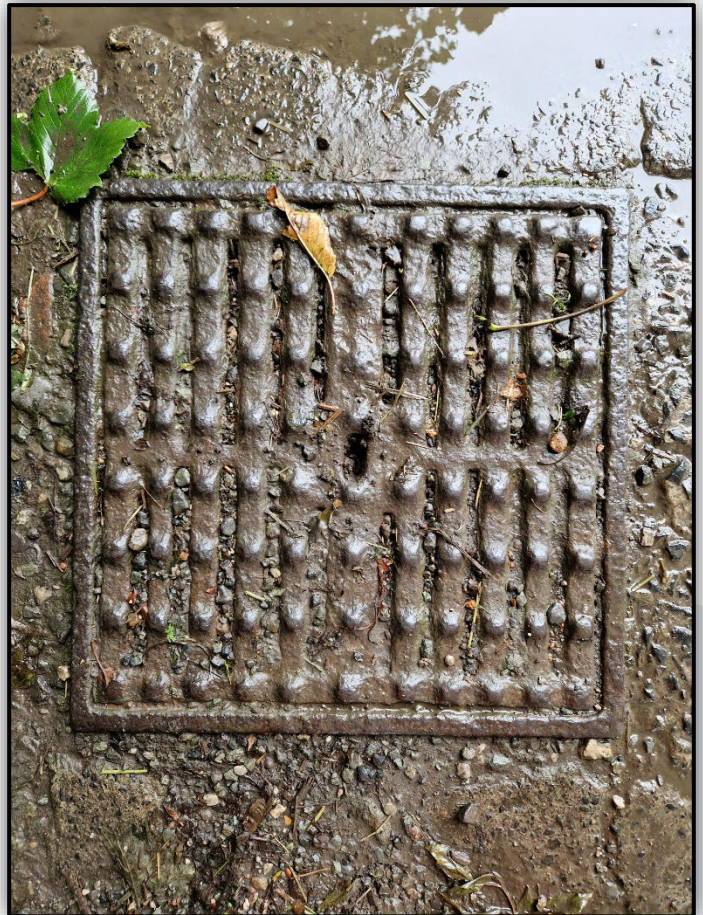
The grated manhole cover on C5 has become seized into its frame and could not be lifted after repeated attempts to free it with hand tools and mechanical lifter.

**C5 Seized Grated Manhole Cover**

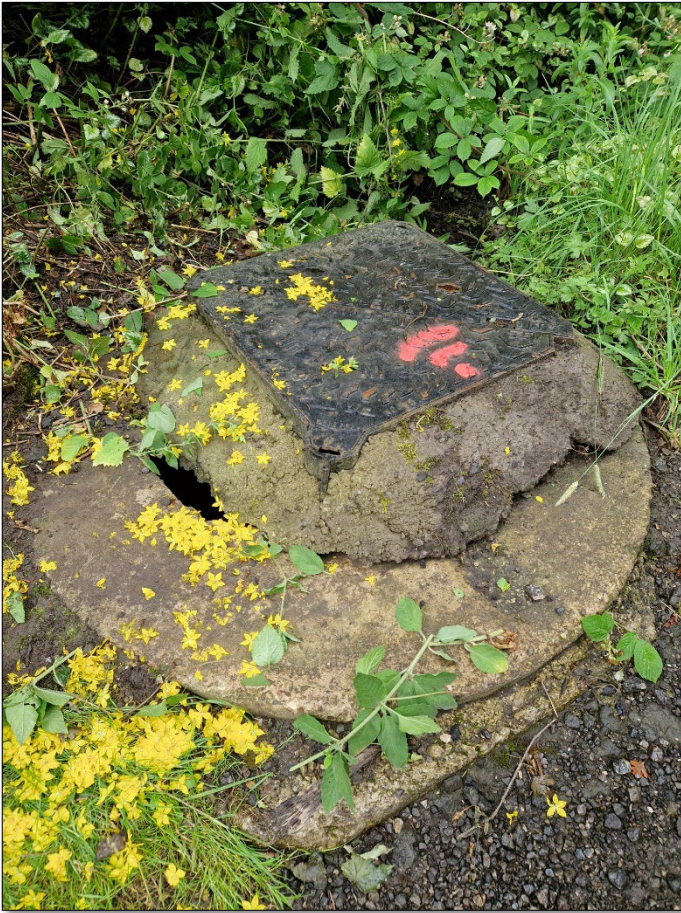
Manhole referenced as MH4 on the connectivity plan was noted to have been damaged cover/frame which have become offset from the cover slab. Care was taken to lift the frame/cover to one side to survey the manhole chamber and electronically traced the downstream line to a concealed manhole on the opposite side of the lane and once completed replaced the cover/frame centrally back over access on the cover slab. Undertook foliage clearance within the area of electronic trace/sonde signal and located/exposed manhole MH5, once lifted recorded all details for manhole card.

**MH4 Manhole Cover Condition View**

- Reposition existing cover & frame MH4 onto cover slab including new fillet surround
- Reposition existing cover & frame MH7 onto cover slab including new fillet surround
- 7.5 tonne Combination Lorry Jetting Unit to attend site to empty and HPWJ manhole MH7 and undertake further investigation/CCTV survey of any accessible connecting sections.
- CCTV survey with crawler unit & cradle extension of the downstream line from MH6 to determine connectivity.
- HPWJ/CCTV survey and line trace of 225mm outfall to watercourse (Access to be arranged with property/landowner prior to attendance)

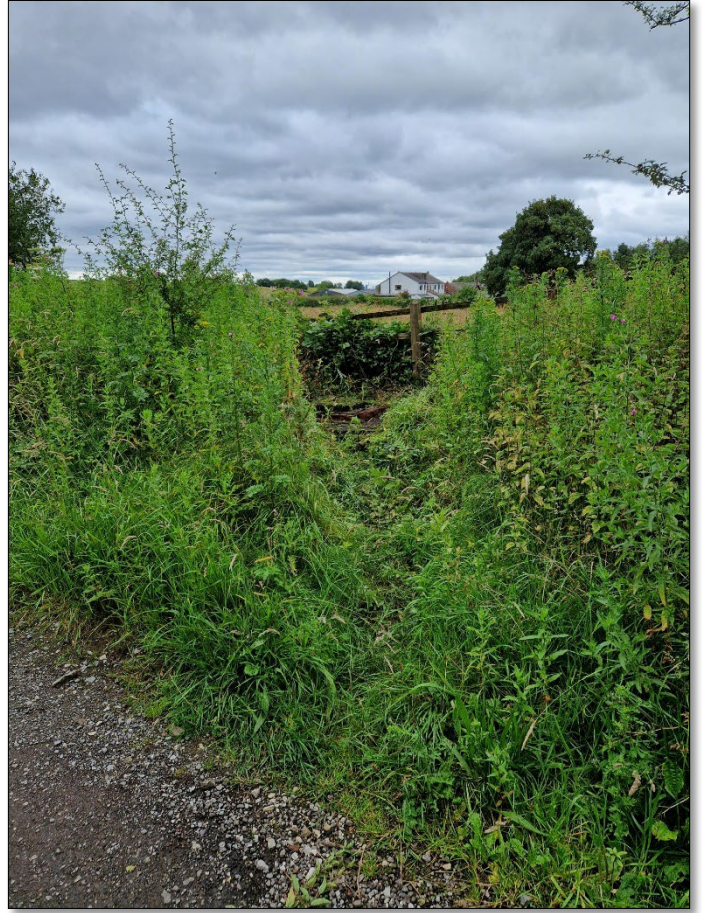
Cleared overgrown foliage to access MH7 and noted the current frame/cover to be loose on cover slab. Lifted manhole and confirmed chamber to be surcharged and recorded visible manhole details from the surface.

**MH7 Location View**

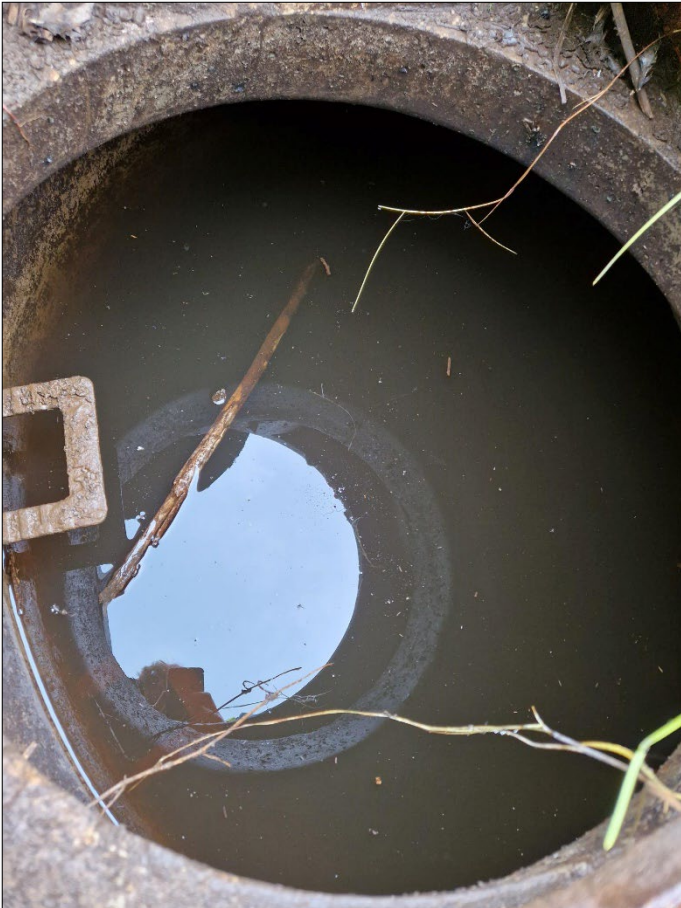
**MH7 Internal View**

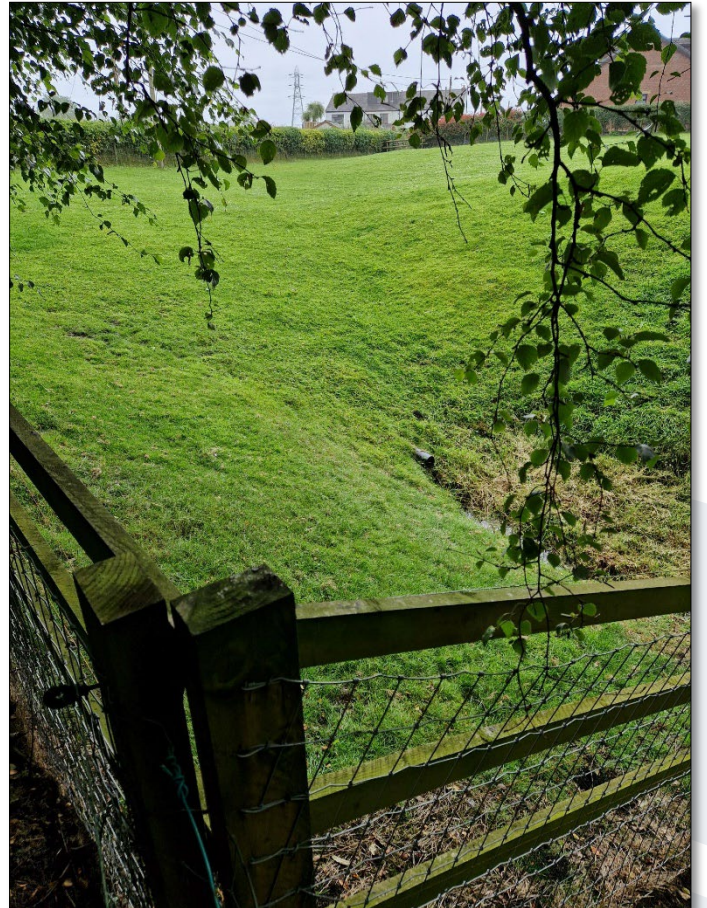
On further review of the layout plan supplied, undertook a visual survey of the area showing the culverts' outfall to an open channel and confirmed another outfall pipe on private property (no access/permission at time of survey).

**Outfall into Watercourse**

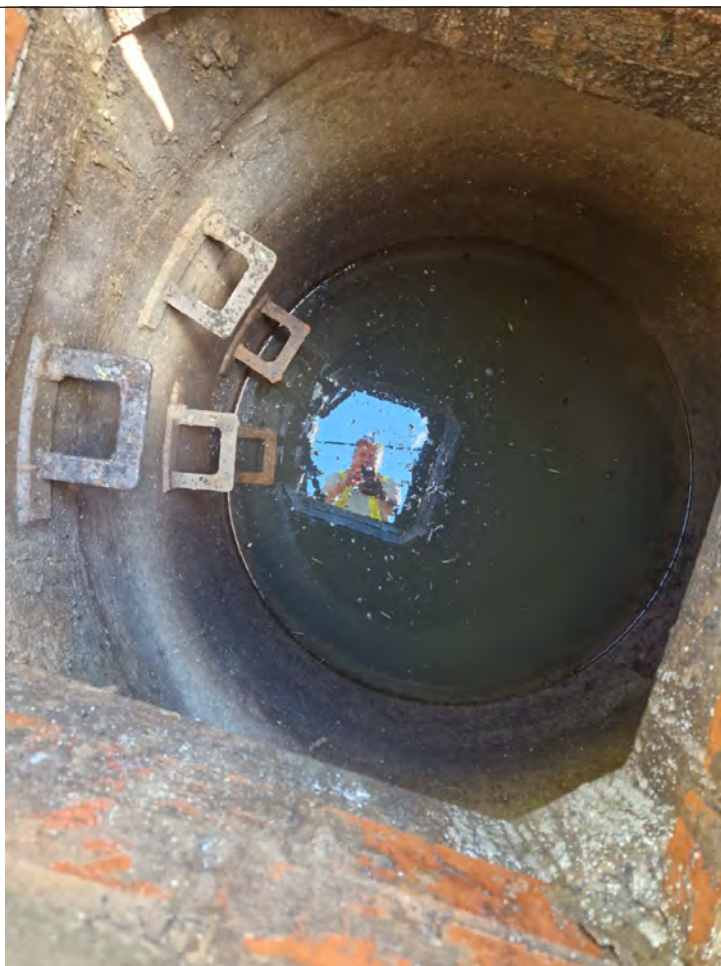
## Photograph

Lifted manhole referenced MH1 (detailed on connectivity plan) and confirmed the chamber to be holding standing water. Further investigation work will be required to establish/confirm whether there is a connection with the fishery lake outfall outlined in Area 4.

| Surcharged manhole no pipes visible |

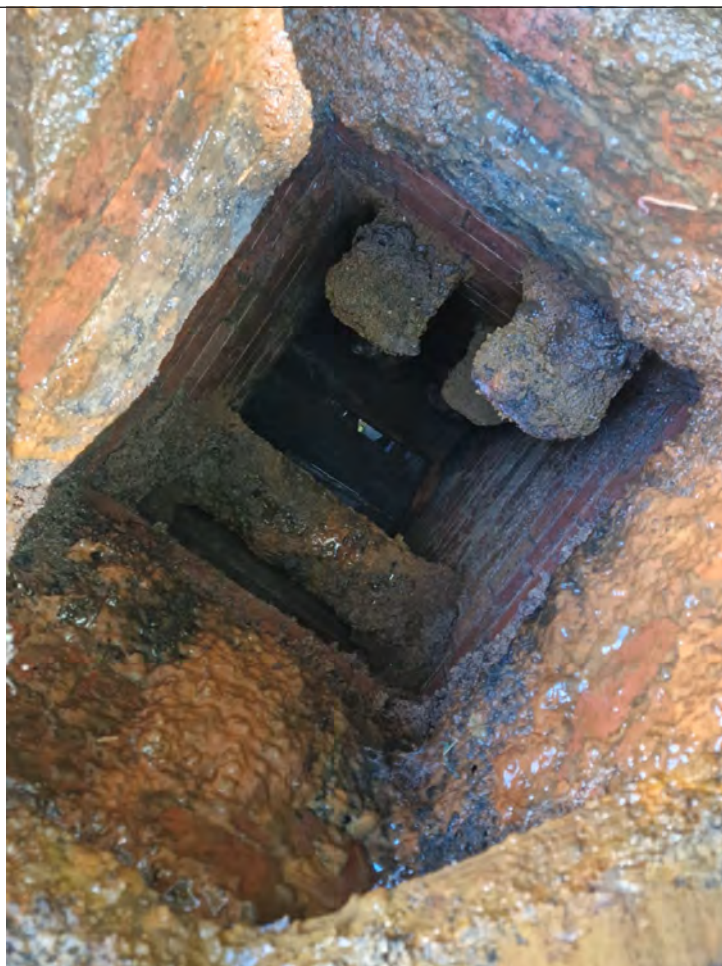
## Photograph

Service running through chamber at 1.12m  
Surcharged foul debris covering step irons & benching

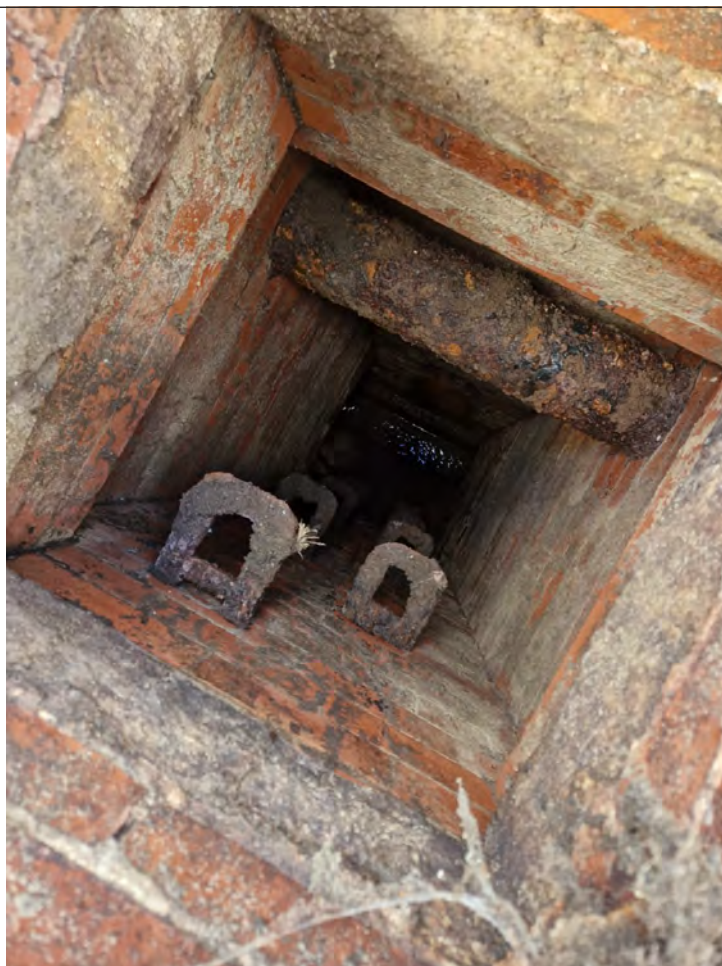
## Photograph

| Service running through manhole at 1.13 |
