# LEOPOLD COURT DIRECT ACCESS HOSTEL

## STRUCTURAL SURVEY

Rochdale Council

Date: November 2025  
BGH Ref: 2215.95.01 V1

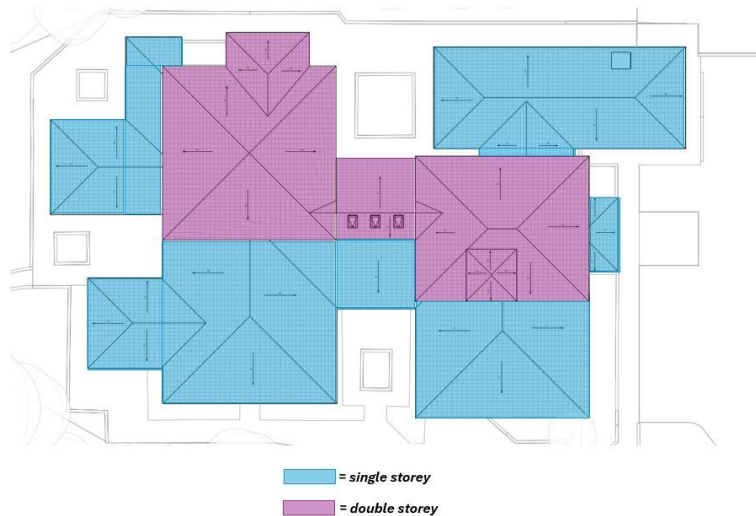
Leopold Court Existing Structure

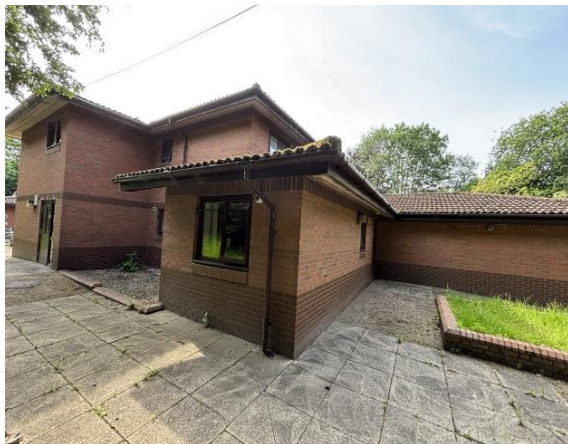
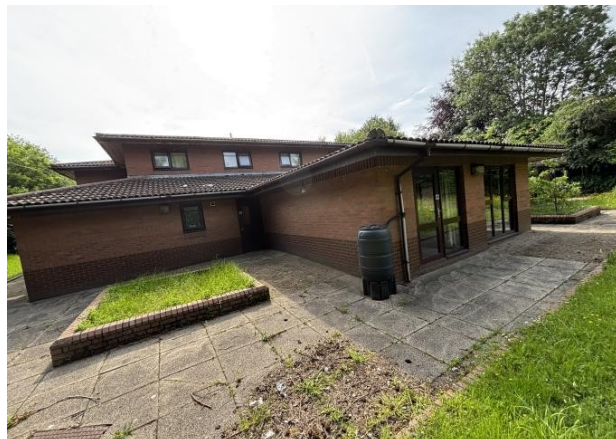
From ground level to first floor, the structure is formed predominantly of load-bearing masonry walls. A large portion of the building is single storey where the walls directly support the timber trussed rafter roof. These walls also support a series of steel beams, lintels (to form openings), and timber floor joists depending on their location within the plan.

No significant structural cracking, displacement, or signs of overloading were observed to the ground floor masonry during inspection.

Single storey masonry wall supporting timber trussed roof

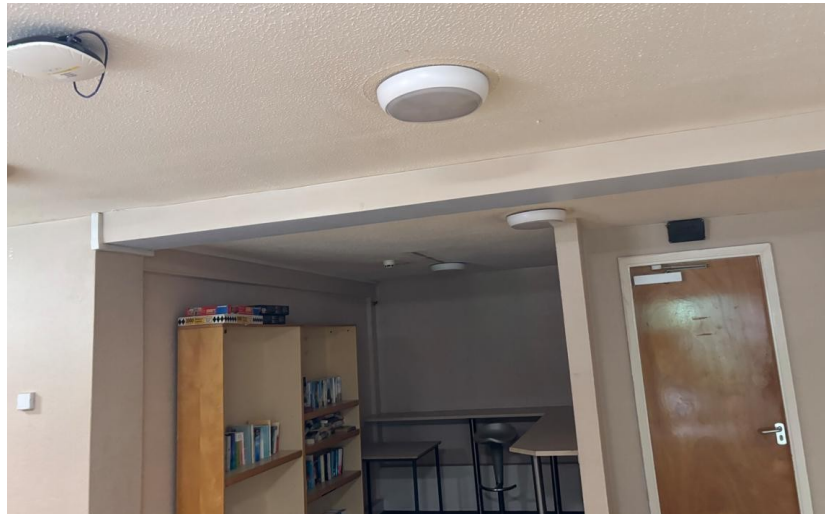
Steel beams appear to have been installed to form corridor openings and support the first-floor construction. The beams are largely boxed in and therefore could not be visually inspected in detail; however:

- No deflection or distortion was noted in adjacent finishes.
- No cracking or distress was visible at bearing ends.
- Lintels above windows and doors appear functional, with no noticeable sagging.

While exact beam sizes and connection details could not be verified, the surrounding masonry showed no signs of stress.

Steel beam supported by internal walls

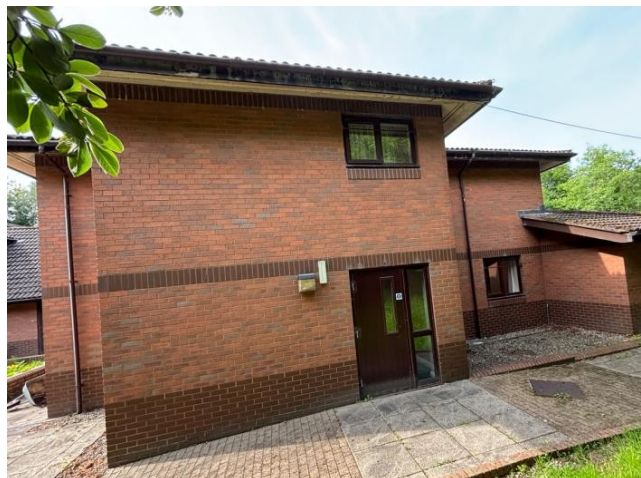
Above the ground floor, the walls continue as load-bearing masonry, supporting both the first-floor timber joists and the timber roof trusses above (see Appendix A for timber floor span direction).

The load path appears to be conventional, where the floor loads transfer onto the timber joists, to the load bearing walls, and to the foundations.
