| PROJECT | SMP - St Mary's CE Primary School |
| TITLE | Elevation EE - Demolition & Repairs |
| NUMBER | SMP-SEV-XX-XX-DR-A-03014 |

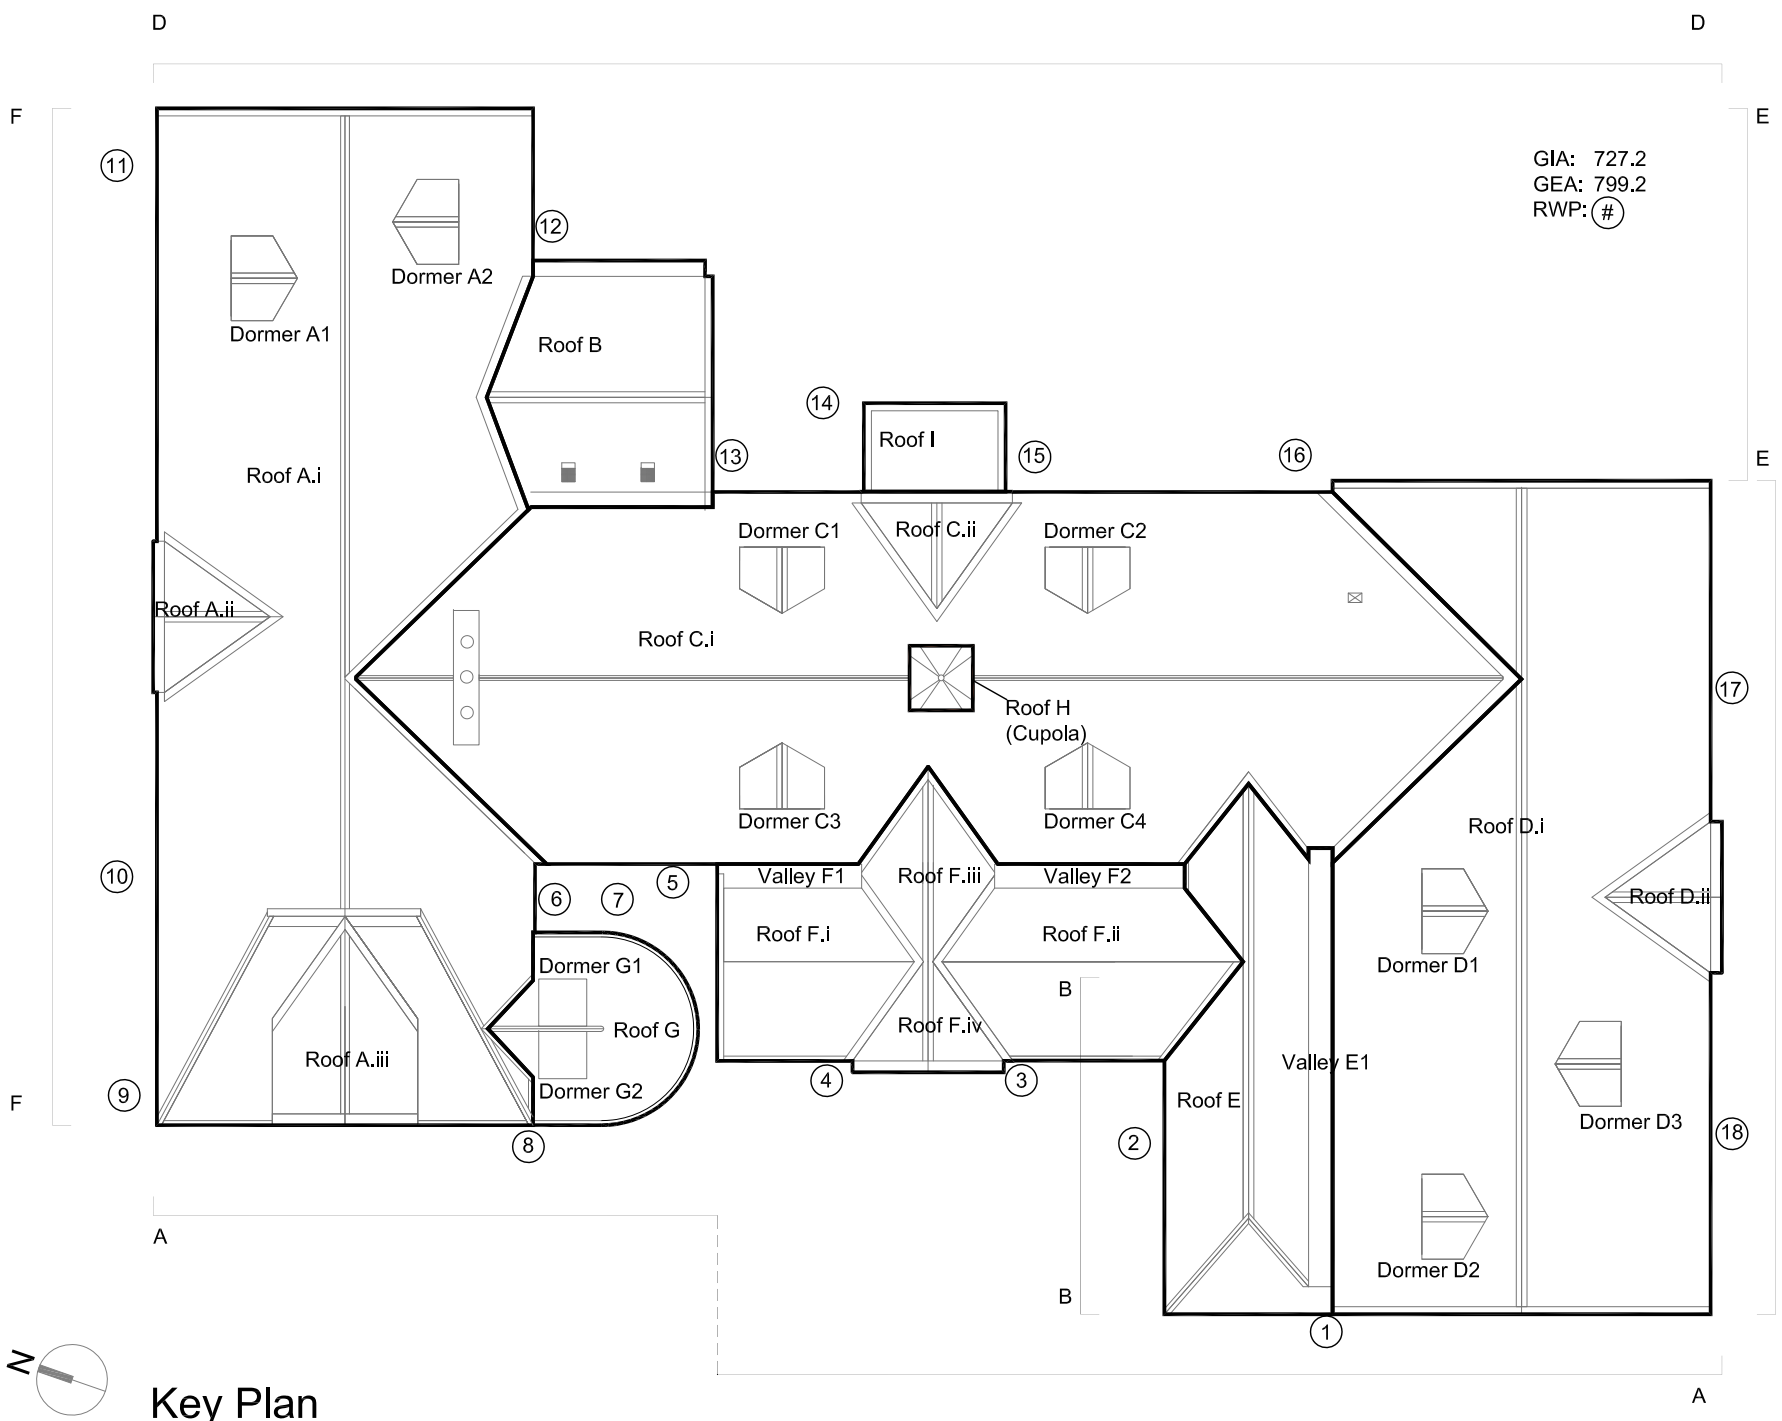
Dormer wood paintwork worn; requires further inspection

Downpipe rusted; requires sanding down & repainting

Dormer Window: 09 no.  
Splice in new timbers where appropriate. Access to be provided for detailed inspection and methodology agreed. Carefully sand down and repaint in appropriate materials as per the specification. Roofing section per detail F-F in drawing SMP-SEV-XX-XX-DR-A-03105 (Typical Dormer Window)

Rainwater Goods: 18 no.  
Down-pipe to be removed and replaced with cast-iron rainwater goods allowing for increased diameter (8 inch) to mitigate increased rainfall. Existing cast-iron hoppers to be retained & refurbished where possible. Guttering per detail B-B in drawing SMP-SEV-XX-XX-DR-A-03100 (Typical External Gutter)
