| HARRISON / HILLBANK ST & CHURCH AVE | | Lancashire |
| HIGHWAY CONDITION SURVEY | | OL16 1BH |
| HILLBANK ST SITE | | Tel:01706 868288 |

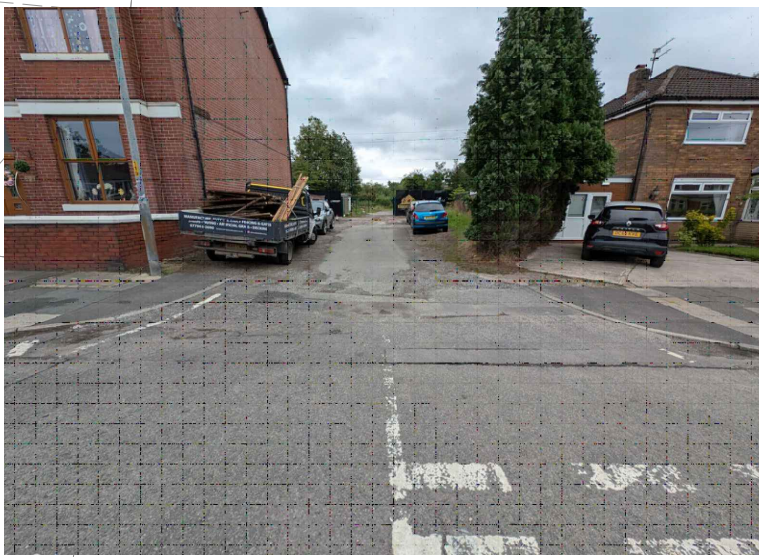
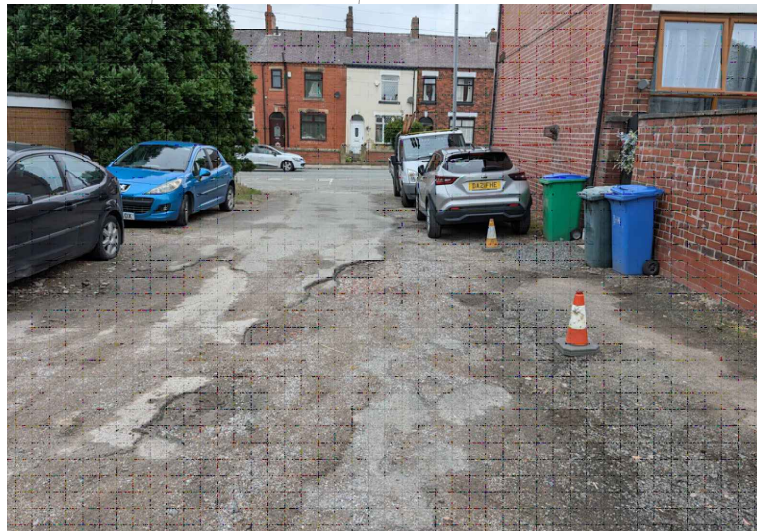
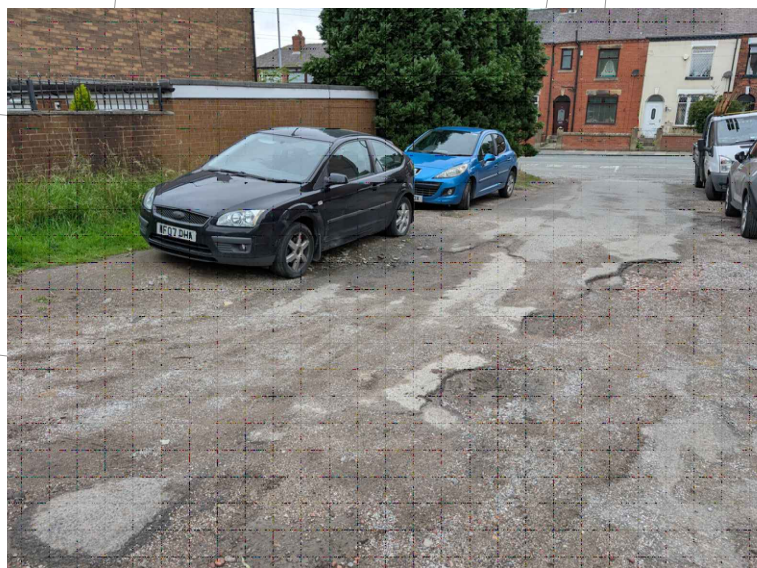
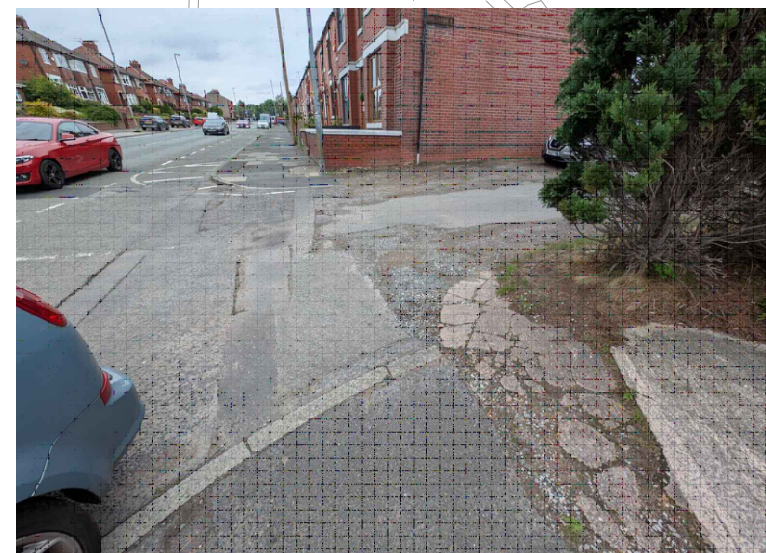
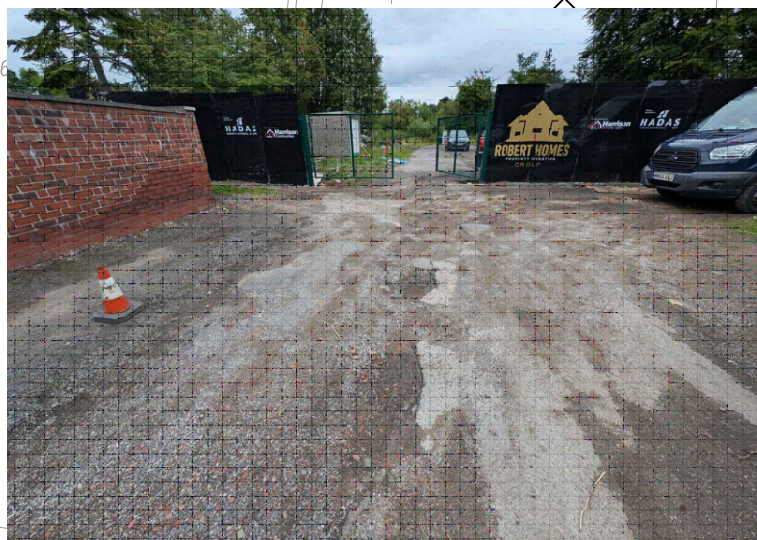
erosion between patch courses 10-15mm deep  
patched DBM surface  
macadam surrounding MH cover depressed & cracked 10-30mm  
erosion between patch courses 0-20mm deep  
numerous stages of patch repairs to previous works  
potholes 20-40mm deep  
potholes 20-40mm deep  
potholes 20-40mm deep  
potholes 20-40mm deep  
potholes 50-60mm deep  
general road condition - very poor  
patchy macadam  
unmade ground comprising hardcore/MOT  
grass verge

DBM surface course good condition
