| PROJECT | SMP - St Mary's CE Primary School |
| TITLE | Elevation FF - Demolition & Repairs |
| NUMBER | SMP-SEV-XX-XX-DR-A-03015 |

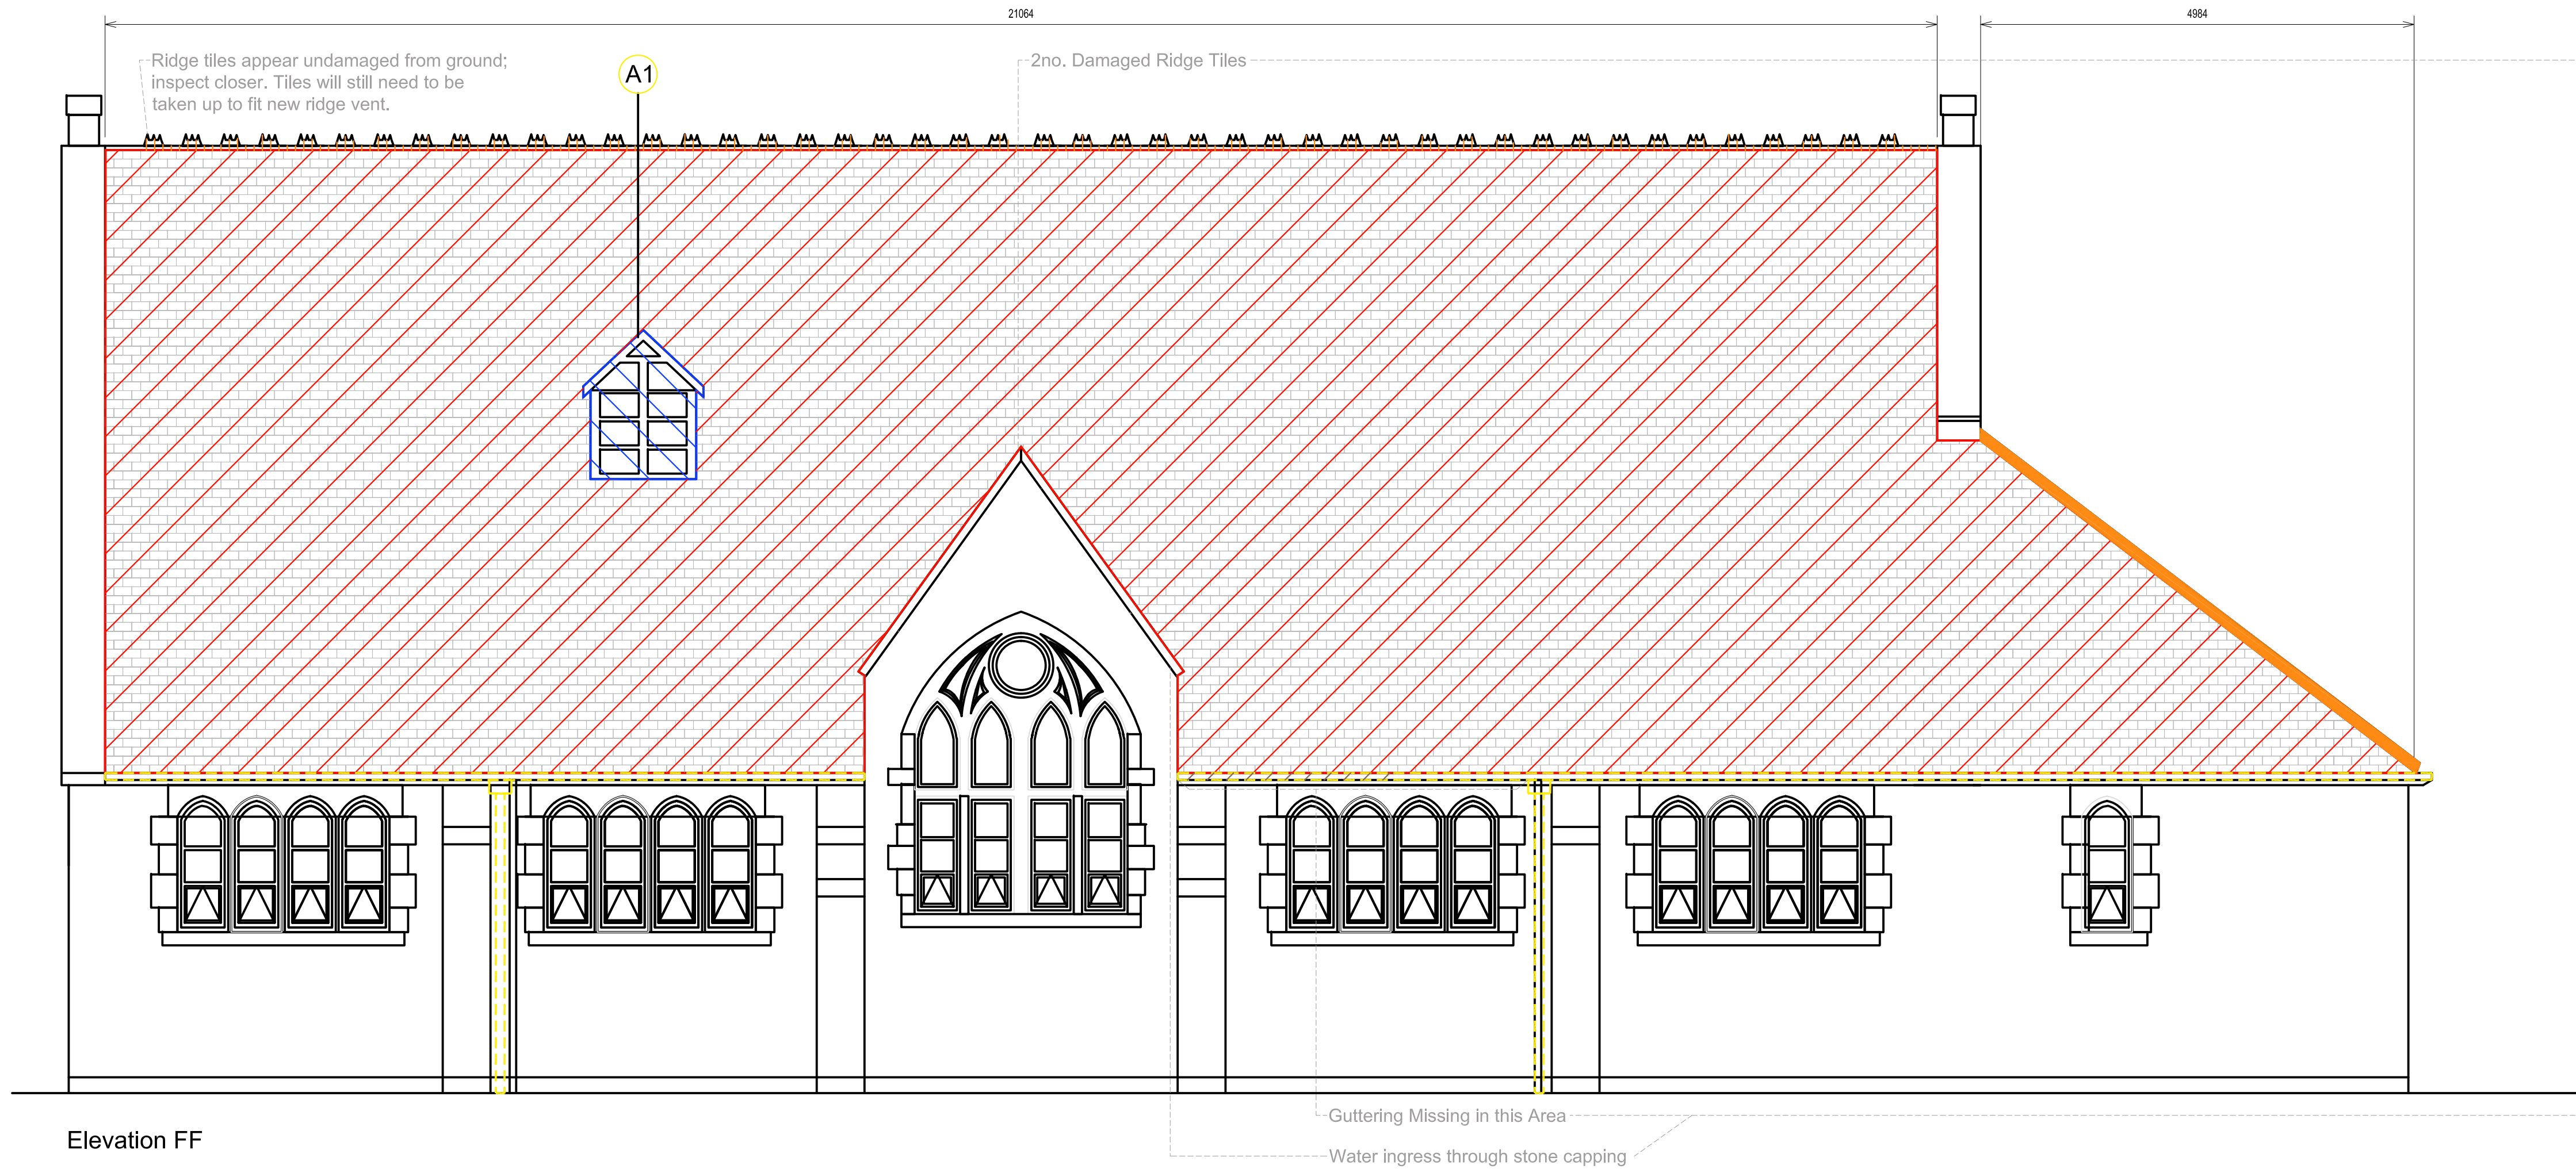
Elevation FF

A1 Woodwork requires sanding down and repainting.

- Roof Slate Restoration: 762sqm / 8220sqft  
Strip existing slate roof coverings and set aside salvaged slates for re-use. Strip existing battens, felt, lead-lined gutters and gutter structure then safely dispose of any defective material. Re-felt & batten existing roof slope. As per detail A-A in drawing SMP-SEV-XX-XX-DR-A-03100 (Typical Roof Build-Up)

- Dormer Window: 09 no.  
Splice in new timbers where appropriate. Access to be provided for detailed inspection and methodology agreed. Carefully sand down and repaint in appropriate materials as per the specification. Roofing section per detail F-F in drawing SMP-SEV-XX-XX-DR-A-03105 (Typical Dormer Window)

- Rainwater Goods: 18 no.  
Down-pipe to be removed and replaced with cast-iron rainwater goods allowing for increased diameter (6 inch) to mitigate increased rainfall. Existing cast-iron hoppers to be retained & refurbished where possible. Guttering per detail B-B in drawing SMP-SEV-XX-XX-DR-A-03100 (Typical External Gutter)

- Lead Flashing: 75 Lm  
Replace with new Terne-coated stainless steel (TCSS) flashing where appropriate, taking note of Historic England guidance (<https://tinyurl.com/3taekx9n>). This also applies to damaged or visually-unfortunate soakers. Access to be provided for detailed inspection and methodology agreed.

- Decorative Ridge Tiles: 105 Lm  
Ridge tiles to be removed and set aside with salvaged tiles for re-use. Replace damaged tiles as per the existing style. Ridge ventilation provided with new linear vent. Ridge venting per detail F-F in drawing SMP-SEV-XX-XX-DR-A-03105 (Typical Dormer Window)
