| PROJECT | SMP - St Mary's CE Primary School |
| TITLE | Elevation CC - Demolition & Repairs |
| NUMBER | SMP-SEV-XX-XX-DR-A-03012 |

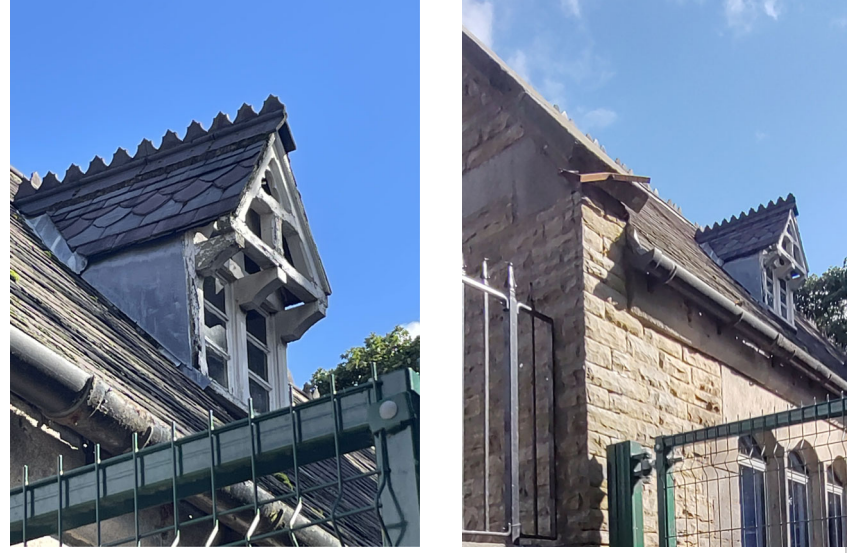
D3 Dormer damaged; requires replacement sections spliced into remaining framework

Rusted metal clamping at base of stone capping

- Dormer Window: 09 no.  
Splice in new timbers where appropriate. Access to be provided for detailed inspection and methodology agreed. Carefully sand down and repaint in appropriate materials as per the specification. Roofing section per detail F-F in drawing SMP-SEV-XX-XX-DR-A-03105 (Typical Dormer Window)

- Stone Capping:  
Take up and re-bed any loose or damaged existing stone capping pieces and re-point. Ensure appropriate stiff mortar (NHL 3.5 Lime Mortar) applied to capping sections. Should any new capping pieces be required; sample cappings to be provided to ensure secure structure.

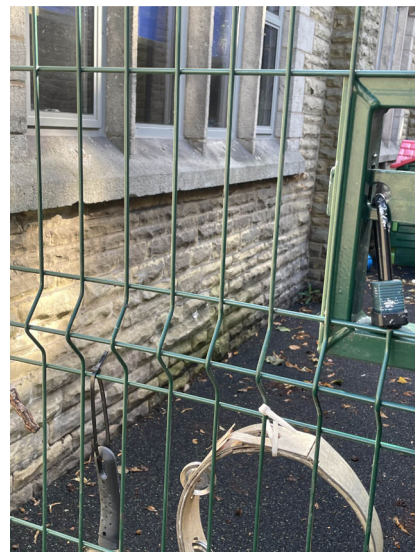
Mould at ground level - investigate if moisture trapped by adjacent Nursery rubberised hard-standing
