# TREE SURVEY & REPORT

For J Owen  
The Cottons  
3 Cotton Hill,  
Milnrow  
Rochdale  
OL16 3FX

## TREE SURVEY / SCHEDULE AND REPORT

Date: 18/09/25

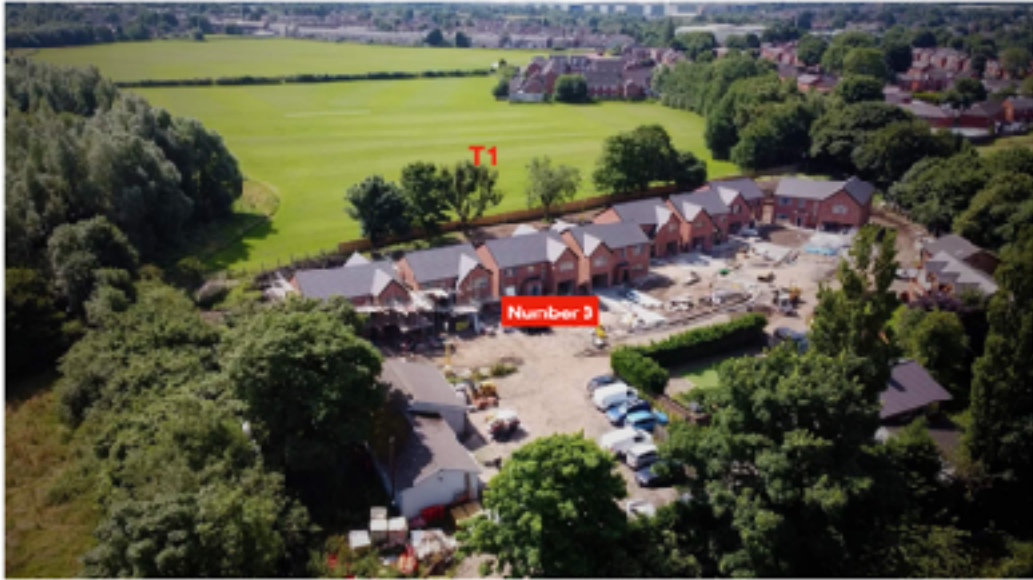
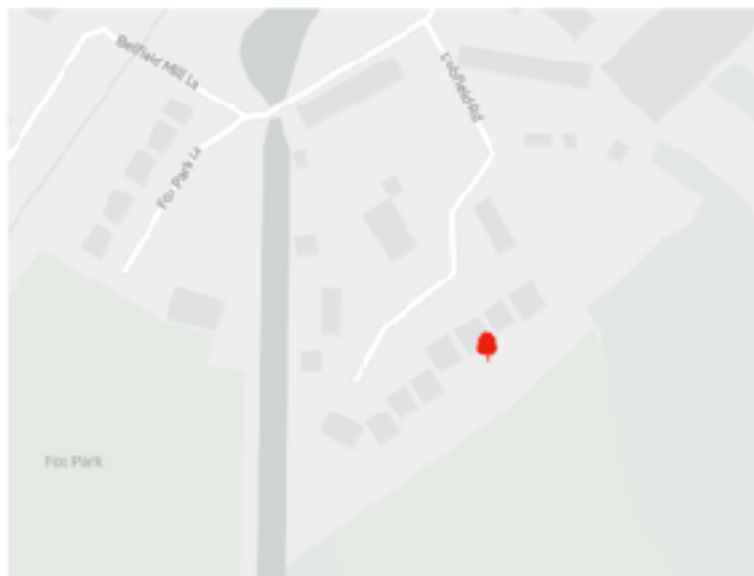
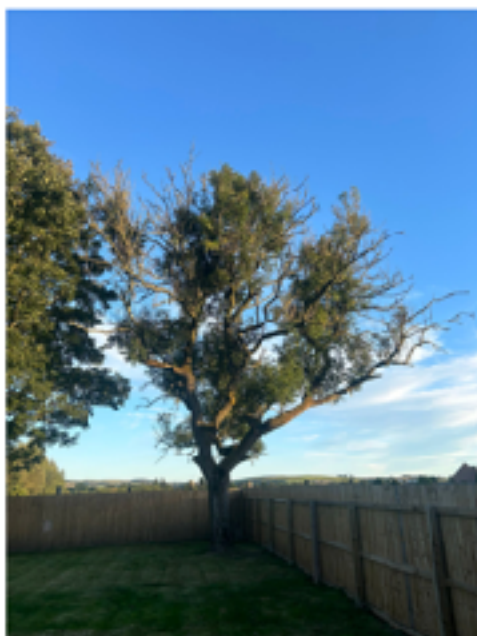
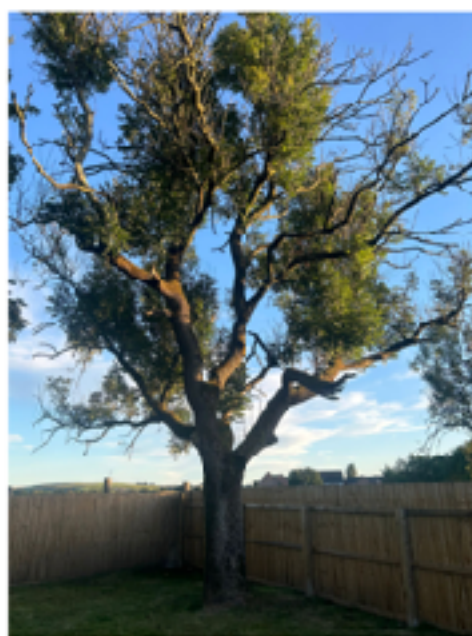
| TREE NO. | SPECIES | D.B.H (CM) | HEIGHT (M) | AGE | CATEGORY BS 5837 | Work RECOMMENDATION |
|---|---|---|---|---|---|---|
| T1 | Ash | 40 | 12 | MA | SS PPP C1 | Remove by section down |

It is clear from the inspection that the tree has had no maintenance or management in the past, but has succumbed to Ash dieback.

The tree is a risk for the residents and their neighbours as it has already shed a large amount of deadwood.

It should be noted that the site developer of the property did not carry out their duty of care or adhere to BS5387 as this Ash tree was already in a state of failure before and during the construction of the site.

The Ash tree is located in the rear garden it can be viewed from the adjacent playing fields. It has had in the past a positive impact on the amenity value of the area. To continue the visual amenity it needs to be felled and a replacement tree such as Prunus planted in its place. If the tree were to be left it would take away the amenity value of residents of the host property or surrounding dwellings.
