## CCTV Inspection Report

**Crimble hall Rochdale OL11 4AD**

**29/07/2025**

# MCC Solutions

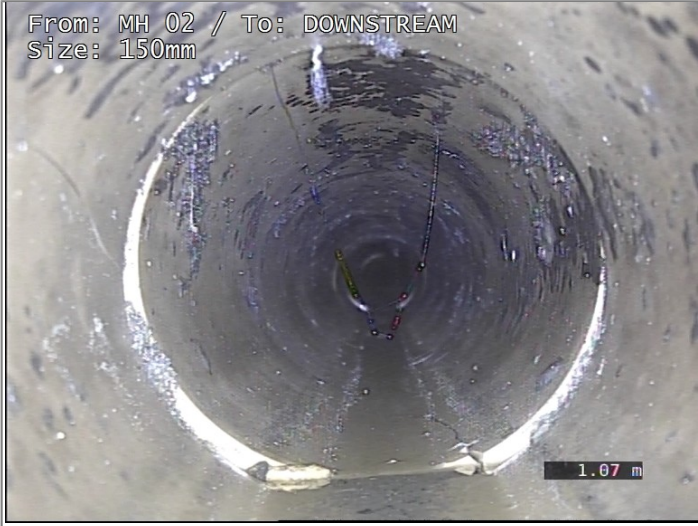
| Position | Code | Description | Photo | Type/Grade |
|---|---|---|---|---|
| 1.07 | FLJ | Fracture longitudinal at 5 o'clock, at joint | 12725692 | Structural / 3 |

| Job Number<br>Crimble Hall | Surveyed by (Operator)<br>B McCabe | Base Unit<br>DPQFOHMAE5 | Date<br>29/07/2025 |
|---|---|---|---|
| <p>From: MH 02 / To: DOWNSTREAM<br/>Size: 150mm</p> <p>Fracture longitudinal at 5 o'clock, at joint</p> | | <p>From: MH 02 / To: DOWNSTREAM<br/>Size: 150mm</p> <p>Crack spiral from 6 to 1 o'clock</p> | |

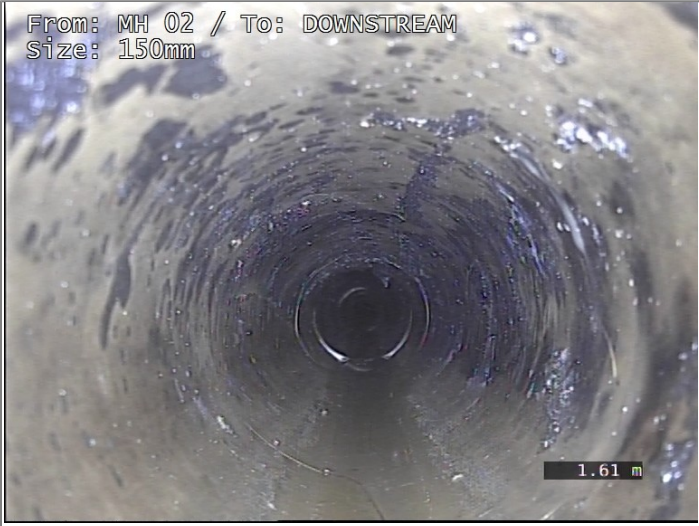
| Position | Code | Description | Photo | Type/Grade |
|---|---|---|---|---|
| 1.61 | CS | Crack spiral from 6 to 1 o'clock | 12725702 | Structural / 3 |

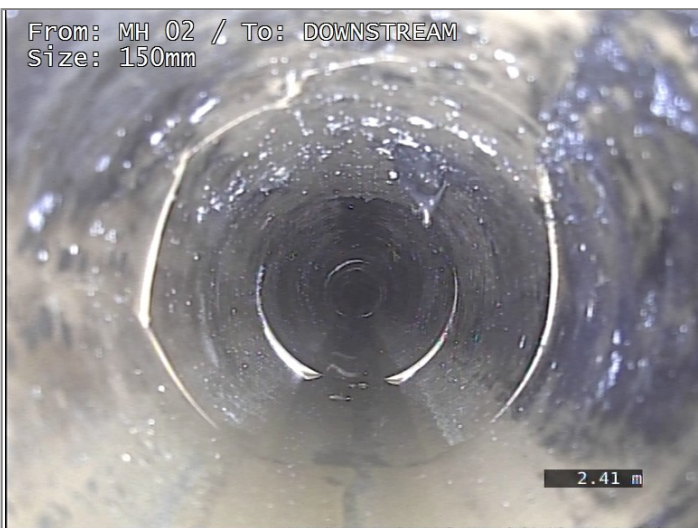
| Position | Code | Description | Photo | Type/Grade |
|---|---|---|---|---|
| 2.41 | FC | Fracture circumferential from 6 to 5 o'clock | 12725705 | Structural / 3 |

| Job Number<br>Crimble Hall | Surveyed by (Operator)<br>B McCabe | Base Unit<br>DPQFOHMAE5 | Date<br>29/07/2025 |
|---|---|---|---|
| <p>From: MH 02 / To: DOWNSTREAM<br/>Size: 150mm</p> <p>Fracture circumferential from 6 to 5 o'clock</p> | | <p>From: MH 02 / To: DOWNSTREAM<br/>Size: 150mm</p> <p>Fracture multiple from 6 to 5 o'clock</p> | |

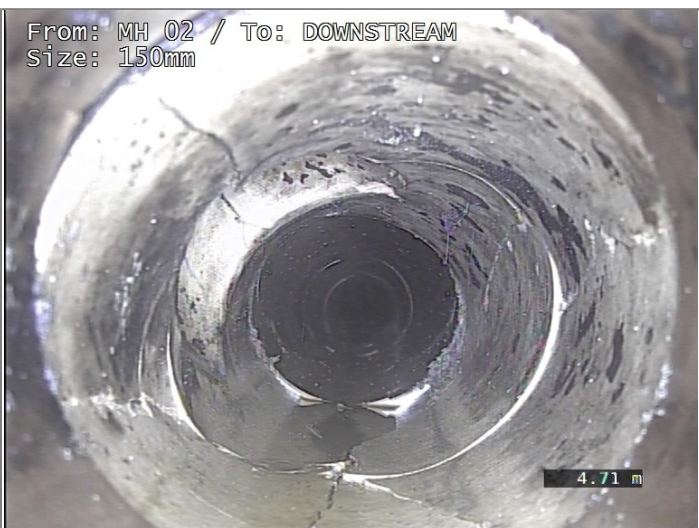
| Position | Code | Description | Photo | Type/Grade |
|---|---|---|---|---|
| 4.71 | FM | Fracture multiple from 6 to 5 o'clock | 12725715 | Structural / 4 |

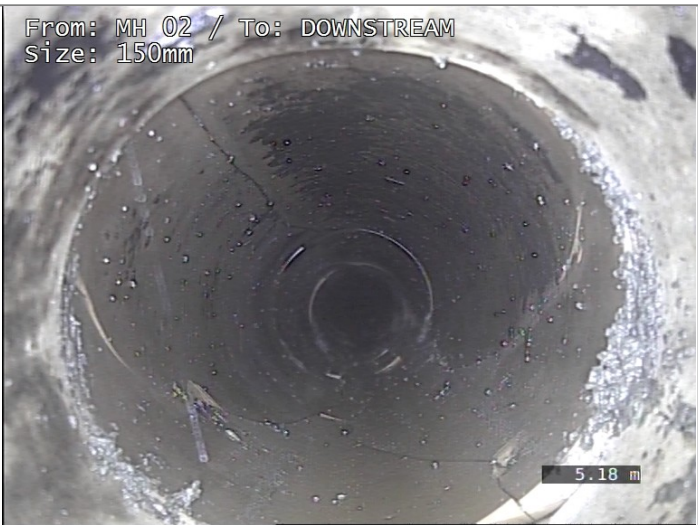
| Position | Code | Description | Photo | Type/Grade |
|---|---|---|---|---|
| 5.18 | CMJ | Cracks multiple from 5 to 11 o'clock, at joint | 12725727 | Structural / 3 |

| Job Number<br><b>Crimble Hall</b> | Surveyed by (Operator)<br><b>B McCabe</b> | Base Unit<br><b>DPQFOHMAE5</b> | Date<br><b>29/07/2025</b> |
|---|---|---|---|
| <div> <div> From: MH 02 / To: DOWNSTREAM<br/>Size: 150mm </div> <div>Junction at 10 o'clock, diameter 100mm</div> </div> <div> <div> From: MH 02 / To: DOWNSTREAM<br/>Size: 150mm </div> <div>Cracks multiple from 5 to 11 o'clock, at joint</div> </div> | | | |

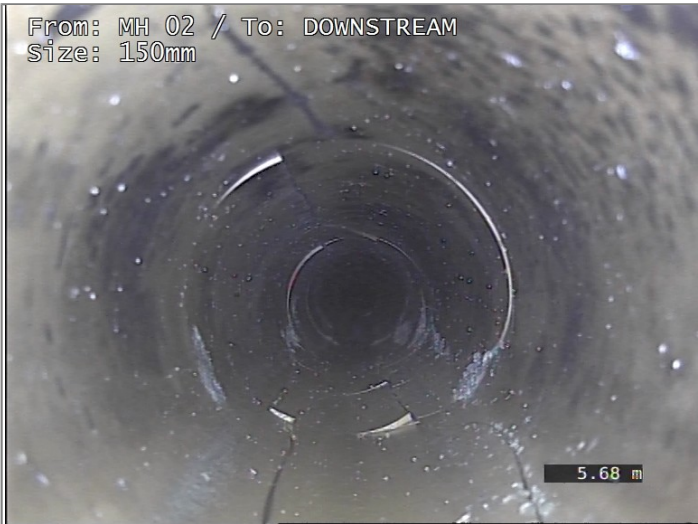
| Position | Code | Description | Photo | Type/Grade |
|---|---|---|---|---|
| 5.68 | FM (S01) | Fracture multiple from 5 to 1 o'clock, Start | 12725834 | Structural / 4 |

| Job Number<br><b>Crimble Hall</b> | Surveyed by (Operator)<br><b>B McCabe</b> | Base Unit<br><b>DPQFOHMAE5</b> | Date<br><b>29/07/2025</b> |
|---|---|---|---|
| <div> <div> From: MH 02 / To: DOWNSTREAM<br/>Size: 150mm </div> <div>Fracture multiple from 5 to 1 o'clock, Start</div> </div> <div> <div> From: MH 02 / To: DOWNSTREAM<br/>Size: 150mm </div> <div>Broken pipe from 4 to 8 o'clock</div> </div> | | | |

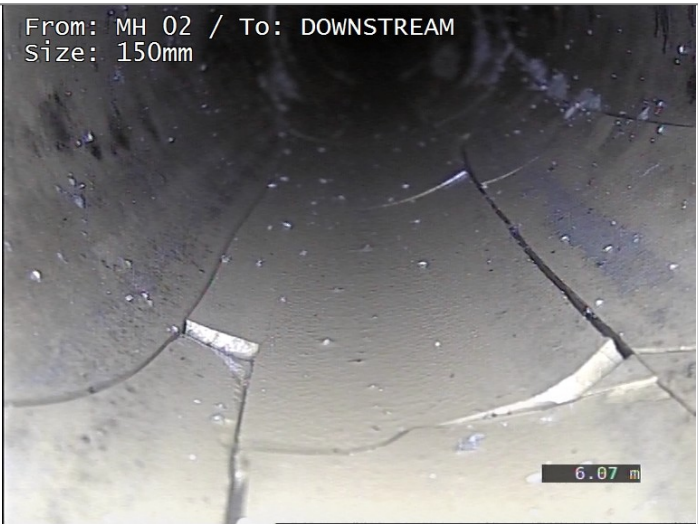
| Position | Code | Description | Photo | Type/Grade |
|---|---|---|---|---|
| 6.07 | B | Broken pipe from 4 to 8 o'clock | 12725837 | Structural / 4 |

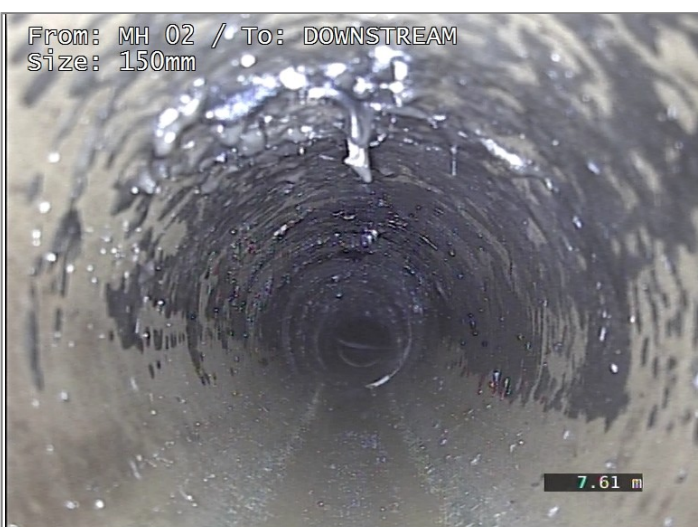
| Position | Code | Description | Photo | Type/Grade |
|---|---|---|---|---|
| 7.61 | FM (F01) | Fracture multiple from 5 to 1 o'clock, Finished | 12725839 | Structural / 4 |

| Job Number<br><b>Crimble Hall</b> | Surveyed by (Operator)<br><b>B McCabe</b> | Base Unit<br><b>DPQFOHMAE5</b> | Date<br><b>29/07/2025</b> |
|---|---|---|---|
| <div> <div> From: MH 02 / To: DOWNSTREAM<br/>Size: 150mm </div> <div>Fracture multiple from 5 to 1 o'clock, Finished</div> </div> <div> <div> From: MH 02 / To: DOWNSTREAM<br/>Size: 150mm </div> <div>Broken pipe from 4 to 7 o'clock, at joint</div> </div> | | | |

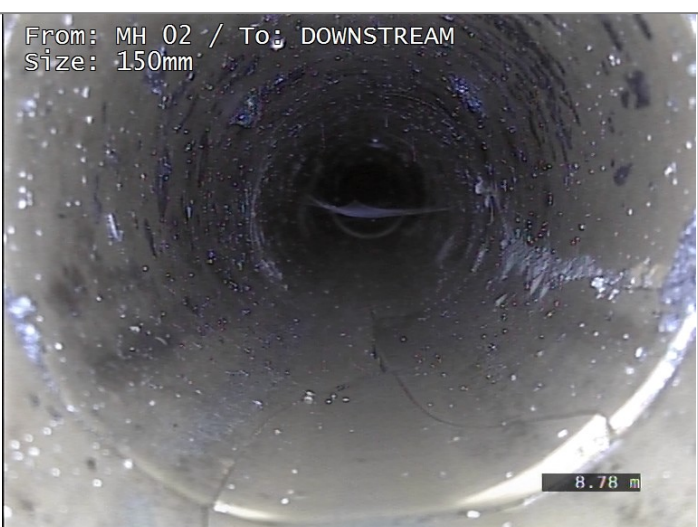
| Position | Code | Description | Photo | Type/Grade |
|---|---|---|---|---|
| 8.78 | BJ | Broken pipe from 4 to 7 o'clock, at joint | 12725848 | Structural / 4 |

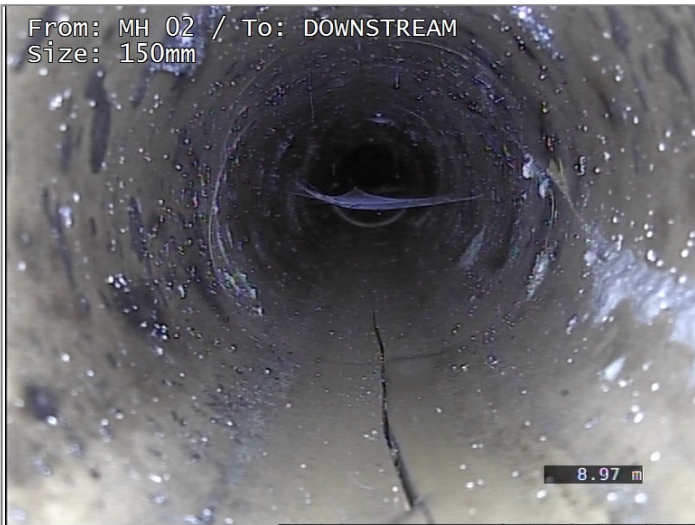
| Position | Code | Description | Photo | Type/Grade |
|---|---|---|---|---|
| 8.97 | FL (S02) | Fracture longitudinal at 6 o'clock, Start | 12725849 | Structural / 3 |

| Job Number<br><b>Crimble Hall</b> | Surveyed by (Operator)<br><b>B McCabe</b> | Base Unit<br><b>DPQFOHMAE5</b> | Date<br><b>29/07/2025</b> |
|---|---|---|---|
| <div> <div> From: MH 02 / To: DOWNSTREAM<br/>Size: 150mm 8.97 m </div> <div>Fracture longitudinal at 6 o'clock, Start</div> </div> <div> <div> From: MH 02 / To: DOWNSTREAM<br/>Size: 150mm 11.70 m </div> <div>Fracture longitudinal at 6 o'clock, Finished</div> </div> | | | |

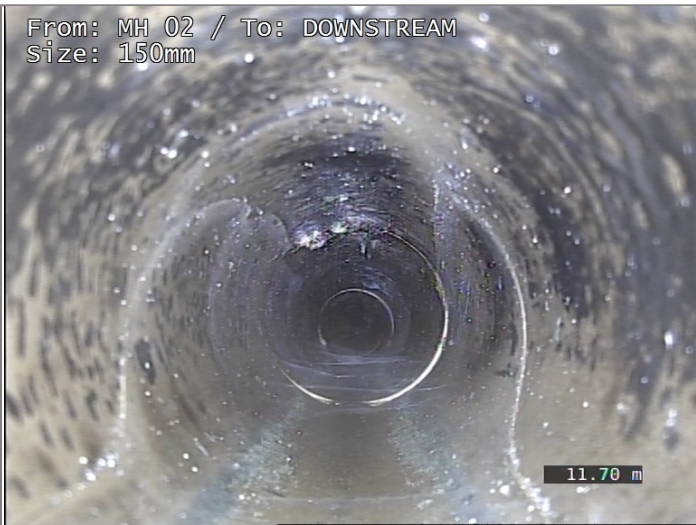
| Position | Code | Description | Photo | Type/Grade |
|---|---|---|---|---|
| 11.70 | FL (F02) | Fracture longitudinal at 6 o'clock, Finished | 12725852 | Structural / 3 |

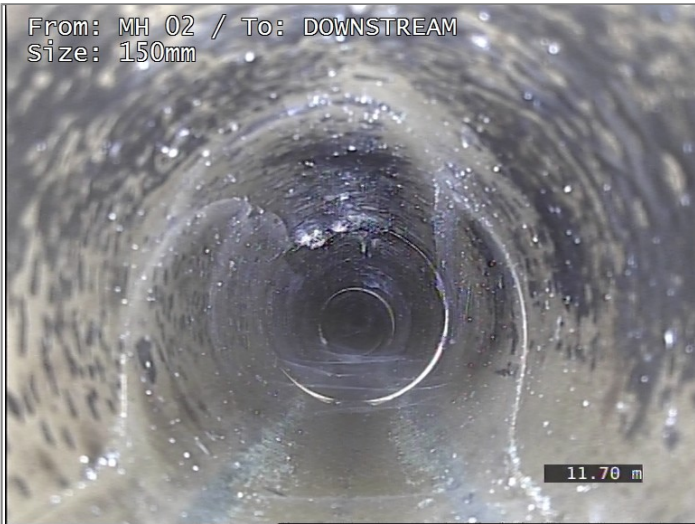
| Position | Code | Description | Photo | Type/Grade |
|---|---|---|---|---|
| 11.70 | FM | Fracture multiple from 1 to 10 o'clock | 12725855 | Structural / 4 |

| Job Number<br><b>Crimble Hall</b> | Surveyed by (Operator)<br><b>B McCabe</b> | Base Unit<br><b>DPQFOHMAE5</b> | Date<br><b>29/07/2025</b> |
|---|---|---|---|
| <div> <div> From: MH 02 / To: DOWNSTREAM<br/>Size: 150mm 11.70 m </div> <div>Fracture multiple from 1 to 10 o'clock</div> </div> <div> <div> From: MH 02 / To: DOWNSTREAM<br/>Size: 150mm 13.29 m </div> <div>Fracture multiple from 3 to 10 o'clock - Remark: TIMES VARY , Start</div> </div> | | | |

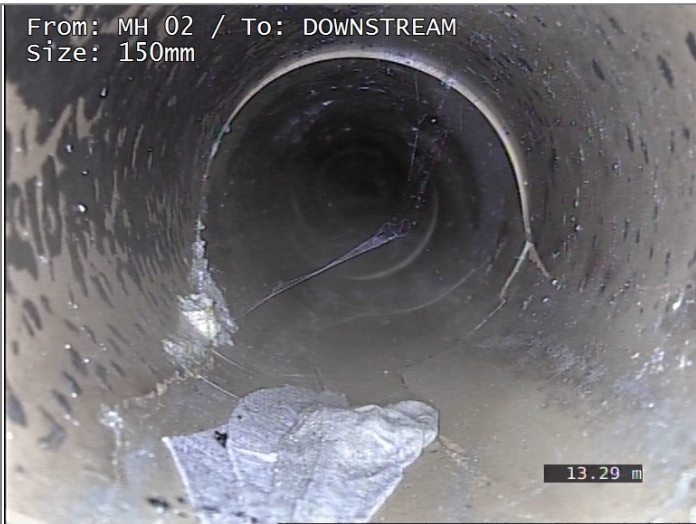
| Position | Code | Description | Photo | Type/Grade |
|---|---|---|---|---|
| 13.29 | FM (S03) | Fracture multiple from 3 to 10 o'clock - Remark: TIMES VARY , Start | 12725859 | Structural / 4 |

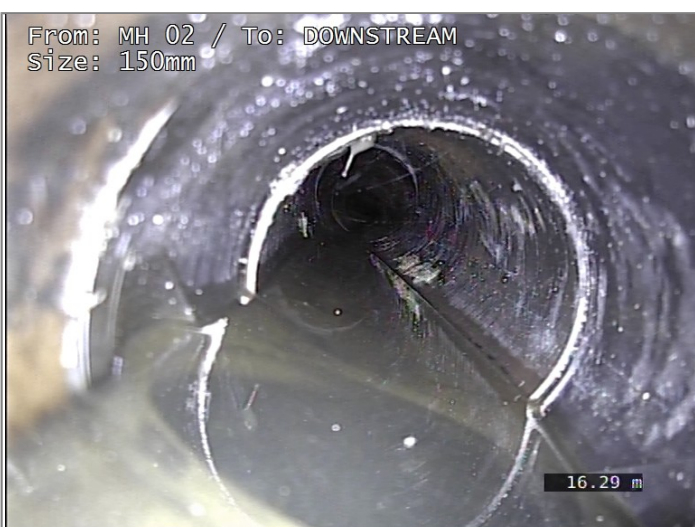
| Position | Code | Description | Photo | Type/Grade |
|---|---|---|---|---|
| 16.29 | REM | BLOCKED DROPSHAFT | 12725865 | Comment / 0 |

| Job Number<br><b>Crimble Hall</b> | Surveyed by (Operator)<br><b>B McCabe</b> | Base Unit<br><b>DPQFOHMAE5</b> | Date<br><b>29/07/2025</b> |
|---|---|---|---|
| <div> <div> From: MH 02 / To: DOWNSTREAM<br/>Size: 150mm 16.29 m </div> <div>BLOCKED DROPSHAFT</div> </div> <div> <div> From: MH 02 / To: DOWNSTREAM<br/>Size: 150mm 16.29 m </div> <div>Survey abandoned - Remark: DUE TO A BLOCKED DROPSHAFT</div> </div> | | | |

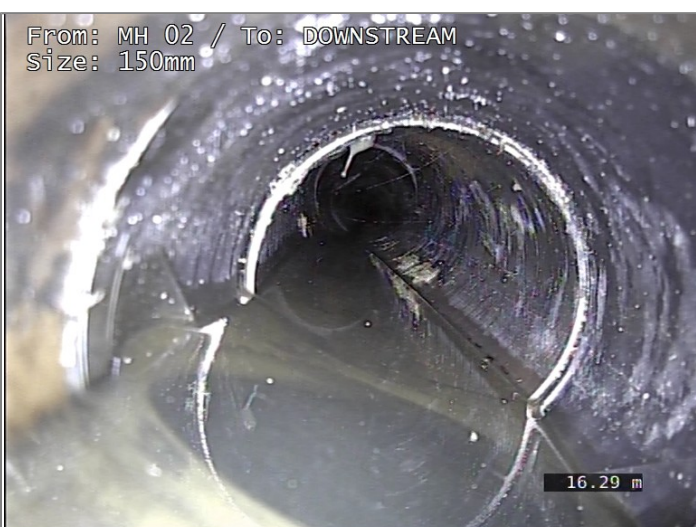
| Position | Code | Description | Photo | Type/Grade |
|---|---|---|---|---|
| 16.29 | SA | Survey abandoned - Remark: DUE TO A BLOCKED DROPSHAFT | 12725870 | Comment / 0 |

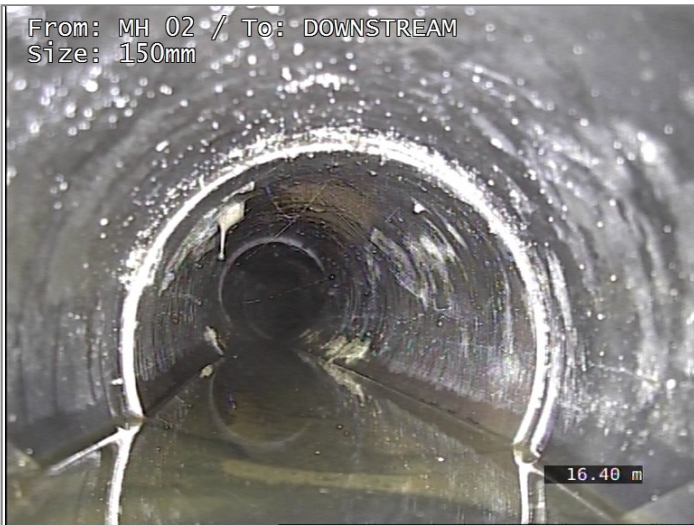
| Position | Code | Description | Photo | Type/Grade |
|---|---|---|---|---|
| 16.40 | FM (F03) | Fracture multiple from 3 to 10 o'clock - Remark: TIMES VARY , Finished | 12725862 | Structural / 4 |

Fracture multiple from 3 to 10 o'clock - Remark: TIMES VARY , Finished

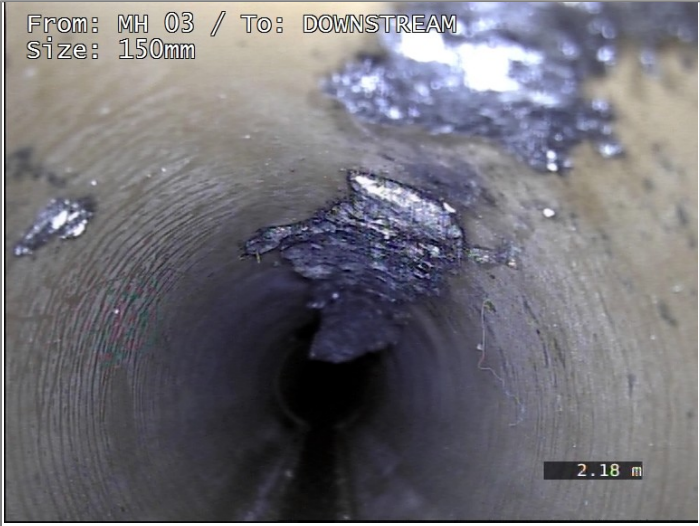
| Position | Code | Description | Photo | Type/Grade |
|---|---|---|---|---|
| 2.18 | DEG (S01) | Attached deposits, grease from 11 to 2 o'clock 10% cross-sectional area loss, Start | 12727141 | Service / 3 |

| Job Number<br>Crimble Hall | Surveyed by (Operator)<br>B McCabe | Base Unit<br>DPQFOHMAE5 | Date<br>29/07/2025 |
|---|---|---|---|
| <p>Attached deposits, grease from 11 to 2 o'clock 10% cross-sectional area loss, Start</p> | | | |

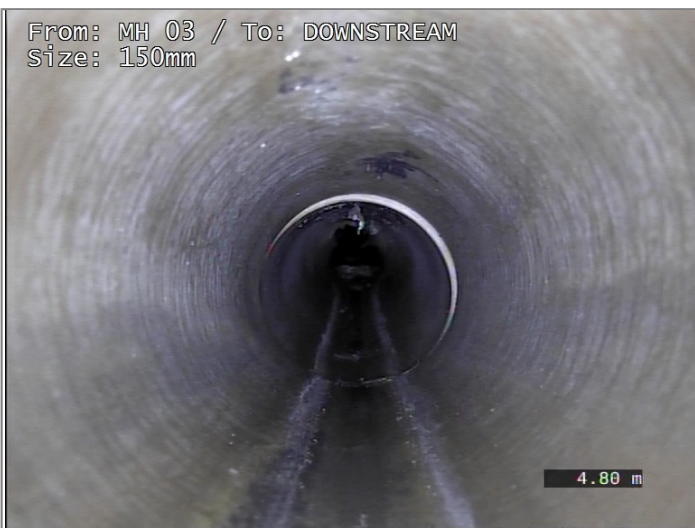
| Position | Code | Description | Photo | Type/Grade |
|---|---|---|---|---|
| 4.80 | DEG (F01) | Attached deposits, grease from 11 to 2 o'clock 10% cross-sectional area loss, Finished | 12727143 | Service / 3 |

| Job Number<br>Crimble Hall | Surveyed by (Operator)<br>B McCabe | Base Unit<br>DPQFOHMAE5 | Date<br>29/07/2025 |
|---|---|---|---|
| <p>Attached deposits, grease from 11 to 2 o'clock 10% cross-sectional area loss, Finished</p> | | | |

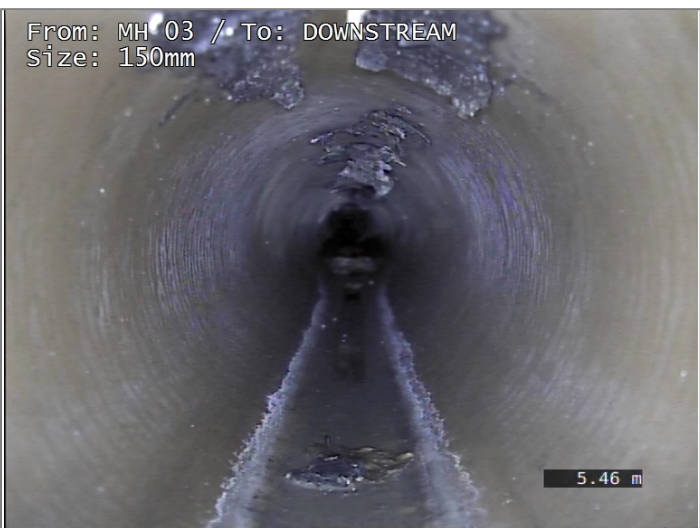
| Position | Code | Description | Photo | Type/Grade |
|---|---|---|---|---|
| 5.46 | DEG (S02) | Attached deposits, grease from 11 to 1 o'clock 10% cross-sectional area loss, Start | 12727144 | Service / 3 |

| Job Number<br>Crimble Hall | Surveyed by (Operator)<br>B McCabe | Base Unit<br>DPQFOHMAE5 | Date<br>29/07/2025 |
|---|---|---|---|
| <p>Attached deposits, grease from 11 to 1 o'clock 10% cross-sectional area loss, Start</p> | | | |

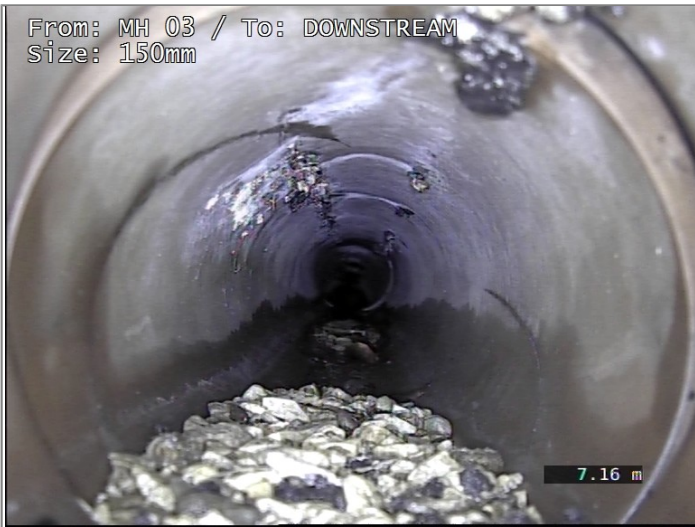
| Position | Code | Description | Photo | Type/Grade |
|---|---|---|---|---|
| 7.16 | DEX | Other settled deposits 25% cross-sectional area loss - Remark: STONE | 12727145 | Service / 4 |

| Job Number<br>Crimble Hall | Surveyed by (Operator)<br>B McCabe | Base Unit<br>DPQFOHMAE5 | Date<br>29/07/2025 |
|---|---|---|---|
| <p>From: MH 03 / To: DOWNSTREAM<br/>Size: 150mm</p> <p>Other settled deposits 25% cross-sectional area loss - Remark: STONE</p> | | | |

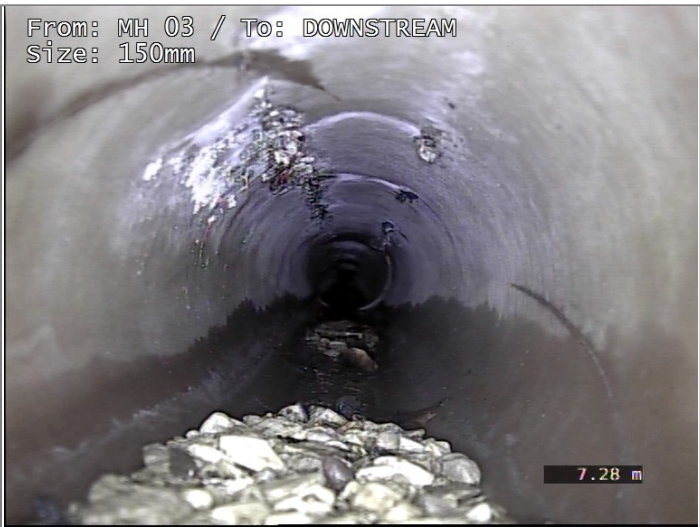
| Position | Code | Description | Photo | Type/Grade |
|---|---|---|---|---|
| 7.28 | FM | Fracture multiple from 3 to 11 o'clock | 12727146 | Structural / 4 |

| Job Number<br>Crimble Hall | Surveyed by (Operator)<br>B McCabe | Base Unit<br>DPQFOHMAE5 | Date<br>29/07/2025 |
|---|---|---|---|
| <p>From: MH 03 / To: DOWNSTREAM<br/>Size: 150mm</p> <p>Fracture multiple from 3 to 11 o'clock</p> | | | |

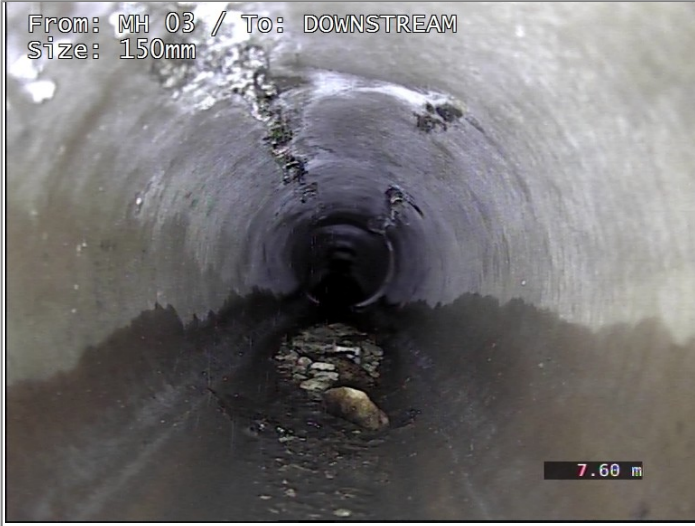
| Position | Code | Description | Photo | Type/Grade |
|---|---|---|---|---|
| 7.60 | DEG (F02) | Attached deposits, grease from 11 to 1 o'clock 10% cross-sectional area loss, Finished | 12727148 | Service / 3 |

| Job Number<br>Crimble Hall | Surveyed by (Operator)<br>B McCabe | Base Unit<br>DPQFOHMAE5 | Date<br>29/07/2025 |
|---|---|---|---|
| <p>From: MH 03 / To: DOWNSTREAM<br/>Size: 150mm</p> <p>Attached deposits, grease from 11 to 1 o'clock 10% cross-sectional area loss, Finished</p> | | | |

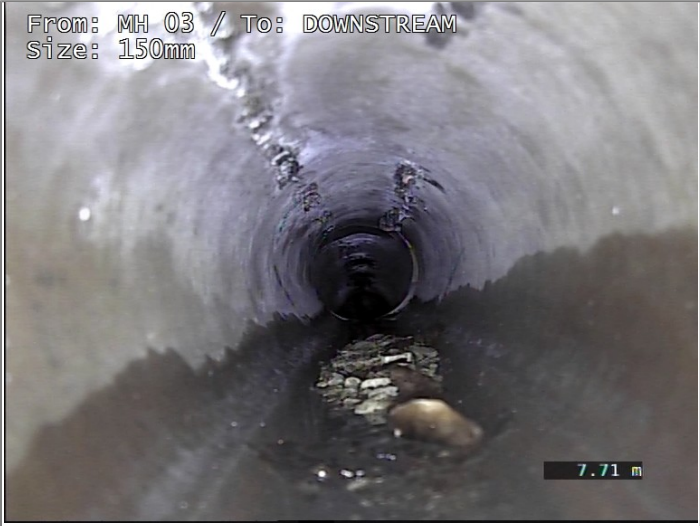
| Position | Code | Description | Photo | Type/Grade |
|---|---|---|---|---|
| 7.71 | SA | Survey abandoned - Remark: DUE TO STONES IN THE LINE | 12727150 | Comment / 0 |

| Job Number<br>Crimble Hall | Surveyed by (Operator)<br>B McCabe | Base Unit<br>DPQFOHMAE5 | Date<br>29/07/2025 |
|---|---|---|---|
| <p>From: MH 03 / To: DOWNSTREAM<br/>Size: 150mm</p> <p>Survey abandoned - Remark: DUE TO STONES IN THE LINE</p> | | | |

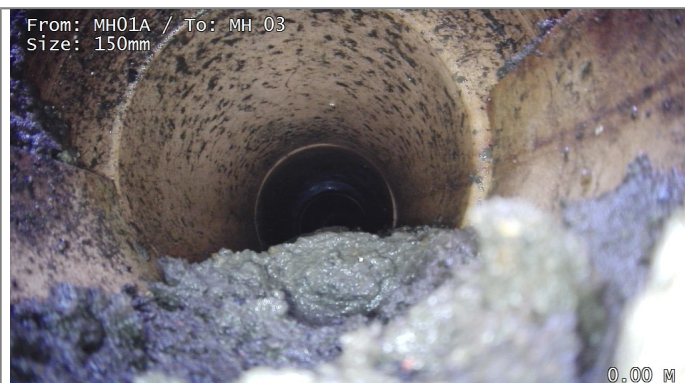
| Job Number<br>Crimble Hall | Surveyed by (Operator)<br>B McCabe | Base Unit<br>DPQFOHMAE5 | Date<br>29/07/2025 |
|---|---|---|---|
| <p>From: MH01A / To: MH_03<br/>Size: 150mm</p> <p>0.00 M</p> <p>Settled deposits coarse 25% cross-sectional area loss - Remark: MUD</p> | | <p>From: MH01A / To: MH_03<br/>Size: 150mm</p> <p>0.00 M</p> <p>Survey abandoned - Remark: UNABLE TO CCTV LINE REQUIRES CLEANING</p> | |

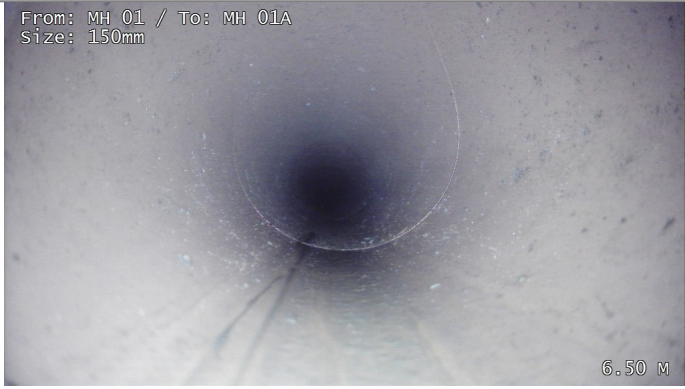
| Position | Code | Description | Photo | Type/Grade |
|---|---|---|---|---|
| 6.52 | CC | Crack circumferential from 1 to 11 o'clock | 12727843 | Structural / 2 |

| Job Number<br>Crimble Hall | Surveyed by (Operator)<br>B McCabe | Base Unit<br>DPQFOHMAE5 | Date<br>29/07/2025 |
|---|---|---|---|
| <p>From: MH 01 / To: MH 01A<br/>Size: 150mm</p> <p>2.38 M</p> <p>Junction at 9 o'clock, diameter 100mm</p> | | <p>From: MH 01 / To: MH 01A<br/>Size: 150mm</p> <p>6.50 M</p> <p>Crack circumferential from 1 to 11 o'clock</p> | |
