| PROJECT | SMP - St Mary's CE Primary School |
| TITLE | Elevation AA - Demolition & Repairs |
| NUMBER | SMP-SEV-XX-XX-DR-A-03010 |

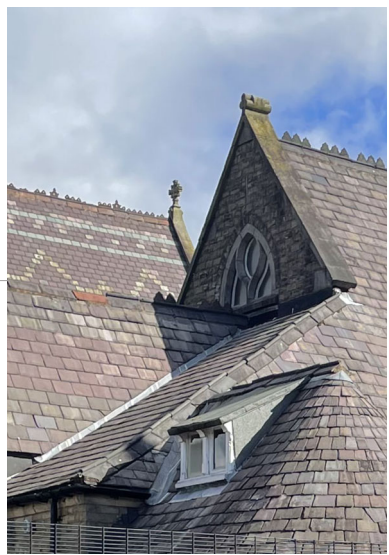
Significant Ridge tile damage in this area

- Flat Ridge Tiles: 50 Lm  
Ridge tiles to be removed and set aside with salvaged tiles for re-use. Replace damaged tiles like-for-like.

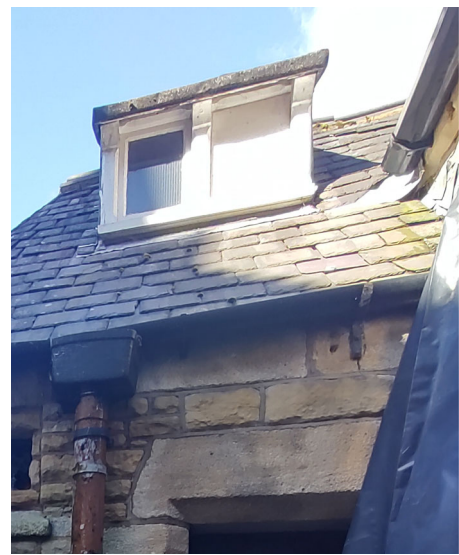
G1 Non-Gabled 'Shed' Dormer Windows require re-felting

- Non-Gabled Dormer Windows:  
'Shed Dormer' windows with flat felt topping. Splice in new timbers where appropriate. Access to be provided for detailed inspection and methodology agreed. Carefully sand down and repaint in appropriate materials as per the specification. Remove felt and re-top with terne-coated stainless steel (TCSS) with a round-batten seam to match Historic England (HE) Guidelines.

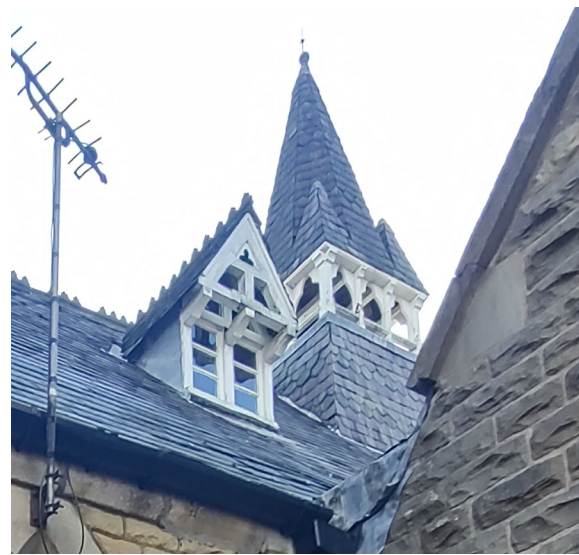
C3 Dormer window woodwork requires repainting

- Dormer Window: 09 no.  
Splice in new timbers where appropriate. Access to be provided for detailed inspection and methodology agreed. Carefully sand down and repaint in appropriate materials as per the specification. Roofing section per detail F-F in drawing SMP-SEV-XX-XX-DR-A-03105 (Typical Dormer Window)

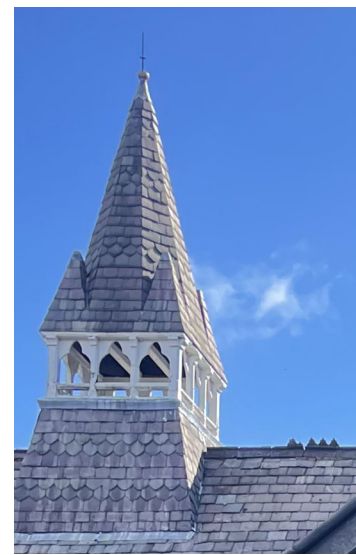
Cupola tiling intact

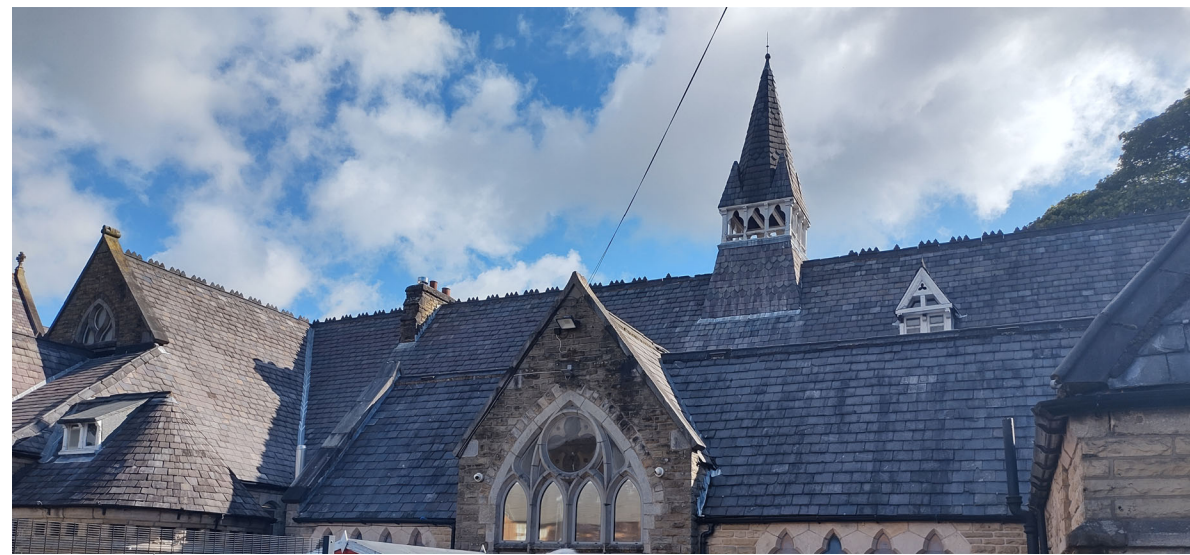
Broken Ridge Tiles mainly around Cupola

- Decorative Ridge Tiles: 105 Lm  
Ridge tiles to be removed and set aside with salvaged tiles for re-use. Replace damaged tiles as per the existing style. Ridge ventilation provided with new linear vent. Ridge venting per detail F-F in drawing SMP-SEV-XX-XX-DR-A-03105 (Typical Dormer Window)

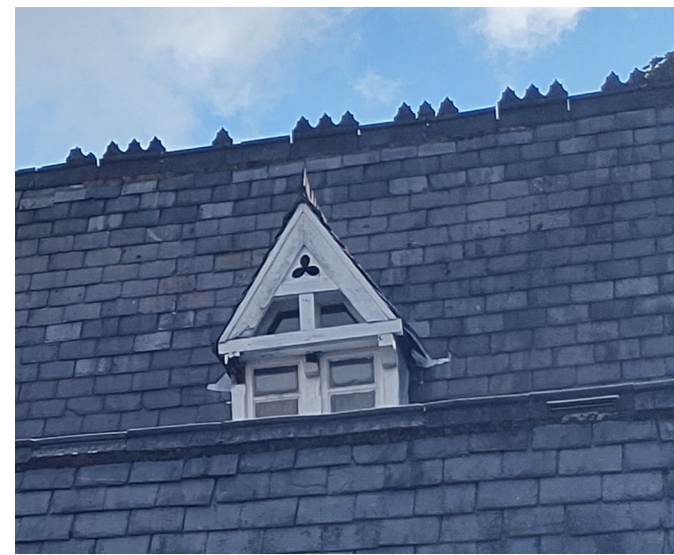
C4 Dormer window woodwork requires repainting

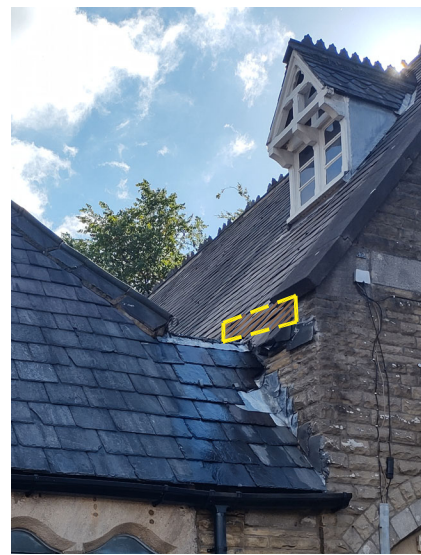
Additional guttering required in this area

- Rainwater Goods: 18 no.  
Down-pipe to be removed and replaced with cast-iron rainwater goods allowing for increased diameter (8 inch) to mitigate increased rainfall. Existing cast-iron hoppers to be retained & refurbished where possible. Guttering per detail B-B in drawing SMP-SEV-XX-XX-DR-A-03100 (Typical External Gutter)
