| PROJECT | SMP - St Mary's CE Primary School |
| TITLE | Elevation DD - Demolition & Repairs |
| NUMBER | SMP-SEV-XX-XX-DR-A-03013 |

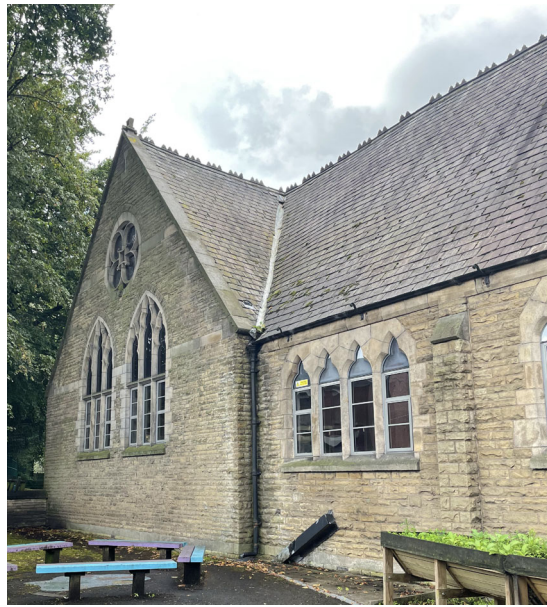
Multiple damaged Ridge Tiles

Decorative Ridge Tiles: 105 Lm  
Ridge tiles to be removed and set aside with salvaged tiles for re-use. Replace damaged tiles as per the existing style. Ridge ventilation provided with new linear vent. Ridge venting per detail F-F in drawing SMP-SEV-XX-XX-DR-A-03105 (Typical Dormer Window)

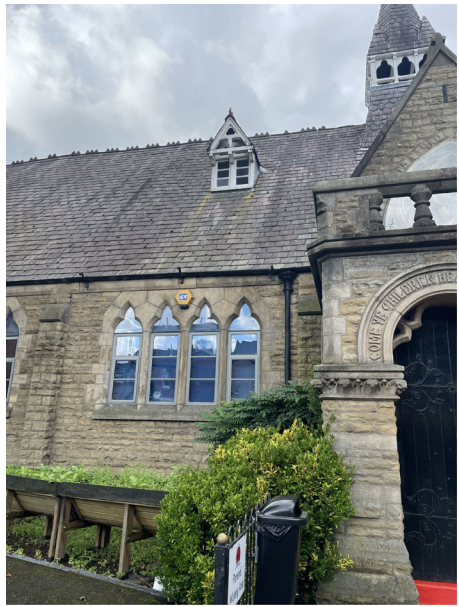
Ridge Tiles damaged near Cupola

Wooden structural arches between 2no. tiled sections

Significant Ridge tile damage in this area

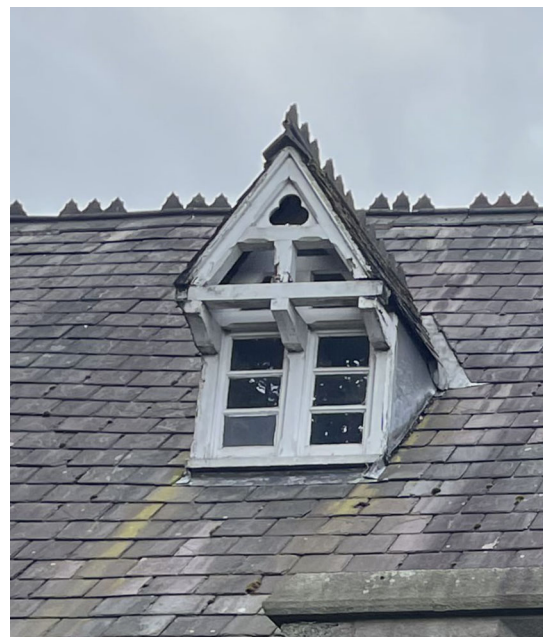
C2 Dormer wooden damaged; requires further inspection

Dormer Window: 09 no.  
Splice in new timbers where appropriate. Access to be provided for detailed inspection and methodology agreed. Carefully sand down and repaint in appropriate materials as per the specification. Roofing section per detail F-F in drawing SMP-SEV-XX-XX-DR-A-03105 (Typical Dormer Window)

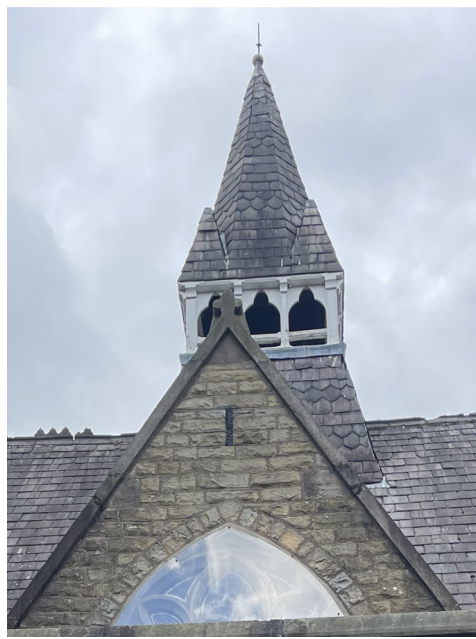
Cupola, East side  
Cupola wooden undamaged; requires further inspection

Cupola: 01 no.  
Splice in new timbers where appropriate. Access to be provided for detailed inspection and methodology agreed. Carefully sand down and repaint in appropriate materials as per the specification. Cupola roofing is as per the building's other slate roof eaves, but is at a steeper gradient (assume larger area than in plan).

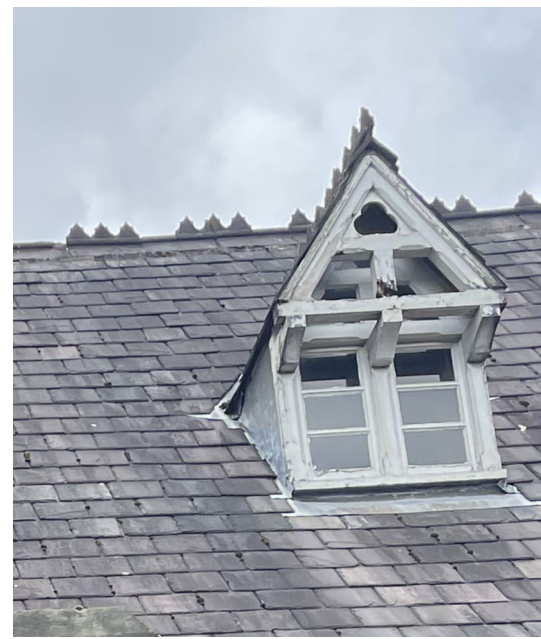
C1 Dormer wooden damaged; will require replacement sections
