# TIMBER DORMER SCHEDULE

Client: Rochdale Borough Council  
Project: St Mary's CE Primary School  
Reference: SMP-SEV-ZZ-XX-RP-A-04001  
Date: August | 2024

| DOCUMENT TITLE | TIMBER DORMER SCHEDULE |

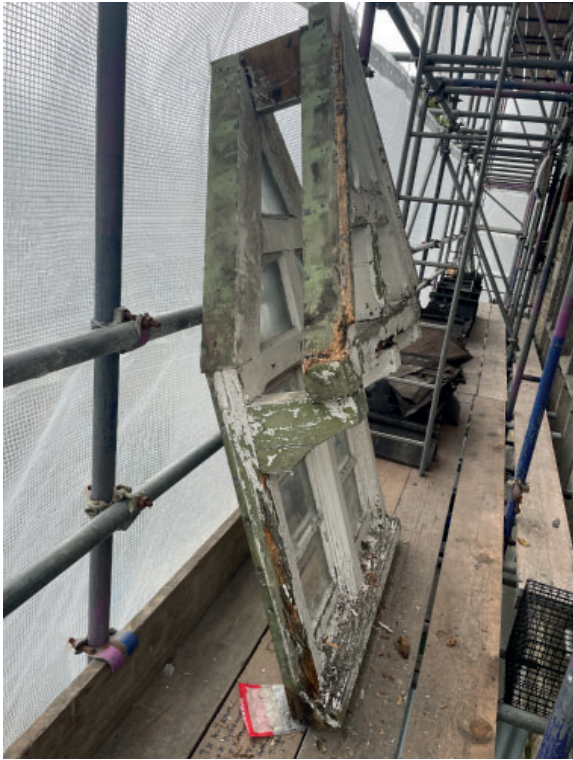
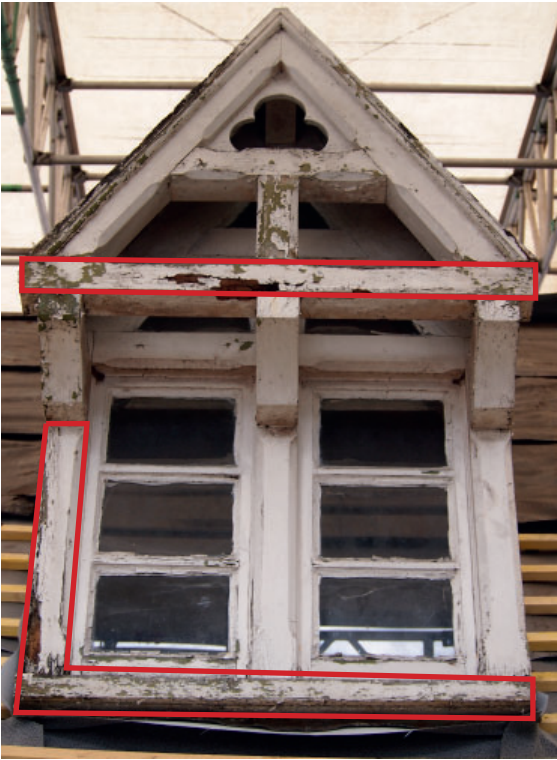
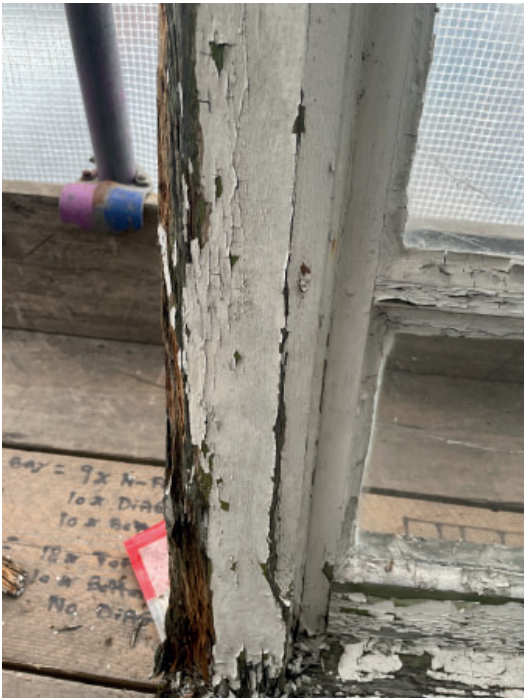
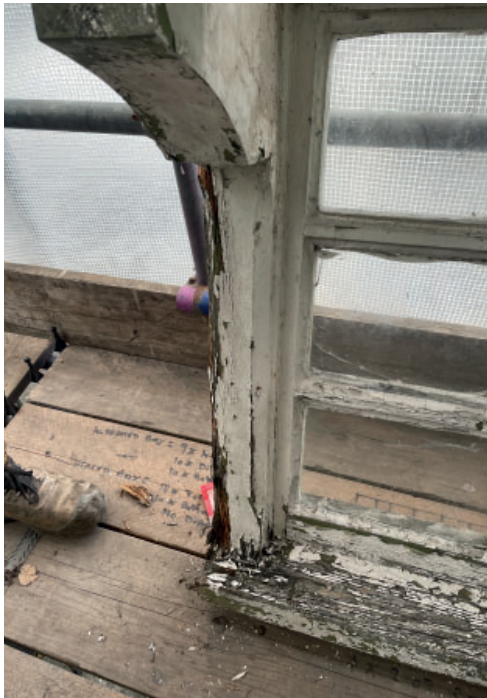
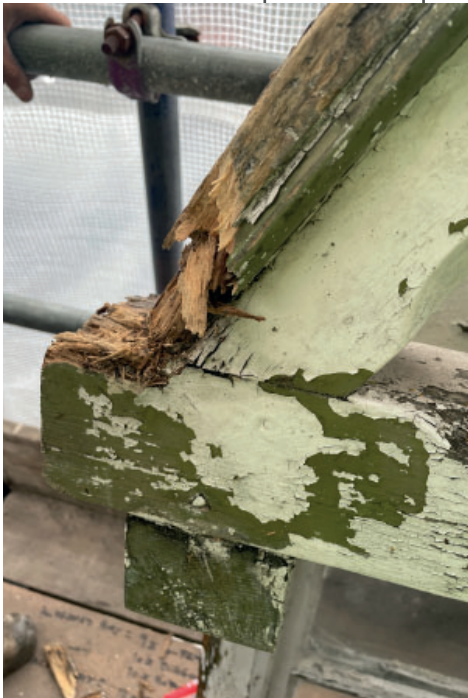
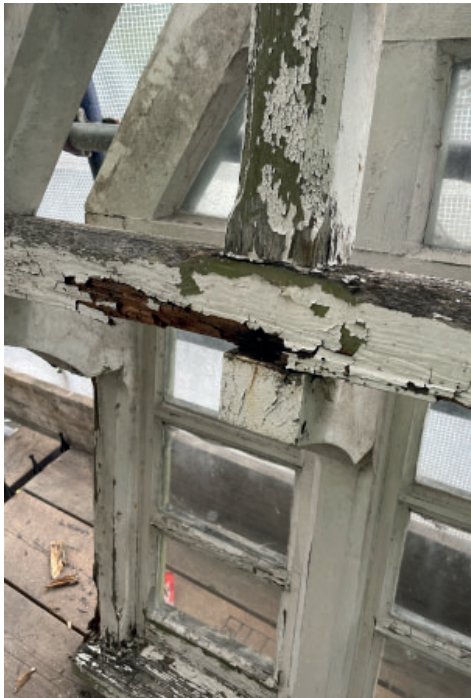
| Reference/ Element | Location | Proposals |
|---|---|---|
| | Dormer D3<br>Roof Di | Dormer has been removed in order to be repaired off site in the workshop.<br><br>All areas highlighted in red are rotten and need to be replaced. Splice repairs to each section with materials to match the existing.<br><br>All paintwork to be carefully sanded back and repainted as per the restoration specification. |

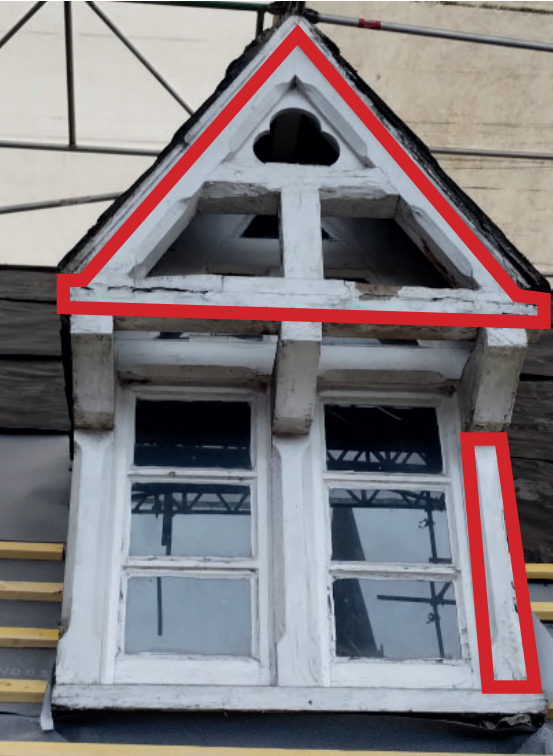
| Reference/ Element | Location | Proposals |
|---|---|---|
| | Dormer D1<br>Roof Di | <p>All areas highlighted in red are rotten and need to be replaced. Splice repairs to each section with materials to match the existing.</p> <p>All paintwork to be carefully sanded back and repainted as per the restoration specification.</p> |

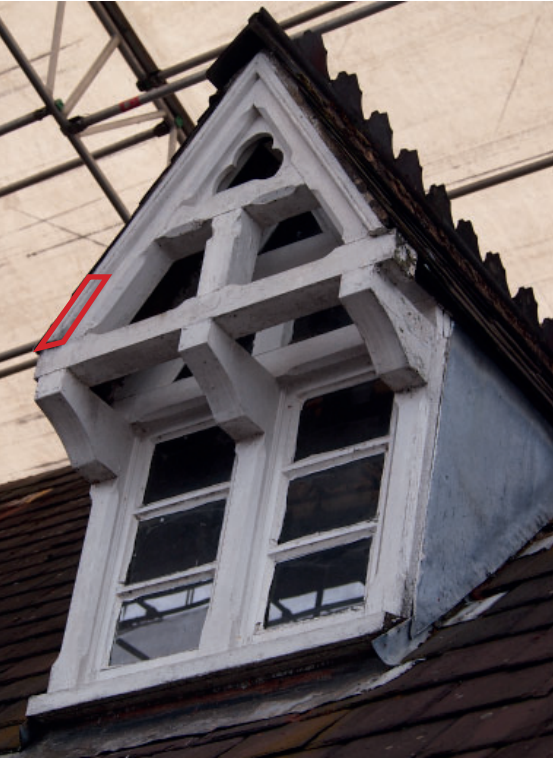
| Reference/ Element | Location | Proposals |
|---|---|---|
| | Dormer D2<br>Roof Di | <p>All areas highlighted in red are rotten and need to be replaced. Splice repairs to each section with materials to match the existing.</p> <p>All paintwork to be carefully sanded back and repainted as per the restoration specification.</p> |

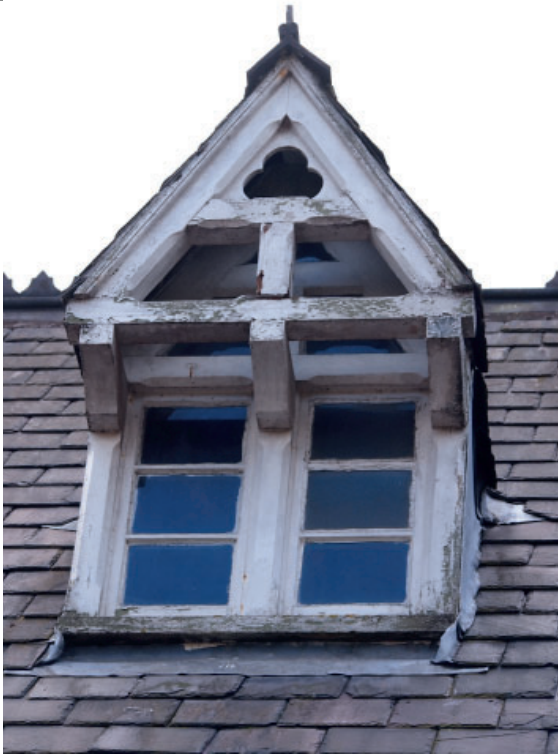
| Reference/ Element | Location | Proposals |
|---|---|---|
| | Dormer A1<br>Roof A.i | All areas highlighted in red are rotten and need to be replaced. Splice repairs to each section with materials to match the existing.<br><br>All paintwork to be carefully sanded back and repainted as per the restoration specification. |

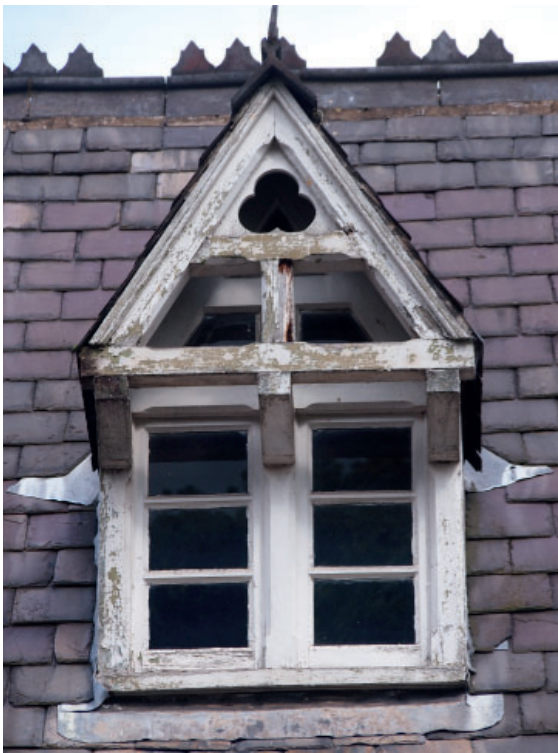
| Reference/ Element | Location | Proposals |
|---|---|---|
| | Dormer A2<br>Roof A.i | All areas highlighted in red are rotten and need to be replaced. Splice repairs to each section with materials to match the existing.<br><br>All paintwork to be carefully sanded back and repainted as per the restoration specification. |

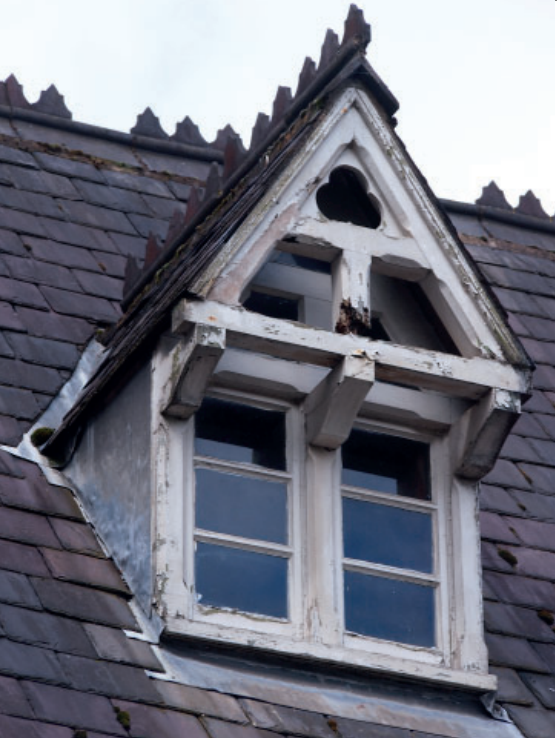
| Reference/ Element | Location | Proposals |
|---|---|---|
| | Dormer C1<br>Roof Ci | Full replacement required. |

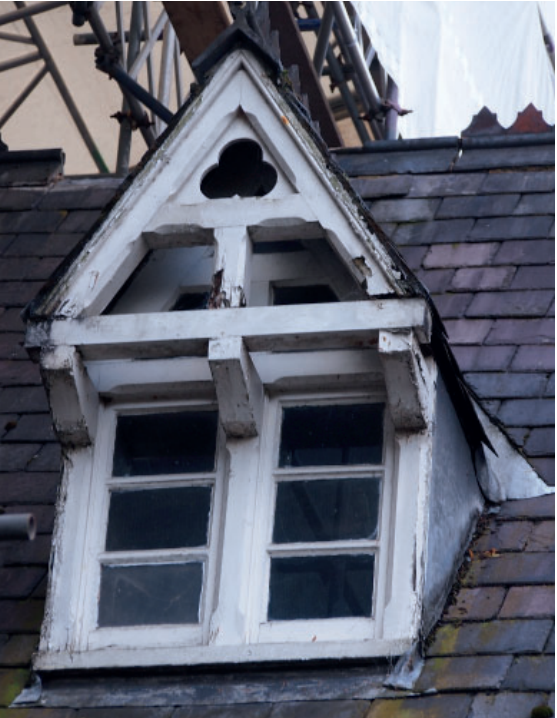
| Reference/ Element | Location | Proposals |
|---|---|---|
| | Dormer C2<br>Roof Ci | Full replacement required. |

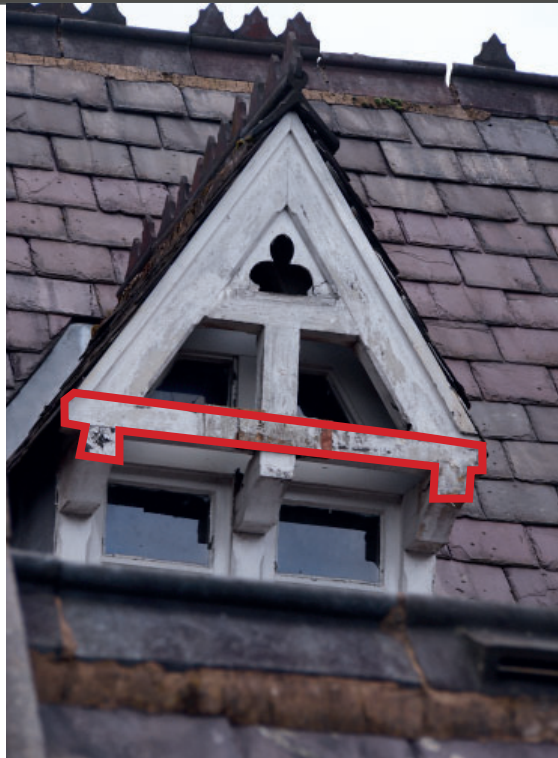
| Reference/ Element | Location | Proposals |
|---|---|---|
| | Dormer C3<br>Roof Ci | <p>All areas highlighted in red are rotten and need to be replaced. Splice repairs to each section with materials to match the existing.</p> <p>All paintwork to be carefully sanded back and repainted as per the restoration specification. All areas highlighted in red are rotten and need to be replaced. Splice repairs to each section with materials to match the existing.</p> <p>All paintwork to be carefully sanded back and repainted as per the restoration specification.</p> |

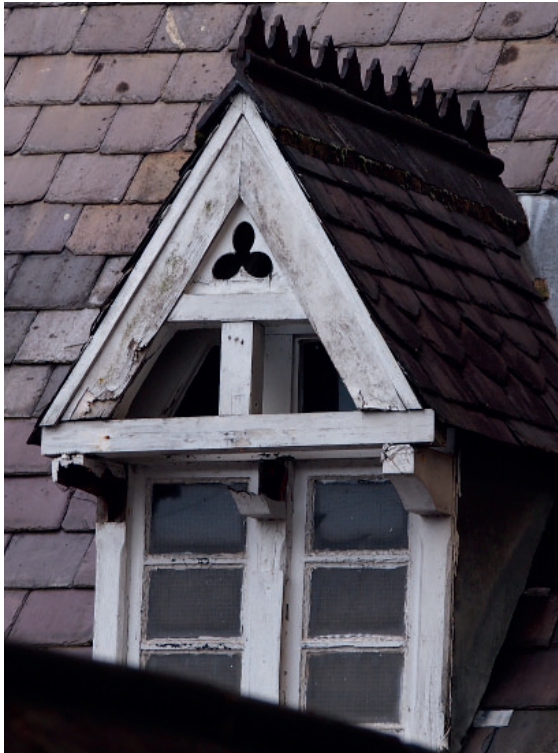
| Reference/ Element | Location | Proposals |
|---|---|---|
| | Dormer C4<br>Roof Ci | <p>All areas highlighted in red are rotten and need to be replaced. Splice repairs to each section with materials to match the existing.</p> <p>All paintwork to be carefully sanded back and repainted as per the restoration specification.</p> |

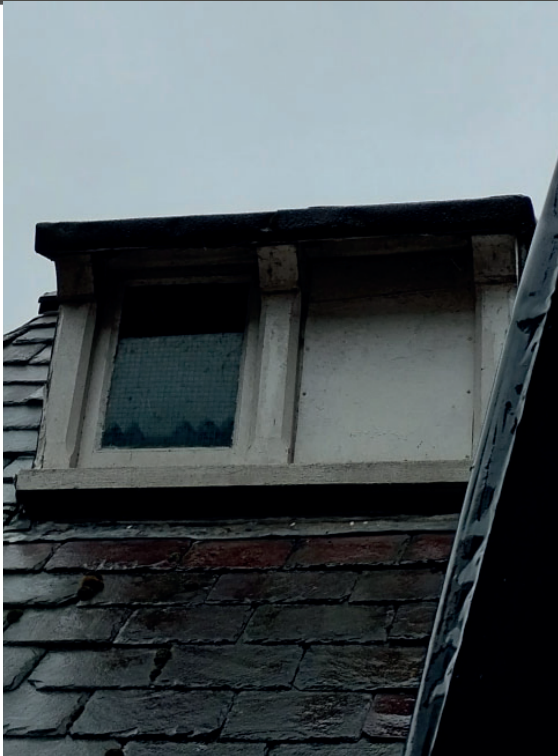
| Reference/ Element | | Location | Proposals |
|---|---|---|---|
| | | Dormer<br>G1<br>Roof G | Full replacement required. |

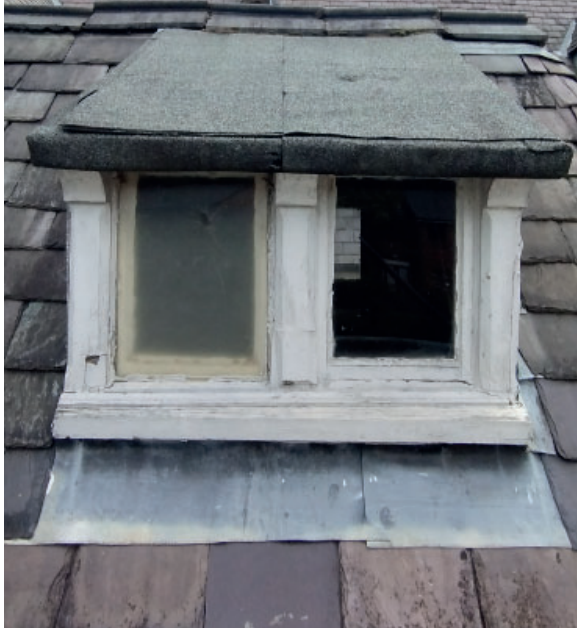
| Reference/ Element | | Location | Proposals |
|---|---|---|---|
| | | Dormer<br>G2<br>Roof G | Full replacement required. |

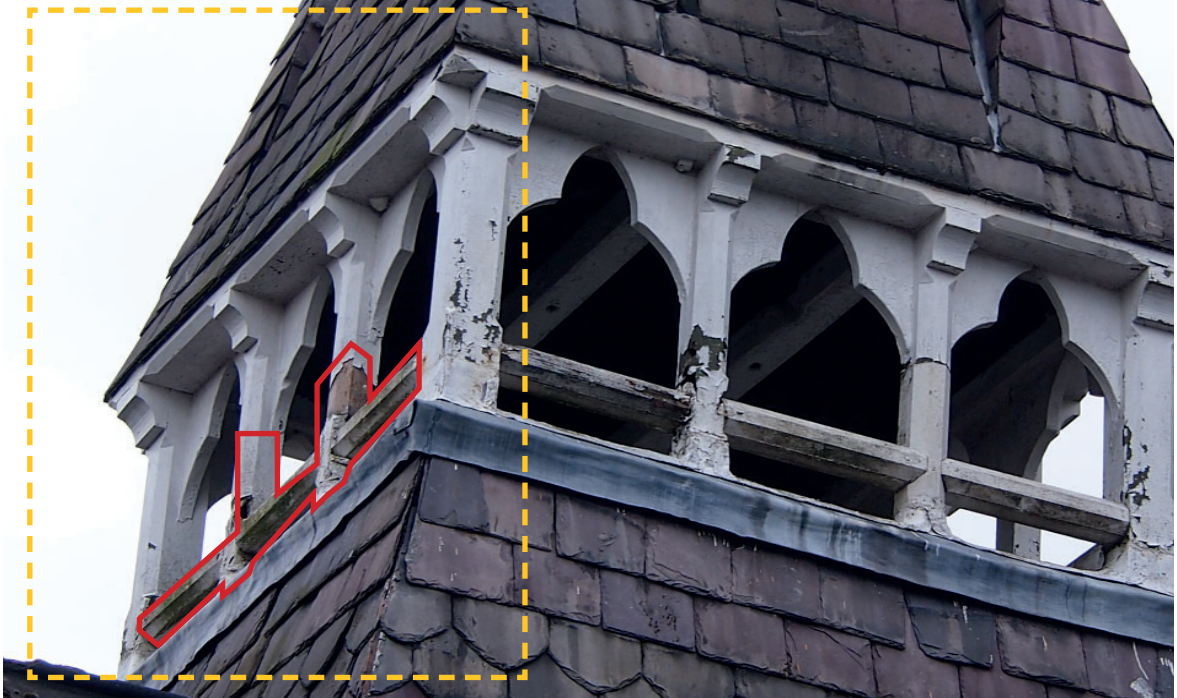
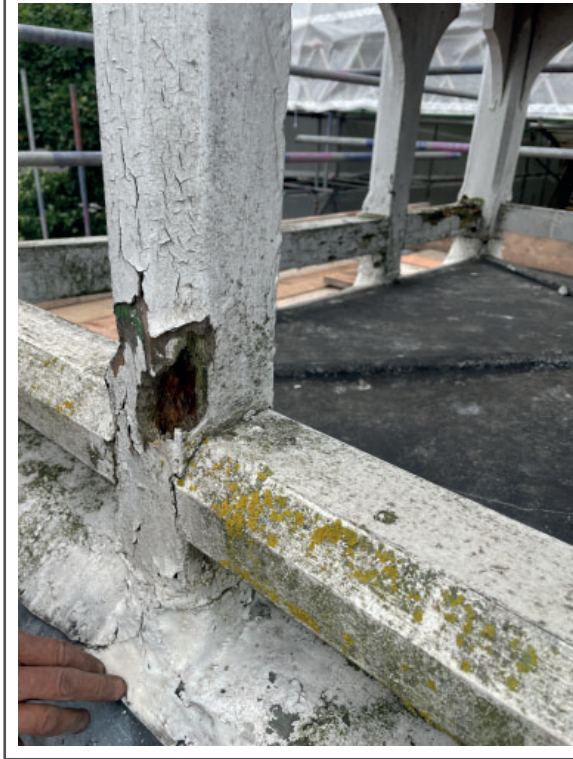
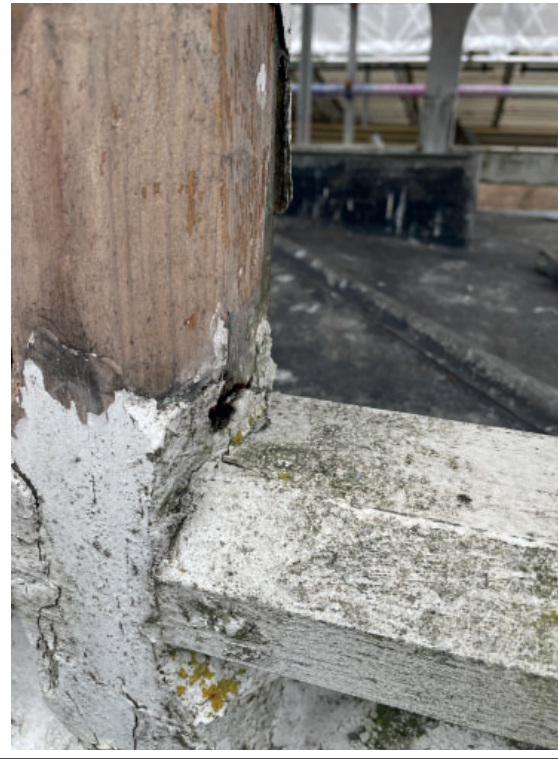
| Reference/ Element | Location | Proposals |
|---|---|---|
| <br><br> | Cupola<br>North<br>Flank | <p>There is considerable rot to the bases of the north flank. These need to be cut out and new timber, to match the original, spliced in.</p> <p>All paintwork to be carefully sanded back and repainted as per the restoration specification.</p> |

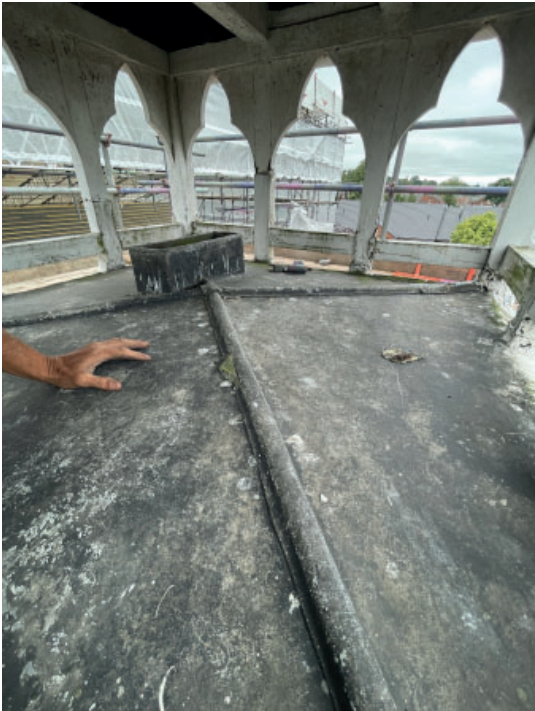
Lead roof looks to be on good condition and does not require renewal. All wraps to timber ends should be in lead.

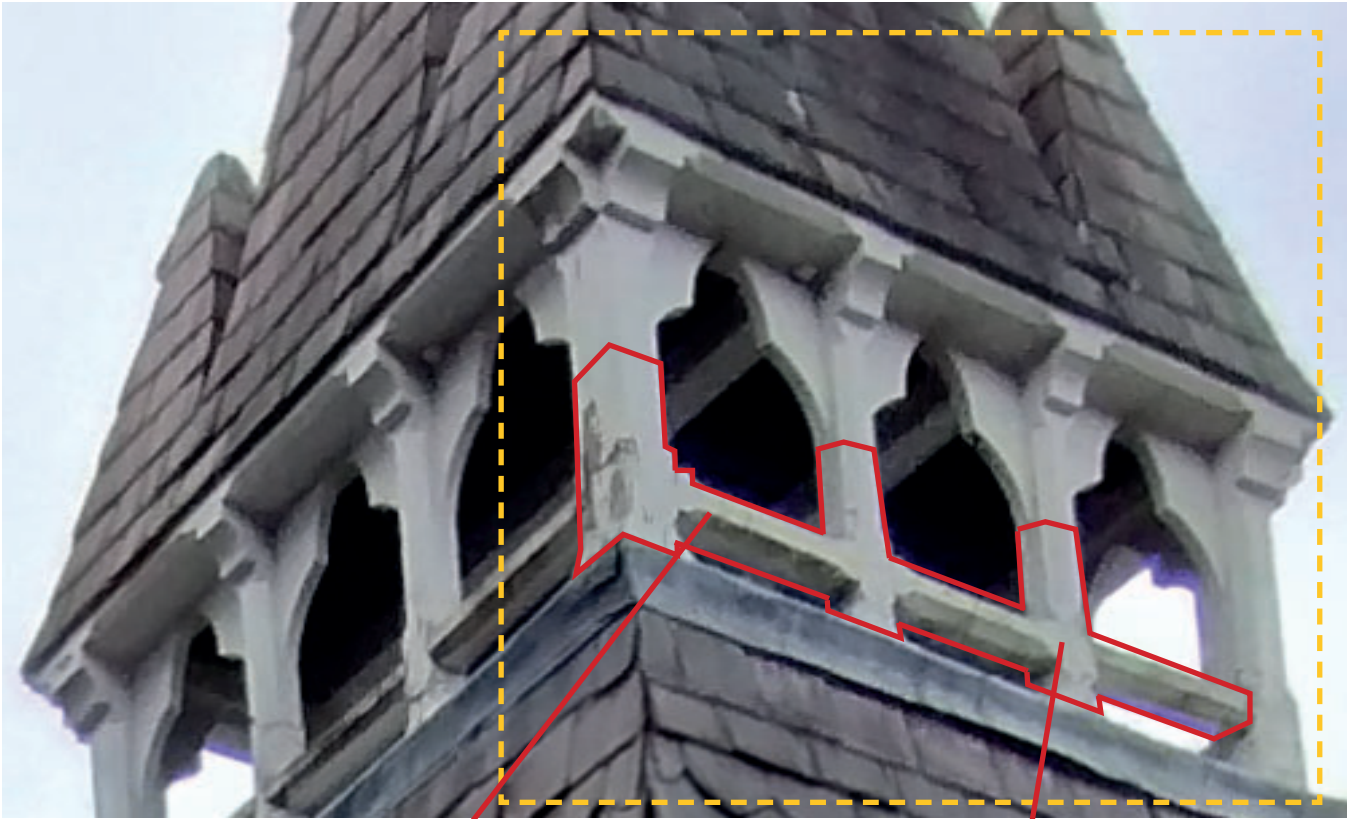
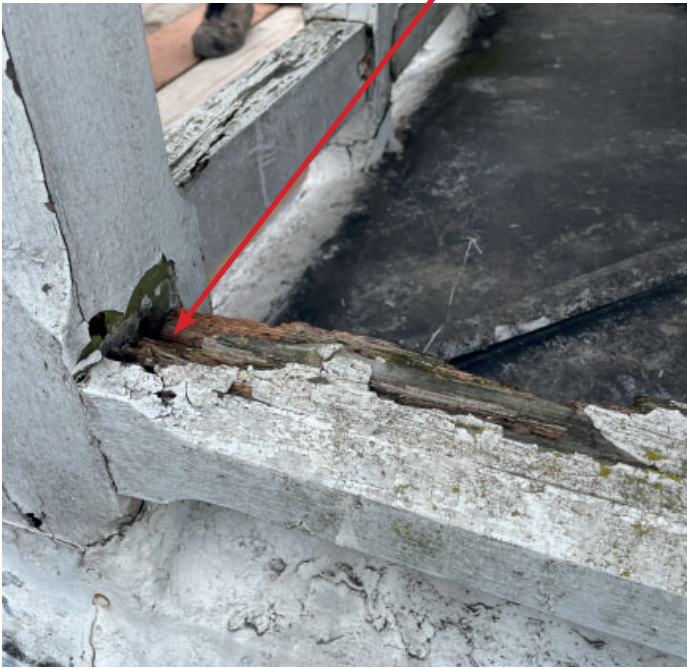
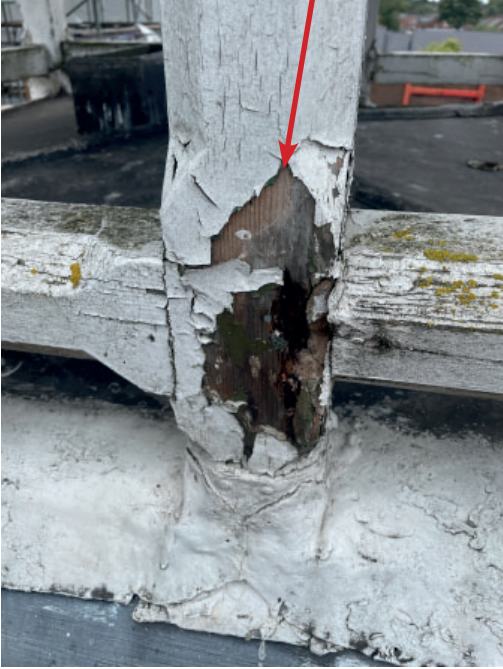
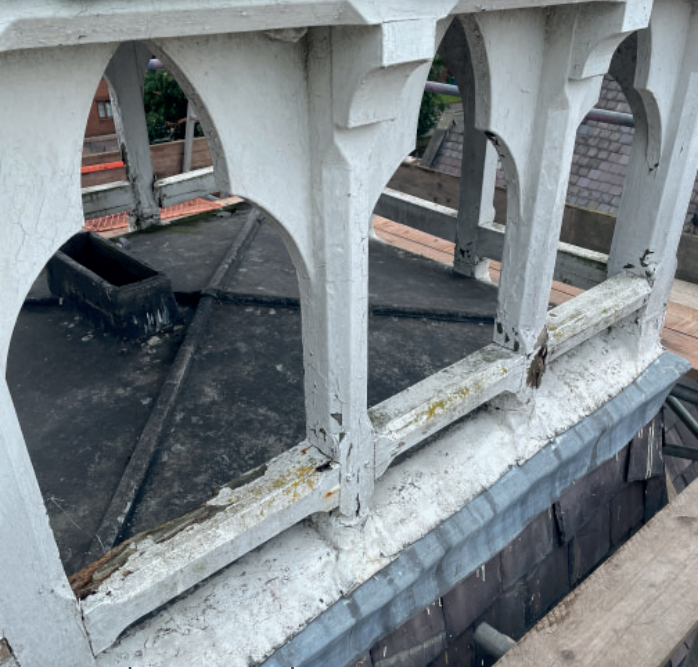
| Reference/ Element | Location | Proposals |
|---|---|---|
| <br><br><br> | Cupola<br>East<br>Flank | <p>All areas highlighted in red are rotten and need to be replaced. Splice repairs to each section with materials to match the existing.</p> <p>All paintwork to be carefully sanded back and repainted as per the restoration specification.</p> |

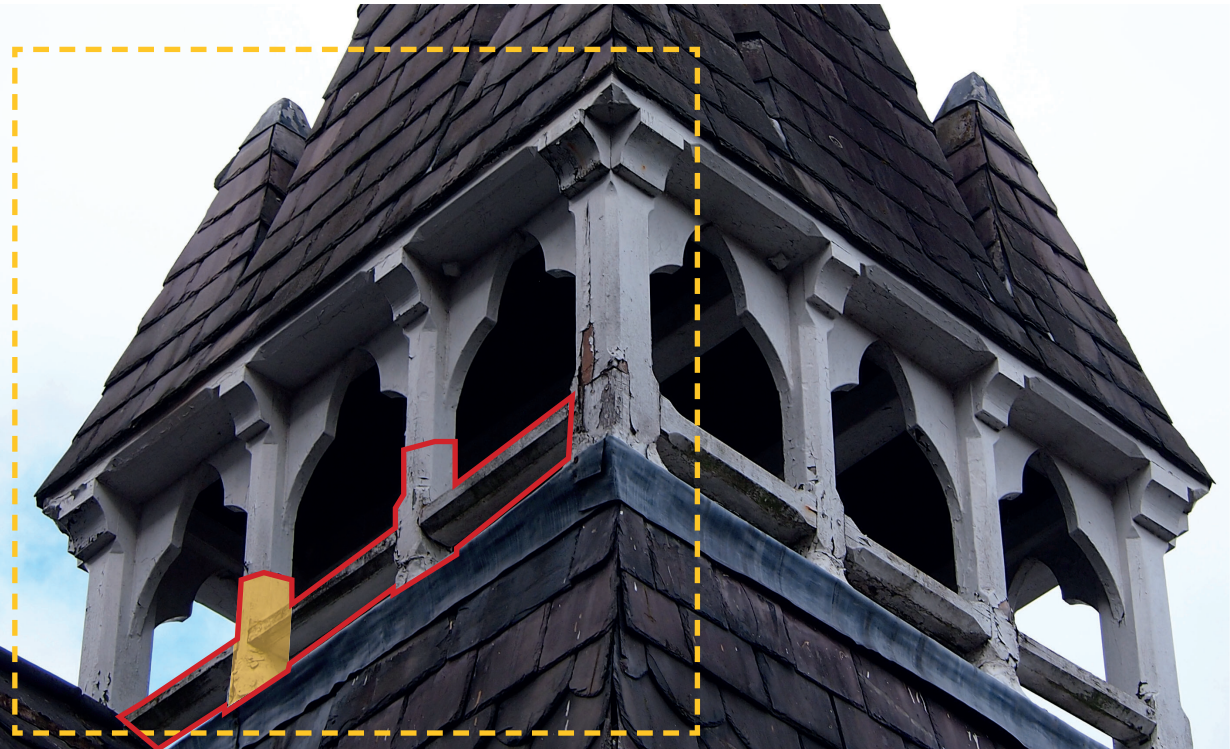
| Reference/ Element | Location | Proposals |
|---|---|---|
| | Cupola<br>South<br>Flank | <p>All areas highlighted in red are rotten and need to be replaced. Splice repairs to each section with materials to match the existing.</p> <p>The area in yellow is an existing splice detail however the joint to the old and new is not flush and requires sanding to exactly match to stop water tracking into the joint.</p> <p>The reverse side of the timber has had a holding repair of plywood which required removal.</p> <p>All paintwork to be carefully sanded back and repainted as per the restoration specification.</p> |

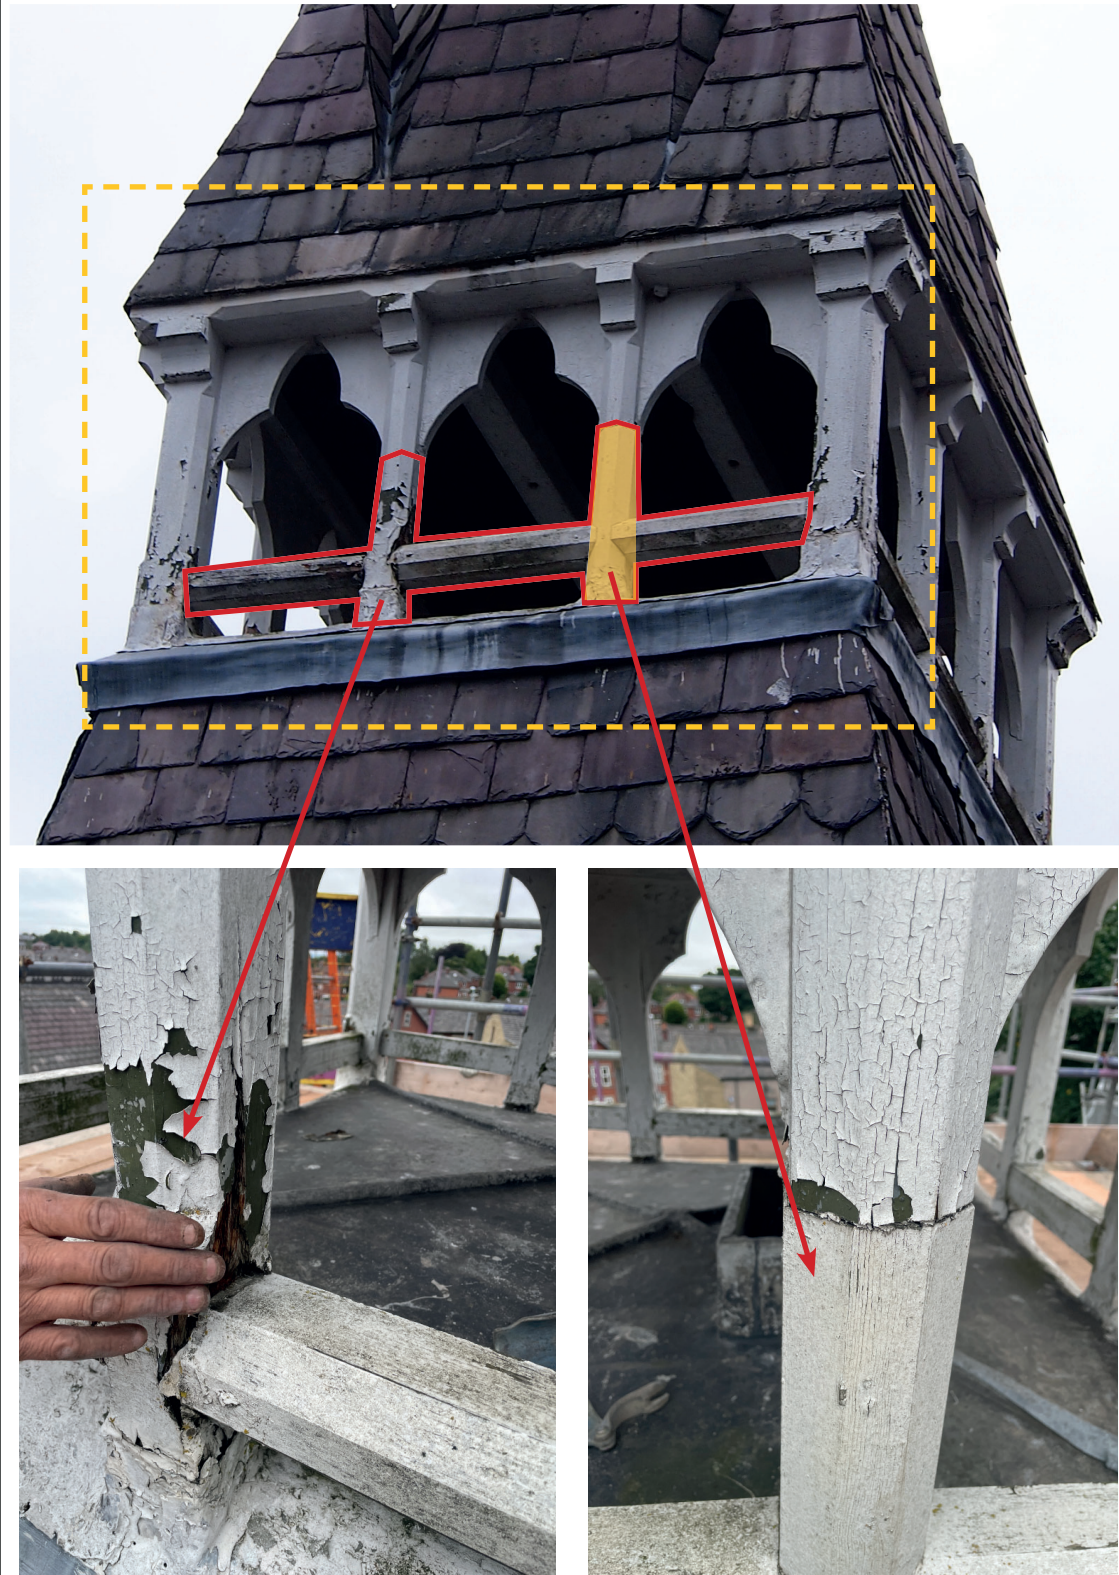
| Reference/ Element | Location | Proposals |
|---|---|---|
| | Cupola<br>West Flank | <p>All areas highlighted in red are rotten and need to be replaced. Splice repairs to each section with materials to match the existing.</p> <p>The area in yellow is an existing splice detail however the joint to the old and new is not flush and requires sanding to exactly match to stop water tracking into the joint.</p> <p>All paintwork to be carefully sanded back and repainted as per the restoration specification.</p> |
