# ARBORICULTURAL REPORT AND SAFETY SURVEY

**Client:** RedSide  
**Site:** Moss Lodge  
Kings Road  
Rochdale  
OL16 5HW

**Date:** 13 June 2025  
**Ref.:** THR25-56

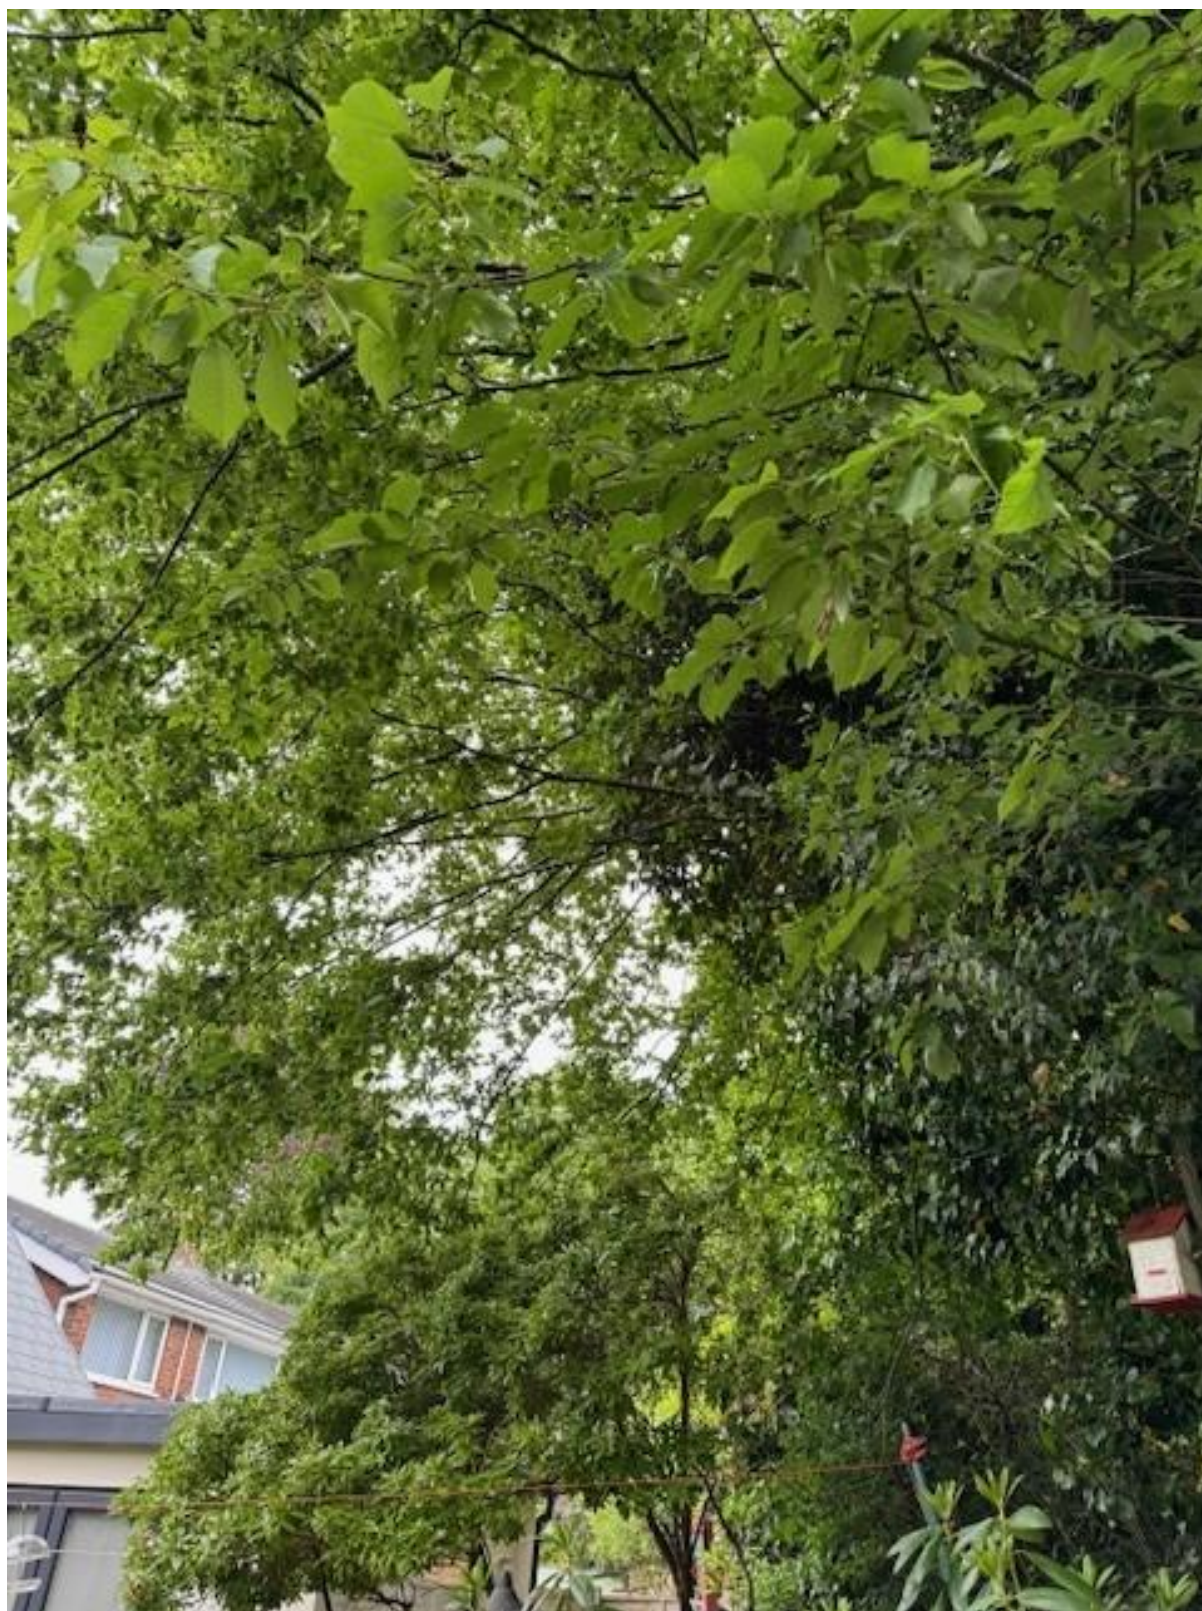
- 7.3 This tree is a mature Hornbeam (*Carpinus betulus*) growing on the boundary of Moss Lodge and the garden of 34 Percy Street. The crown is low over the garden and overhangs by 3-4 metres at the widest point. This makes the house very dark and forces any plants in the garden to grow out trying to get light. The tree has Ivy growing up the stem into the crown, this not only makes inspection of the stem difficult but also make the crown appear very dark even in winter for the residents to the rear.

- 7.4 Mr & Mrs Cooke stated that they had lived there for many years and that the tree had not had any maintenance during that time. Their main complaint is the height and width of the tree makes their property very dark and that it is now difficult to enjoy their garden due to the encroaching branches. The dense Ivy throughout the tree spoils its appearance and makes the tree very dark even in winter.

Photo 1: Garden of 34 Percy Street showing extent of overhang

- 7.6 I believe that it is essential to severe the Ivy at the base and let it die before attempting to remove it from the tree. Once the Ivy is removed it would be possible to crown lift the tree to 4-5 metres over the garden. The remaining upper crown should then be carefully reduced back from the property by 2-3 metres, reducing the crown by a similar amount to improve the light into the house and garden.

- Sever Ivy and remove when dead.
- Raise crown to 4-5 metres over garden.
- Reduce remaining crown over garden of 34 Percy Street by 2-3 metres, carefully reducing the height by a similar amount to leave a natural flow to the tree. The reduction should be in line with BS3998

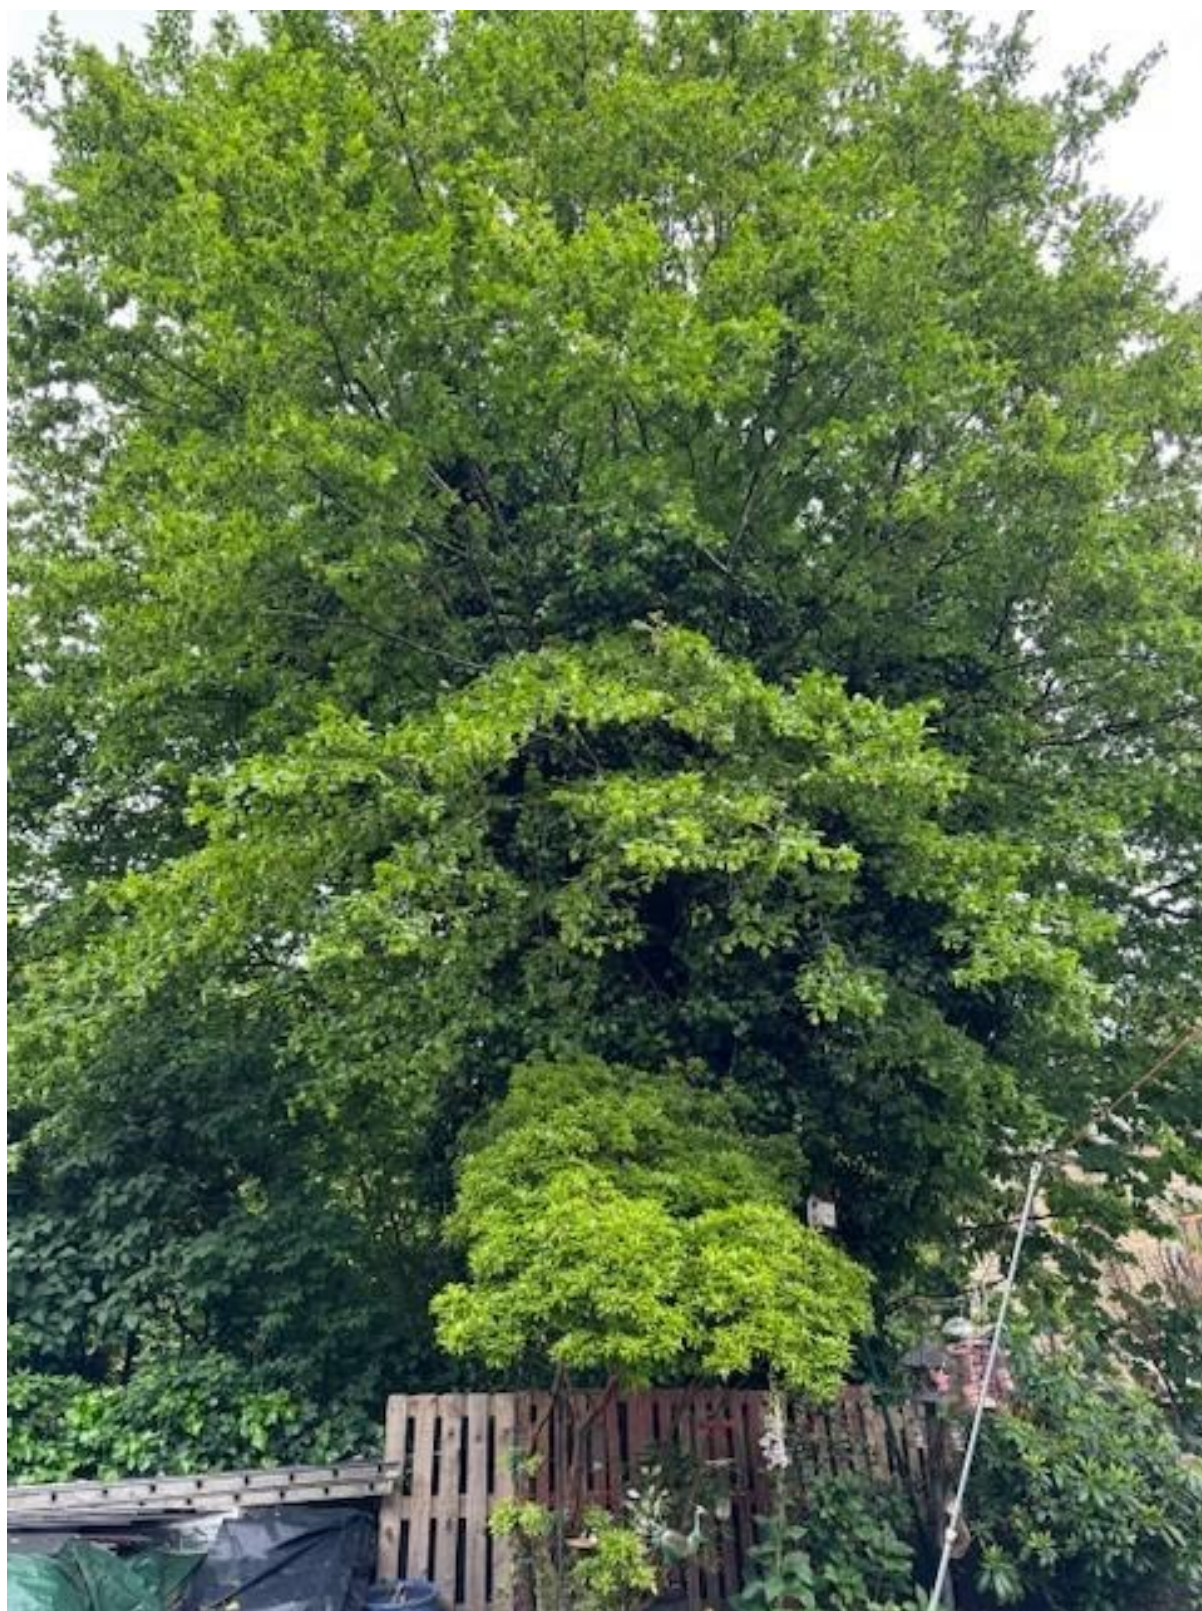
- 7.5 The Ivy is an issue with this tree because it has started to smother the crown. Although this may not kill the tree it is a problem when you wish to reduce the crown size as the Ivy will romp away and smother any new growth.

Photo 2: Hornbeam from 34 Percy Street showing dominance of tree
