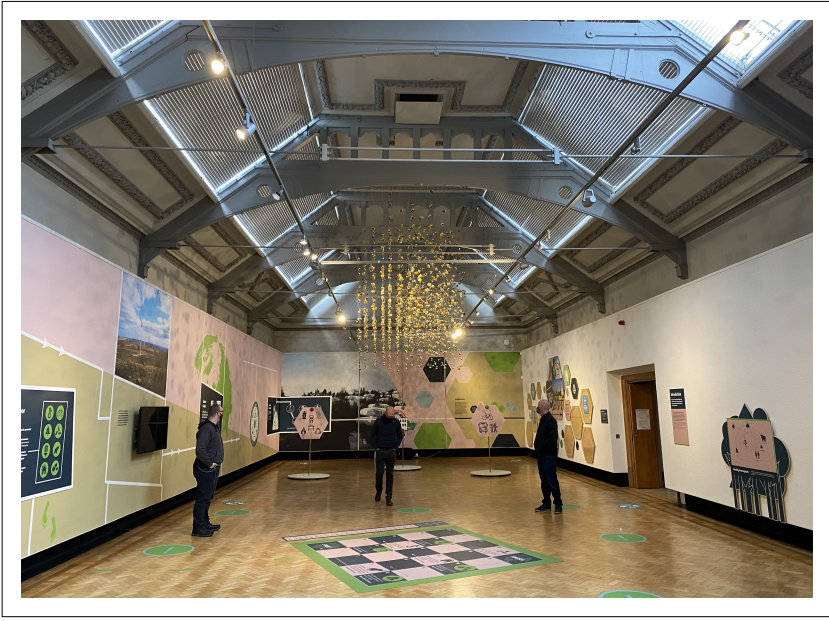
**Image 04 - Gallery 04**  
Photograph c.2024

**Notes:**  
Pipework exposed, but hidden by exhibition boards projection / shadow gap detail to base of walls. Existing extract ventilation visible at roof level.
