Existing Wall Coverings Condition (Exhibition Boards Removed)  
Photographs - February 2024 onwards

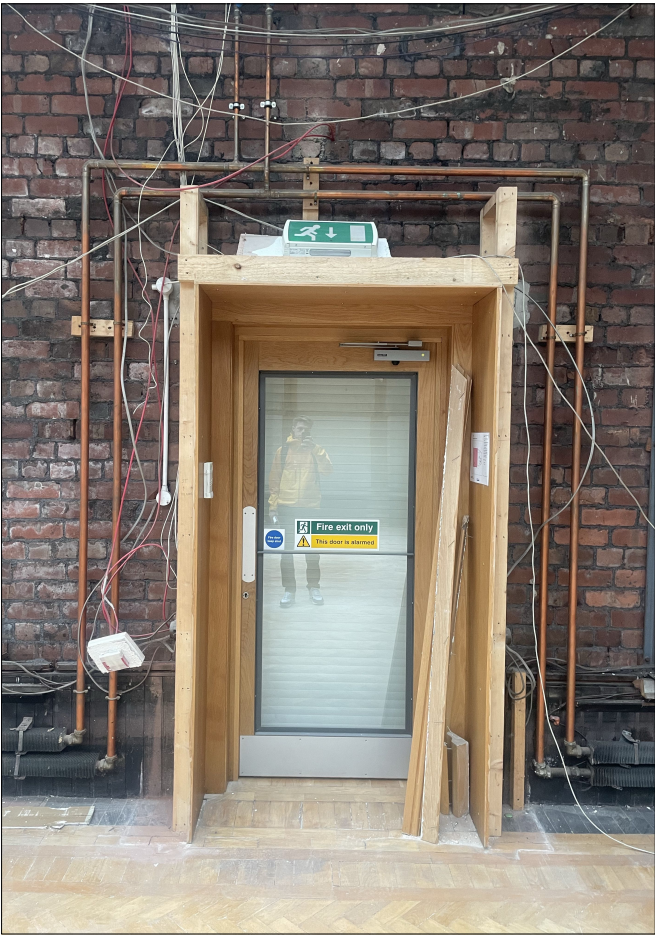
Image 01/04 -  
Example area around escape door where existing wall coverings have been removed (historically). The exposed brickwork was uncovered following the exhibition boards removal.

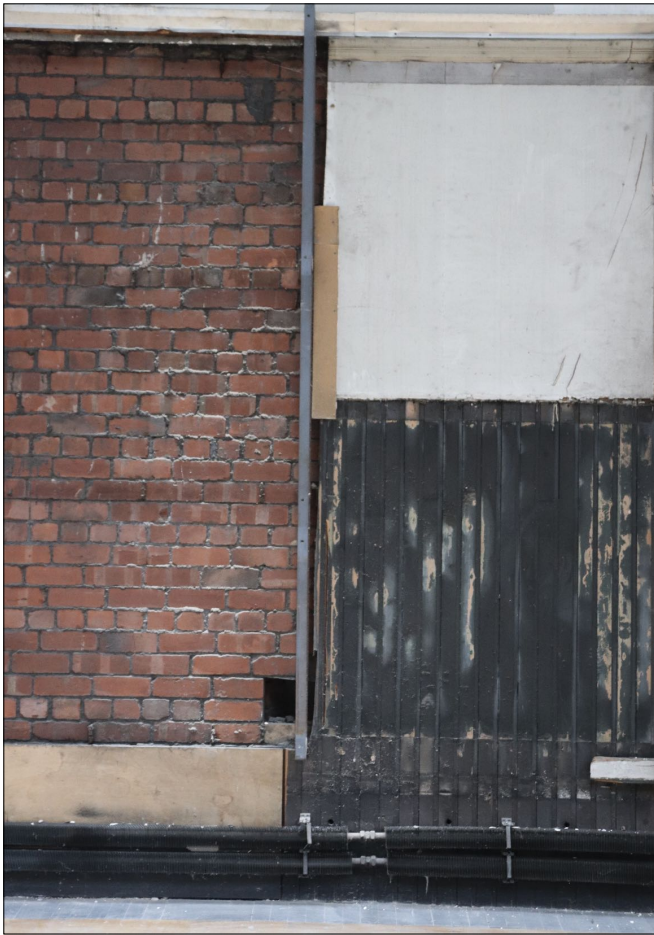
Image 02/04 -  
Example area where existing wall coverings came loose following exhibition board removal due to deteriorated fixing points / general poor condition. Brickwork and (one of many) existing ventilation point became exposed.

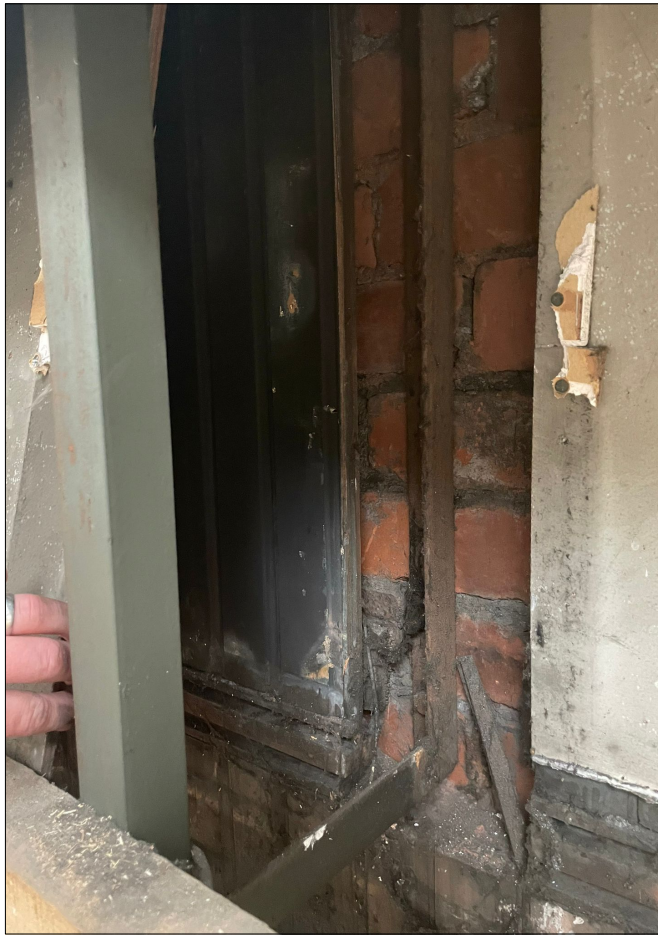
Image 03/04 -  
Close up image of existing cut through wall coverings for historic metal frame fixing points throughout gallery spaces. Historic cutting of wall covering has meant T&G / boarding has become less secure and is in poor condition as visible in images.

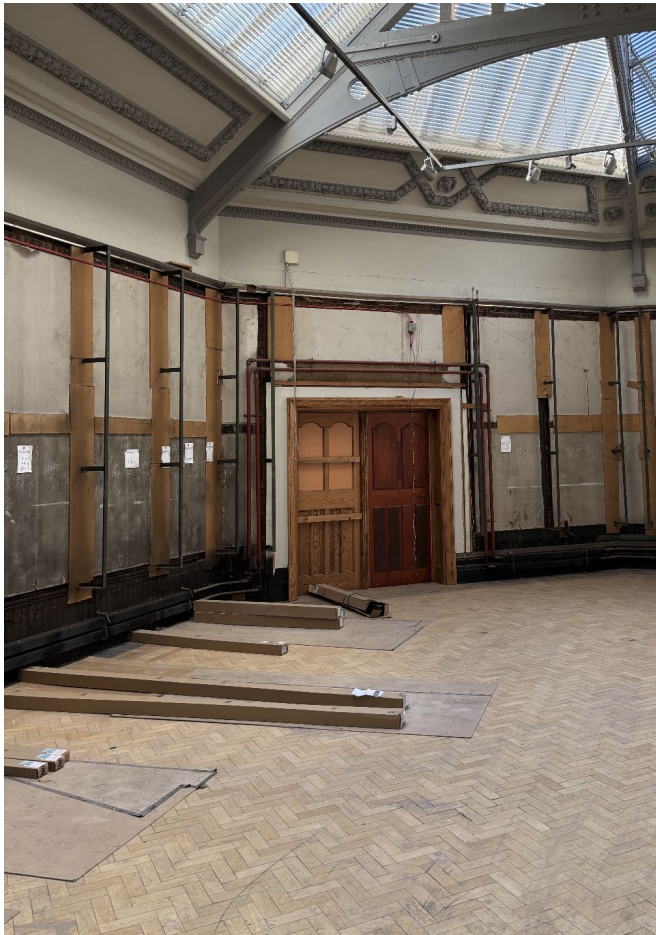
Image 04/04 -  
Image highlighting numerous locations where T&G has been cut to allow for metal frame fixing into brickwork behind (image from Gallery 3). Non-original overboarding included to support T&G behind due to poor condition.
