## STRUCTURAL ENGINEER'S REPORT

37 Rochdale Road  
Middleton  
M24 2PT

Contract No: 12489  
Dated: October 2024

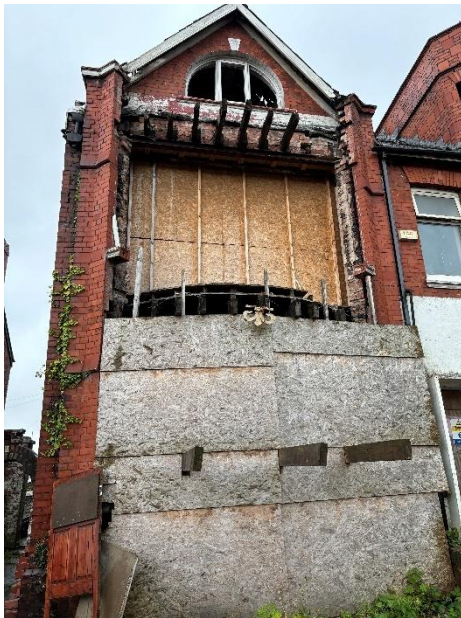
- 4.1.1 The front elevation comprised a combination of brick and terracotta masonry. The two storey bay had been dismantled leaving the first floor joists at both floor and roof levels protruding. At the roof level a steel beam had been incorporated to support the joists; it could not be determined whether this was an original feature or whether there had originally been a timber bressummer beam as present at the first floor level. The steel beam showed extensive corrosion. There was no clear evidence of distress to the bay gable

Missing front bay

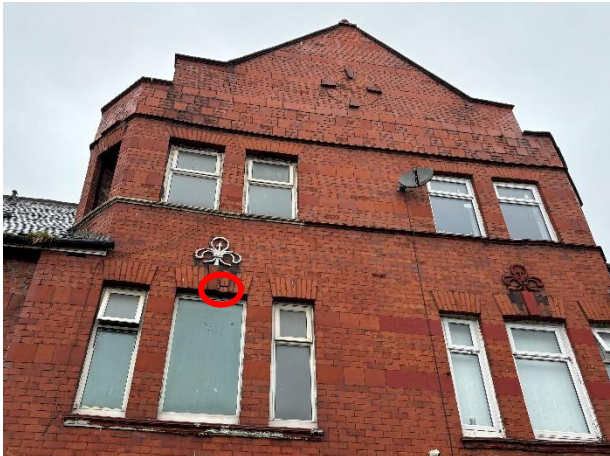
Dropped lintel over first floor window

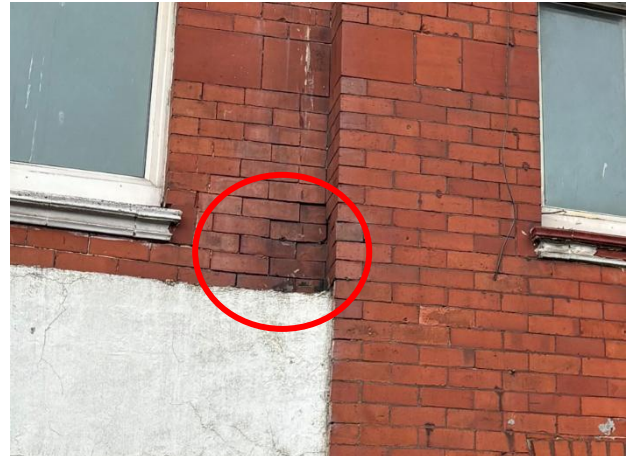
Distortion of brickwork above front door

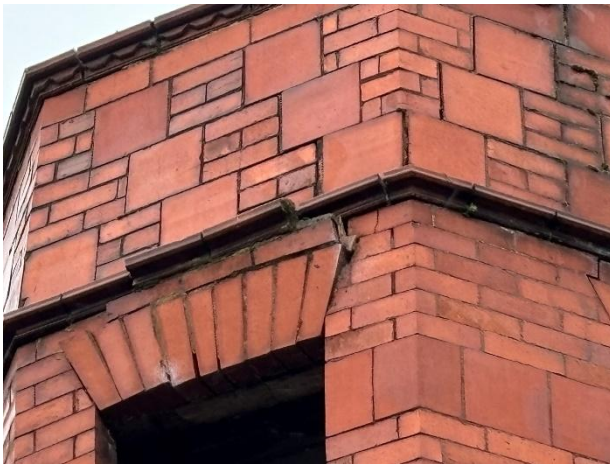
Cracking and distortion of the brickwork was noted to the front lefthand corner of the central bay of the building. The brick arch lintel above the second floor window in the chamfered wall had rotated outwards at its head and opening of the masonry joints throughout the corner of the wall had occurred commensurate with outward movement of the high level parapet wall.

Rotated brick arch and cracking to parapet

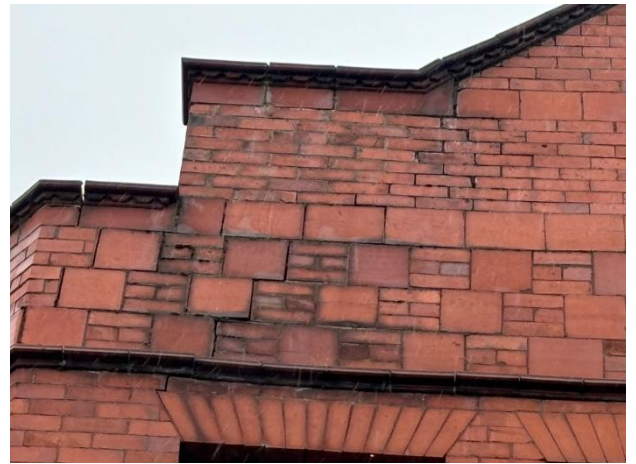
Cracking to parapet wall above second floor windows

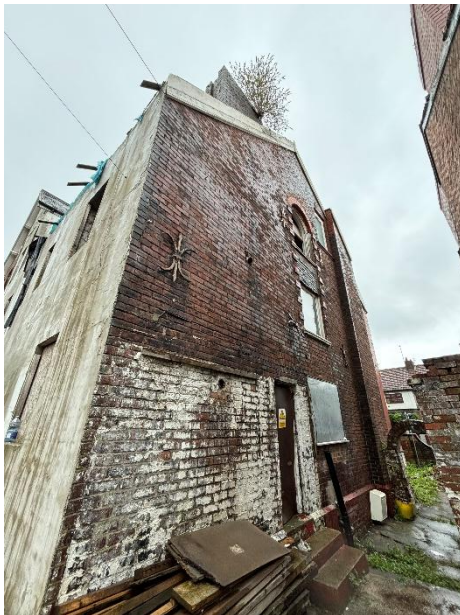
4.1.11 The remainder of the gable was constructed in common brick. This wall appeared to undulate but significant cracking defects were not noted, albeit that visibility of the wall was restricted due to access. Five pattress plates were noted; three at first floor level and two at second floor. The pattress plates were not fitted tight to the wall. It was apparent that the stair window used to extend from first floor up to second floor; an infill was noted at the half landing level to which tile hanging had been affixed.

Lefthand gable viewed from rear

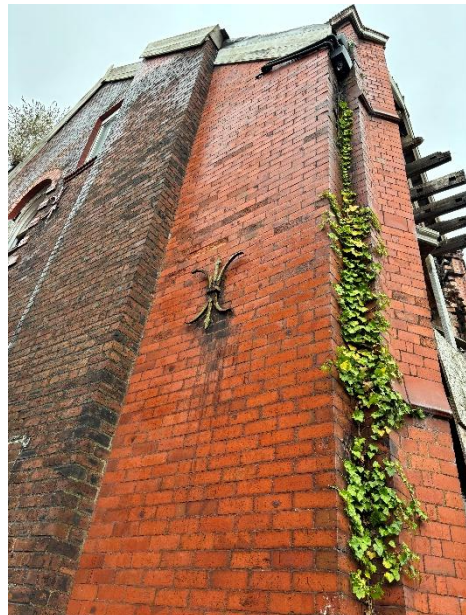
4.1.10 The front return on the gable wall was constructed of the same Ruabon brick as the front elevation; it appeared that this had also been drilled for the installation of remedial wall ties. A single pattress plate was noted at first floor level in this panel of wall; it appeared that there may previously have been another plate vertically aligned with this one at second floor level but it was no longer present at the time of our inspection. The coping to the parapet at the junction of the front elevation with the lefthand gable was displaced.

Front return on lefthand gable

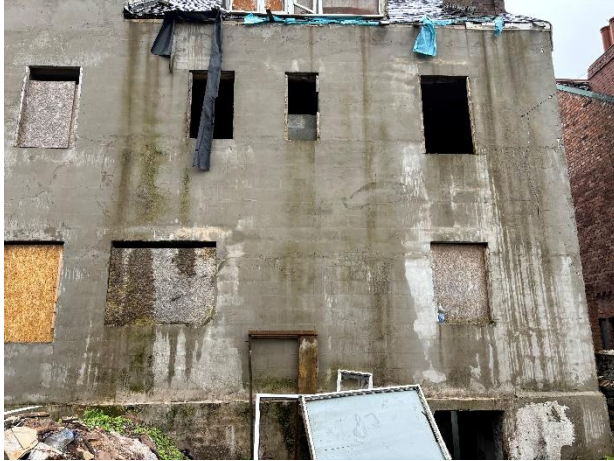
4.1.13 The rear elevation had been substantially reconstructed in blockwork and the entire elevation had been rendered leaving the shadow of the blockwork clearly visible through the render. It appeared that the panel of masonry over the party wall remained as brickwork with the blockwork commencing at the righthand (when viewed from the front) reveal of the first stack of windows and extending across to the righthand reveal of the lefthand windows. There were no major defects relating to the rendered blockwork however the lack of rainwater goods and incomplete detailing the roof edge had allowed water ingress and staining to affect the wall. All of the window frames

were missing to this elevation and the lack of head and cill detailing was exacerbating the effects of the water running down the face of the wall.

Water staining on rear wall

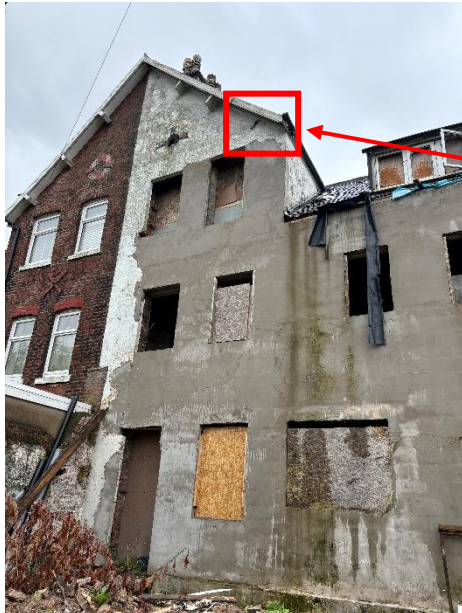
Rear elevation

- 5.20 The damage done to the rear wall is immense. Being cognisant of the damage inflicted by a previous owner, we suggest that it may be acceptable to remove the outer leaf of blockwork and to reinstate it using brickwork to match that of the rear elevation of No. 39. This approach will need to be discussed with the Conservation Officer.

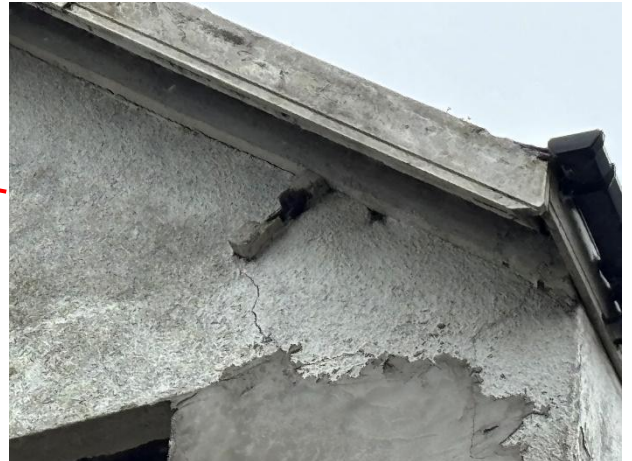
The purlins protruded through the rear gable. It could be seen that external end of the lowest purlin was rotten and there appeared to be a considerable loss of its cross section.

Rotten purlin end

- 5.16 Measures will also need to be detailed to ensure that the ends of the purlins are properly supported and restrained against rotation.
- 5.17 Careful detailing of the bay window will be required to ensure that it does not suffer from lack of restraint or other previous defects. It is currently anticipated that provision of adequate strapping at floor levels will be sufficient to provide the necessary restraint.

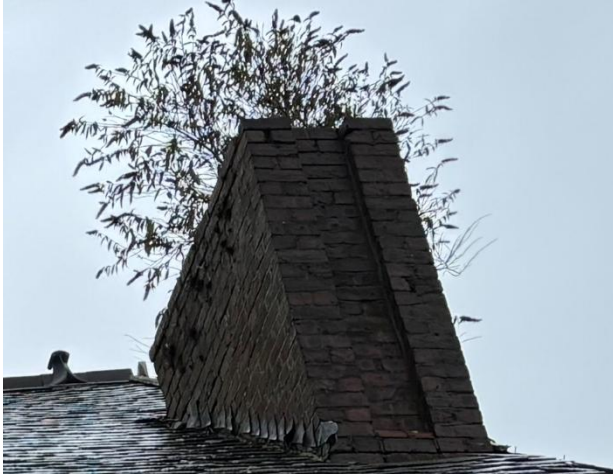
The chimney stack that remained at the rear lefthand corner of the building was in a relatively poor condition with missing and damage flashings together with vegetation growth.

Rear lefthand chimney stack

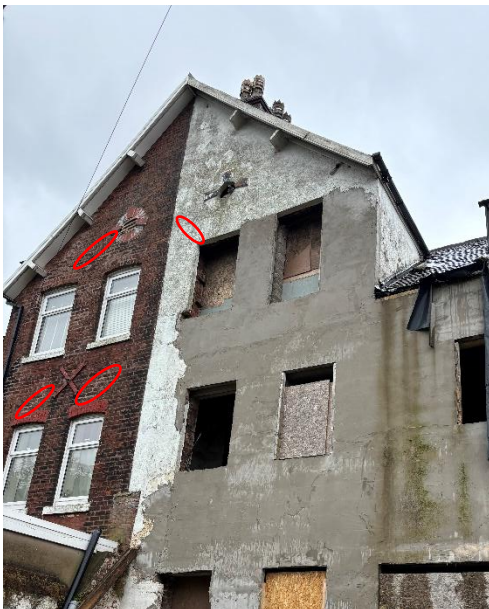
There was no visible evidence of pattress plates on the rear elevation which would correspond to those noted on the front elevation. Such a plate was evident at second floor level on the adjoining property. Cracking was noted above the first and second floor window of the adjoining property which was indicative of downward movement of the gable wall. A commensurate crack was noted above the righthand corner of the righthand second floor window of No. 37. Other commensurate cracks may have been dealt with by the reconstruction of the rear wall.

Cracking in rear wall of No.s 37 and 39

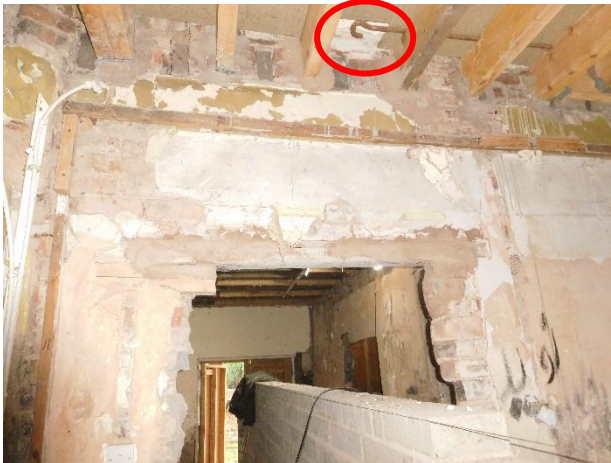
4.2.10 New floor joists had been installed for the first floor, these spanned from front to rear. But over the righthand end of the room the joists were trimmed short of the wall. The reason for this appeared to be to allow the historic tie rod to remain in place as it would have impinged on the new joists. A second tie rod was present adjacent to the front wall of the rear room; this was notched into the top of the new floor joists. The rod extended from the lefthand elevation of the building to its hooked end but the corresponding rod from the righthand party wall was missing.

End of tie rod from lefthand elevation, righthand rod missing

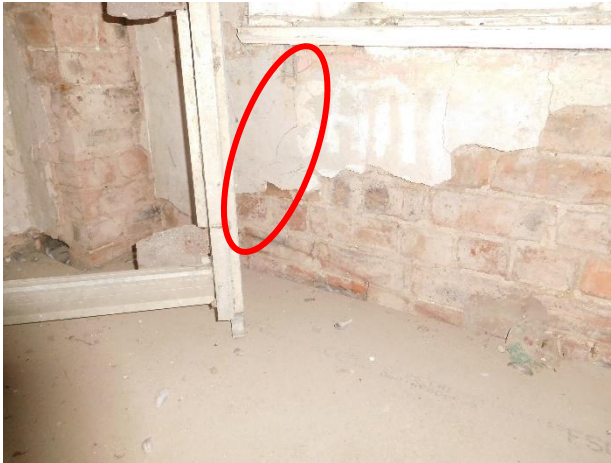
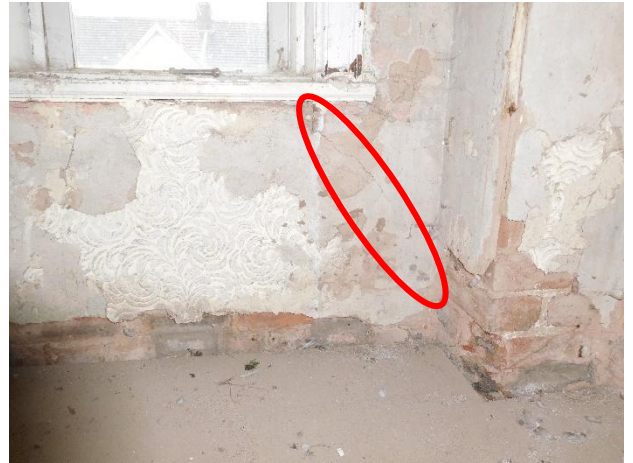
4.3.4 Diagonal cracking was noted below the front windows which was indicative of downward movement of the lintel over them.

Cracking below front righthand room windows

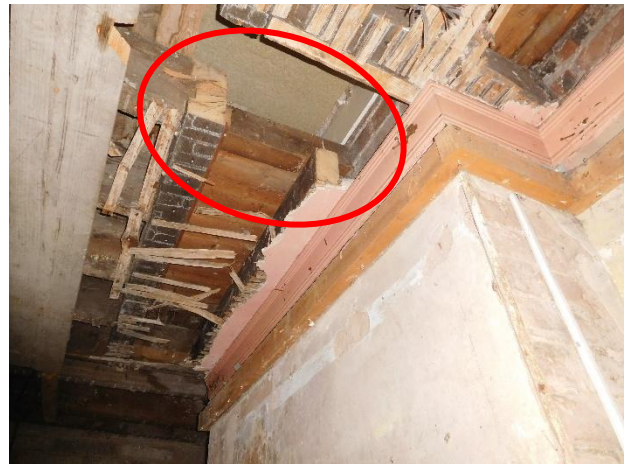
Various holes could be seen in the underside of the floor above but the majority of these had been covered with plywood sheeting. A view of the underside of the second floor adjacent to the chimney breast in the front righthand room revealed that a timber trimmer beam which would have supported the floor joists had been cut through.

Trimmers cut in front of chimney breast

- 5.14 There are locations in the building where alterations have been made to the span direction of floor joists and where trimming of joists has been undertaken. A more detailed consideration of these will be required to confirm the structural adequacy of these alterations. However, it is not expected that these will found to be in need of major intervention. At the same time consideration would be given to making good damage such as the trimmer that has been cut at second floor level.

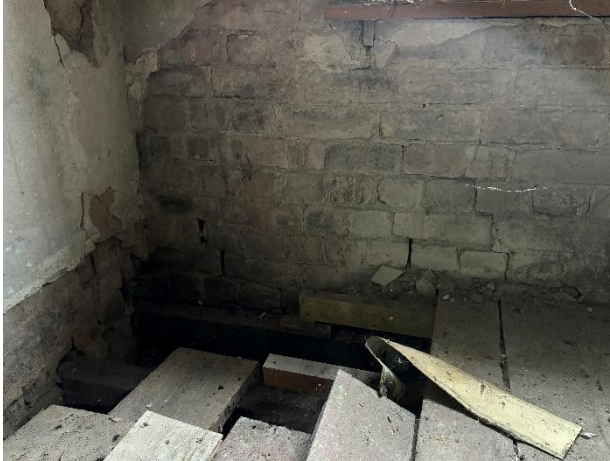
On the landing some open joints were noted below the righthand end of the window cill, but it could not be determined whether this had shown through the plaster as significant cracking prior to removal of the plaster.

Cracking below landing window

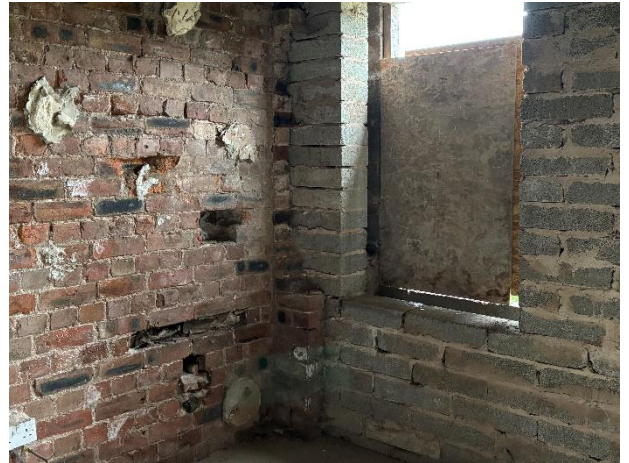
In the rear righthand room the rear wall had been rebuilt in blockwork; this appeared to be block laid on its side providing a 215mm inner leaf to the wall. The junction with the internal division wall with the rear wall indicated the external wall having been moved outwards by approximately 100mm relative to the brickwork of the original rear wall.

Junction of rear and internal walls

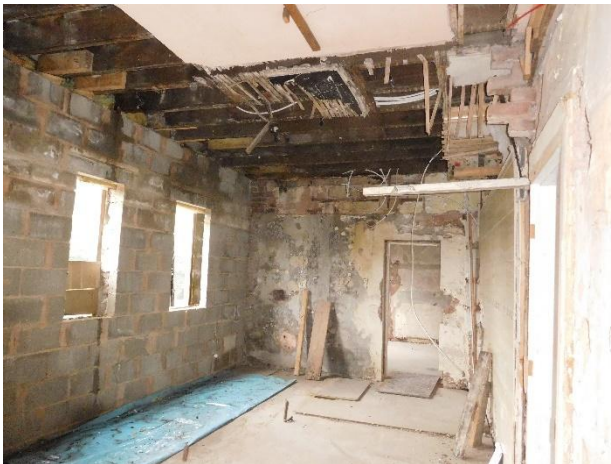
In the rear lefthand room it was noted that extensive water ingress was occurring along the line of the rear wall. This wall was reconstructed in blockwork. Looking into the cavity of the wall between the windows it was noted that whilst there were wall ties incorporated into the construction the cavity wall insulation had been omitted.

Water ingress along head of rear wall

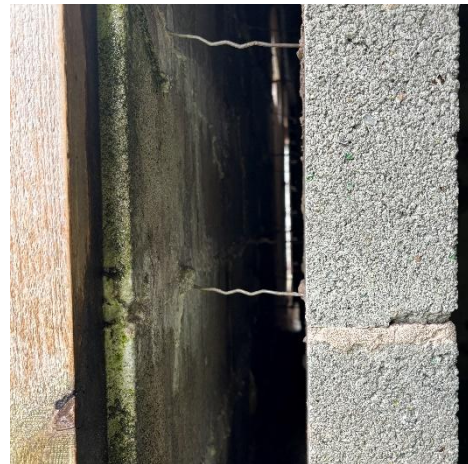
View into cavity wall showing no insulation

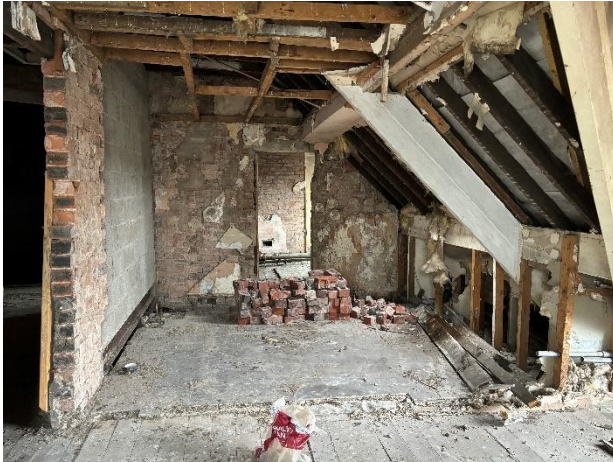
Brickwork, presumably from the parapet of the dismantled bay, was stored in the front lefthand room next to the doorway into the righthand room. The floor in this area visibly sagged and the division wall next to where the masonry was stored was cracked indicating deflection of the lintel

Masonry stored at second floor

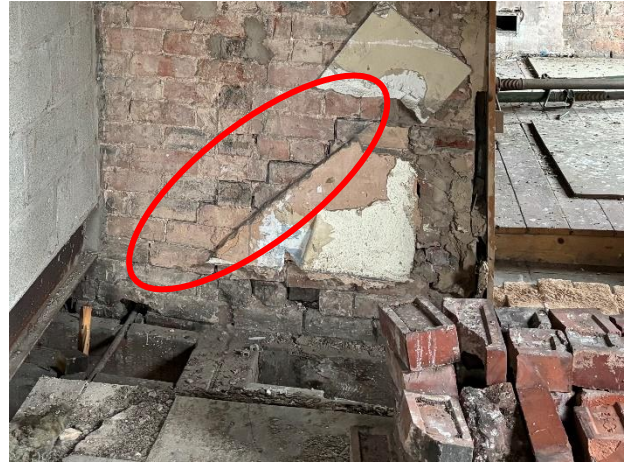
over the first floor opening in this wall; whilst this may have been exacerbated by the loading it appeared to be more probable that inadequate support whilst installing the lintel will be the cause of this cracking.

Cracking in wall between front rooms

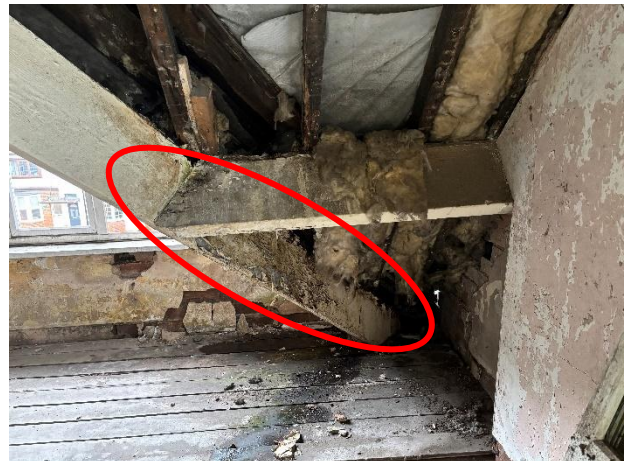
The roof structure was generally exposed in this room. Modern roofing materials indicated that some work had been undertaken relatively recently but the quality of this could not be determined from our visual inspection. The lefthand timber valley member for the dormer above the bay window showed indications of wet rot at its foot and also in the vicinity of the purlin.

Rot in lefthand valley member of bay dormer

- 5.15 The repair that has been undertaken to the bottom end of the valley member is crude and inaccurately detailed which has resulted in the bolts acting in bending as opposed to shear. This member will need to be propped and a new support detail devised to transfer the loads more appropriately.

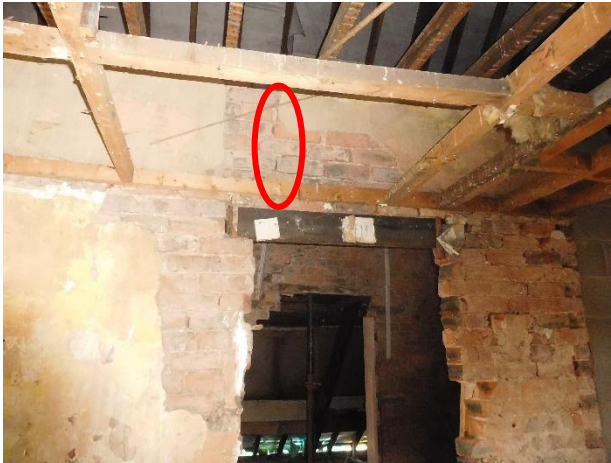
The rear wall of the front lefthand room had a roughly formed doorway out to the stairwell; cracking was noted in the brickwork above this doorway. The righthand end of the wall had been reconstructed in blockwork built on a steel beam

Cracking above doorway

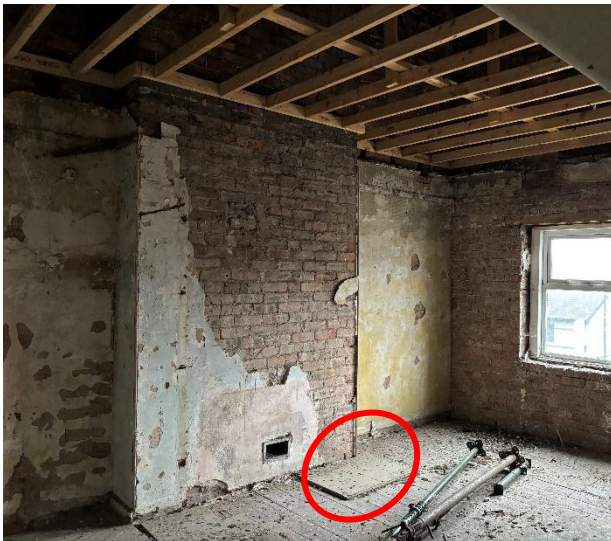
In the front righthand room it was noted that a piece of board had been placed over the location described in 4.3.6 where a trimmer had been cut and the floor was not adequately supported. Cracking was noted to the masonry both above and below the windows in this room; the pattern was not clear but most probably related to some movement at first floor window head.

Boarding over cut floor trimmer

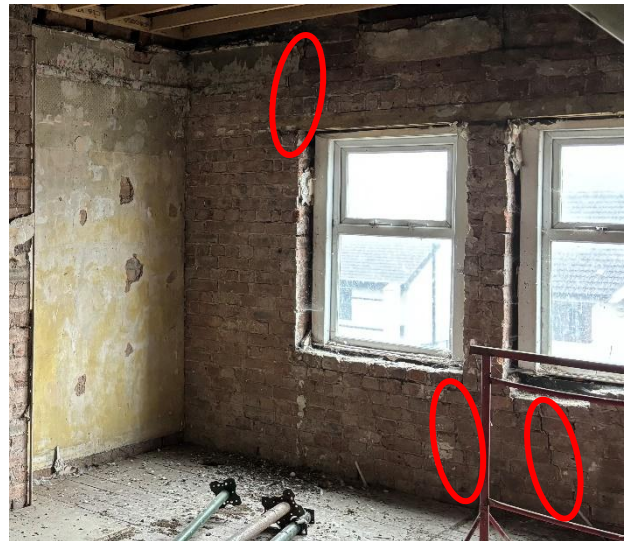
Cracking in front elevation

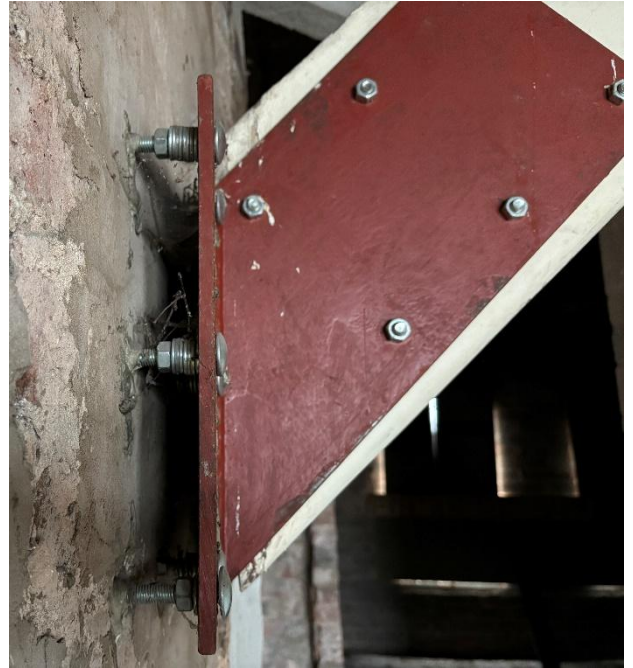
Front of bracket showing gap between wall and steelwork

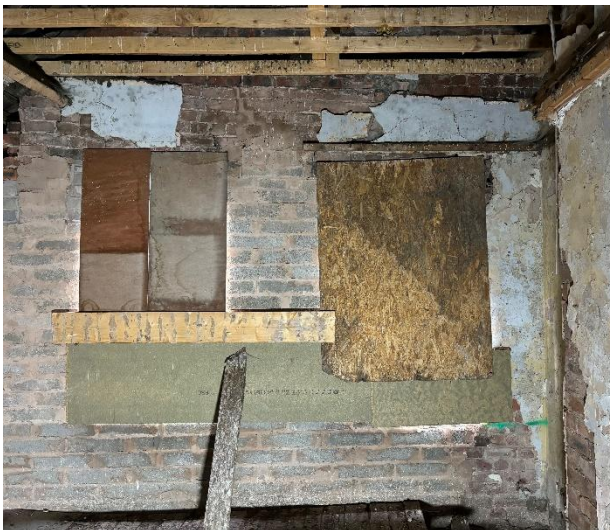
In the rear righthand room more areas of missing floor boards were noted. The rear wall had been reconstructed in blockwork up to the window head level above which the pike of the gable was original brickwork. The coursing of the original brickwork sloped down towards the party wall. The rear ends of the purlins were built into the gable brickwork and restrained against rotation. The division wall with the rear lefthand room was original masonry which did not appear to have been bonded or tied into the new blockwork rear wall.

Rear wall constructed in blockwork up to window head.  
Note, sloping bedjoints in original masonry above window

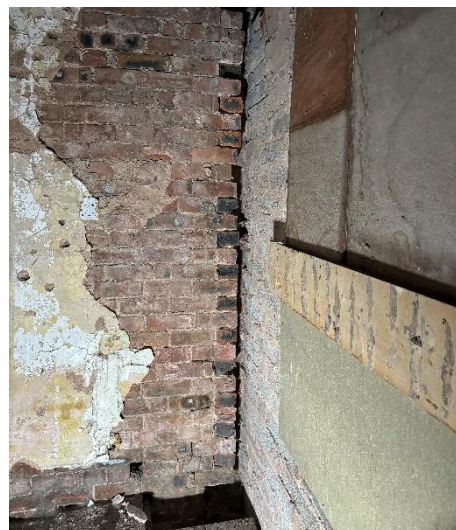
Lack of bonding between rear and internal walls

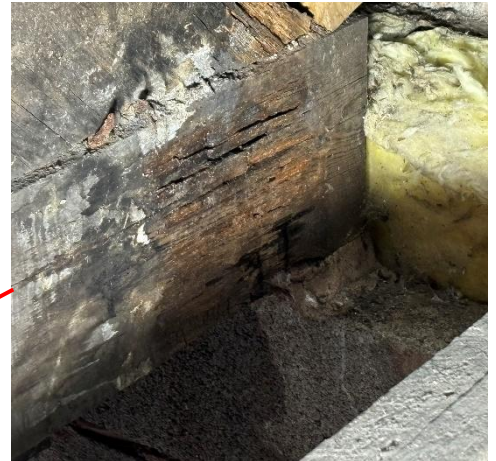
4.4.17 Areas of water ingress were noted particularly along the rear eaves and to the sides of the dormer window. To the righthand side of the dormer the connection between the principal rafter and floor beam was suffering from wet rot.

Wet rot in connection between principal rafter and beam

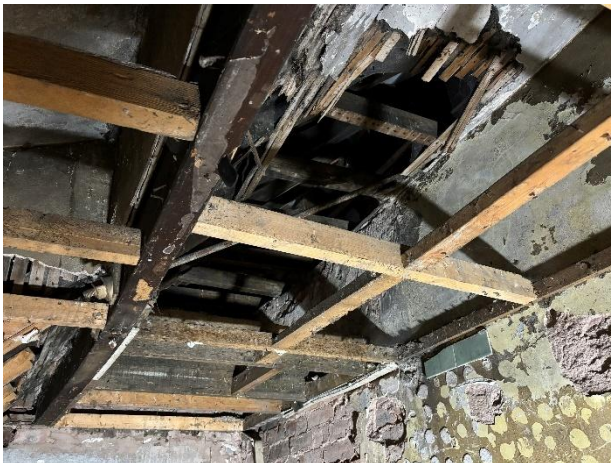
4.4.19 The purlin at the head of the dormer window was distorted at the point at which it was penetrated by an inclined tie rod; it appeared likely that this was associated with rot in the purlin.

Distorted purlin

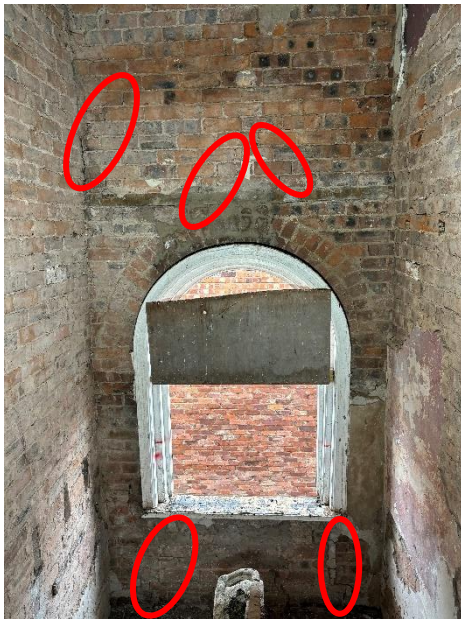
- 4.4.22 Within the stairwell it was noted that the arched window frame did not sit neatly below the brickwork arch and minor cracking was evident in the panel of brickwork above the arch. Old cracking was also noted below the window, but this panel of masonry appeared to be an infill with the cracking occurring along the infill lines. The top two flights of the stair were in a very poor condition.

Cracking above and below stairwell window

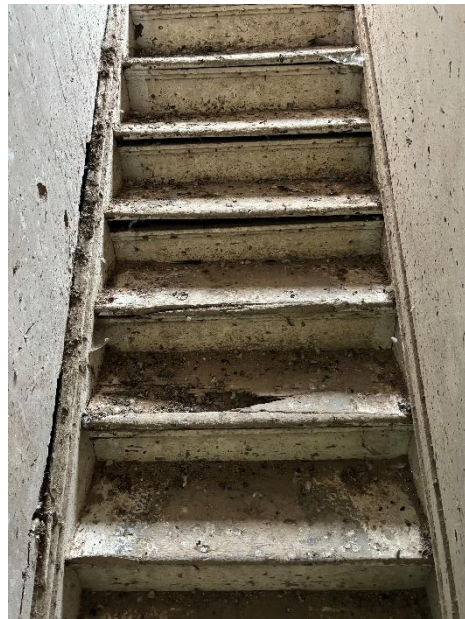
Stairs in very poor condition

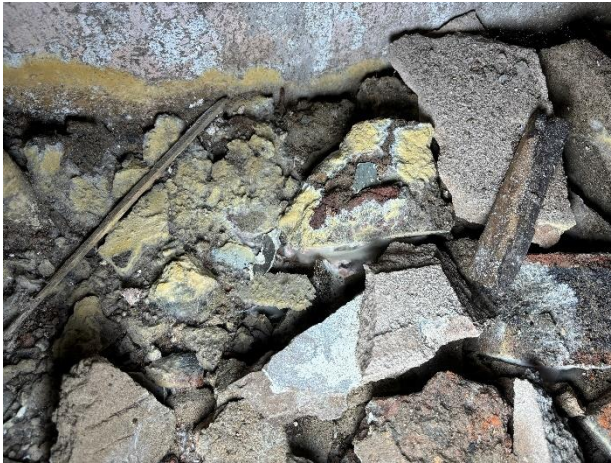
Fungal growth on building debris
