# 1 CASTLE HILL CRESCENT, ROCHDALE, OL11 4HZ.

## Preliminary Roost Assessment update and Nocturnal Bat Survey Report

*January 2026*

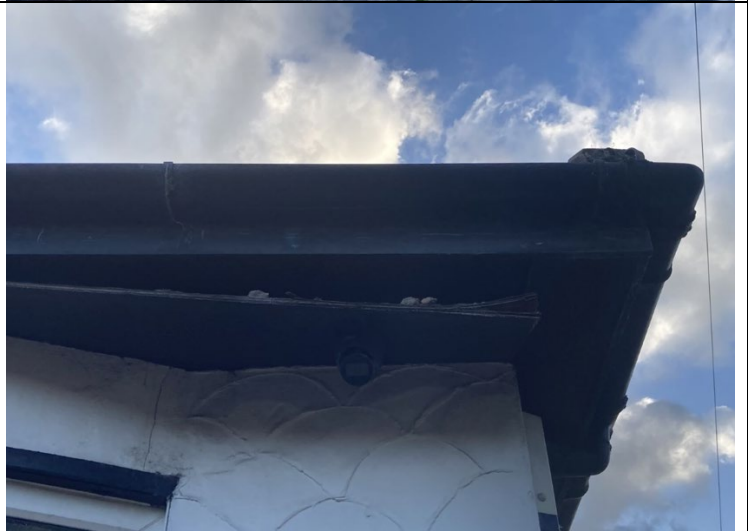
| <p>Photograph 2- Southeast corner broken fascia, this feature offers access into the soffit area, no evidence of bats was observed, and the feature was rated low value.</p> | |

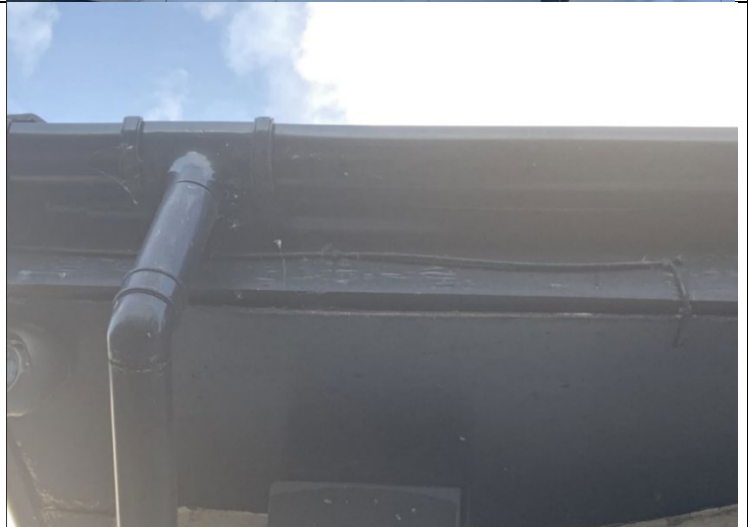
| <p>Photograph 3- Low value PRF on the northern elevation, with an area of open fascia and soffit. No evidence of bats was observed.</p> | |

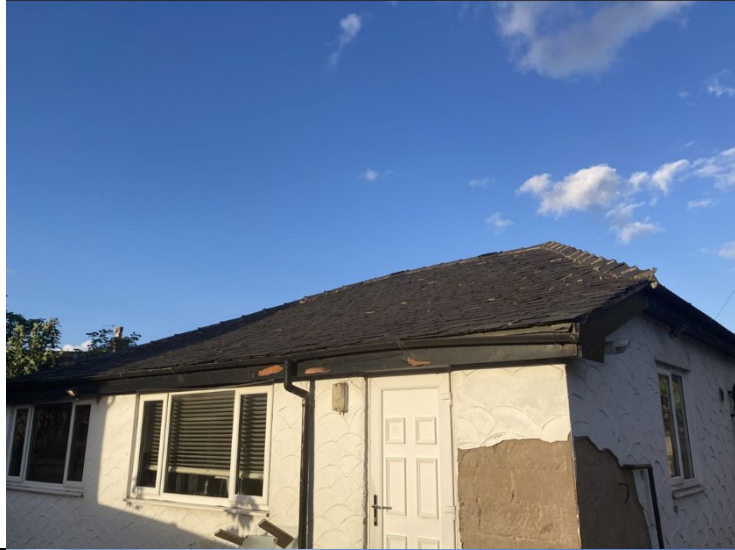
Photograph 5- Northern elevation showing the slate roof and damaged render, no features were evident on the rendered walls

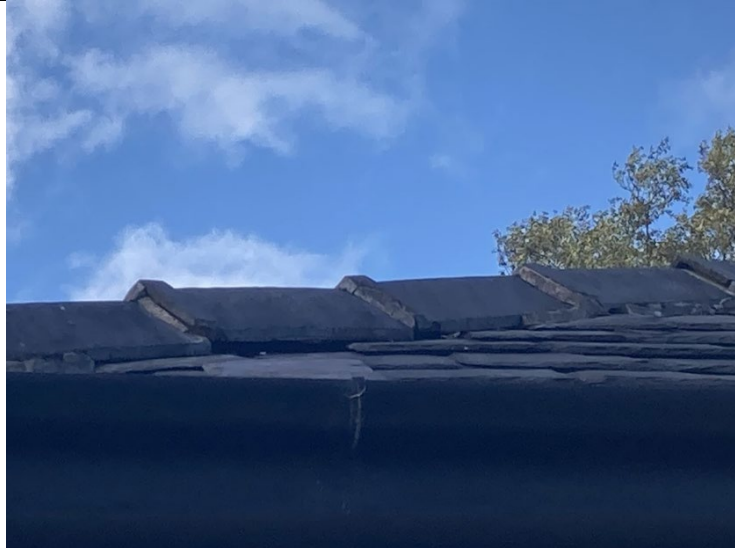
3.1.6. Multiple sections of damaged and missing ridge and hip tiles were observed at the union with the slate roof covering on the northwestern and southern roof elevations. These offered crevice dwelling species access between the slate roof covering and the felt liner.

Photograph 6- northwest corner ridge line and hip showing missing mortar and small gaps between ridge tiles and slates, these features were rated as moderate and could not be fully inspected from the ground. They were all covered by the emergence surveys and NVA cameras.

- Hand demolition only will be used when stripping the roof covering. All slates and ridge/hip tiles will be removed using a 'lift and flip' method whereby each underneath face is inspected before discarding to check for torpid bats.

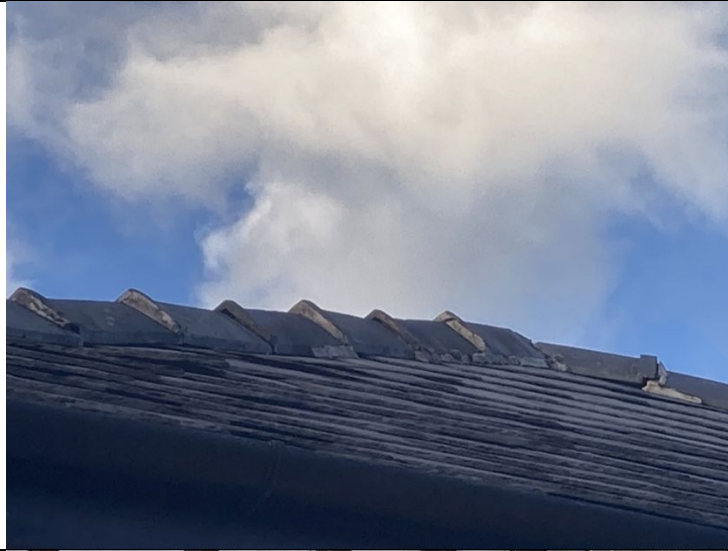
Photograph 7-Lifted Ridge tile on the main ridgeline, this feature held moderate suitability and was covered by the resulting emergence surveys.

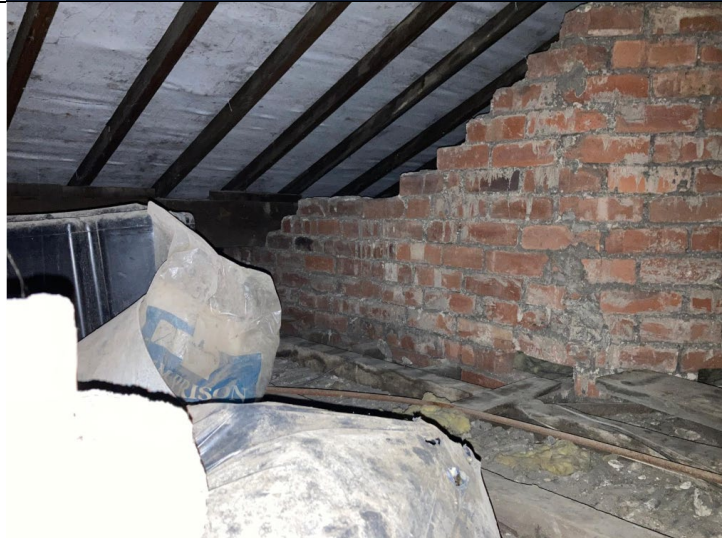
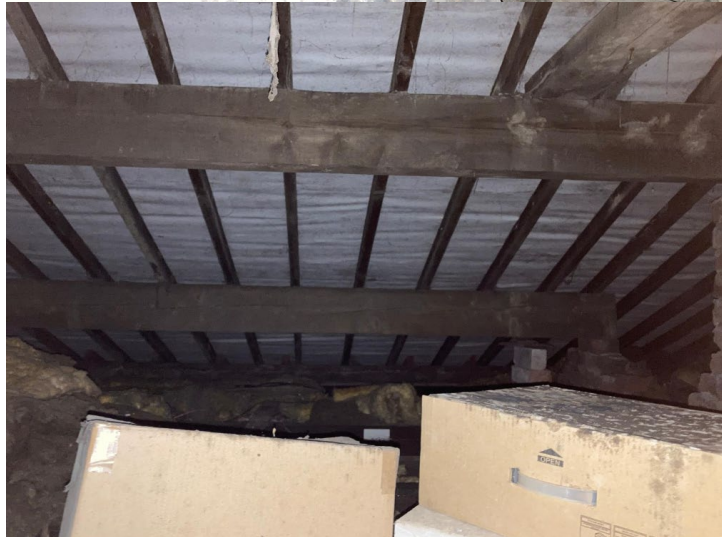
Photograph 8 - Internal loft void

3.1.7. A number of small tears were evident in the bitumen felt liner within the roof loft void. These were too small to offer external access into the loft void for void dwelling species as they measured only 10mm at their largest point.

3.1.8. The roof void was very clean, and no observable light egress was visible when inside in the dark, especially corresponding to any external features noted during the PRA such as slipped or missing tiles or the damaged soffit and fascia

3.1.9. No bat droppings, feeding remains or evidence of bats was observed within the loft space.

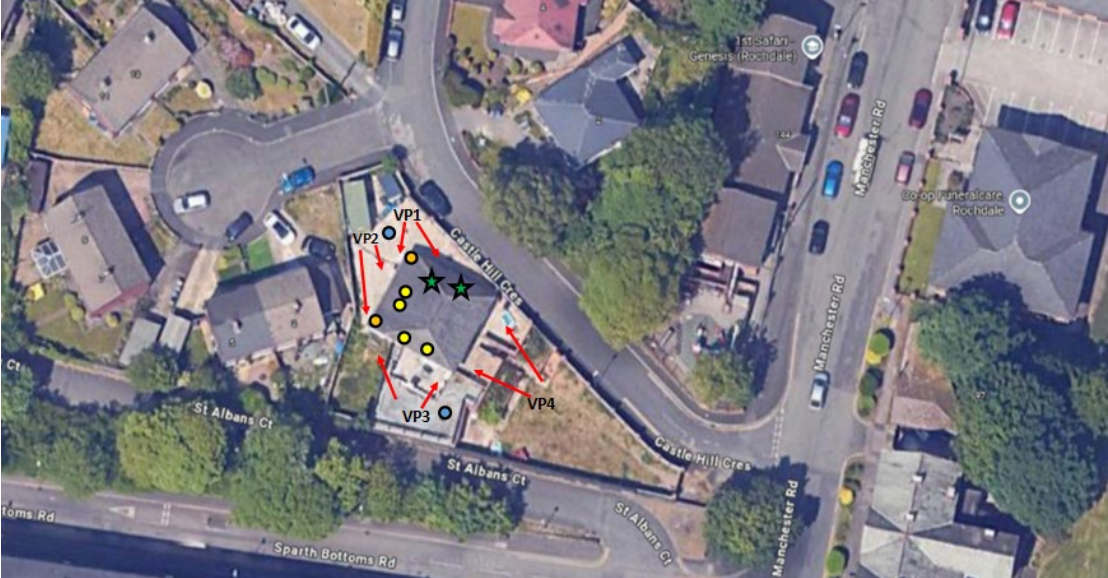
Figure 3.1- PRF features building plan.

Yellow dots lifted and slipped tiles and slates  
Orange dots damaged fascia and soffit  
Green stars areas of damaged felt liner
