**Project Title: Supporting Structural Condition Review Report**

**Project Address: 37 Rochdale Road, Middleton, M24 2PT**

**Project Number: 2026**

**Client: Farzana Iqbal**

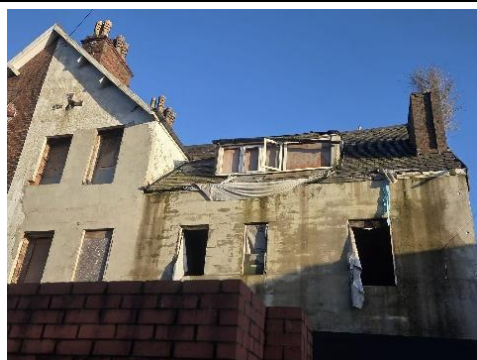
- 2.2.1 Water staining to the rear elevation was observed to be more pronounced than previously recorded. Moisture ingress appears to be occurring through the rear wall and around window openings, likely as a result of inadequate weather detailing and prolonged exposure. The worsening of this condition indicates that water penetration is ongoing rather than historic, and if left unaddressed, is likely to accelerate deterioration of both masonry and adjacent structural timbers.

Evidence of water staining to the rear wall

- 2.9.1 Urgent works are recommended to make the roof weather-tight, including reinstatement of missing tiles and repair of flashings. Sources of water ingress at the rear wall and window openings should be remedied. Once surfaces are cleaned and safe access is available, further inspection, including crack monitoring and selective opening-up, should be considered. The recommendations of the previous Structural Engineer's Report should be implemented without delay.

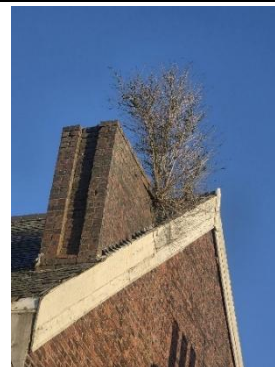
2.5.1 Chimney stacks and associated flashings remain in poor condition. Defective or missing flashings allow water to penetrate at roof junctions, contributing to localised dampness and decay of adjacent timber elements. If not addressed, these defects may result in further deterioration and potential instability of chimney masonry.

Rear lefthand chimney stack

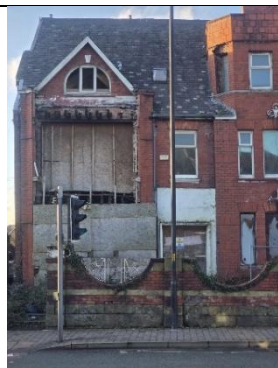
Front bay missing

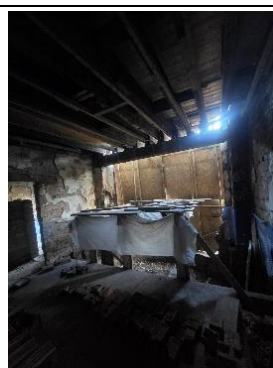
Front elevation showing dismantled bay

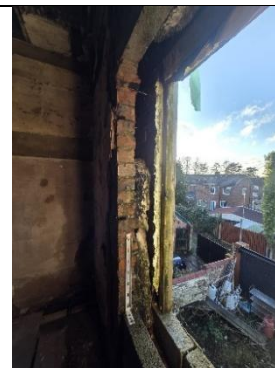
Internal evidence of water ingress to rear wall

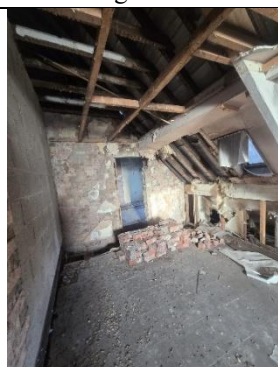
Masonry stored at second floor

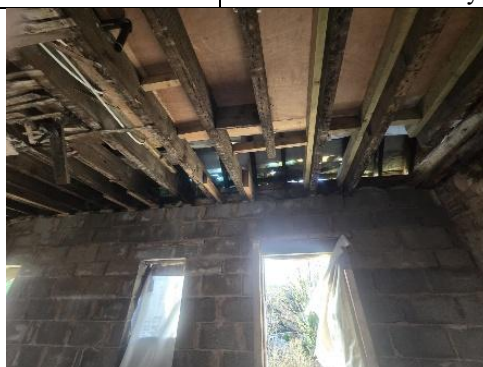
Water ingress along head of rear wall

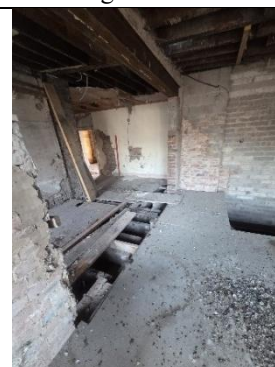
Holes in floor
