**2025 MAN12009**

# **The Former Reed Hotel / Public House**

## **1 Reed Hill, Rochdale OL16 1DF**

### **Structural Condition Report**

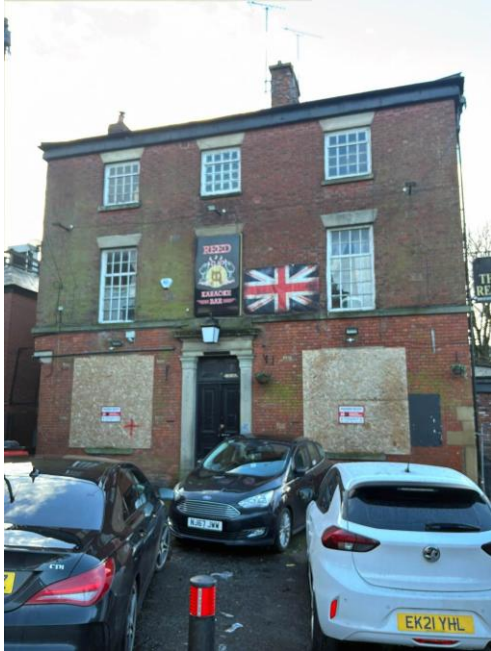
| <b>No</b> | 1 |

| <b>Location</b> | Front Elevation (north east) - general |
| <b>Observations</b> | General view showing the front elevation. The elevation is of solid construction with headers every alternate course. The elevation is in reasonable horizontal and vertical alignment. |

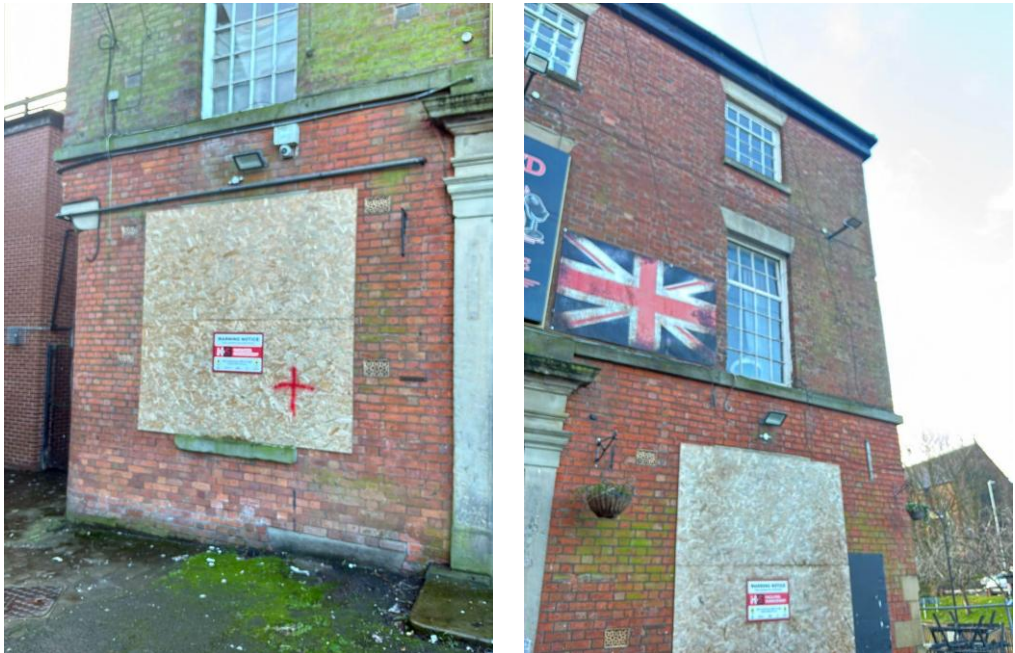
| <b>No</b> | 2 |

| <b>Location</b> | Front Elevation - general |
| <b>Observations</b> | Ground floor level brickwork below the first floor feature band is of contrasting brick face appearance to that above.<br>Brickwork is slightly weathered and open jointed. |

In these most highly weathered areas, the loss of pointing results in the brickwork becoming prone to water ingress, leading to acceleration of deterioration in the condition of the brickwork overall, including additional spalling. It is therefore recommended that repointing work is carried out to high level areas to all elevations where necessary, with the requirement for repointing diminishing with height of the building.

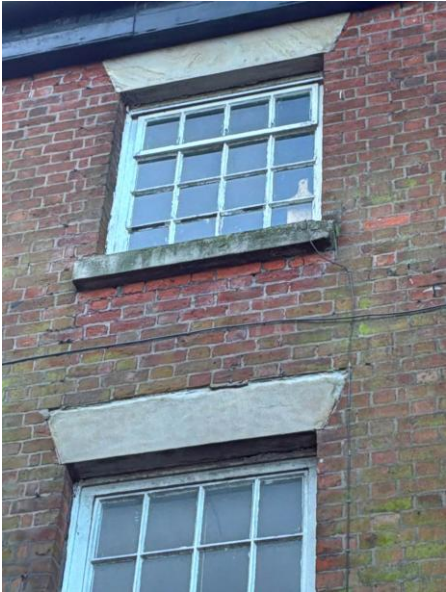
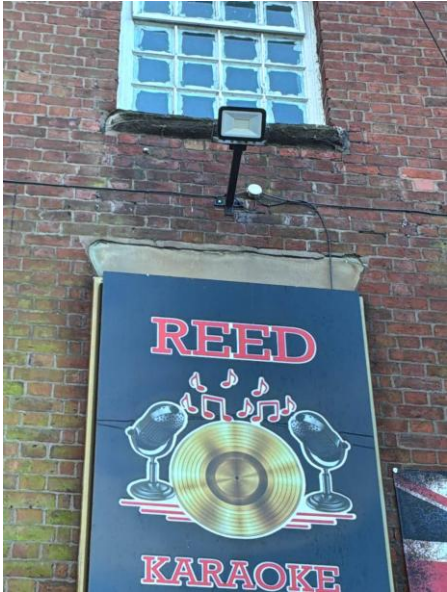
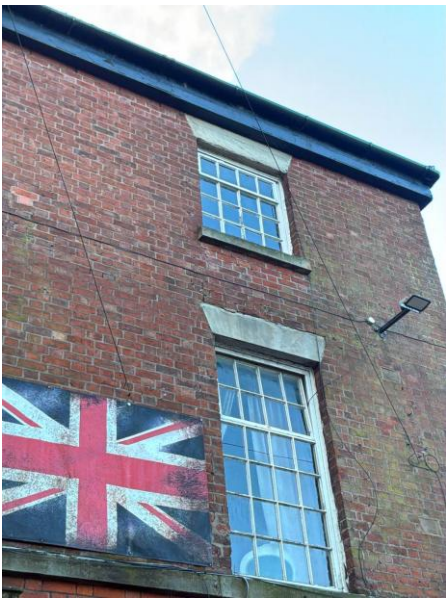
| <b>No</b> | 3 |

| <b>Location</b> | Front Elevation – spalling to lintels and cills |
| <b>Observations</b> | Spalling is noted to concrete lintels and cills to window openings, probably attributable to frost / thaw action of penetrating rainwater. |

- The building is robust and free from evidence of significant structural movement.
- There are areas of spalling to concrete lintels and cills which require repair to restore integrity.

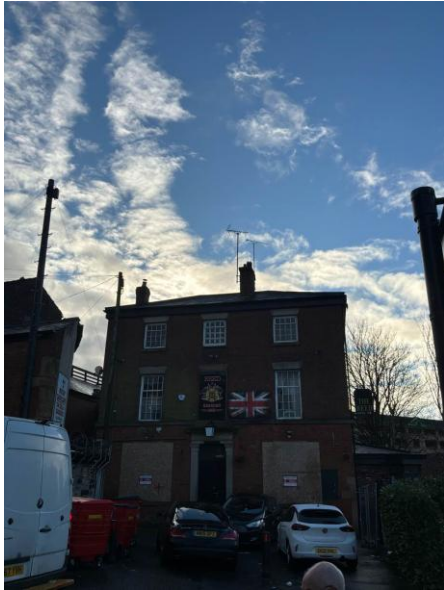
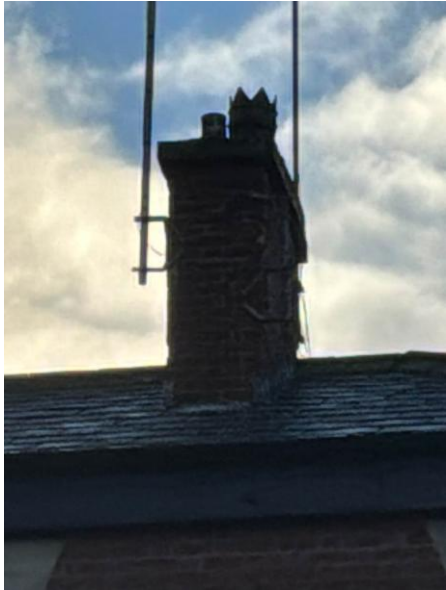
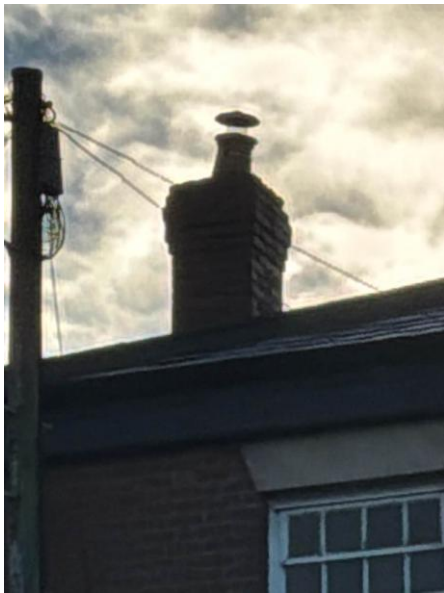
| <b>No</b> | 4 |

| <b>Location</b> | Front Elevation – roof structure |
| <b>Observations</b> | Slight deflection is noted to the roof hip members and ridge. Isolated tiles are displaced. Brickwork to the external chimney stacks is weathered and open jointed. |

Because the property is vacant, it may have been subject to vandalism and theft of leadwork at roof level. We therefore recommend that a specialist roofing contractor is appointed to carry out a survey of all the roof areas and prepare a specification and schedule of work (beyond the scope of this report) including consideration of requirements for thermal insulation to satisfy current Building Regulations. Associated work will include repointing of brickwork and joints together with the refurbishment of rainwater outlets.

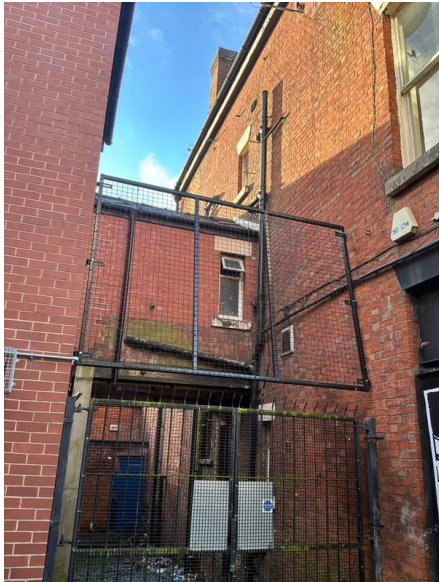
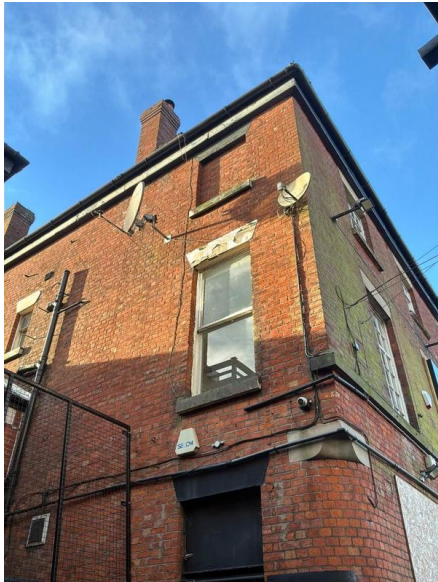
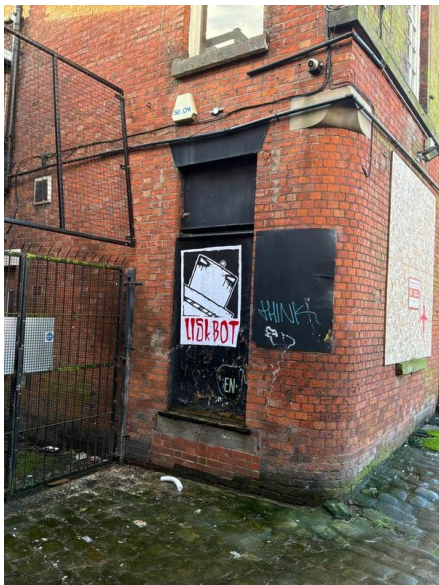
| <b>No</b> | 5 |

| <b>Location</b> | Left Hand Elevation (south east) - general |
| <b>Observations</b> | The elevation is in reasonable horizontal and vertical alignment.<br>Brickwork is open jointed at low level. No access was possible to allow closer inspection of the first link structure in which the gents w/c is located. |

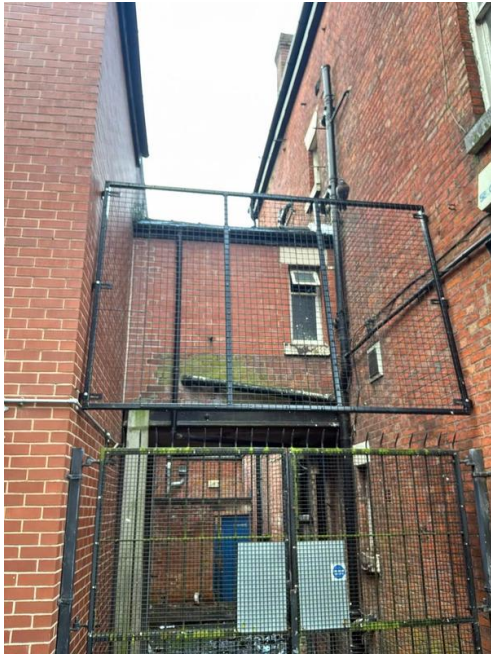
| <b>No</b> | 6 |

| <b>Location</b> | Left Hand Elevation – first floor link structure |
| <b>Observations</b> | There is a first floor link structure which abuts the adjacent property. External walls are supported by steel beams. Low level brickwork appears to have been locally rebuilt. Slight deflection is noted to the roof ridge. |

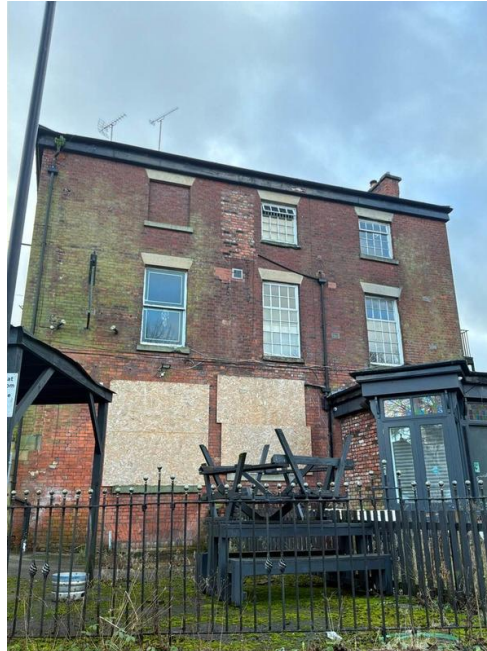
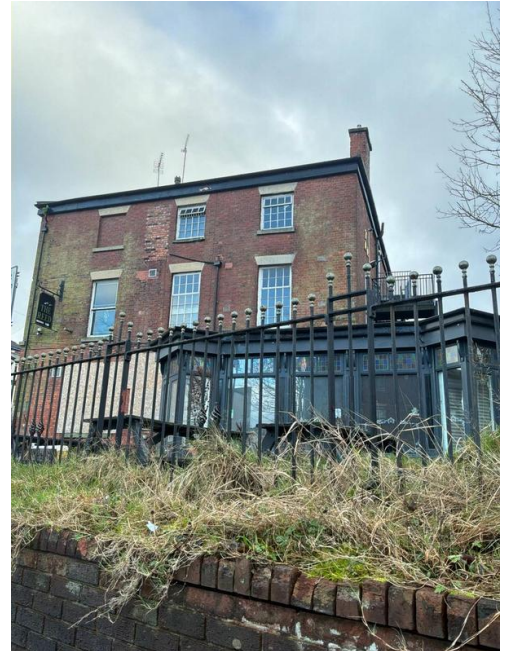
| <b>No</b> | 7 |

| <b>Location</b> | Right Hand Elevation (north west) - general |
| <b>Observations</b> | General views showing the right-hand elevation and single storey extension. Brickwork is in reasonable horizontal and vertical alignment. |

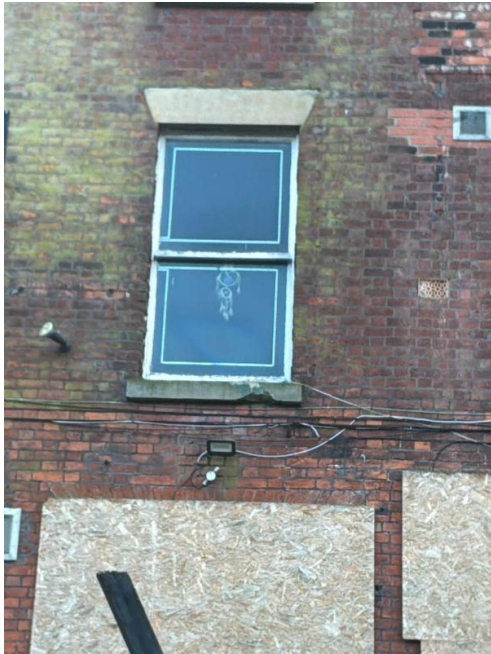
| <b>No</b> | 8 |

| <b>Location</b> | Right Hand Elevation – spalling to lintels and cills |
| <b>Observations</b> | Spalling is noted to concrete lintels and cills to window openings, probably attributable to frost / thaw action of penetrating rainwater. Local areas of brickwork have been rebuilt with previous openings infilled. |

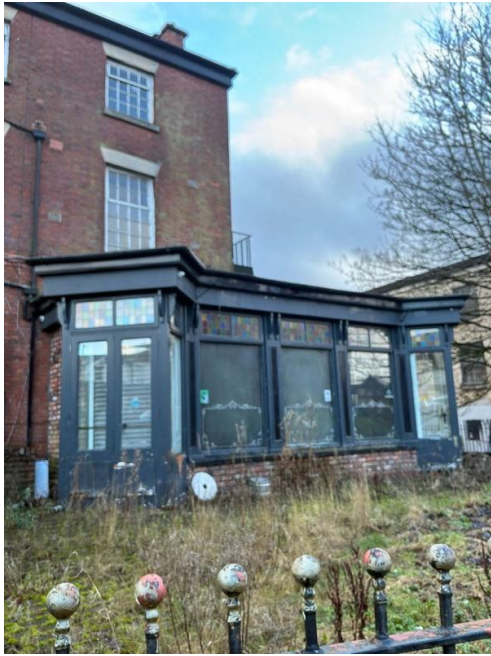
| <b>No</b> | 9 |

| <b>Location</b> | Right Hand Elevation – single storey extension |
| <b>Observations</b> | Timber to the single storey extension is showing signs of deterioration. |

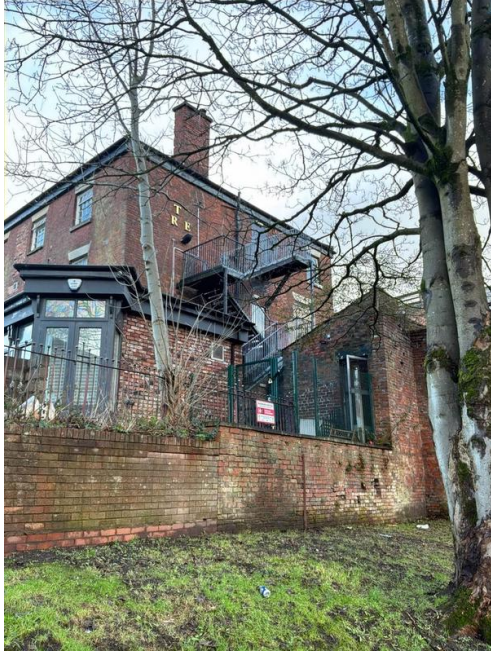
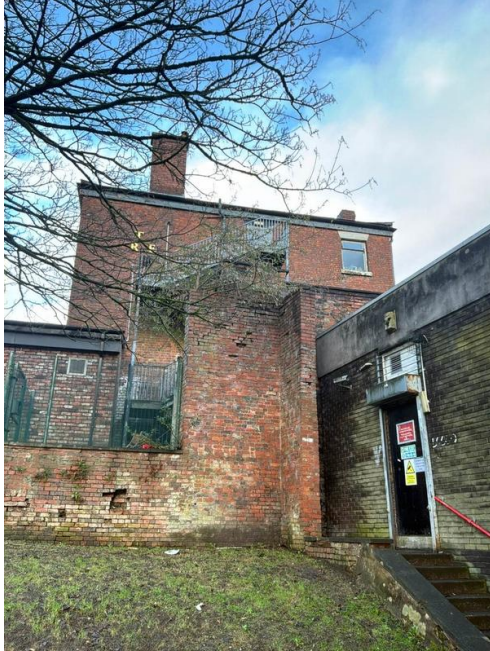
| <b>No</b> | 10 |

| <b>Location</b> | Rear Elevation (south west) - general |
| <b>Observations</b> | General views showing the rear elevation and steel fire escape staircase. Brickwork appears to be in reasonable horizontal and vertical alignment although close inspection was not possible. |

It is noted at several locations that there are steel fixings to the face of the external elevations with a steel staircase noted to the rear elevation. Steelwork has the potential to corrode and expand to a significant degree and, where fixed to brickwork, this can result in cracking.

It is recommended that all redundant steel fixings be removed. Confirmation will be required as to whether the steel staircase is to be retained. Although not inspected closely, it can be reasonably assumed that the fire escape is fixed to the masonry and likely to be suffering some degree of corrosion.

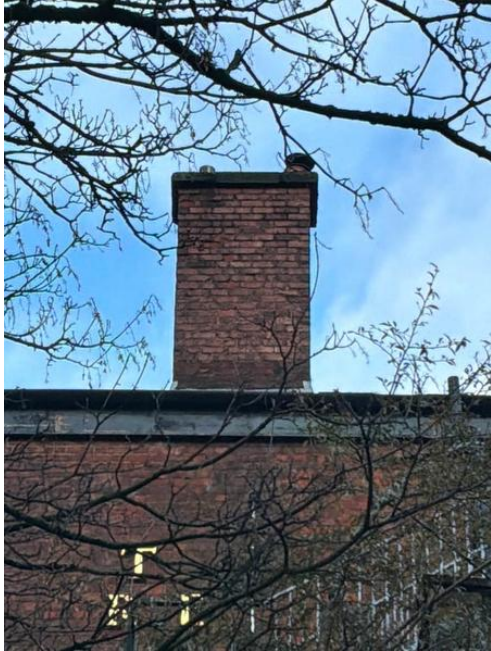
| <b>No</b> | 11 |

| <b>Location</b> | Rear Elevation – chimney stacks |
| <b>Observations</b> | Brickwork to the external chimney stacks stack is generally weathered and open jointed. |

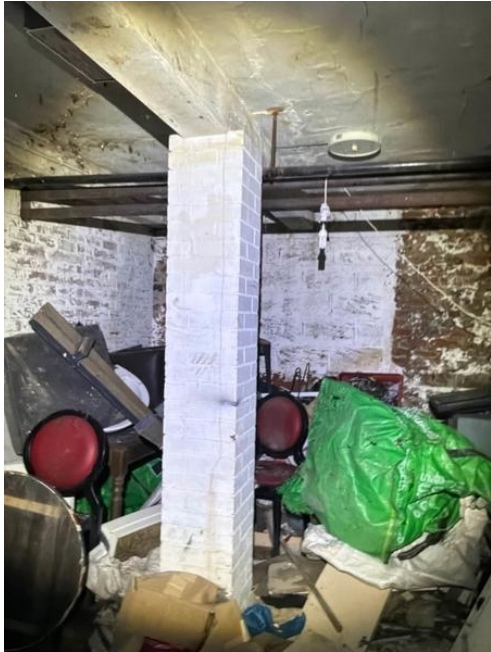
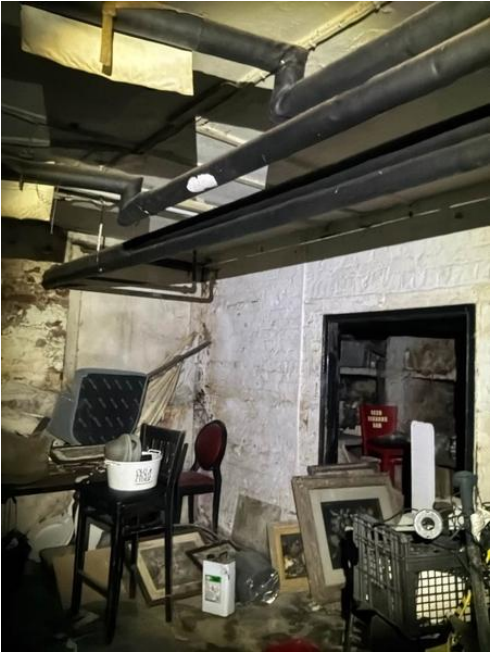
| <b>No</b> | 12 |

| <b>Location</b> | Cellar - general |
| <b>Observations</b> | General views within the cellar. The suspended ground floor timber joists are supported by loadbearing masonry walls, piers and miscellaneous steelwork. |

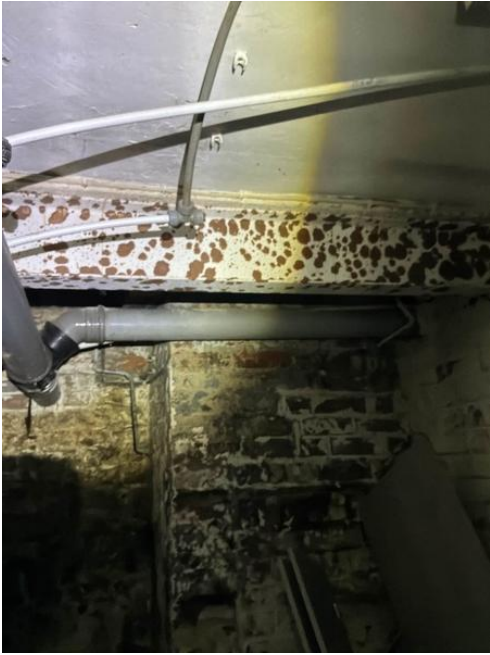
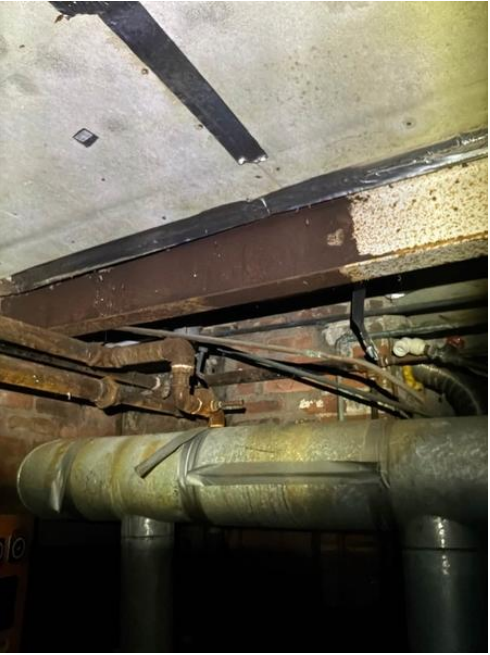
| <b>No</b> | 13 |

| <b>Location</b> | Cellar – exposed steelwork |
| <b>Observations</b> | Surface corrosion is noted to exposed steelwork at ceiling level, probably attributable to the damp environment noted. |

Structural design checks will be required to confirm the suitability of the existing timber joists and supporting steelwork.

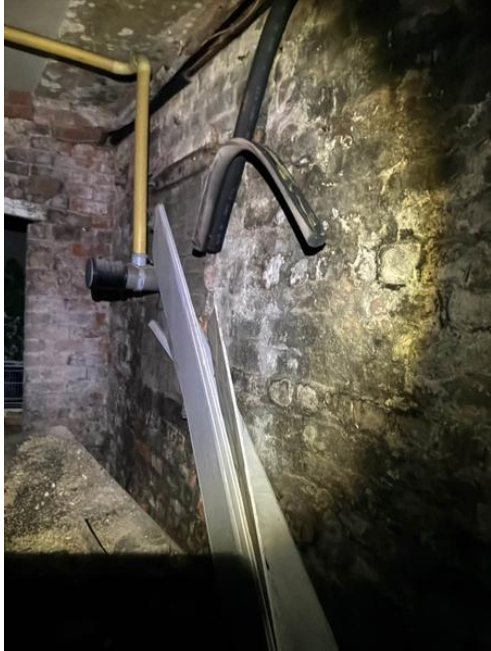
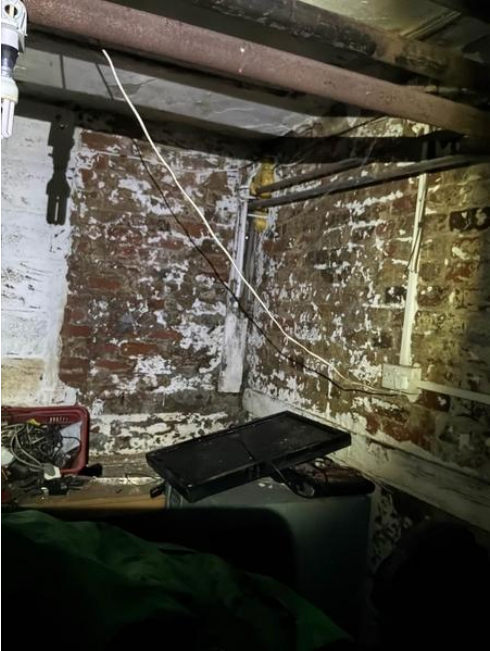
| <b>No</b> | 14 |

| <b>Location</b> | Cellar – retaining walls |
| <b>Observations</b> | Exposed brickwork faces to the perimeter retaining walls are damp in areas throughout the cellar. |

Subject to proposals within the cellar as part of the conversion works, consideration should be given to waterproofing the walls and floor slab.

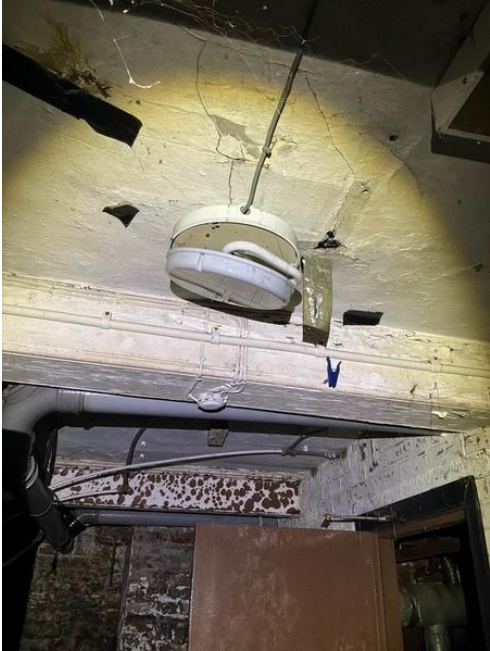
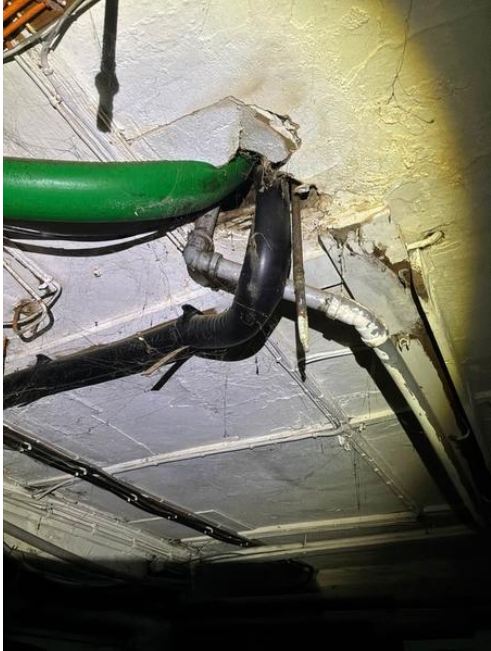
| <b>No</b> | 15 |

| <b>Location</b> | Cellar – damage to ceilings |
| <b>Observations</b> | Widespread cracking is noted to lath and plaster ceiling finishes throughout with local areas detached from the underside of the ground floor joists. |

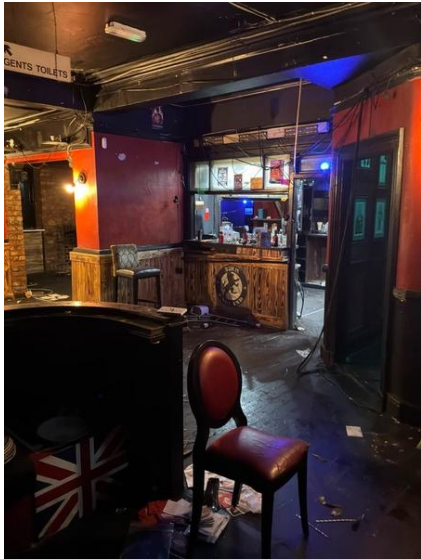
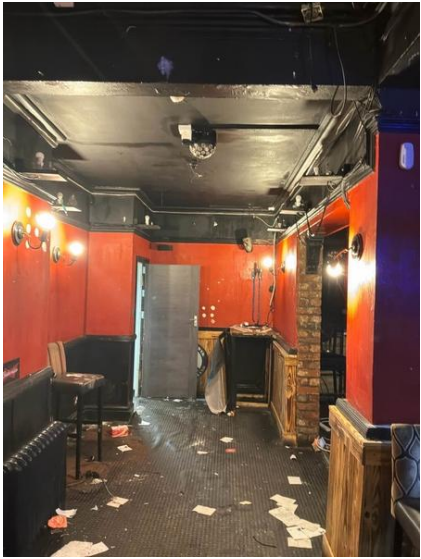
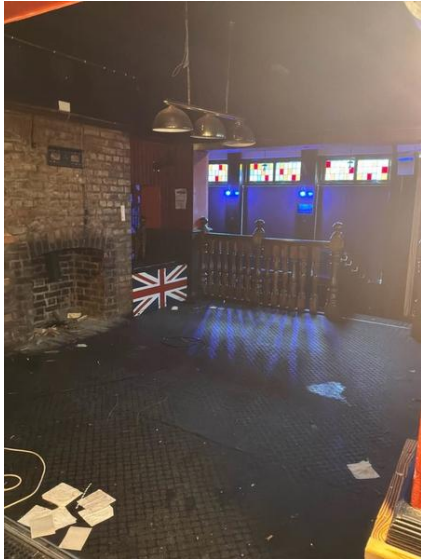
| <b>Location</b> | Ground Floor – previous public areas |
| <b>Observations</b> | General views within the main bar areas. Internal walls are a combination of loadbearing masonry and partitions. There is a central masonry spine wall which extends front to back supporting steelwork running perpendicular which in turn support the first floor timber joists. The retained fixtures and fittings suggests that the property has only recently been vacated. |

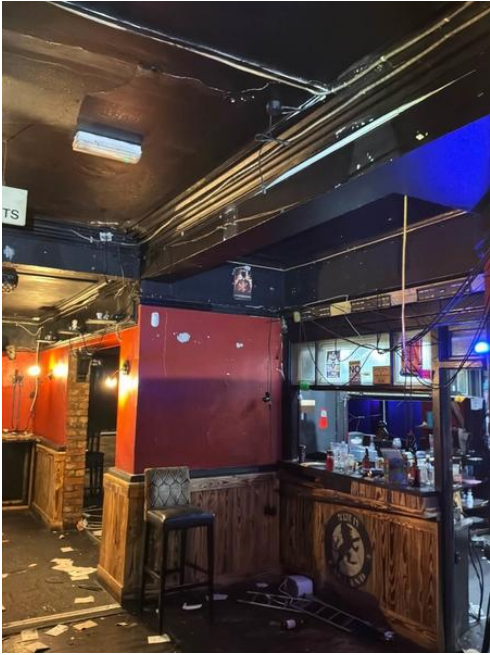
| <b>No</b> | 17 |

| <b>Location</b> | Ground Floor – supporting steelwork |
| <b>Observations</b> | General views showing the downstand steel beams spanning between loadbearing masonry walls visible above the previous bar area. |

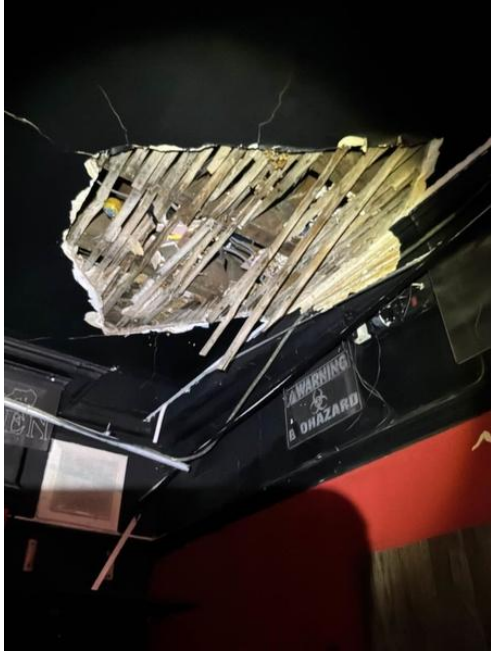
| <b>No</b> | 18 |

| <b>Location</b> | Ground Floor – first floor joists |
| <b>Observations</b> | A local area of damage to ceiling finishes has exposed the timber first floor joists above which span from front to back. The joists are measured at 63mm wide x 200mm deep at 340mm centres. |

Local areas of the suspended timber floor joists were exposed. First floor joists were measured at 63mm wide x 200mm deep at 340mm centres.

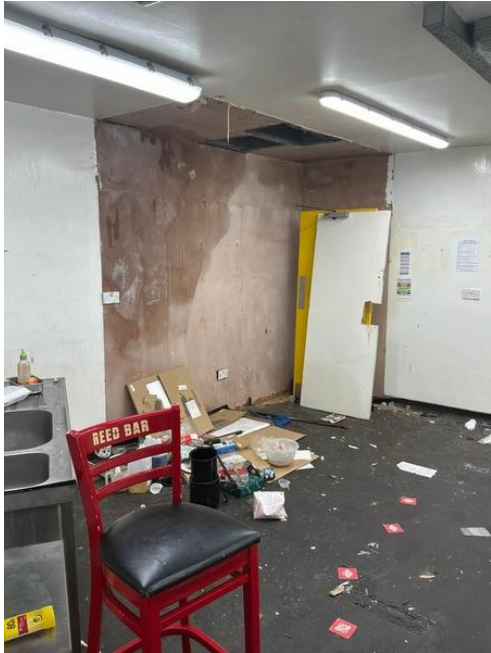
| <b>No</b> | 19 |

| <b>Location</b> | Ground Floor – rear storeroom |
| <b>Observations</b> | Evidence of ongoing water ingress is noted to the rear left-hand corner of the property within the storeroom to the rear of the main property. |

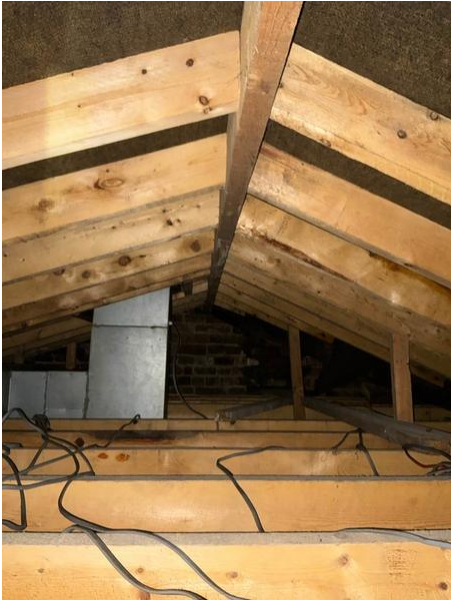
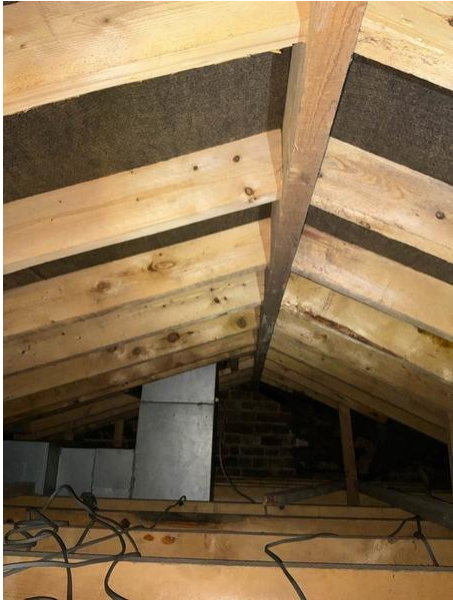
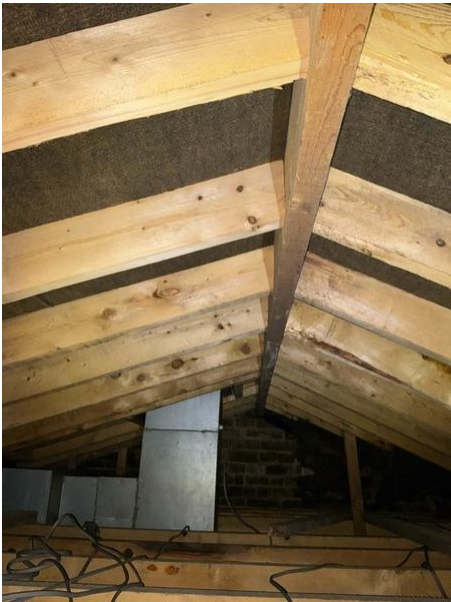
| <b>No</b> | 20 |

| <b>Location</b> | Roof Space – above storeroom |
| <b>Observations</b> | No obvious defects are noted to the roof structure above the storeroom. Timber members appear to be of adequate section size with a felt layer noted above the rafters. |

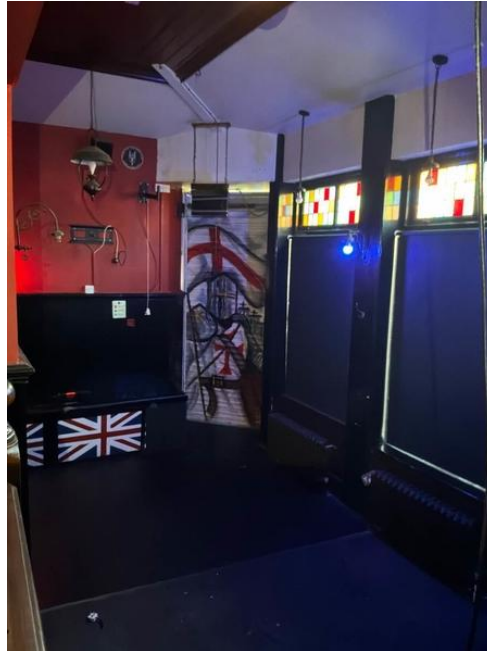
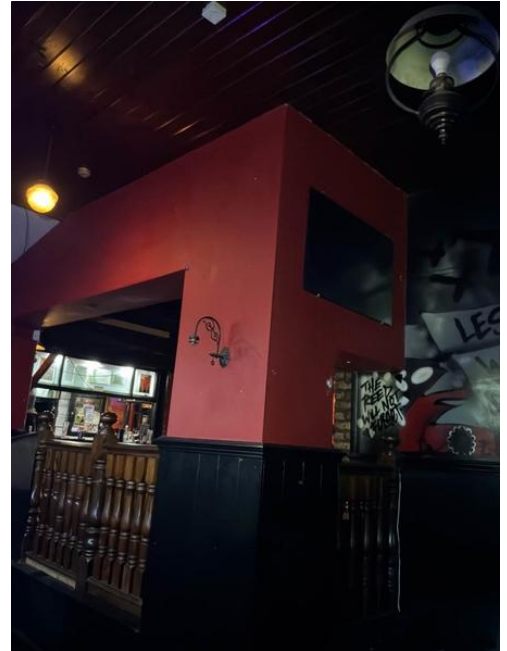
| <b>No</b> | 21 |

| <b>Location</b> | Ground Floor – single storey extension |
| <b>Observations</b> | General views within the single storey extension. No obvious structural defects noted. |

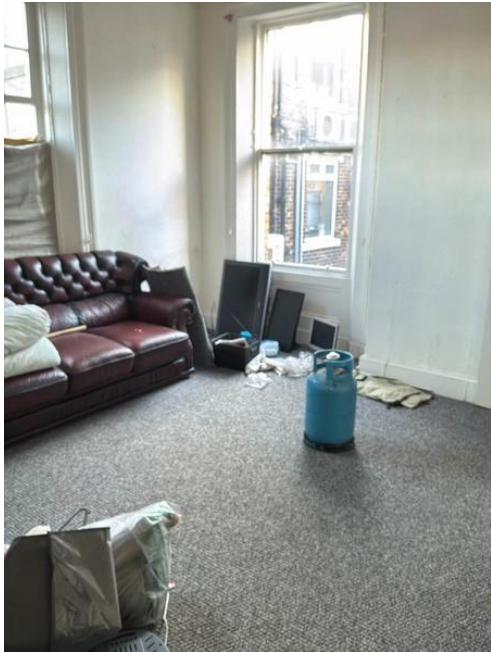
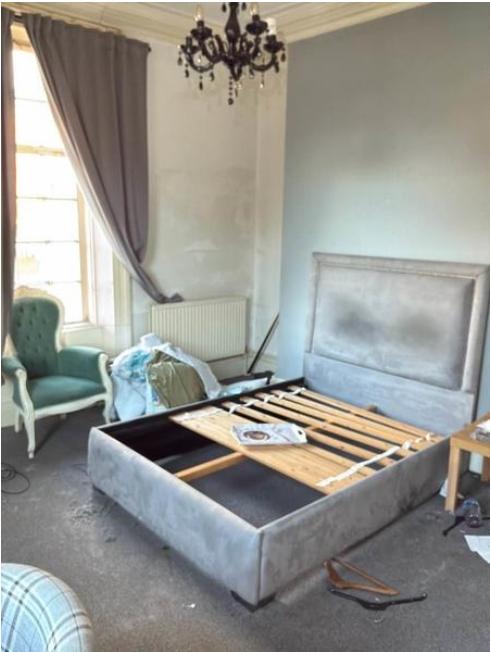
| <b>No</b> | 22 |

| <b>Location</b> | First Floor - general |
| <b>Observations</b> | <p>Images showing the general condition of the property at first floor level. The central masonry spine wall noted at ground floor level extends up to first floor level.</p> <p>The floor footprint has been sub-divided to provide separate accommodation areas.</p> |

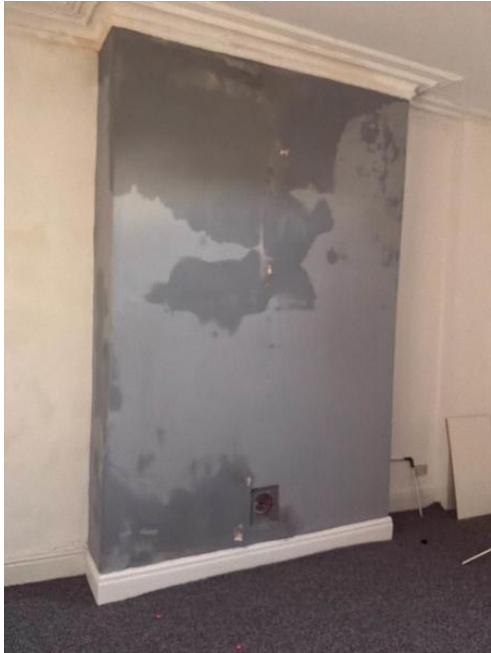
| <b>No</b> | 23 |

| <b>Location</b> | First Floor – water ingress |
| <b>Observations</b> | Water ingress is noted around the chimney breast towards the rear left-hand corner of the property. |

However, internal inspection confirmed evidence of water ingress, primarily around chimney breasts where the external stacks extend above with lead flashings dressed into external brickwork.

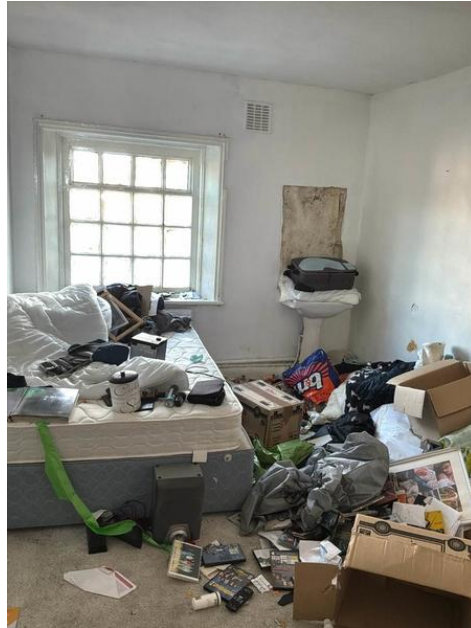
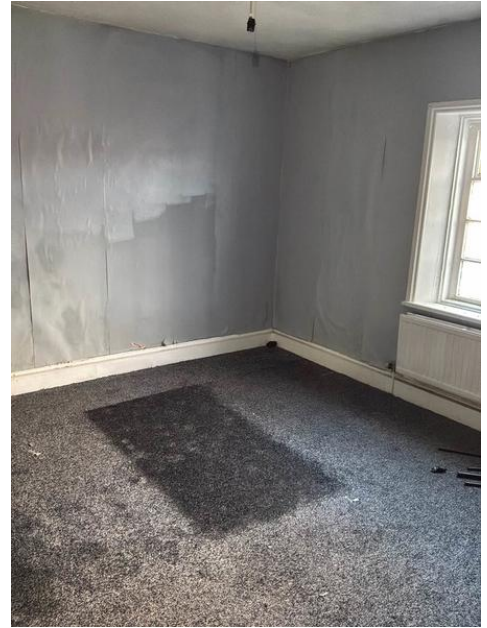
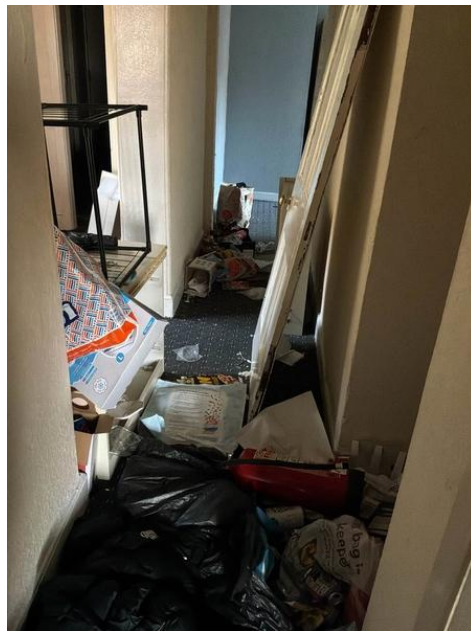
| <b>No</b> | 24 |

| <b>Location</b> | Second Floor - general |
| <b>Observations</b> | Images showing the general condition of the property at second floor level. The central spine wall extends up to roof level. |

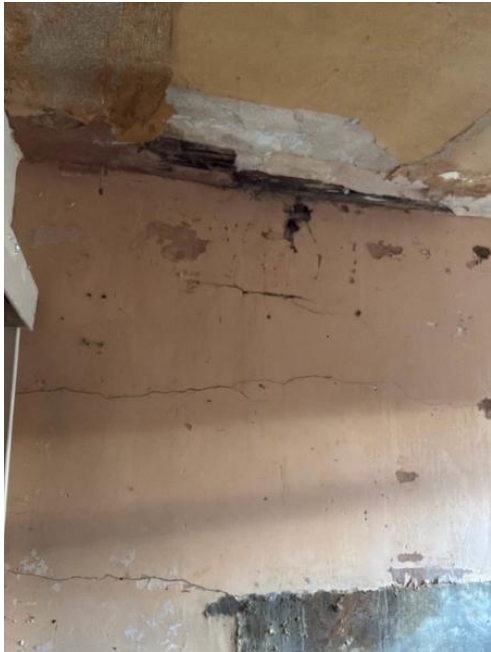
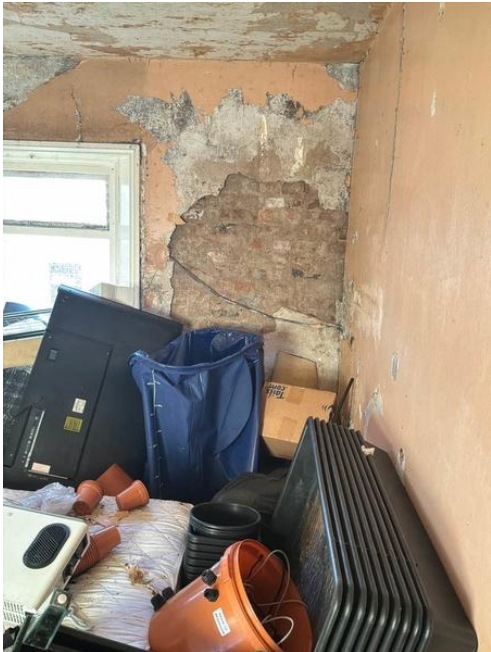
| <b>Location</b> | Second Floor – damage within rear left corner chamber |
| <b>Observations</b> | Locally collapsed ceiling finishes and evidence of water ingress is noted around the chimney breast towards the rear left-hand corner of the property. Floor joists generally span from front to back. Brickwork is exposed to the rear elevation and generally appears dry. The rear elevation is approximately 400mm thick. |

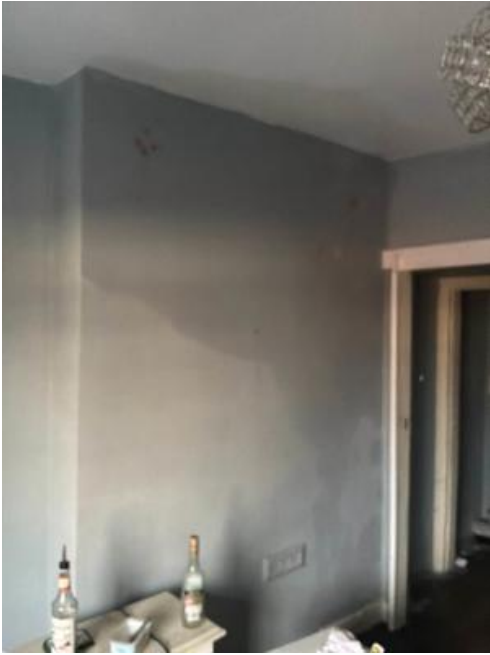
| <b>No</b> | 26 |

| <b>Location</b> | Second Floor – front left hand corner chamber |
| <b>Observations</b> | Evidence of water ingress is noted around the chimney breast towards the front left-hand corner of the property. |

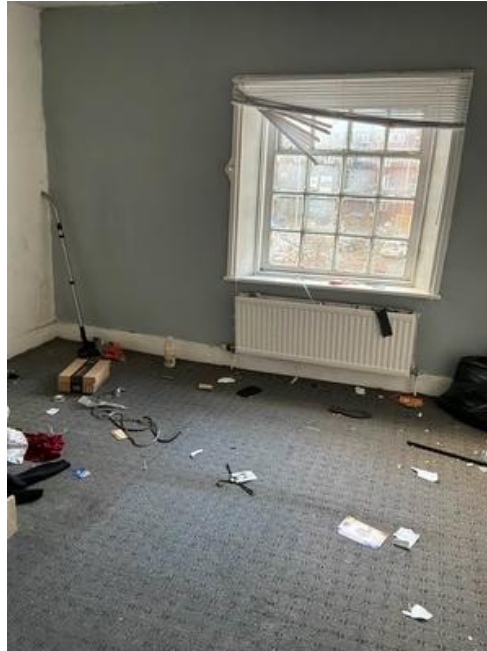
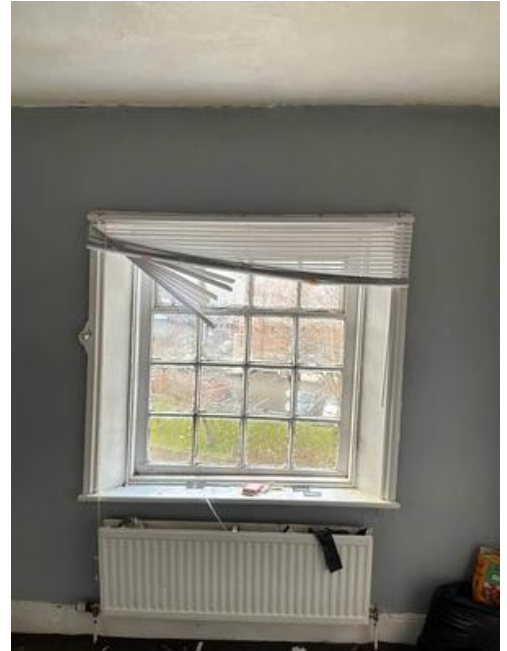
| <b>No</b> | 27 |

| <b>Location</b> | Second Floor – rear right hand corner chamber |
| <b>Observations</b> | Slight deflection of the second floor joists and sloping window head / cill is noted towards the rear right-hand corner of the property. |

Whereas slight deflection of the floor joists was noted at second floor level, floors generally appear structurally sound underfoot.

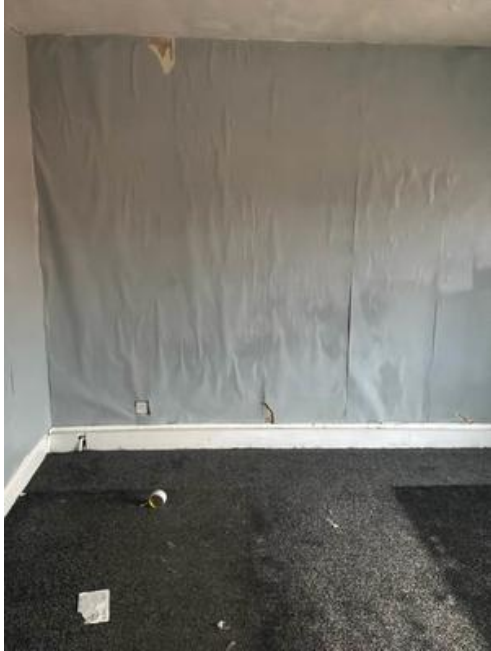
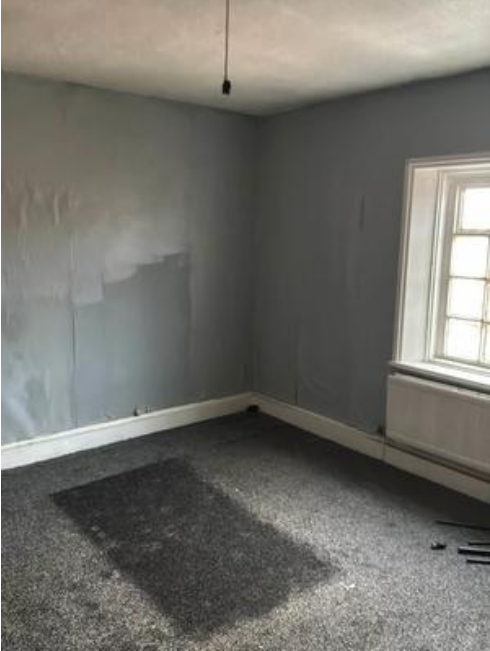
| <b>Location</b> | Second Floor - front right hand corner chamber |
| <b>Observations</b> | Evidence of water ingress is noted through the external walls towards the front right-hand corner. |

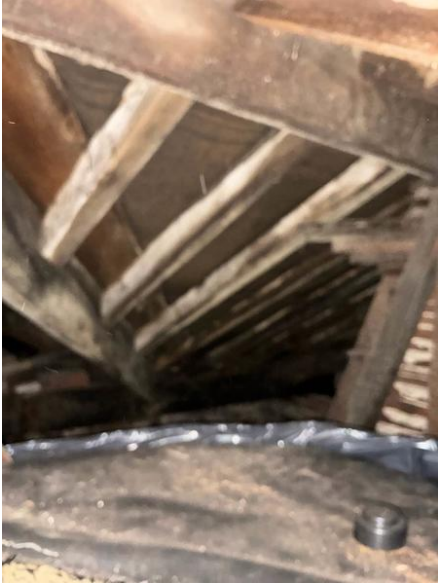
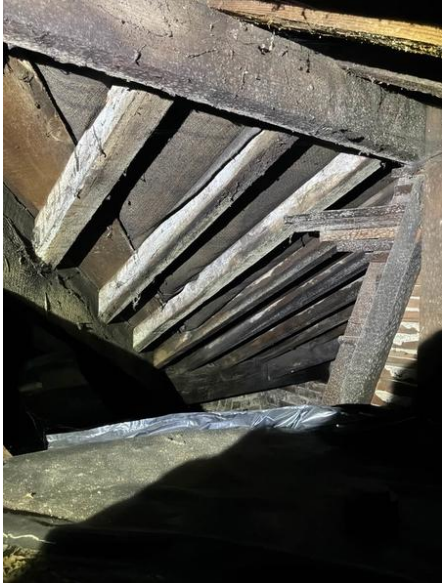
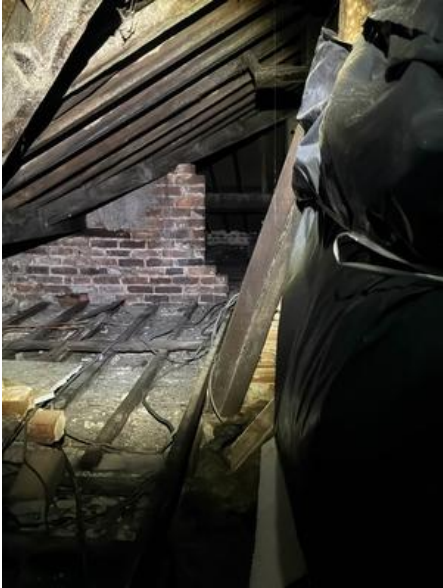
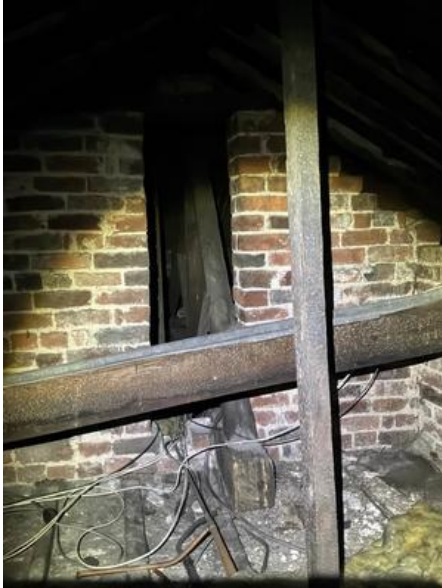
| <b>Location</b> | Roof Space - general |
| <b>Observations</b> | General views within the roof space showing the timber roof structure which comprises trusses, hips, purlins and rafters. All members visible appear to be of adequate section size. |

A brief inspection within the roof space confirmed that the roof structure comprises timber hips and purlins supported by internal timber trusses. All timber structural members appeared to be of adequate section size, however, it must be appreciated that we have not carried out any design checks to confirm this in accordance with our brief.

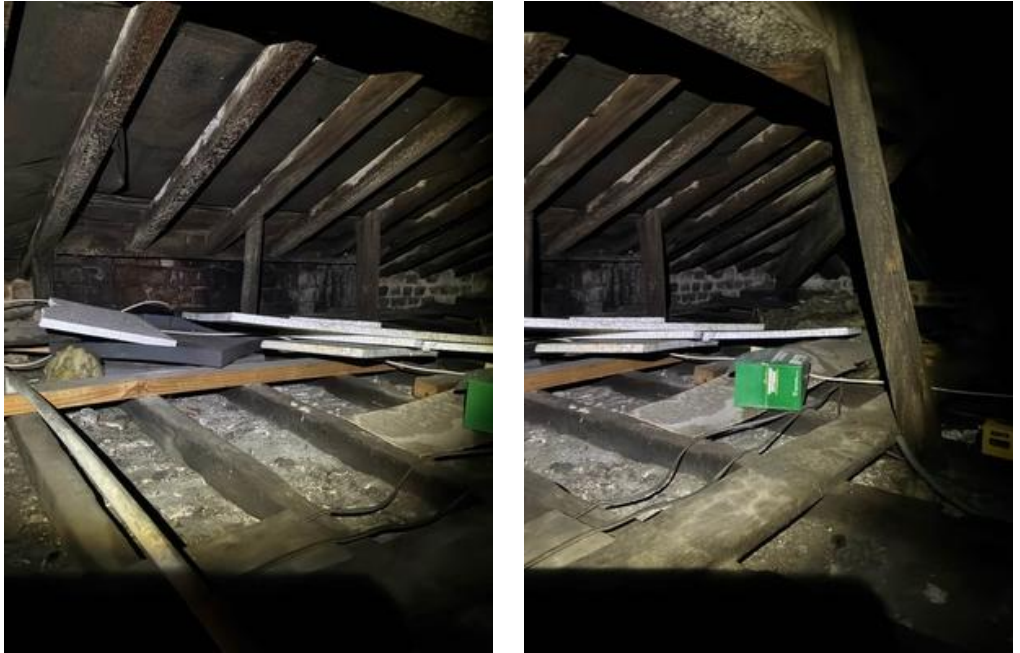
| <b>No</b> | 30 |

| <b>Location</b> | Roof Space – water ingress |
| <b>Observations</b> | Evidence of water ingress is noted around the chimney breast towards the rear left-hand corner of the property. A felt later is noted above the rafters. |
