# STRUCTURAL REPAIRS & METHODOLOGY

Project Ref: Silver Hill Farm, Rochdale

Date: 28 October 2025

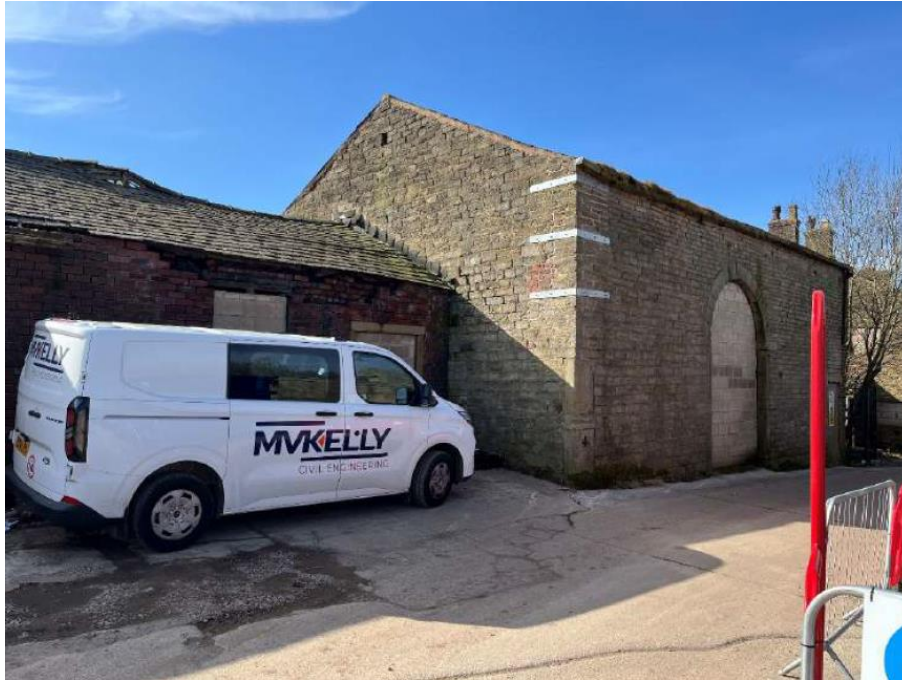
Photo 3 Barn North Elevation Showing Two-storey Section

- 6.5 The current condition of the East wing extension of the barn is in a poor state of disrepair. As referenced in section 5.0, items 11 and 13 shown the external masonry walls to the front and rear elevation are leaning outwards with large areas of missing facing bricks (Photo 3, Photo 4 & Photo 8) . This lateral movement is likely to be caused by damage the roof has sustained. The timber ridgeboard (item 12 in section 5.0) has failed (Photo 3 & Photo 13) along with the collapse of the ceiling (Photo 14) will have caused the roof to over deflect and generate a lateral thrust to the top of the masonry wall. This is noted to have occurred to both the front and rear elevation of the single storey East wing extension that is proposed to be retained. It is also noted that the external masonry walls do not have sufficient wall ties, which may have also contributed to the lateral movement.

- 7.2 Items 11, 12 & 13. A large portion of the single storey structure is to be demolished, however, due to the compromised structural integrity of the existing structure that is to remain, this will render it unstable. If demolition works are to be carried out, the gable end will require building immediately after to prevent further lateral movement of the existing front and rear elevation walls. Please note, the large amount of repair works to the remaining single storey structure comprises of over 50% of the area of the building. The temporary works and repair works required are likely to be uneconomically feasible and the likelihood of the structure to collapse is of high risk. Therefore, we recommend that the single storey structure to the East wing of the Barn is to be demolished in it's entirety and rebuilt with modern construction methods. This will require confirmation from the conservation officer.

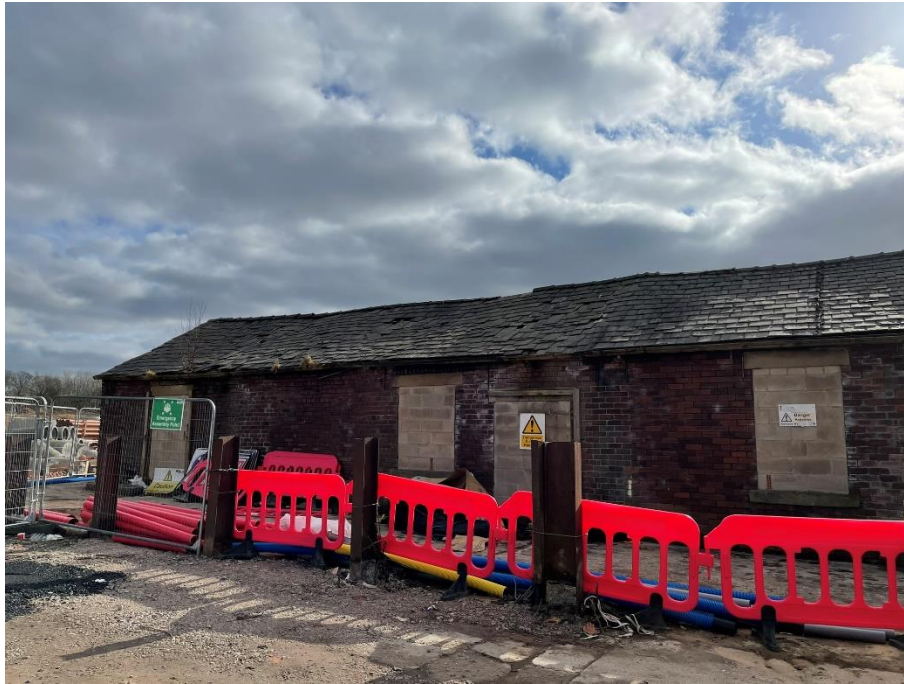
Photo 4 Barn North Elevation Showing Single Storey Section

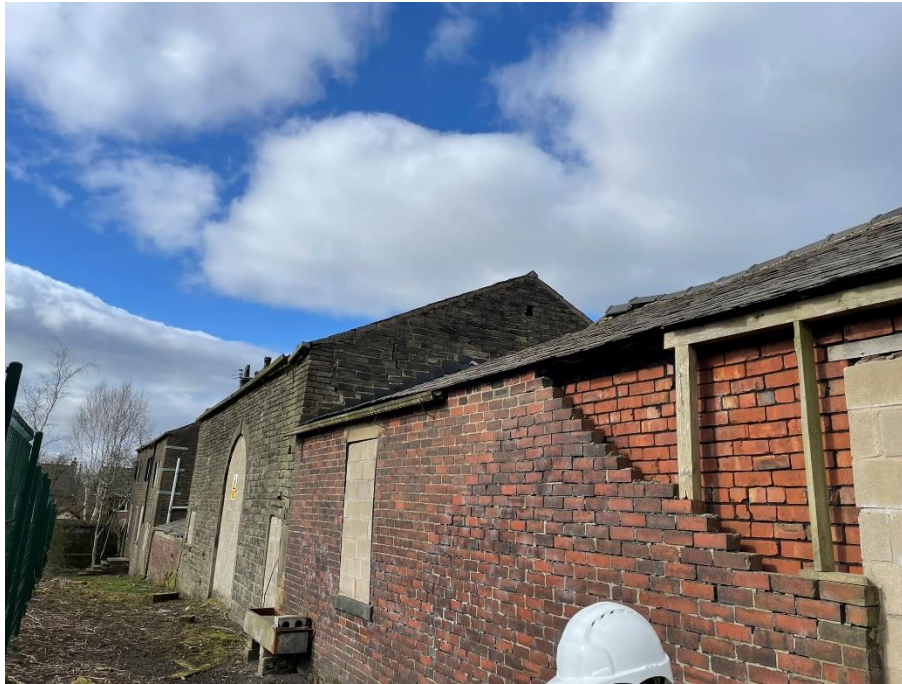
Photo 8 Barn South Elevation Between Single & Two Storey

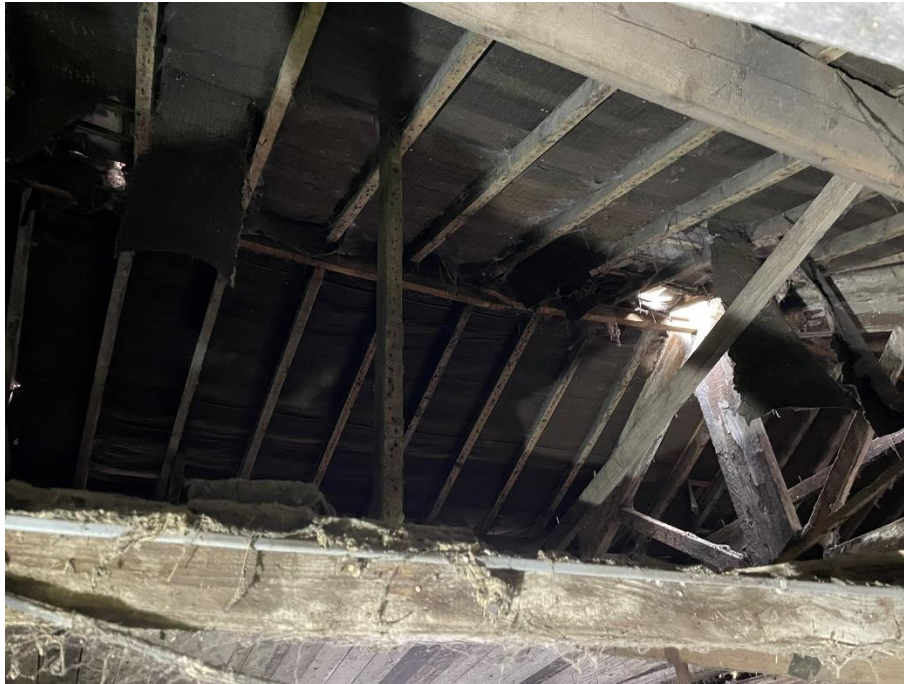
Photo 13 Barn Single Storey Roof Structure

- 6.6 The condition of the existing timber trusses (Photo 13 & Photo 14) could not be inspected close-up due to health and safety risks.
- 6.7 To the central area of the Barn is a two storey building. The existing roof structure typically looks to be in good condition. However, a number of areas to the external solid stone walls require attention. Item 29, as referenced in section 5.0, significant lateral movement has occurred. The likely cause of this may be due to the failed roof of the adjacent single storey. Item 28, as referenced in section 5.0, the upper section of the gable end wall has collapsed. This has resulted in 2No. timber purlins unsupported. To the lower section of the gable end wall is an attached single storey out-building. This out-building is proposed to be demolished.

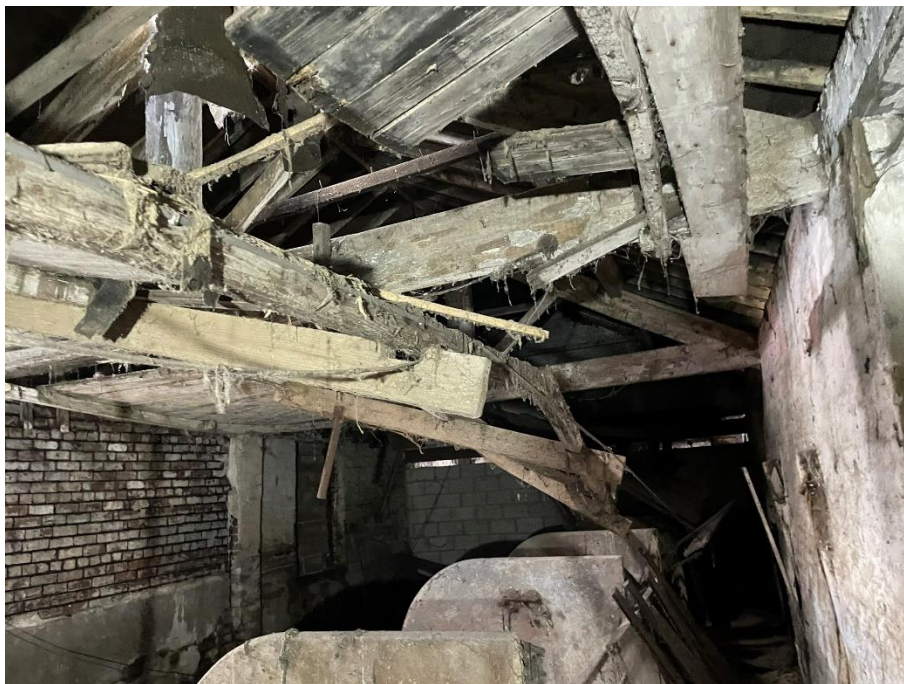
Photo 14 Barn Single Storey Ceiling

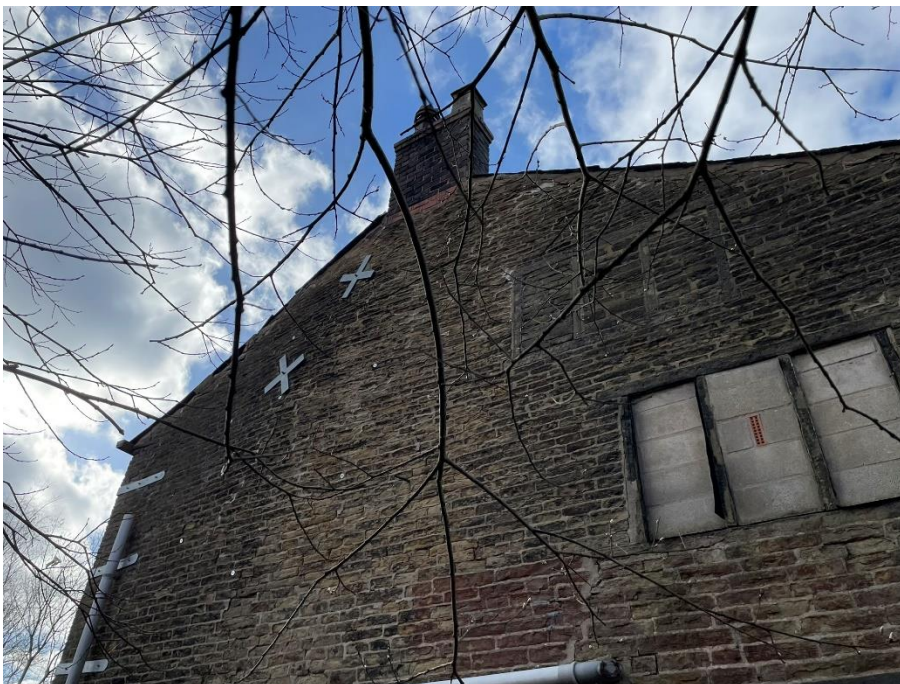
Photo 16 Farmhouse East Elevation on Gable End

- 6.8 The current condition of the existing farmhouse external stone walls are typically in a good state of repair. However, the East gable is experiencing bulging to the upper section of the wall (item 24 in section 5.0). Existing remedial ties have been installed previously to help prevent further movement (Photo 16). Internally, no visible signs of lateral movement related to the bulging was noticed.

- 7.5 Item 24. The outer skin of stone to the upper section of the gable end looks to have separated from the inner skin. No temporary works are required, however, the outer skin of stone masonry is to be carefully removed and rebuilt. During rebuild, remedial wall ties are to be installed.
