**STRUCTURAL DESIGN OF A STEEL PLATE COVER TO A  
CULVERT AT HOLLINGWORTH ROAD,  
LITTLEBOROUGH.**

**Project ref:** YZ074  
**Issue:** 04  
**Date:** 10/02/2026  
**Prepared by:** Henry Byfield  
Engineer  
BEng | AaPS

| <br> | <b>Project</b><br>LITTLEBOROUGH CULVERT COVER STEEL PLATE DESIGN | | | <b>Job No.</b><br>YZ074 |

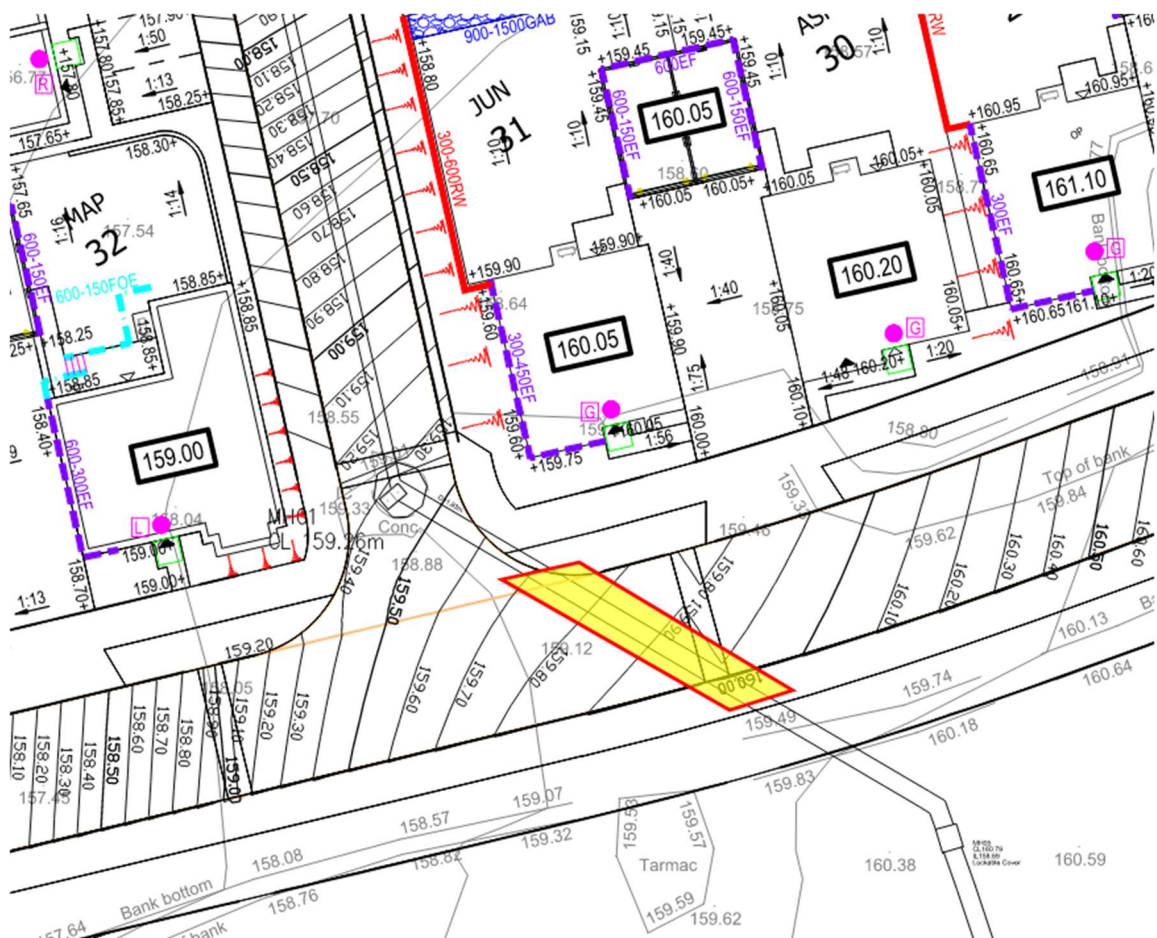
Minimum cover to culvert:

**4.65 kN/m<sup>2</sup> < 8.50 kN/m<sup>2</sup>, Therefore PASS (55% Utl.)**

Compared to soil overburden (1.2m  $\times$  18kN/m<sup>3</sup>  $\approx$  22 kN/m<sup>2</sup>) – Traffic loads only make up  $\sim$  15% extra.

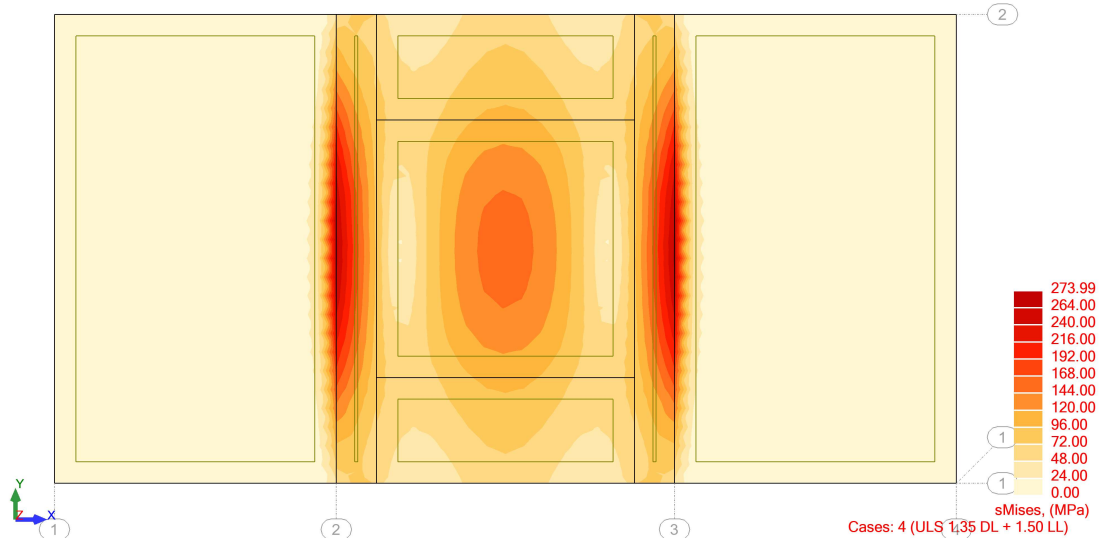
$273.99 \text{ N/mm}^2 < 275 \text{ N/mm}^2$ , Therefore PASS  
Stresses are within allowable limits.

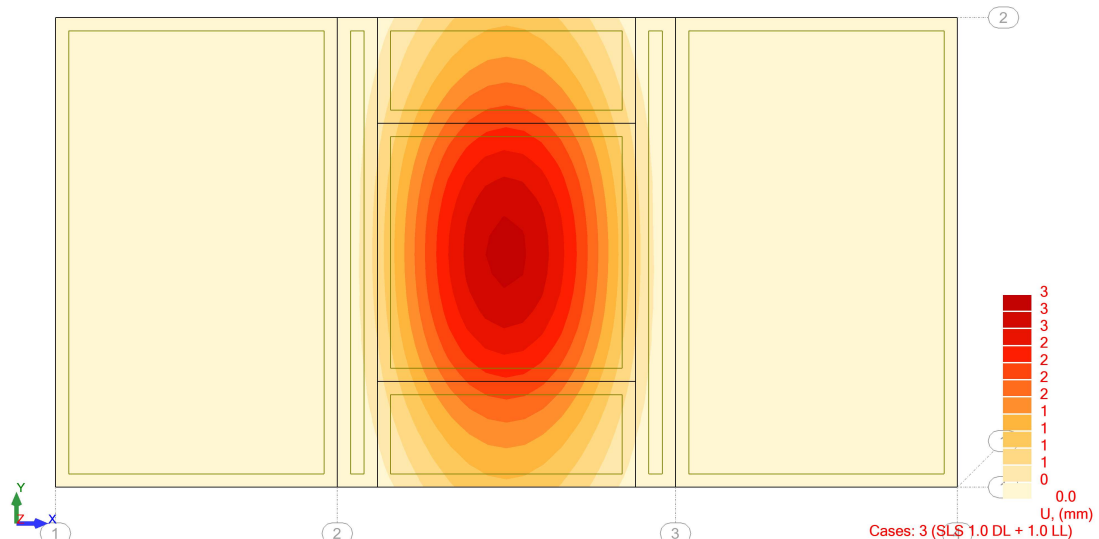
Consider an allowable deflection = span / 200 for a short spanning structural element with no brittle finishes =  $900 / 200 = 4.5 \text{ mm}$

$3 \text{ mm} < 4.5 \text{ mm}$ , Therefore PASS  
Deflections are within allowable limits.
