**STRUCTURAL APPRAISAL  
OF  
STID FOLD BARN,  
WARDLE,  
ROCHDALE**

| <b>CONTRACT NO. 3761</b> | <b>PHILIP WRIGHT ASSOCIATES LTD<br/>21 UNION STREET<br/>RAMSBOTTOM<br/>BURY BL0 9AN</b> |
| <b>JULY 2025</b> | <b>TEL. 01706 828781/ 07939 547865<br/>E-MAIL: <a href="mailto:info@philipwrightassociates.co.uk">info@philipwrightassociates.co.uk</a></b> |

**STRUCTURAL APPRAISAL**  
**STID FOLD BARN, BARNFIELD LANE, WARDLE, ROCHDALE OL12 9PN**

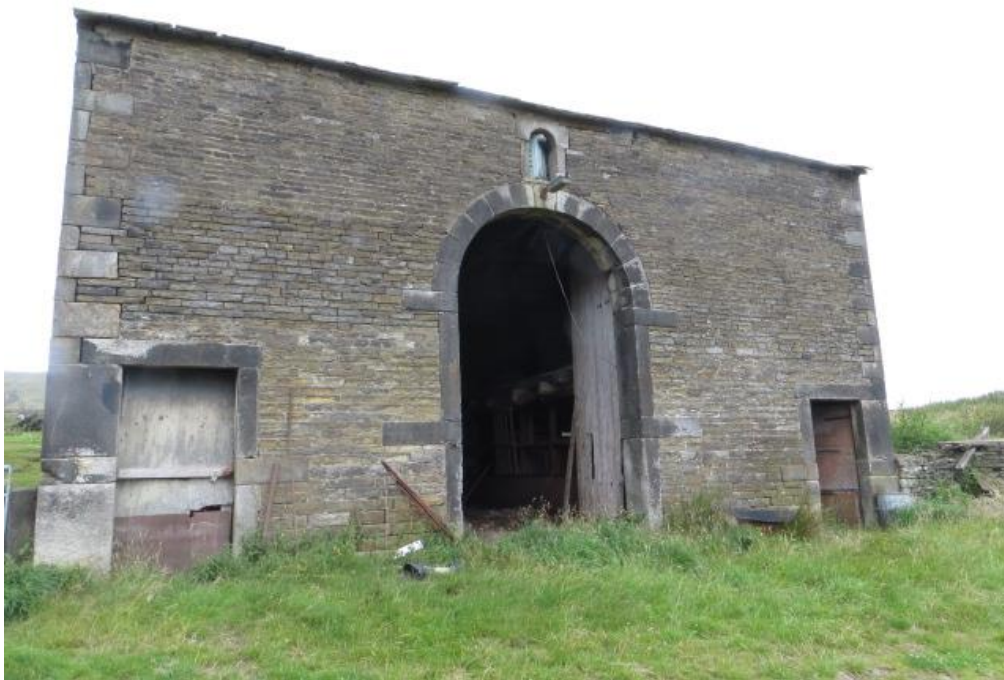
**FRONT ELEVATION**

The front elevation incorporates a large full height opening with arched stone head, a door to the left and right hand corners with stone surrounds and with stone quoins to the corners. A small opening was evident over the top of the arched head. The wall adjacent to ground level was noted to be reasonably plumb and was considered to be within acceptable tolerance. The stonework was noted to be level within acceptable tolerance. Some open joints were evident, particularly over the top of the arch, to the stone surround to the small opening to the top of the arch and to the quoins.

- The quoins and stonework will be required to be locally rebuilt to all corners.
- The floors will be required to be removed and replaced to suit current Building Regulations.
- The cracking noted to the left hand gable adjacent to the front and to the right hand gable should be locally rebuilt to tie in with the quoins.
- The rear right hand corner should be bonded internally by the installation of Helifix type ties to tie the corner together which should be recessed into the stonework and fixed with epoxy mortar. The ties should be fixed at approximately 500mm vertical centres.

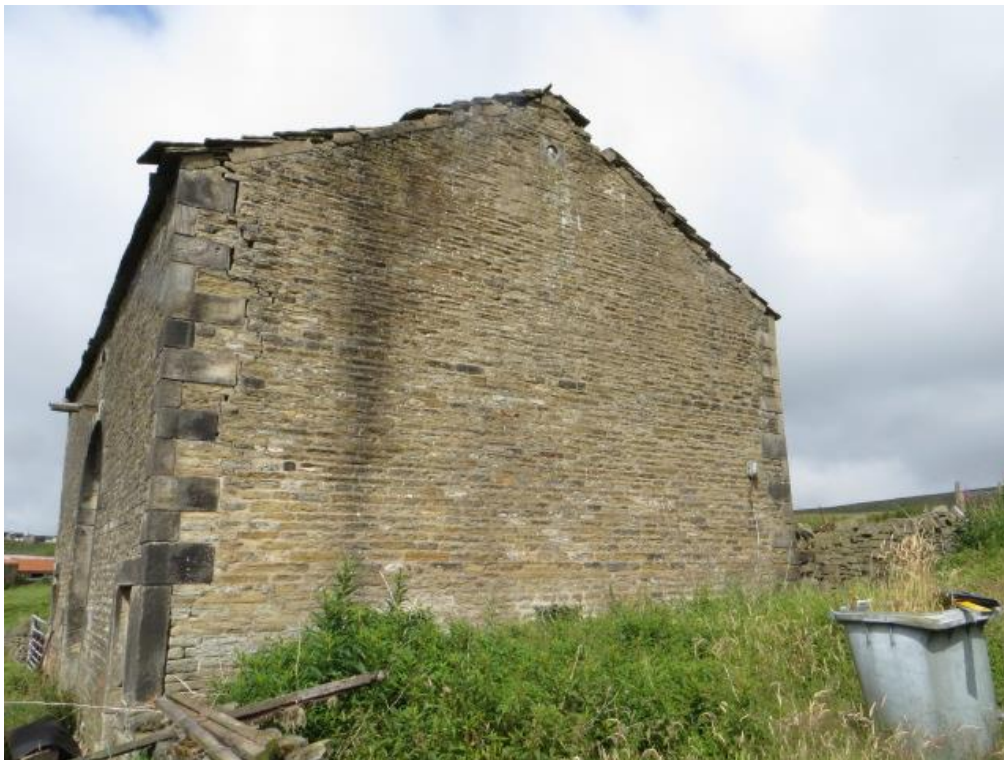
**RIGHT HAND GABLE**

The wall to the right hand gable is of coursed stone with wide lime mortar joints. The wall incorporates three openings at low level with the ground rising upwards towards the rear. Vertical cracking was evident to the face of the quoins at high level to the rear corner being approximately 12mm. The wall was uneven and was noted to lean outwards to the front face of the pike with notable visual distortion. Cracking was evident to the face of the quoins to the rear corner.

- The roof in its entirety to be removed and to be reconstructed with the stone tiles to be refitted. A new supporting structure of rafters and purlins will be required. The substantial trusses, if these are to remain, should be checked by a specialist for any decay.
- The pikes to both the left and right hand elevations show evidence of visual distortion and these should be taken down and locally rebuilt.
- The left hand gable should be taken down to the top of the level of the proposed first floor and to be rebuilt.
- The whole of the property will require to be locally repointed, gaps were evidence particularly to the quoins and around the stone surrounds.
- The hay loft floors are unsuitable for residential accommodation and are required to be replaced.

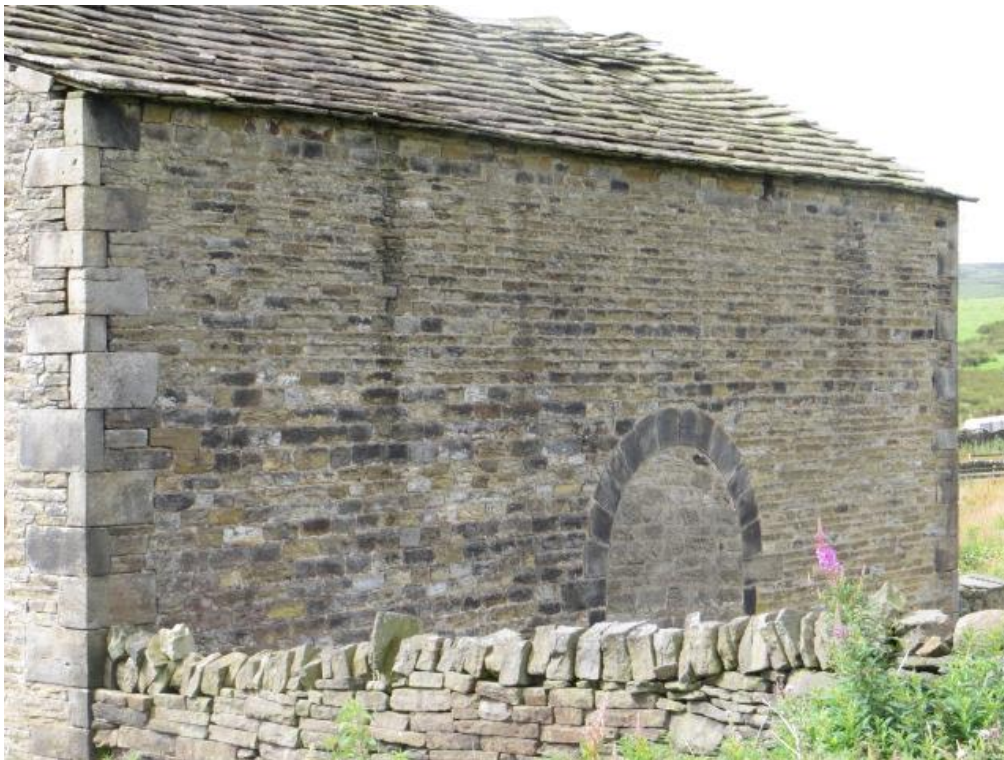
**REAR ELEVATION**

The rear elevation incorporates a door to the right hand corner and with a central arched opening which had been infilled with stone. A gap was evident between the quoins and the stonework to the right hand corner and vertical cracking 1-2mm was noted adjacent to the quoins to the left hand corner. The remainder of the wall was noted to be reasonably plumb within acceptable tolerance and the coursing level.

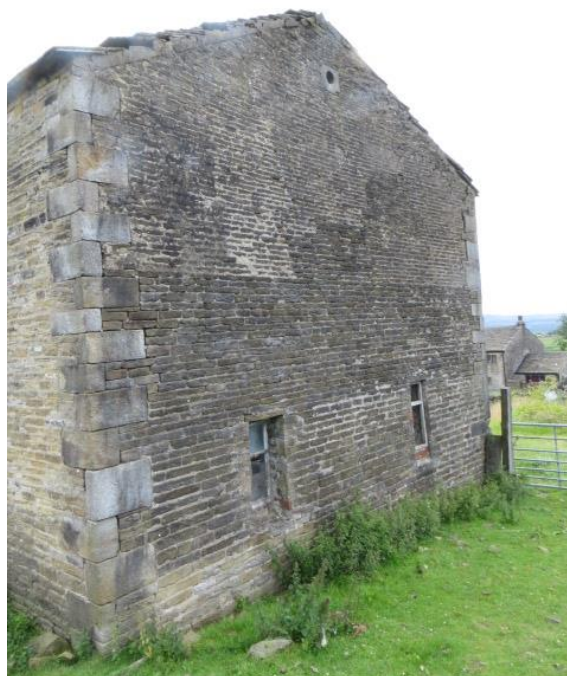
**LEFT HAND GABLE**

The wall to the left hand elevation incorporates two low level windows with stone heads. A gap was evident between the front quoin and the main wall being up to 75mm wide. Diagonal cracking was evident from the lintel to the window to the front running down to the rear. The pike was noted to be distorted visually with a lean/bow inwards by approximately 100mm.

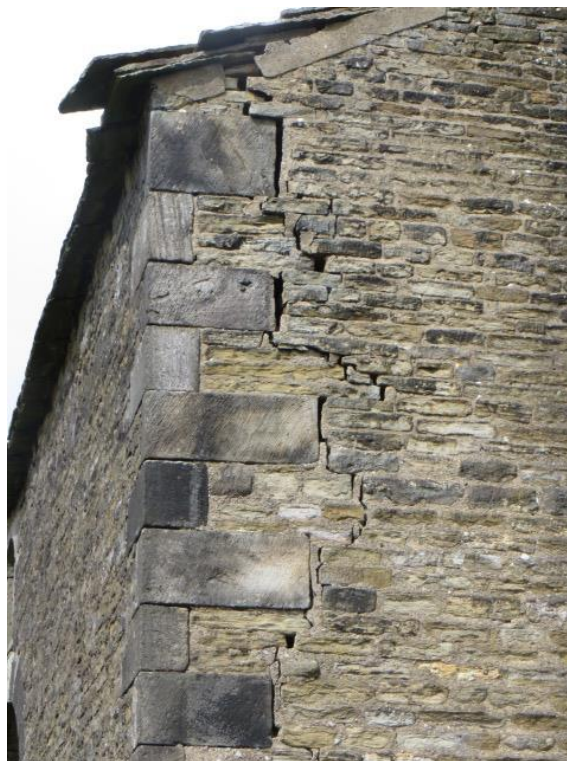
**CRACK ADJACENT TO QUOINS TO FRONT CORNER**

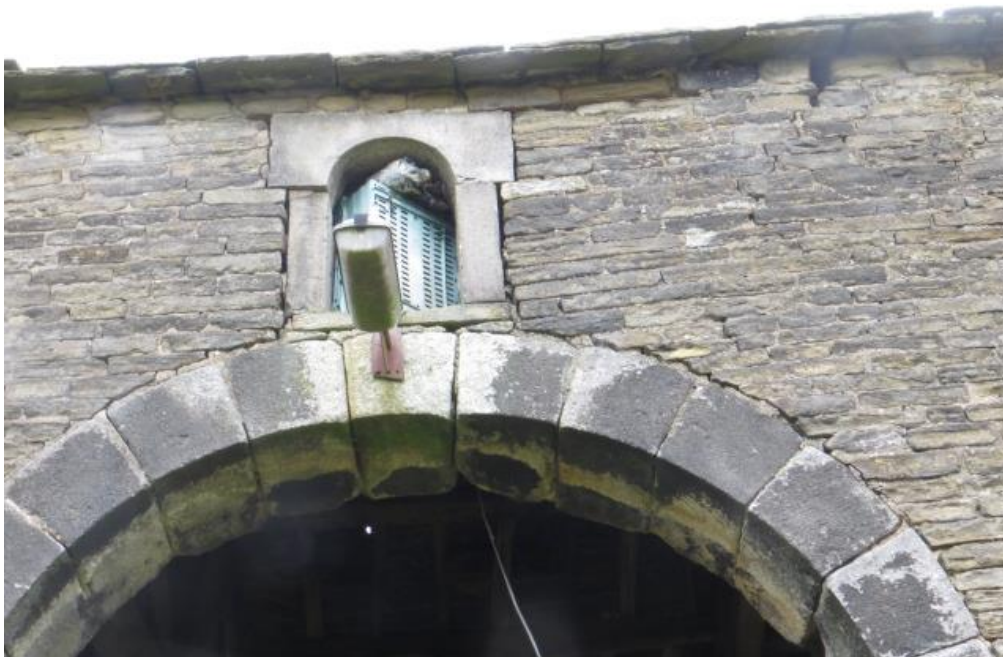
**OPEN JOINTS TO SMALL WINDOW OVER ARCHED OPENING**
