## The Old Duke, Littleborough

### Bat Survey Report

5<sup>th</sup> March 2026

| Document ref: MBE/BAT/2026/015/01 | | | | |

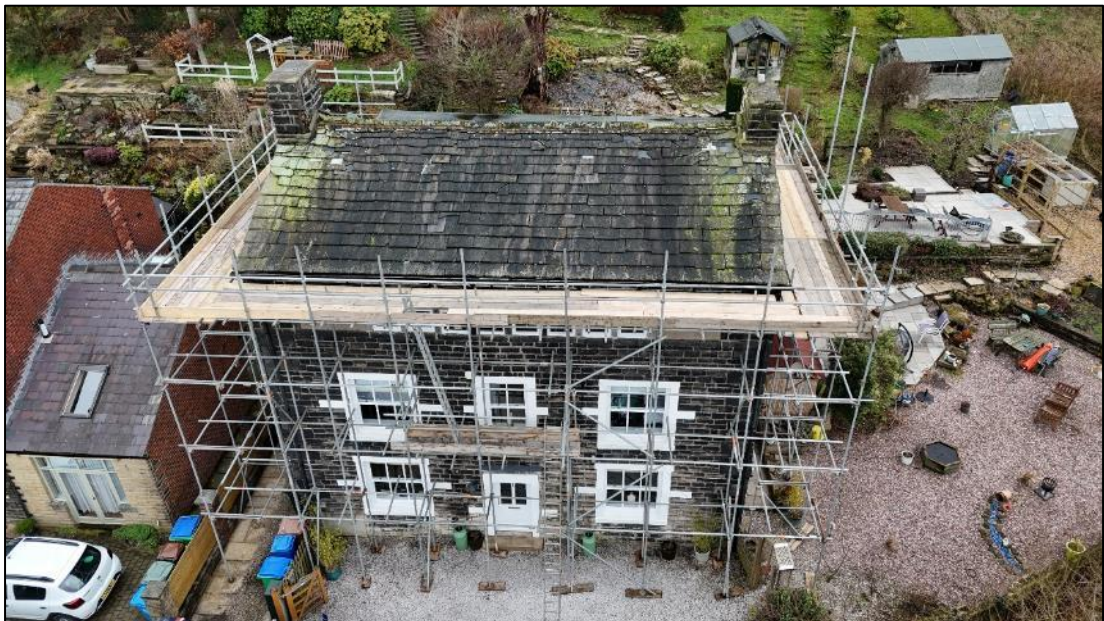
**Plate 1. Façade – southwest elevation**

- 5.2.3 The Old Duke comprised a Grade II listed early C19<sup>th</sup> stone-built three-storey dwelling formerly used as a pub, and initially as a series of dwellings (Plates 1-3). On the rear/northeast of the building was a three storey stone extension, which now comprised a separate dwelling (Plates 2 & 3). The main house had a dual-pitch stone slate roof, with a mortar-filled verge and mortar-bedded ridge tiles. Stone chimneys were present in either gable, although these chimneys were capped with the exception of one gas flue pipe. A flat roof covered in mineral-surfaced roofing felt was present across the northeast extension. The pitched roof of the main dwelling had been subject to numerous short-term repairs over recent decades, with sections of steel and plastic sheet inserted to replace or seal gaps between broken stone slates.

- 5.2.4 The dwelling had solid stone walls, with wood-framed double glazed windows. The façade/southwest elevation had wooden guttering, whilst the edges of the extension's flat roof had a plastic fascia board and plastic guttering. The extension's northwest elevation had a single-storey wood-framed porch with a dual-pitched Welsh-slate covered roof with mortared clay ridge tiles and wooden barge boards (Plate 3).

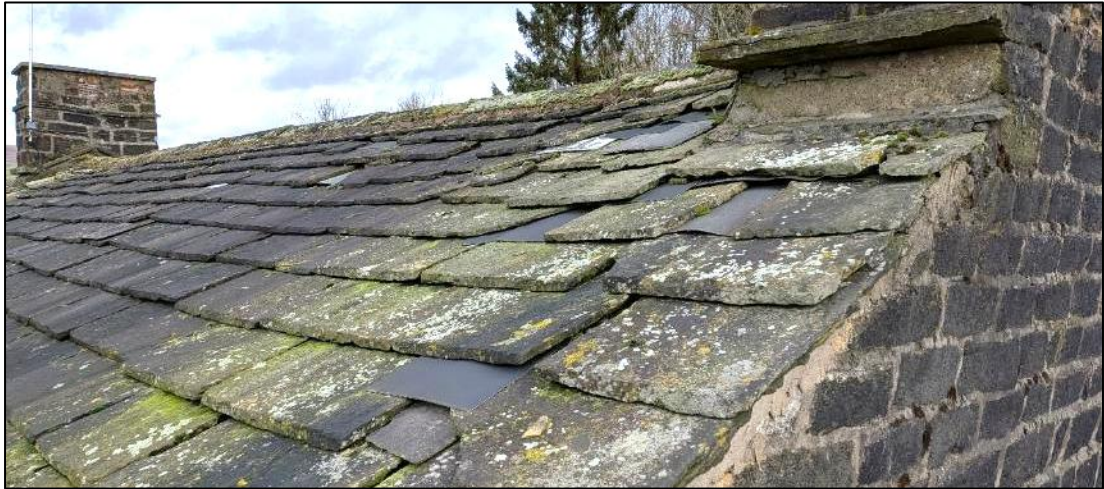
- Gaps between uneven stone slates, particularly near the gable verges (Plates 4-6).
- In one location near the northeast chimney, a larger opening between roof slates in the verge had allowed access to jackdaw, which the owner reported had nested in that location in the past (Plate 6).
- Very occasional access to the wall top at the base of the southwest roof pitch, although this potential opening was mainly mortar filled.
- A gap – up to c. 2 cm between the fascia board and wall of the extension, in places.

**Plate 4. Representative section of roof near southwest gable, showing extensive repairs and gaps between stone slates**

- 6.3.5 The Old Duke is to be re-roofed with stone slates. Consequently, potential roosting features on the existing roof, which result from slates of uneven width, will largely be re-created ‘like for like’ during the re-roofing process. In the event that a bat roost, which was not in use at the time, was uncovered then there would be scope to re-create this in the same location, although the need for a licence would need to be re-assessed at this stage. Hessian-backed Type 1F bituminous felt would be used at any identified bat roost location.

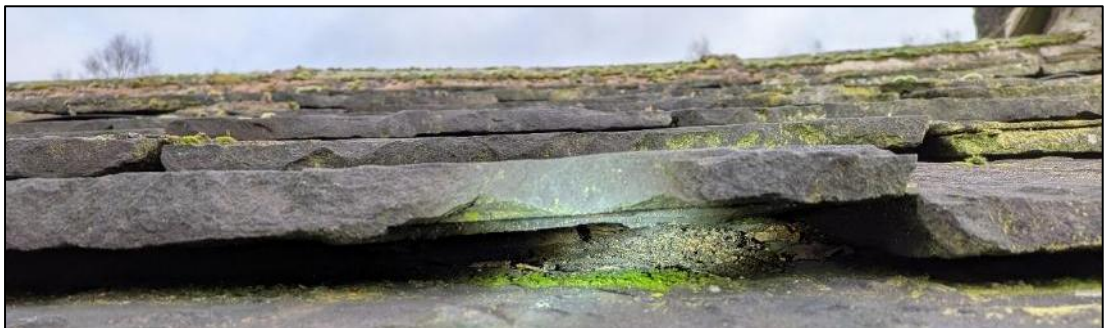
5.2.7 It was possible to access the main pitched roof, and all gaps between the slates were inspected using a torch and endoscope, together with the access points onto the southwest wall top. Gaps between the fascia board and wall on the extension could

**Plate 5. Inspecting gaps between stone slates on the mid-pitch**

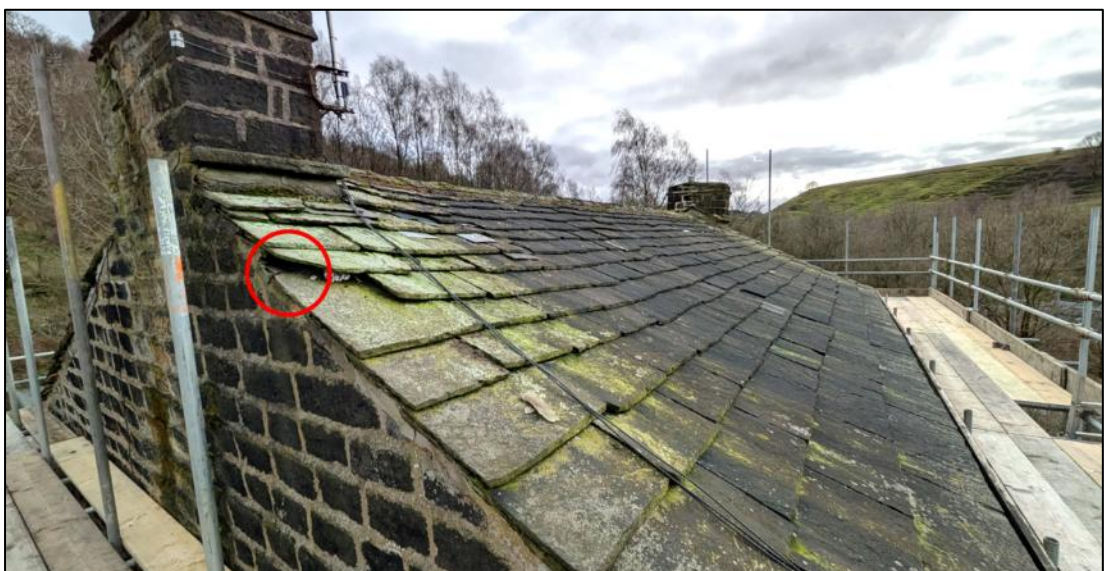
**Plate 6. Larger gap between slates leading to void accessed by jackdaw, above northwest gable**

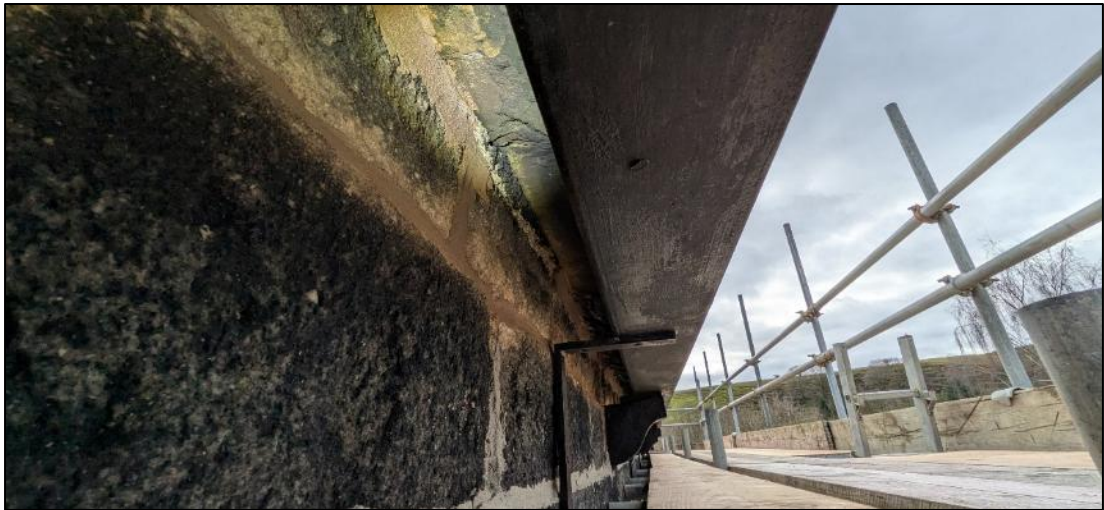
**Plate 7. Space between top of wall and underside of roof slates on southwest elevation, mainly mortar filled**

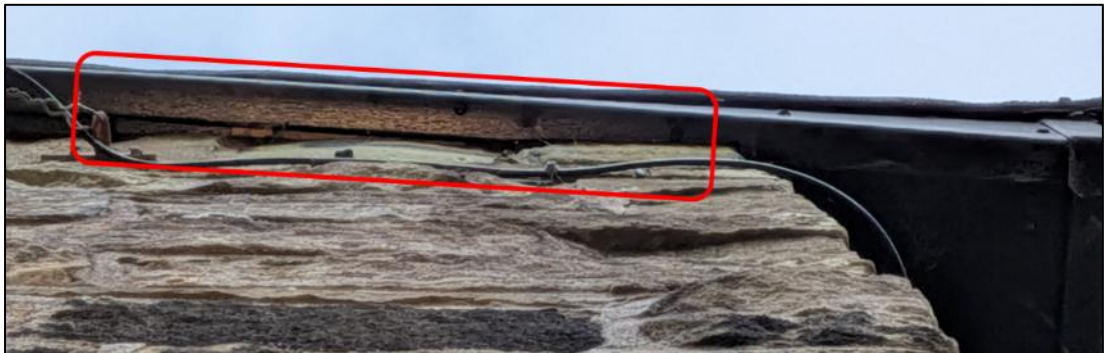
only be inspected from ground level using a torch. However, this potential roost feature would not be impacted by the proposed works.

**Plate 8. Gap between fascia board and wall on extension**

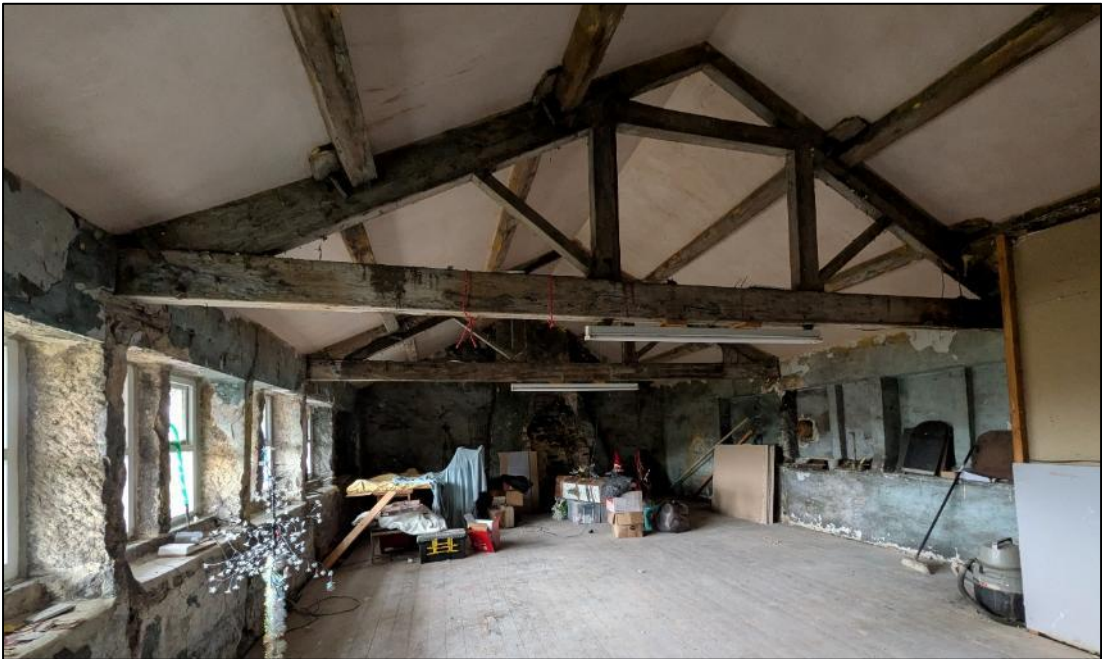
**Plate 9. Roof space of dwelling in February 2026**

- 5.2.8 The pitched roof was suspended on queen post roof trusses, purlins, a ridge beam, rafters and battens. The roof had been quite recently vaulted (during Winter 2025/2026) at the time of survey, with the upper floor of the house and the open roof space very clean, due to recent works in the area (Plate 9).
- 5.2.9 An image of the roof, taken prior to works to vault it, showed that spray foam insulation had been used on the underside of the slates, with the homeowner confirming this was installed before 2007 (Plate 10).

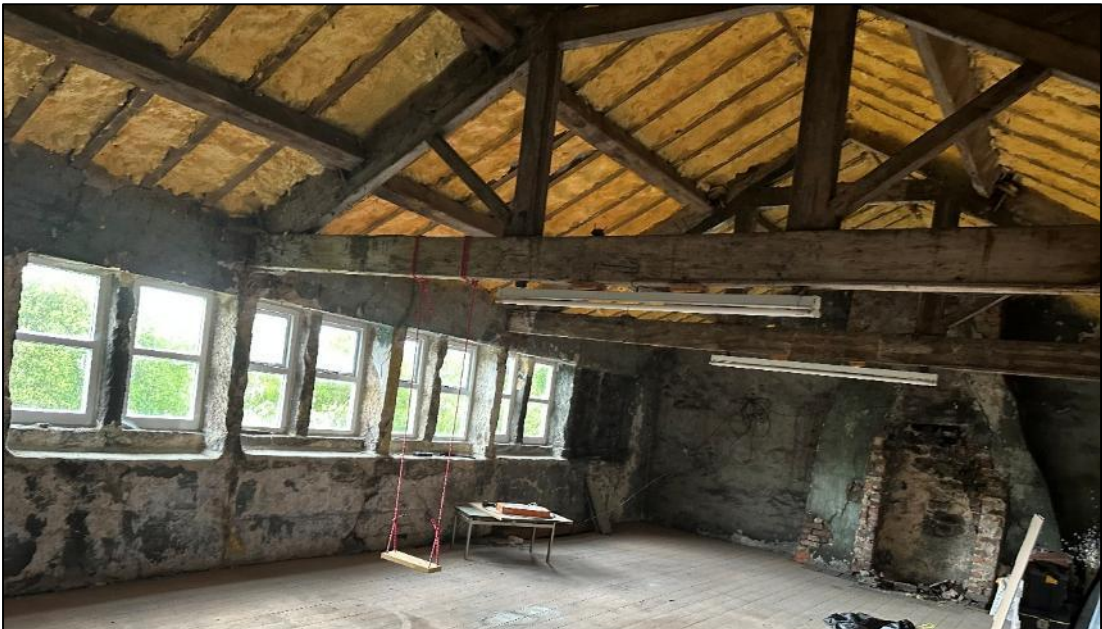
**Plate 10. Image of roof space taken by third party, prior to vaulting, showing spray-foam insulation on underside of roof slates**

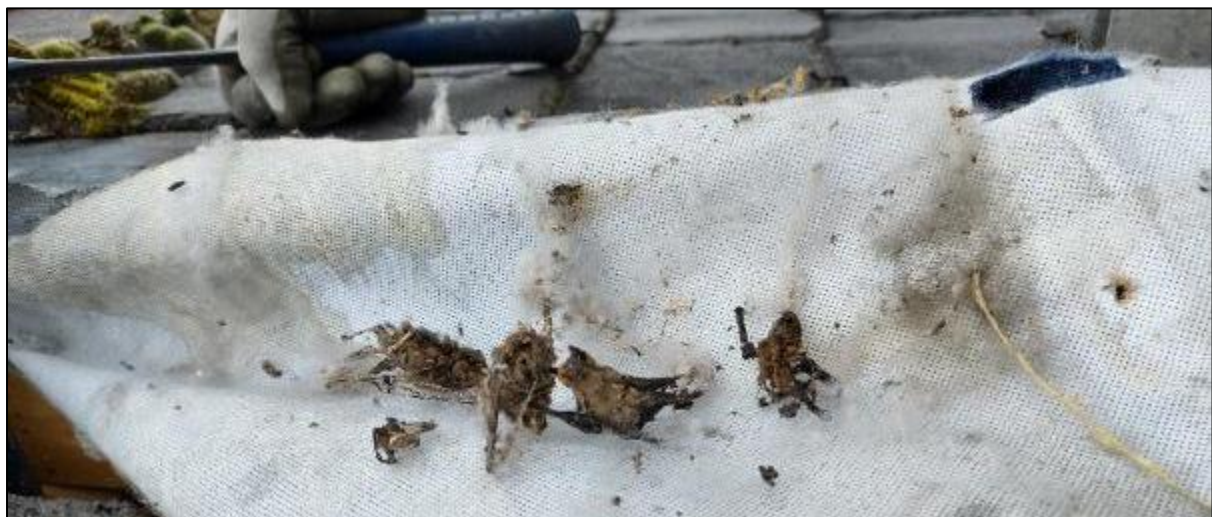
Non-bitumen coated membranes used below roof slates and tiles present a significant problem for bats. Over time, strands are pulled away from the surface of these materials as bats crawl over them. These fuzzy strands are very strong and can tangle and trap bats, sometimes causing the death of bats over multiple years<sup>1</sup>.

One example we have encountered comprised a pipistrelle roost which formed in a building extension constructed in 2009. Over the course of just 13 years the roofing felt degraded to the extent that it trapped and killed more than 10 bats. Fortunately, the problem in this roost was identified and remedial work was undertaken to replace the roofing membrane in 2022.

### Plate A1.1. Four dead pipistrelles tangled in breathable roofing felt

The best roofing membrane option for areas where bat roosts are expected is traditional Type 1F bitumen coated hessian backed roofing felt. Bitumen coated roofing felts have been widely and safely used as a secondary weather barrier since approximately the 1950s/1960s. Wooden sarking has also been used for many decades and if appropriately treated, is safe for

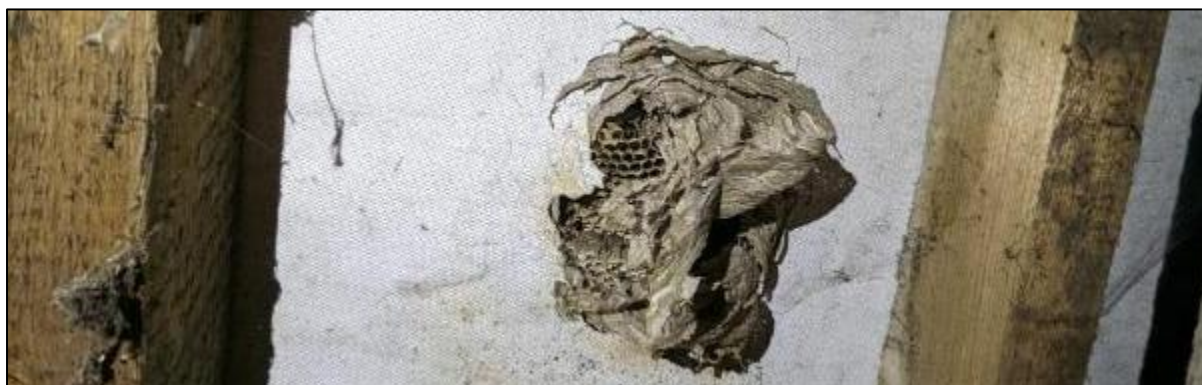
In recent years a fairly substantial proportion of the lofts we have surveyed which had existing breathable felt, were found to have been damaged by wasps (Plate A1.2). In these situations, the wasps appear to have chewed holes in the felt and formed nests in the holes. This doesn't appear to be a problem associated with the traditional bitumen coated roofing felt. Obviously, any holes within roofing felt would be likely to significantly reduce its functionality as a secondary weather barrier. Where bats or birds do come into contact with breathable roofing membranes, they can damage the membrane causing it to leak and they can also significantly reduce the breathability of the felt in that location.

#### **Plate A1.2. Damage to a breathable roofing membrane adjacent to a wasp nest**
