# Historic Building Record

## Level 3

# Parkfield House,

Manchester Old Road, Middleton, M24 3EB

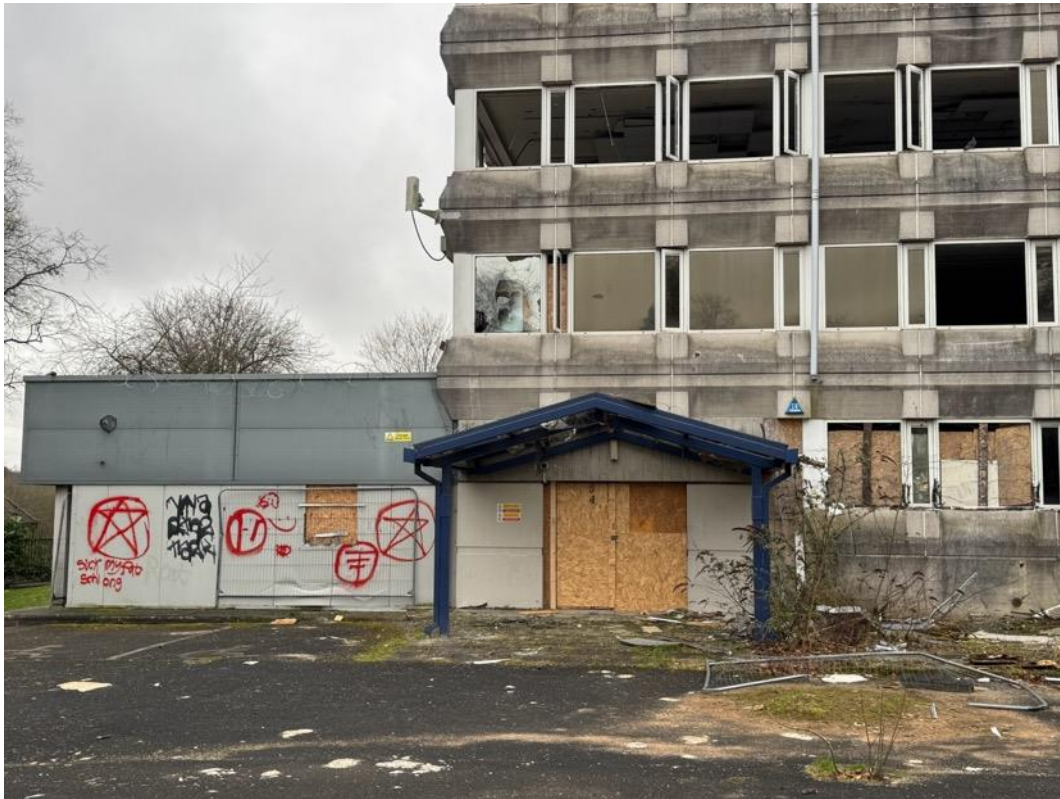
*Image 8 – Closer view of main entrance point, with metal and glass canopy.*

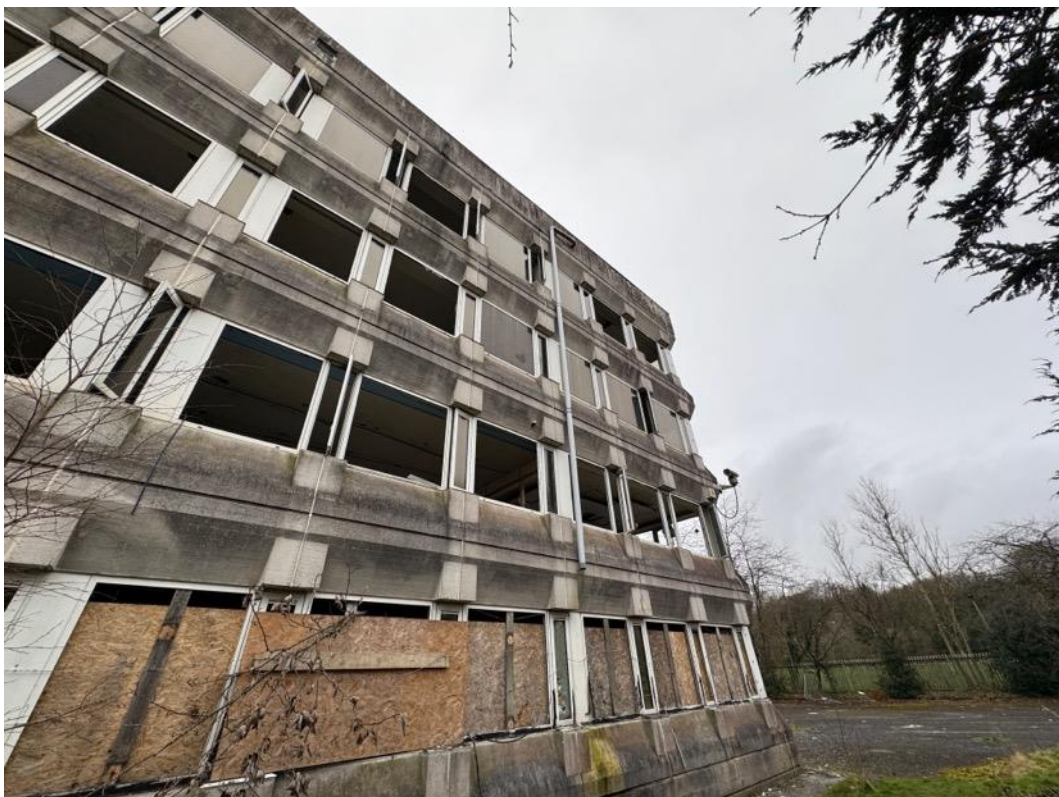
*Image 15 – Closer view of northeast corner, access restricted by extensive vegetation.*

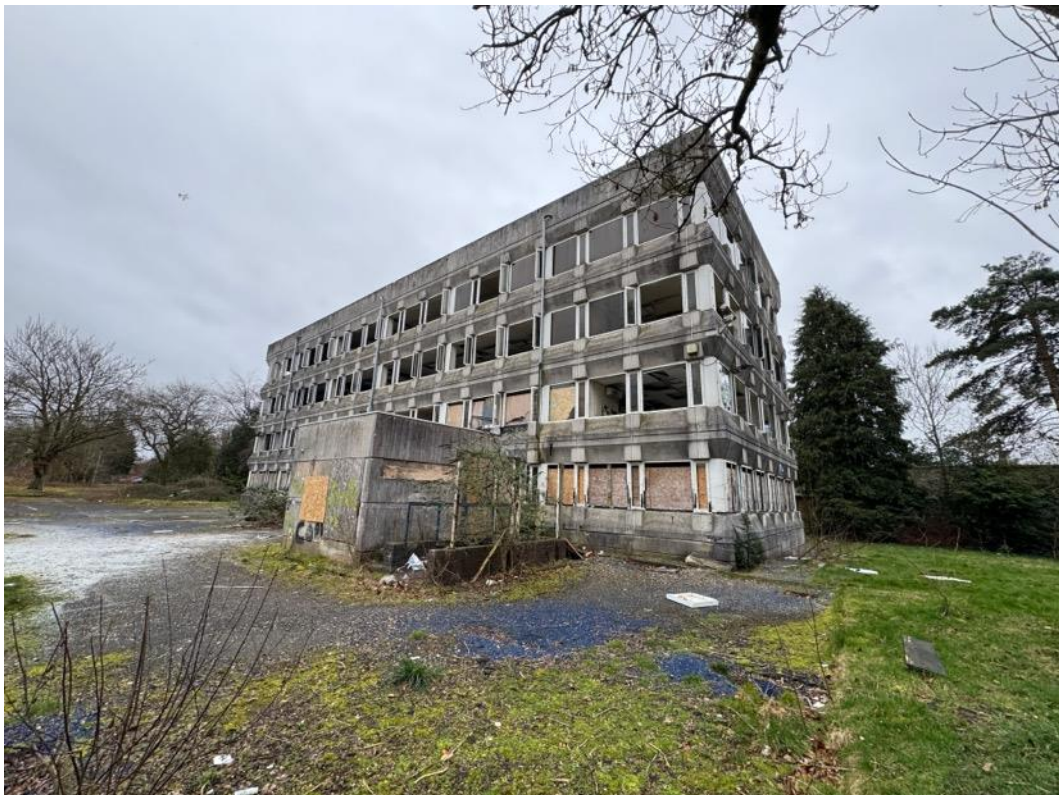
*Image 19 – View of northwest corner. Ground floor extension believed to be a plant room or substation.*

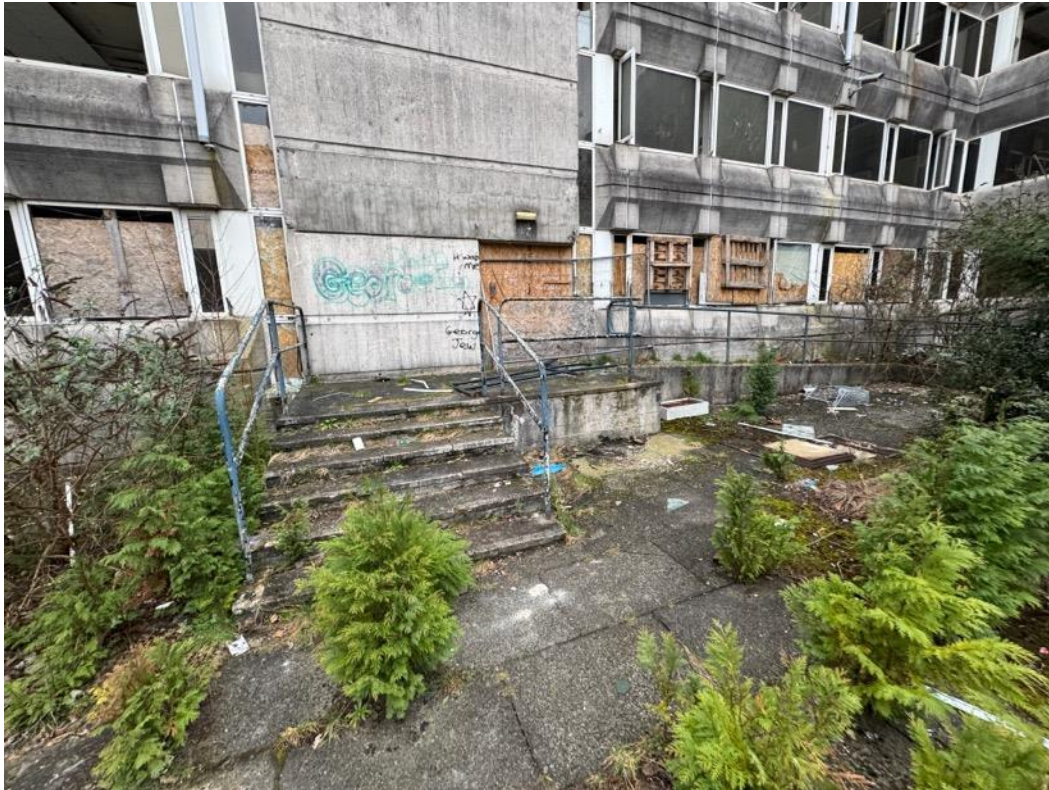
*Image 26 – Closer view of access stairs and ramp to south elevation, doors have been boarded but once provided access to stairwell. Original concrete block canopy removed and not replaced.*

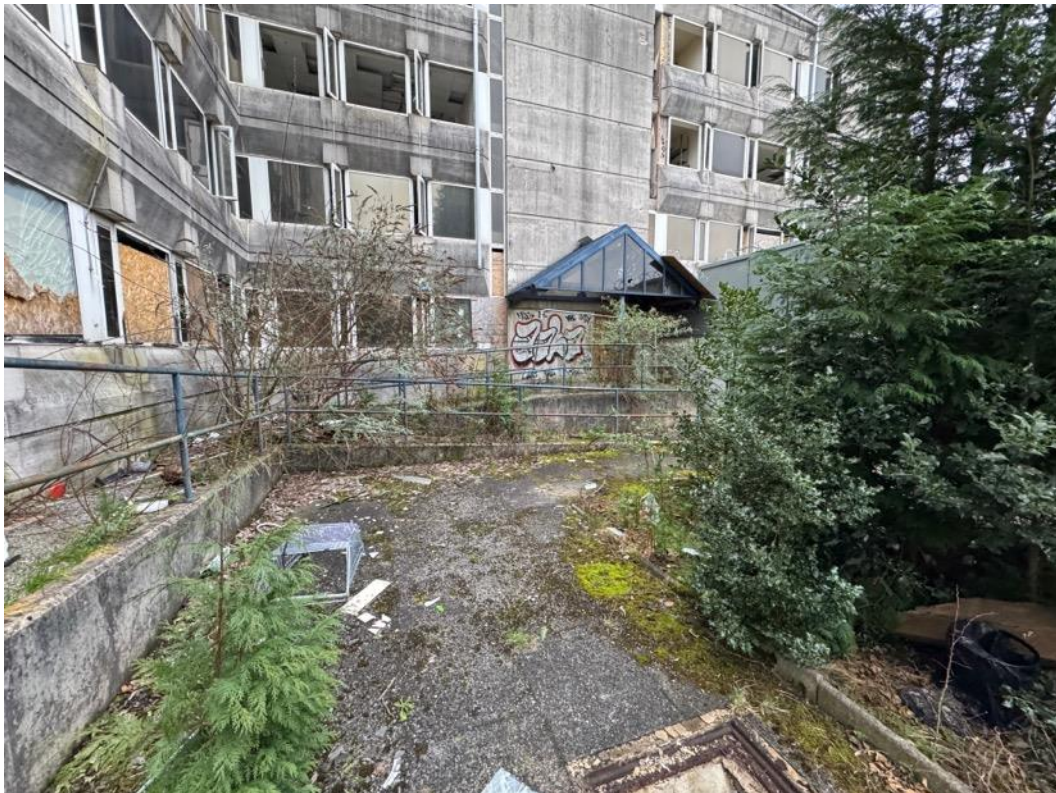
*Image 27 – View of access/egress point to west elevation. Original concrete block canopy replaced by metal and glass canopy.*

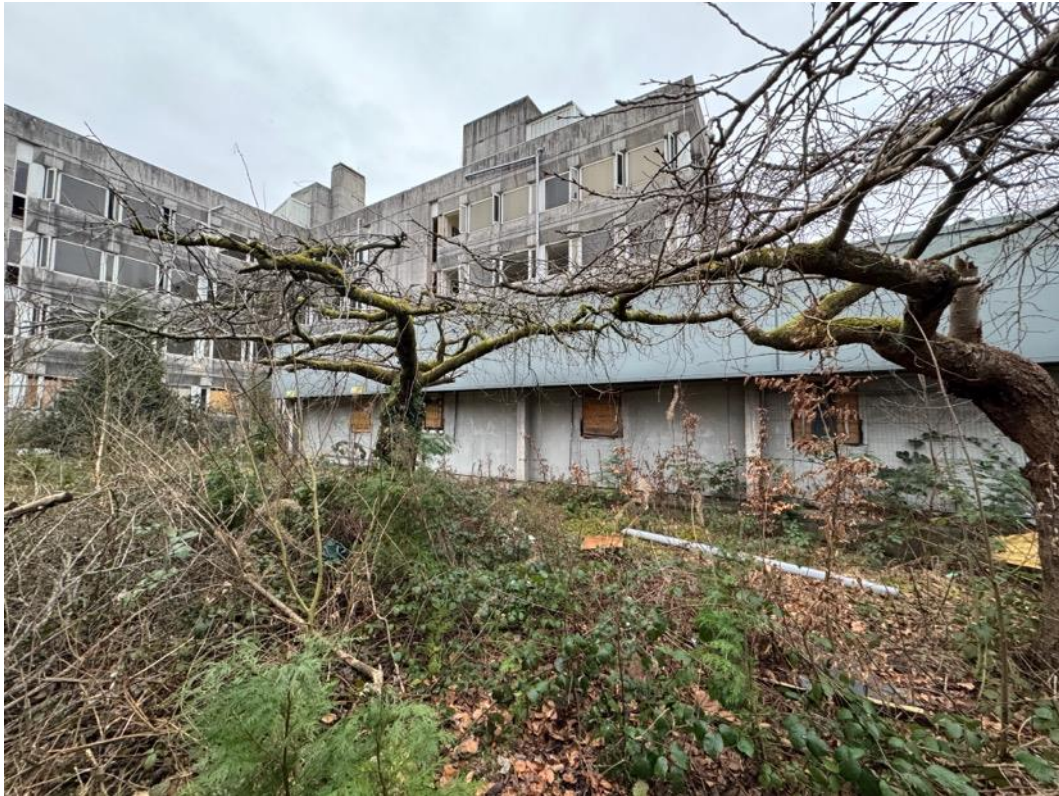
*Image 30 – View of west elevation of ground floor extension. Courtyard garden area now heavily overgrown. Original glazing to length of extension has been removed and overclad.*

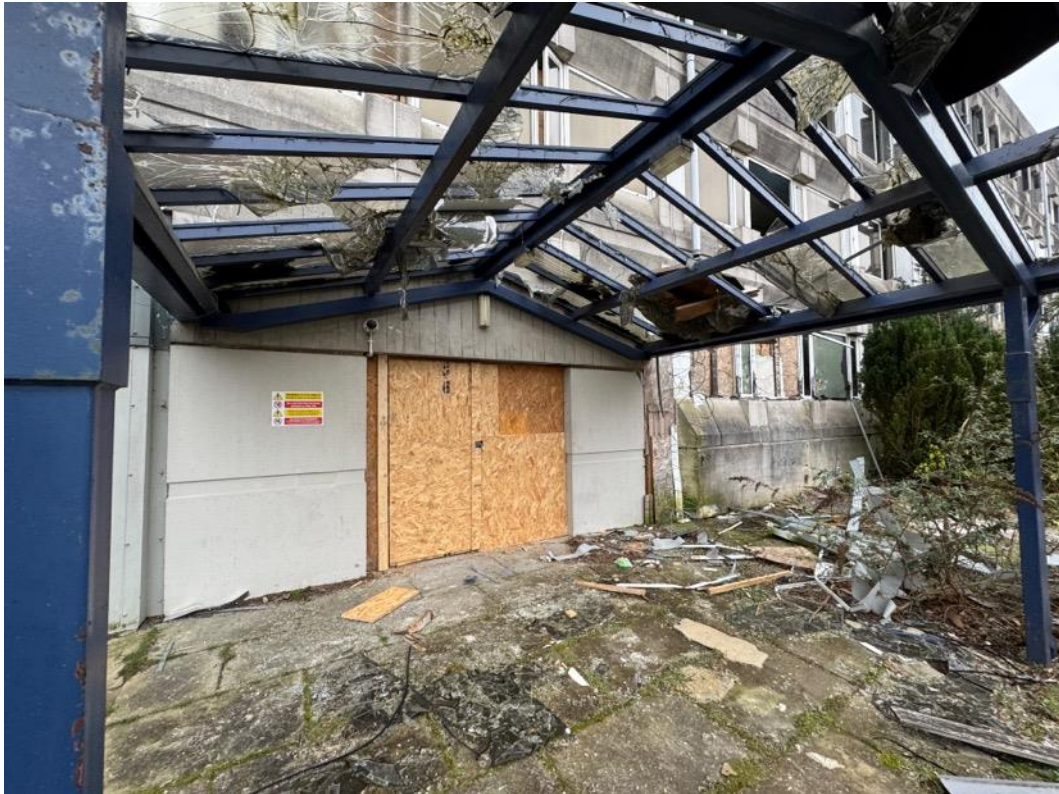
*Image 40 – View of main entrance area, with doors boarded to prevent entry.*

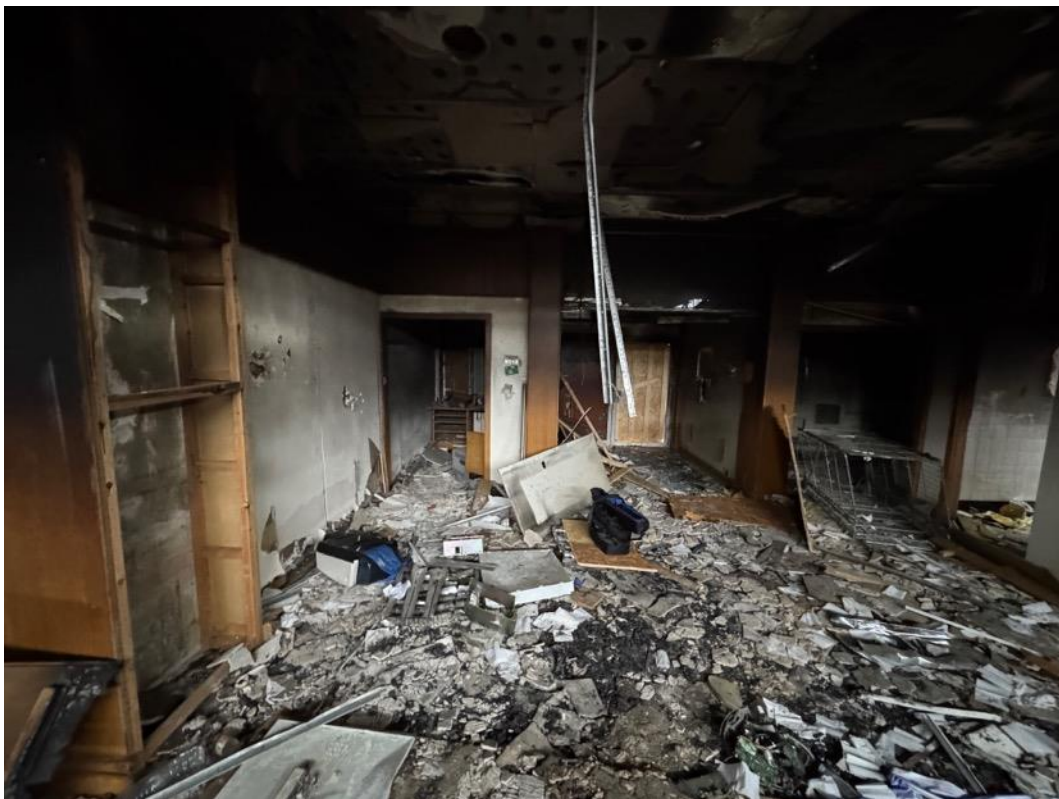
*Image 41 – Internal view of main entrance lobby, small office space to left through archway. Extensive damage from arson and vandalism.*

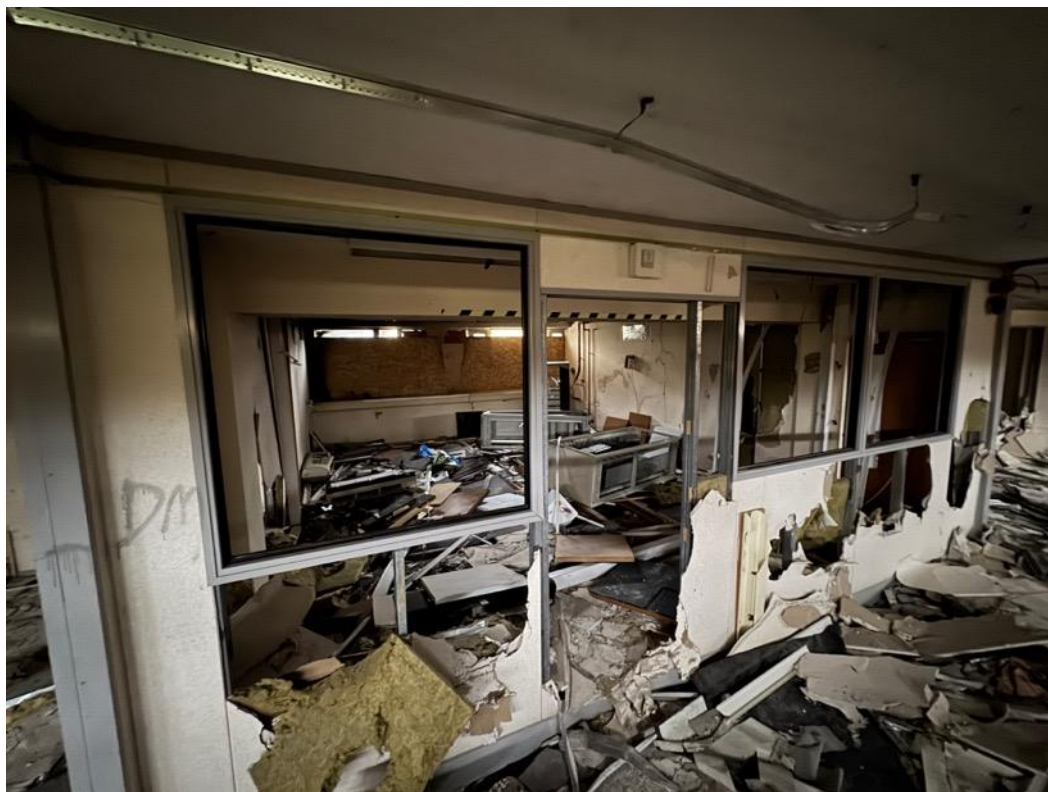
*Image 55 – Office space to ground floor. Internal glazing missing and walls destroyed.*

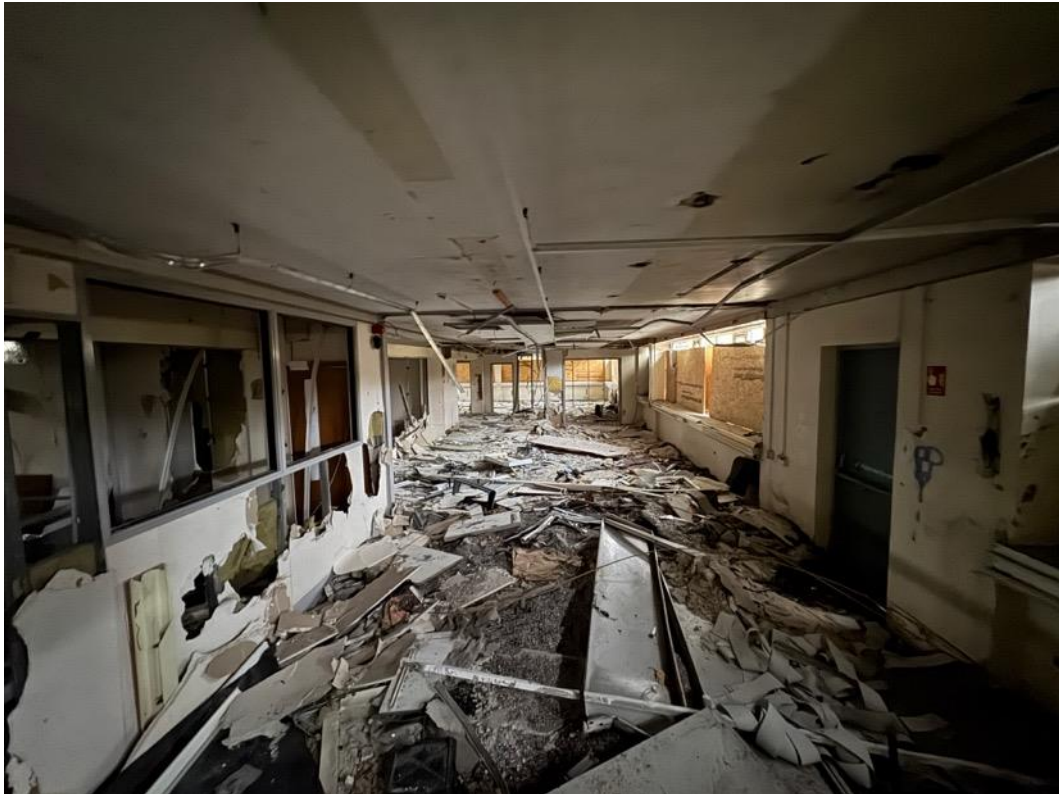
*Image 58 – View to length of northern side of the ground floor, heavy piles of debris made access difficult.*

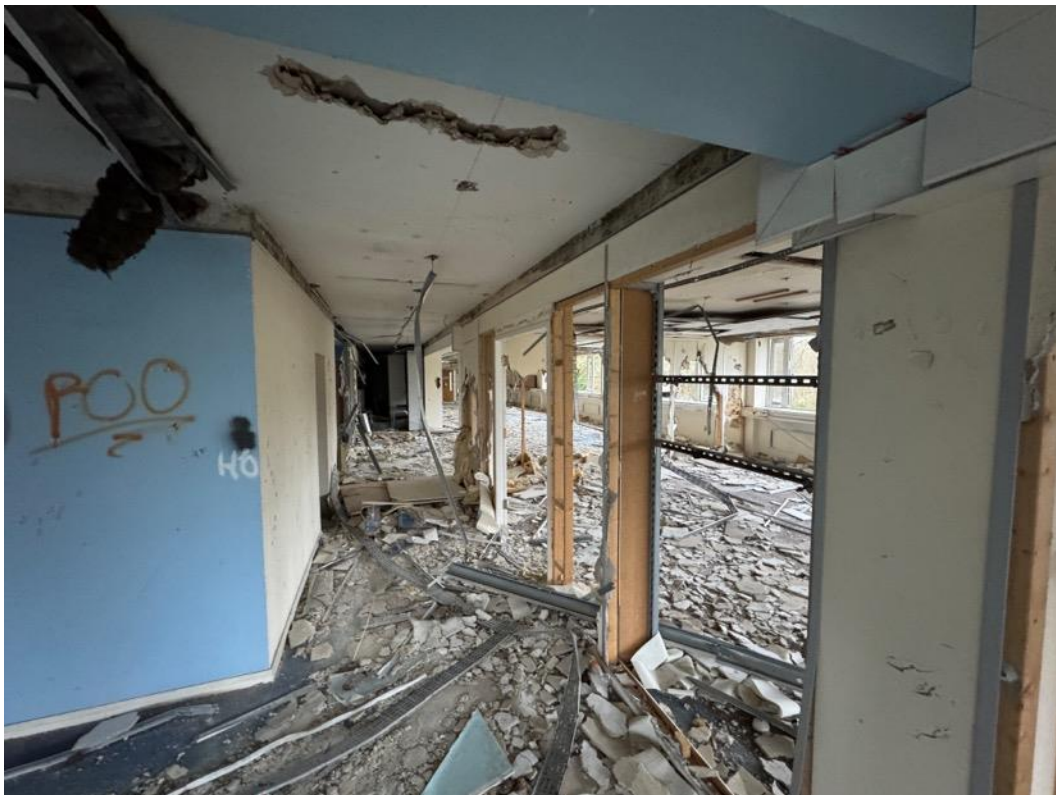
*Image 71 – View to central corridor space, first floor. All partitions heavily damaged.*

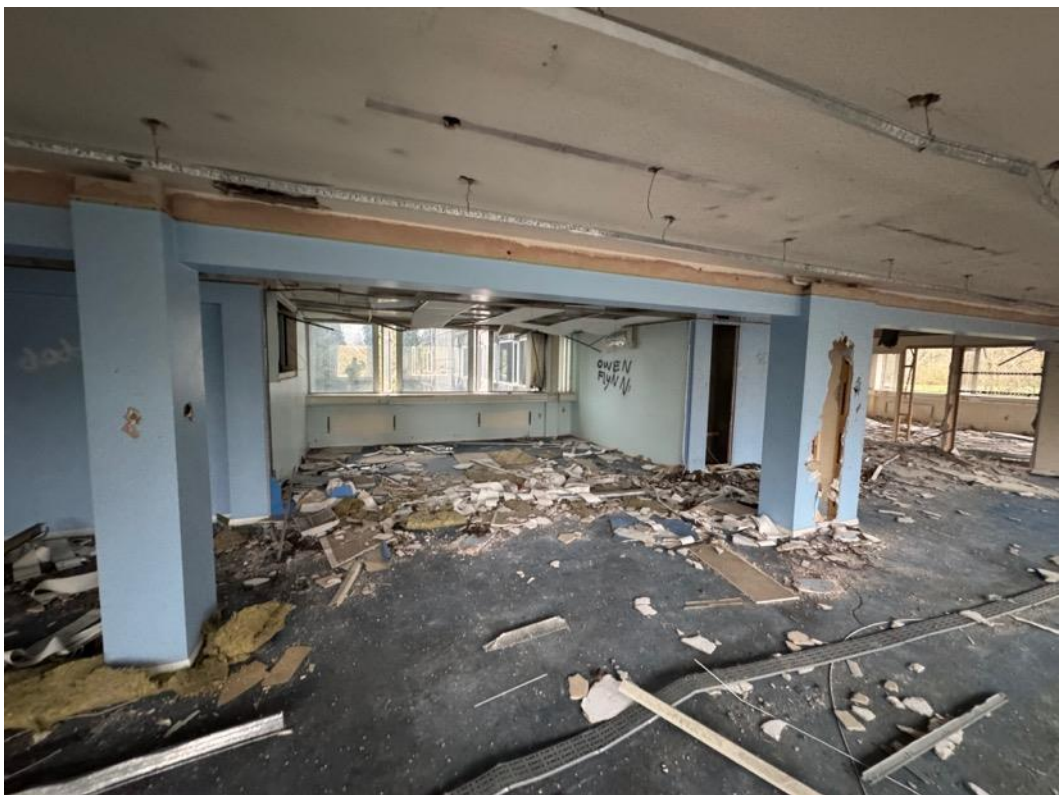
*Image 73 – Former separate room to western edge first floor, partition wall now lost.*

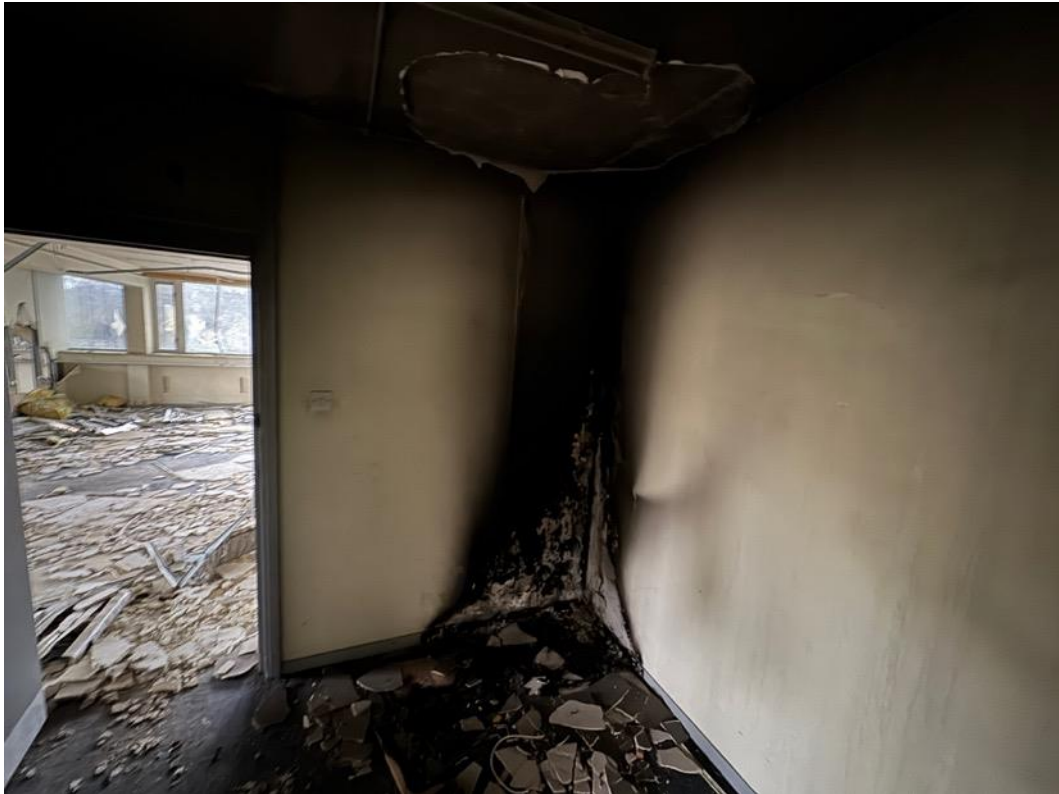
*Image 88 – Fire damaged to central storeroom, looking toward the north.*
