## SUBFLOOR VOID VALIDATION – HAWKS VIEW, CASTLETON

| <b>Project Number:</b> | 14-768 |
| <b>Client:</b> | Kellen Homes |
| <b>Plots:</b> | Subfloor Void – Plots 171-174 |

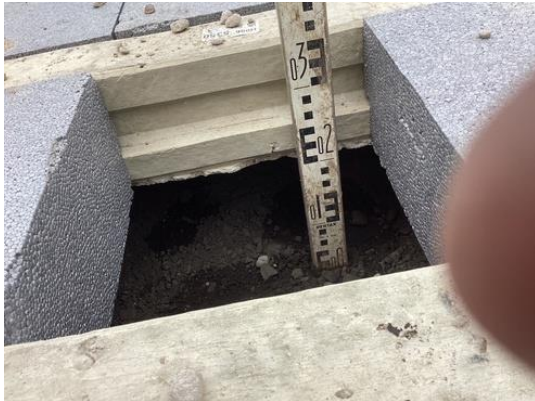
Photo 1

| Plot Number | 172 |
| Is the void clear? | Yes |
| Depth of Void | 200 |

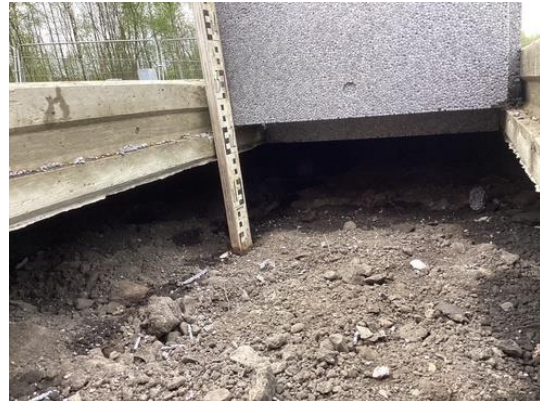
Photo 2

| Plot Number | 173 |
| Is the void clear? | Yes |
| Depth of Void | 180 |

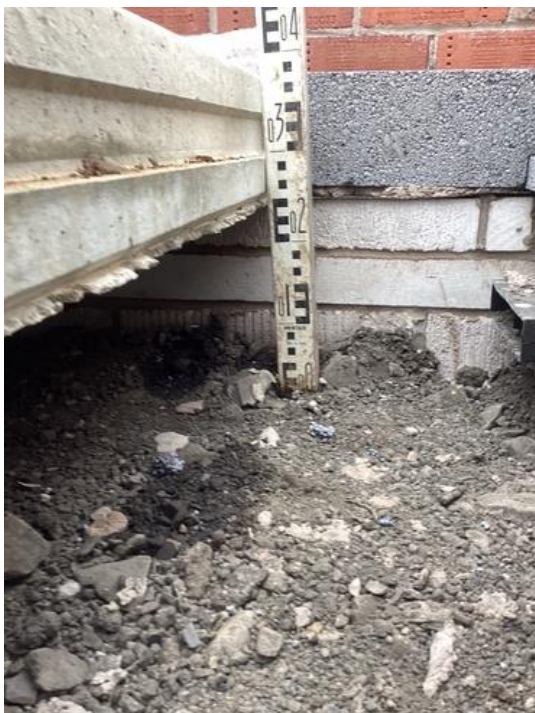
Photo 3

171

Yes

190

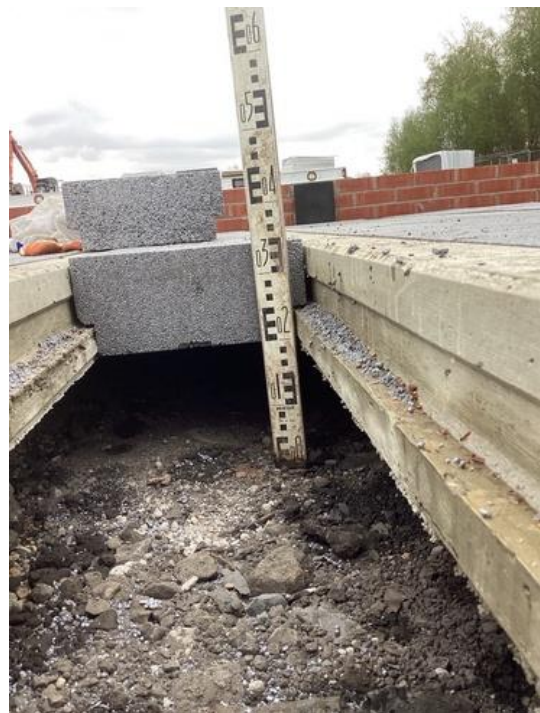
Photo 4

174

Yes

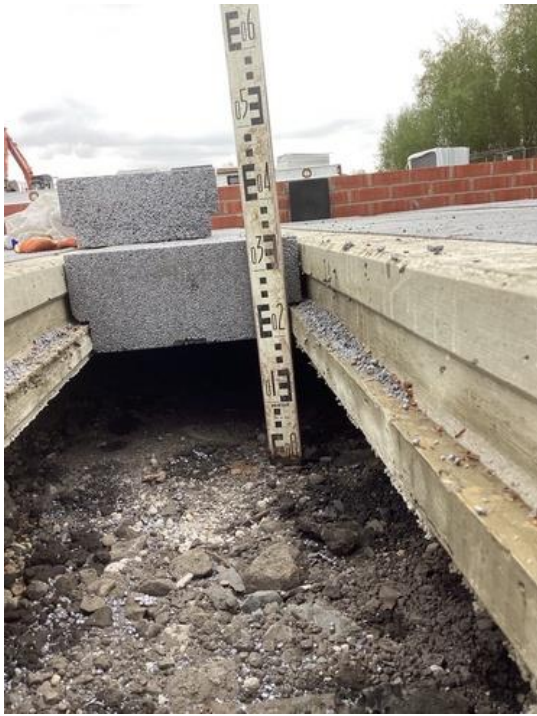
Photo 5

190
