Date: 17 March 2025  
Reference: 14-768-V1

## GAS MEMBRANE VALIDATION – HAWKS VIEW, CASTLETON

| <b>Project Name:</b> | Hawks View, Castleton (formerly known as Castleton Sidings) |
| <b>Ground Gas Protection Design Report:</b> | E3P Gas Protection Design Report (14-768-R8, March 2025) |

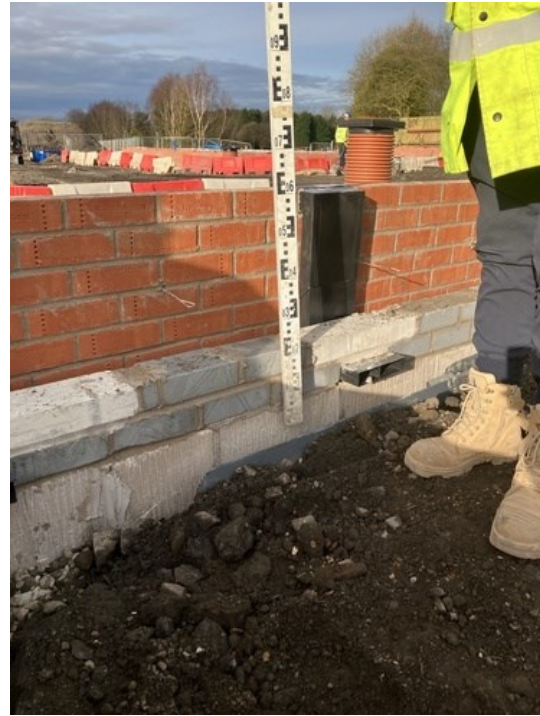
Photo 1

Is the void clear? Yes

Depth of Void 150

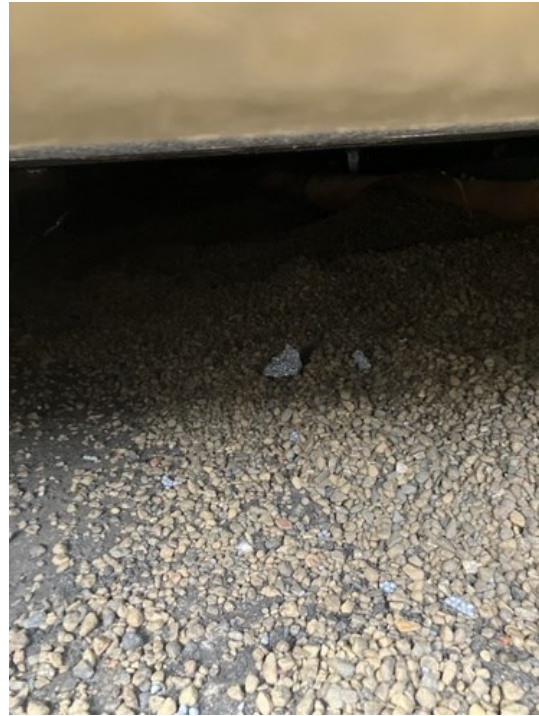
Photo 41

The sub-floor void was observed and inspected to be a minimum of 150 mm with no visible inclusions that would limit the performance of this ventilation mechanism. Sleeper wall ventilation bricks were also observed to be present. Where these were found to be absent (plots 19 and 127/128), Westbourne Civils were notified and instructed to rectify prior to a follow up inspection.

No

A return visit was made on 17th March to reinspect and confirmed the sleeper wall ventilation for plots 19 and 127/128 to have been installed.

Sleeper Vents to be installed-revisit 17/3/25

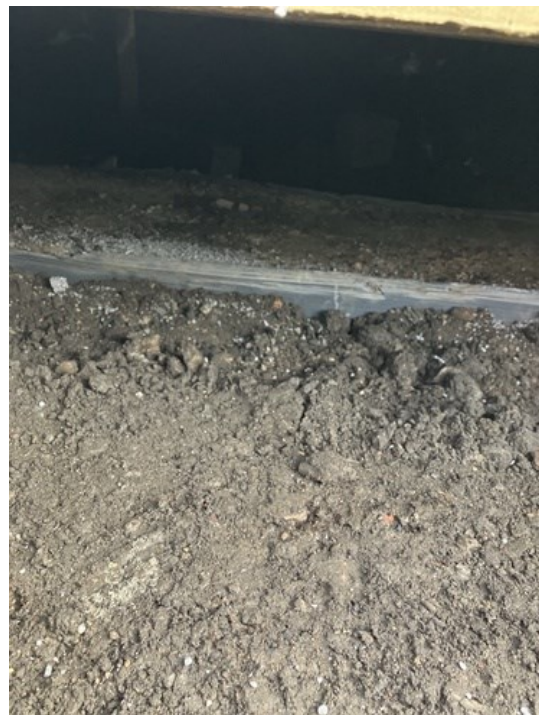
Photo 63

No

Vents to be added-revisit 17/3/25

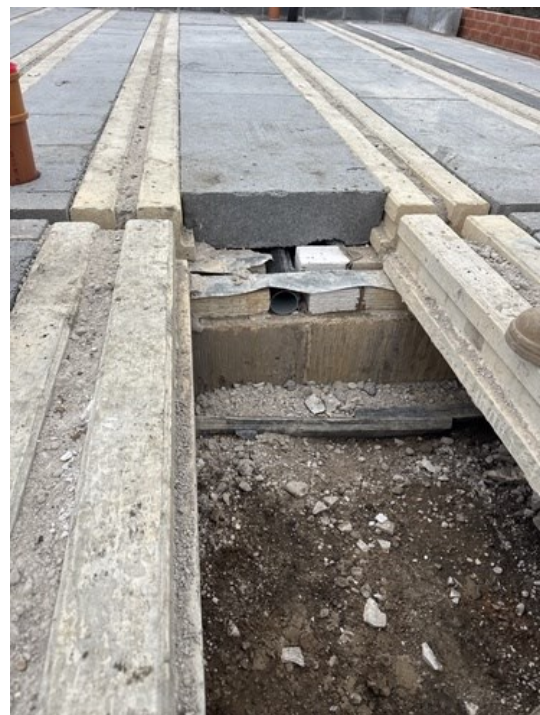
Photo 1

| Plot Number | 21 |
| Is the void clear? | Yes |
| Depth of Void | 300 |

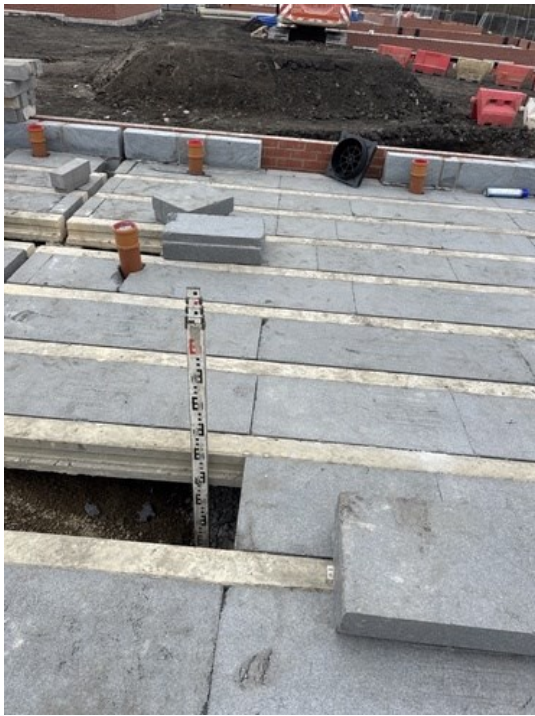
Photo 2

| Are Sleeper Walls Vented? | Yes |
