Date: 15th April 2025  
Reference: 14-768-V7

## GAS MEMBRANE VALIDATION – HAWKS VIEW, CASTLETON

| <b>Project Name:</b> | Hawks View, Castleton (formerly known as Castleton Sidings) |
| <b>Project Number:</b> | 14-768 |

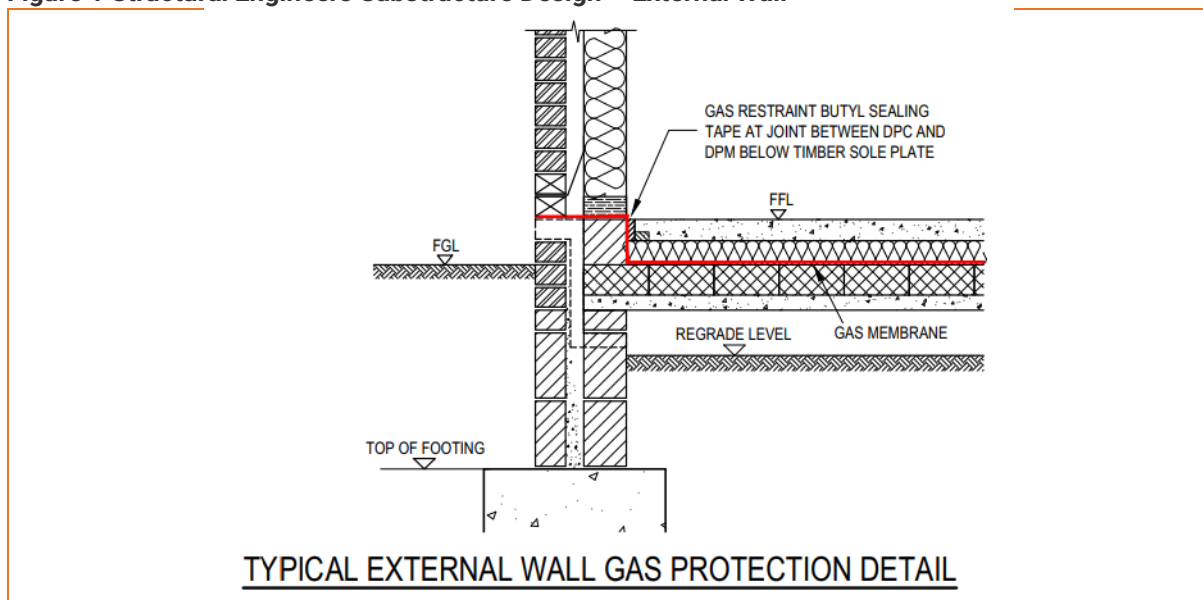
**Figure 1 Structural Engineers Substructure Design – External Wall**

The E3P Technician has inspected the installation of this membrane in line with the structural engineer's specifications in terms of placement and position (Figure 1-3), and the manufacturer's detail in terms of the workmanship.
