## GAS MEMBRANE VALIDATION – HAWKS VIEW, CASTLETON

| <b>Project Name:</b> | Hawks View, Castleton (formerly known as Castleton Sidings) |
| <b>Project Number:</b> | 14-768 |
| <b>Plots:</b> | Membrane – Plots 119, 120, 172, 173 |

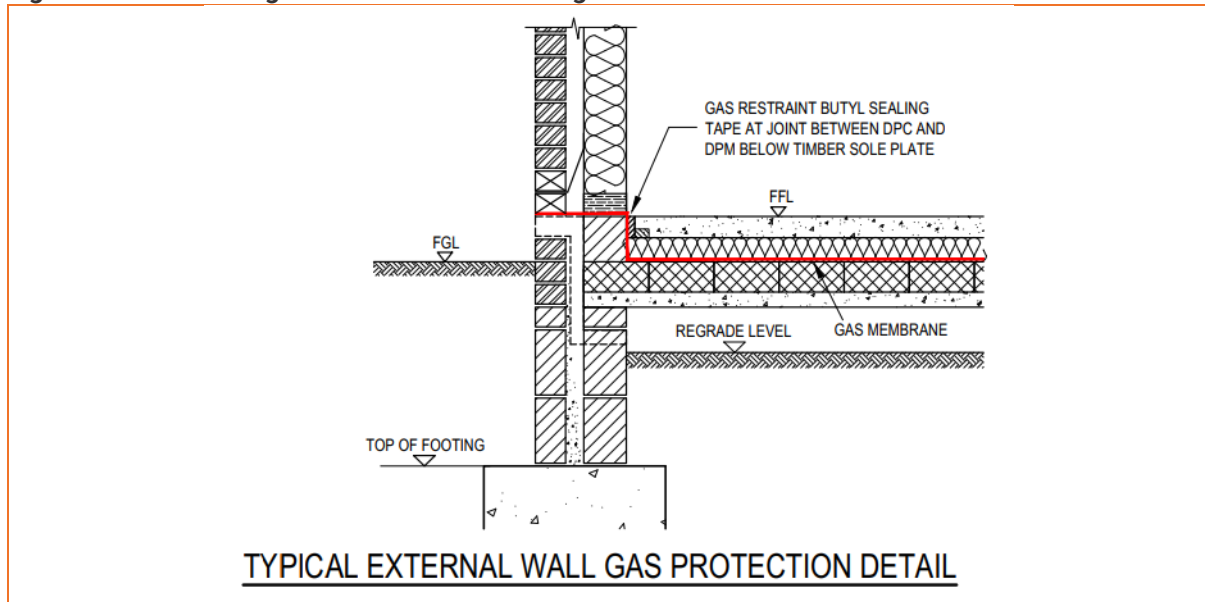
Figure 1 Structural Engineers Substructure Design – External Wall

The E3P Technician has inspected the installation of this membrane in line with the structural engineer's specifications in terms of placement and position (Figure 1-3), and the manufacturer's detail in terms of the workmanship.

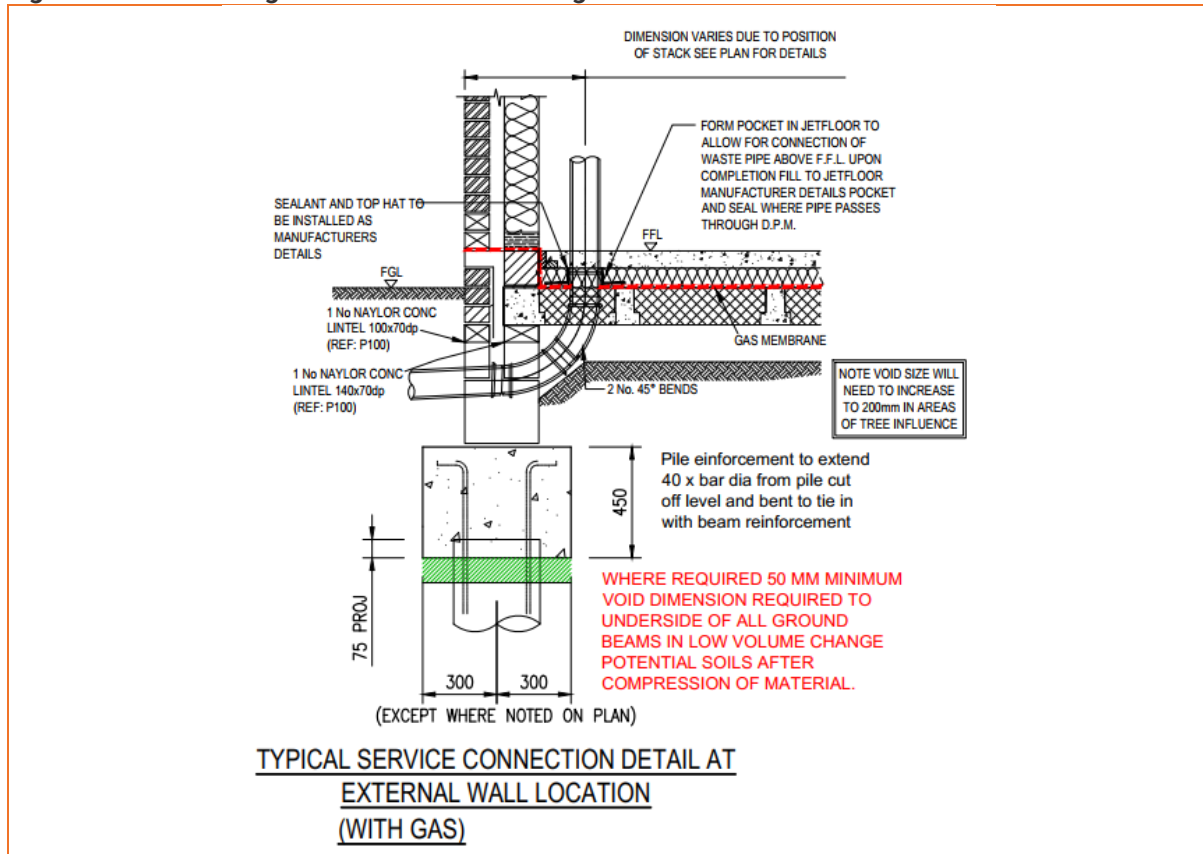
Figure 3 Structural Engineers Substructure Design – Service Penetration

Where any penetration or service duct is present within the floor area E3P inspected each one in turn and can confirm that rigid black polyethylene top hat units have been adequately sealed against the membrane with double-sided jointing tape at both the base and the protruding pipe.

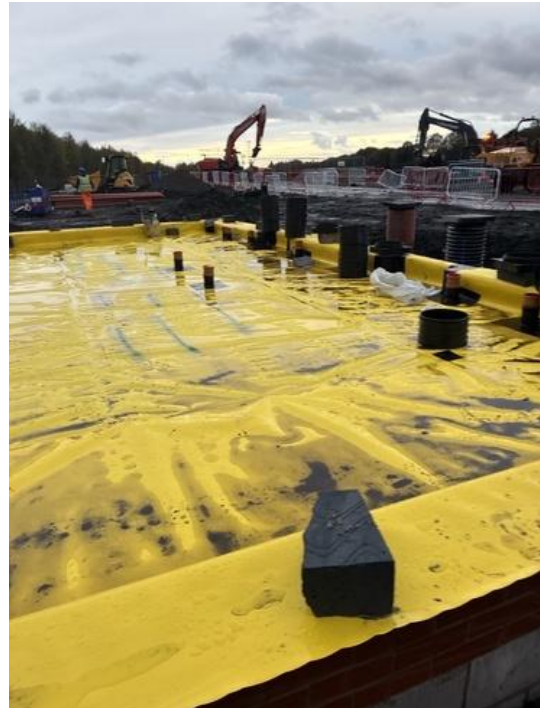
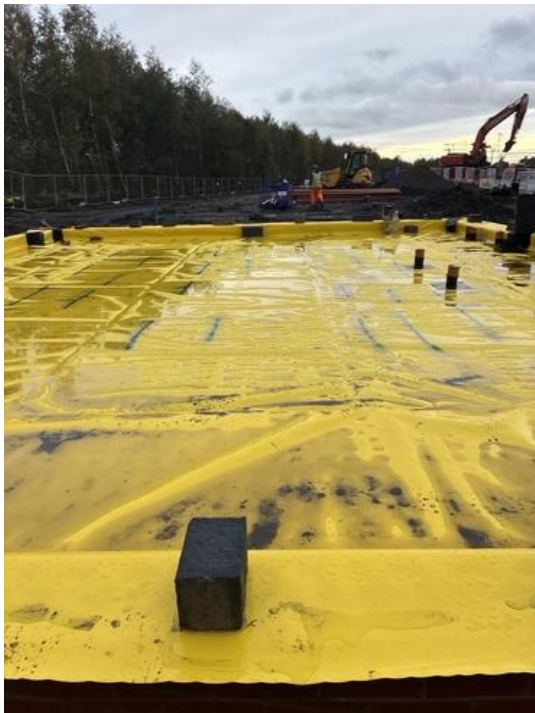
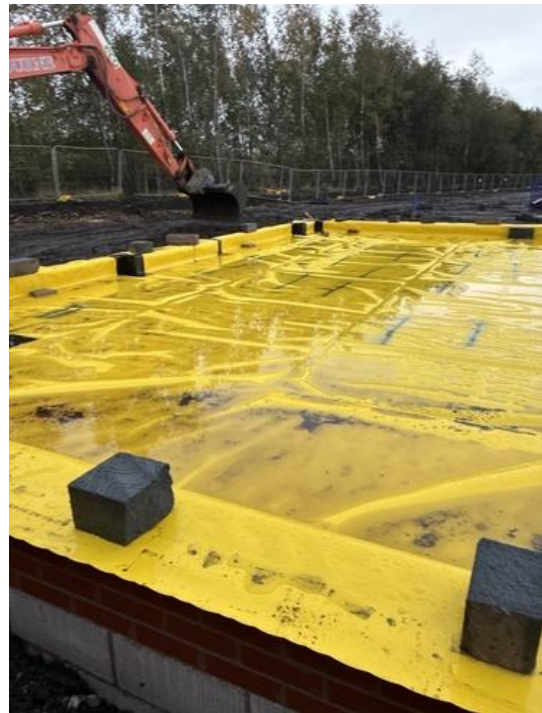
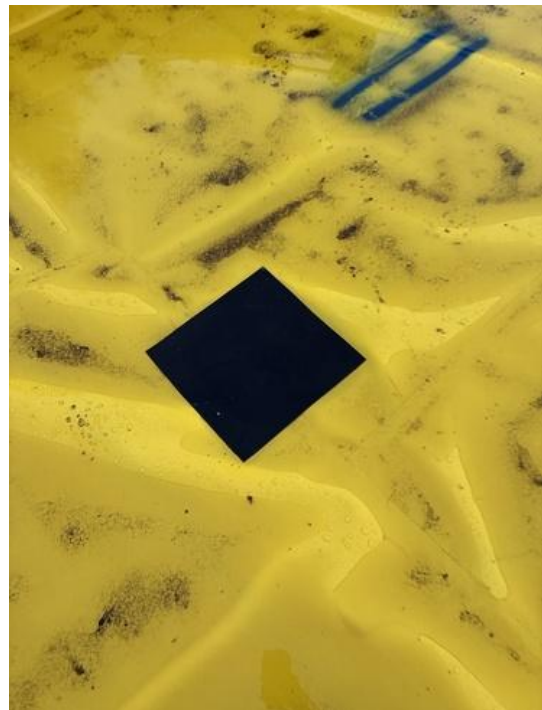
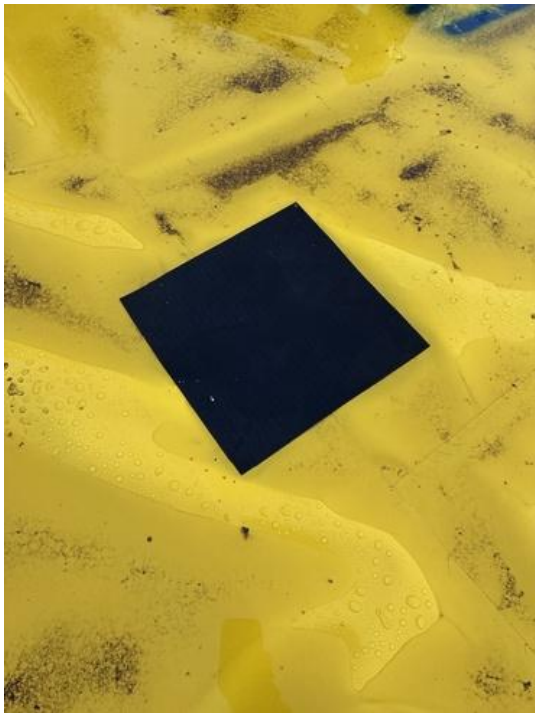
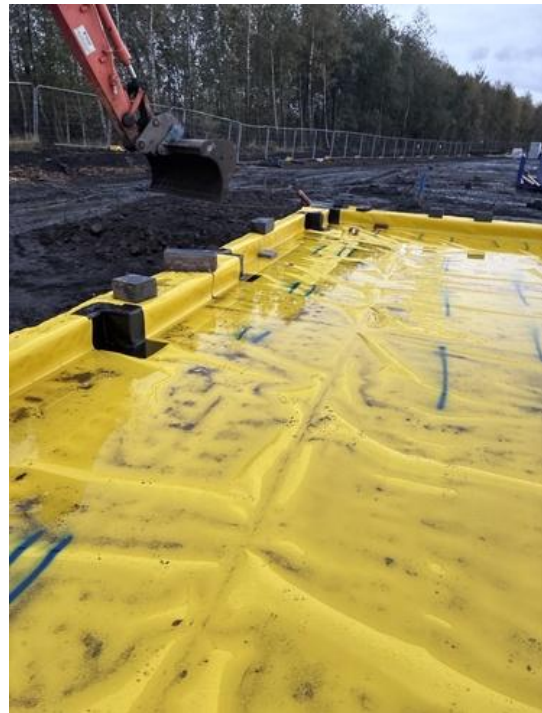
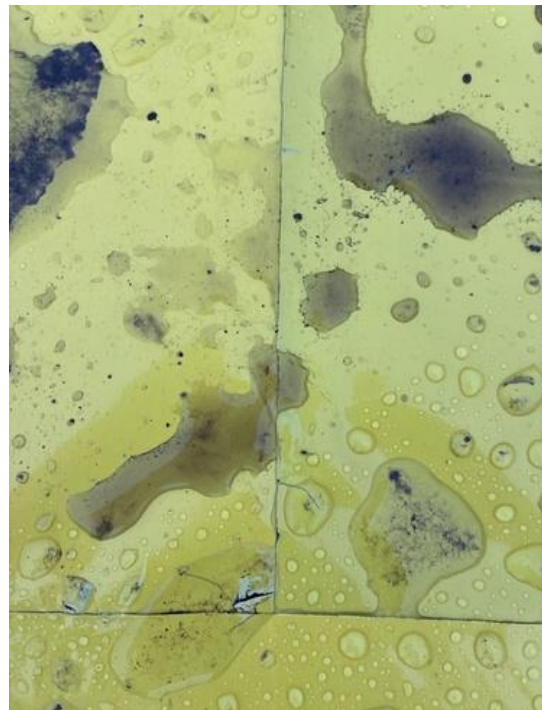
**Gas Membrane Condition: Open punctures, tears, rips, stretching, Presence of debris, Repairs, Signs of weakness such as raised or sunken indentations, Protection plan in place to restrict access to lain gas membrane? IF FAIL DESCRIPTION IN ACTIONS AND PHOTOS REQUIRED**

Pass

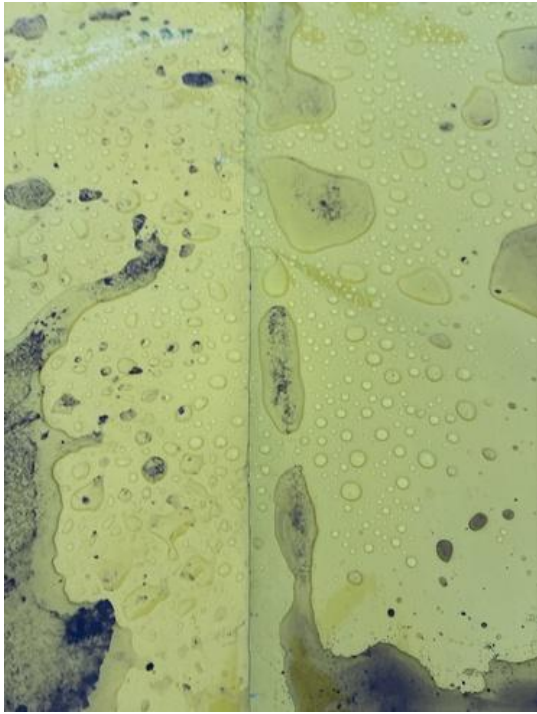
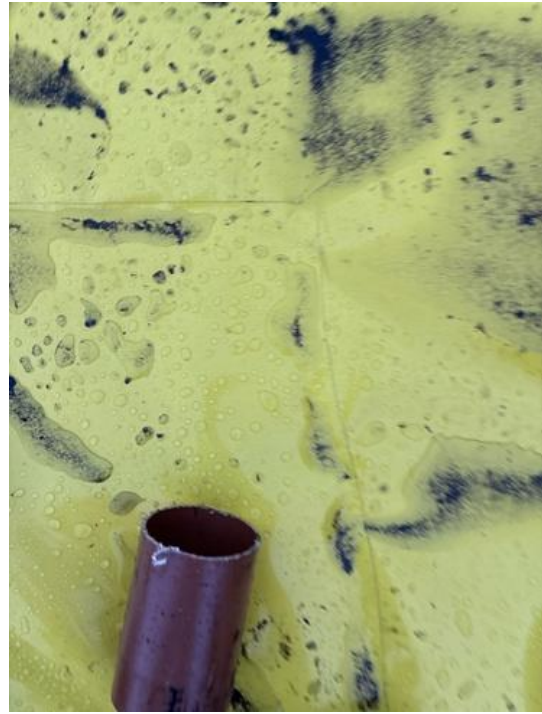
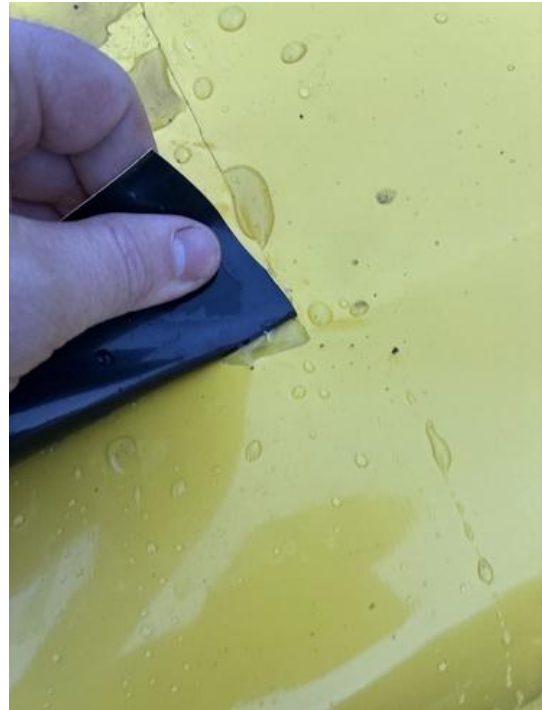
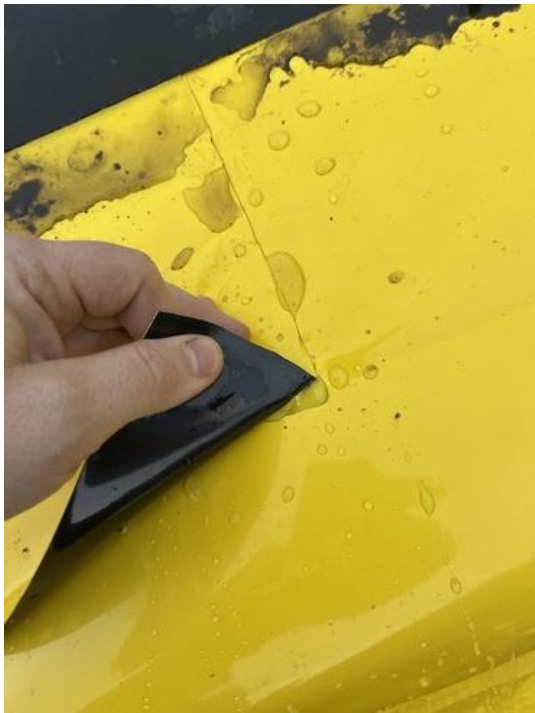
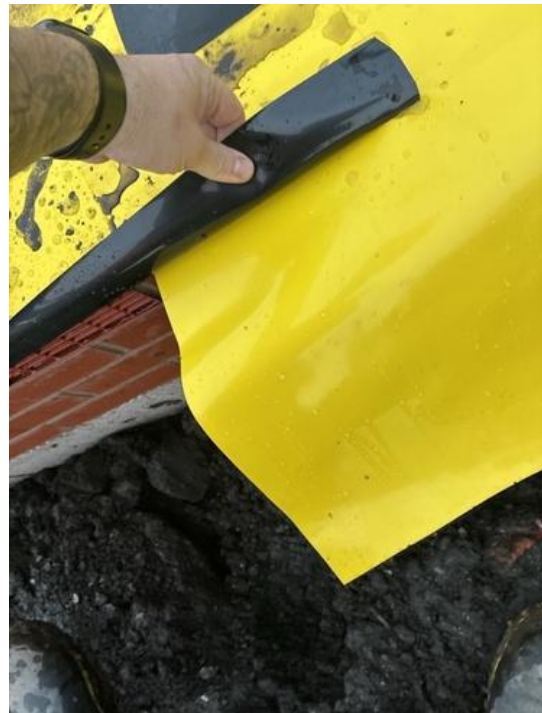
**Are welds complete?**

Yes

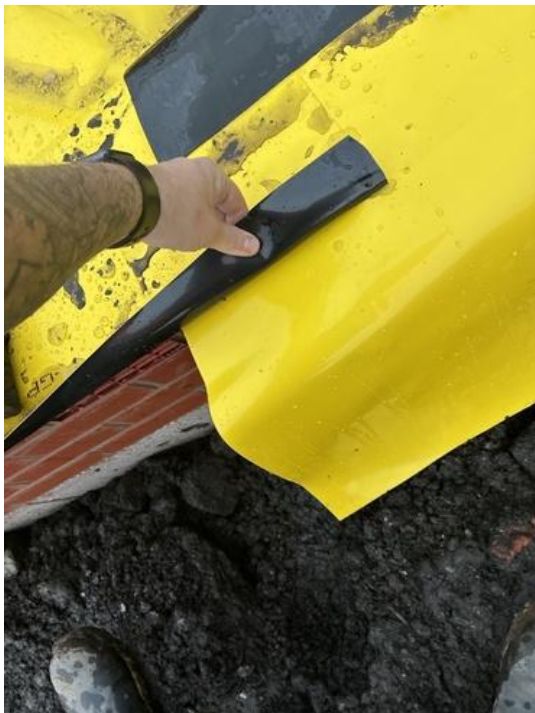
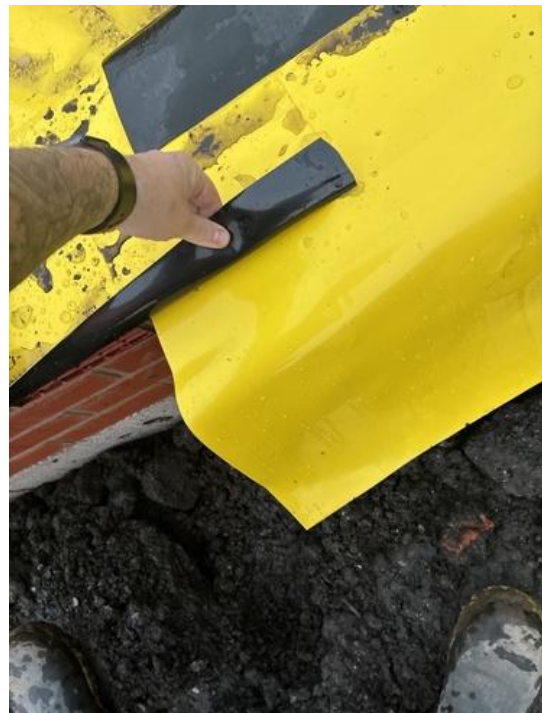
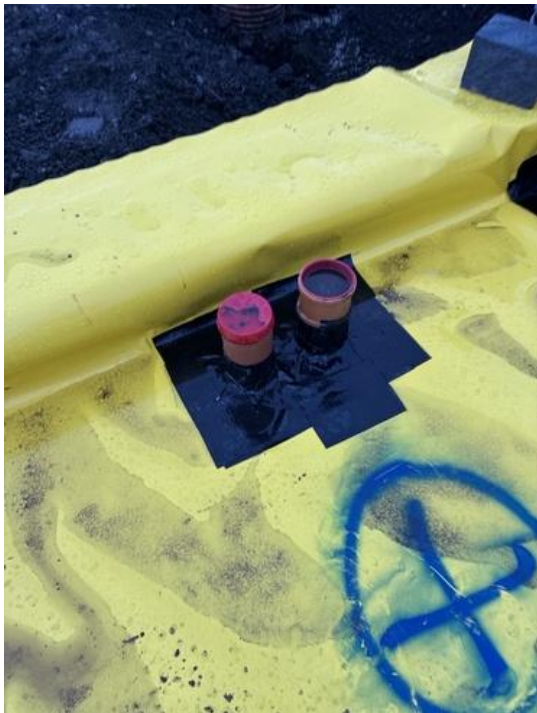
**Are Joints lapped and sealed in accordance with manufacturer's requirements/ specification?**

Yes

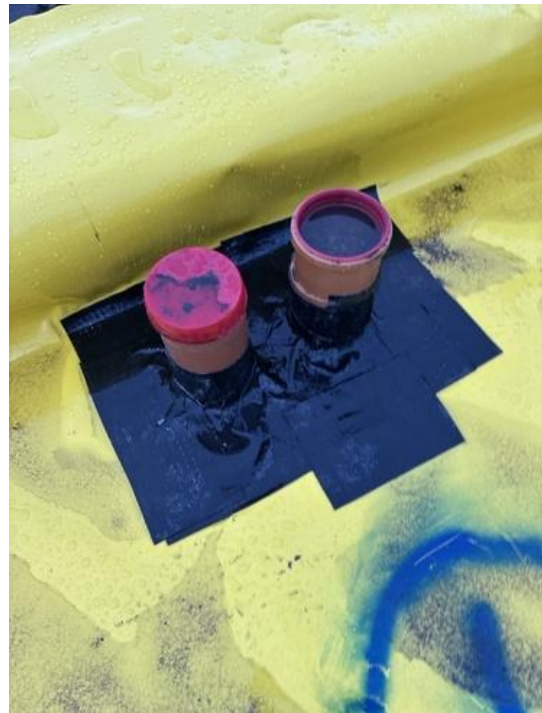
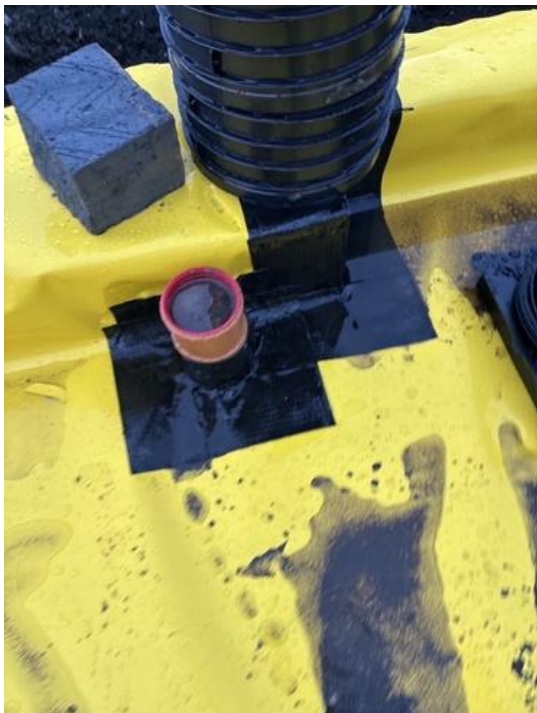
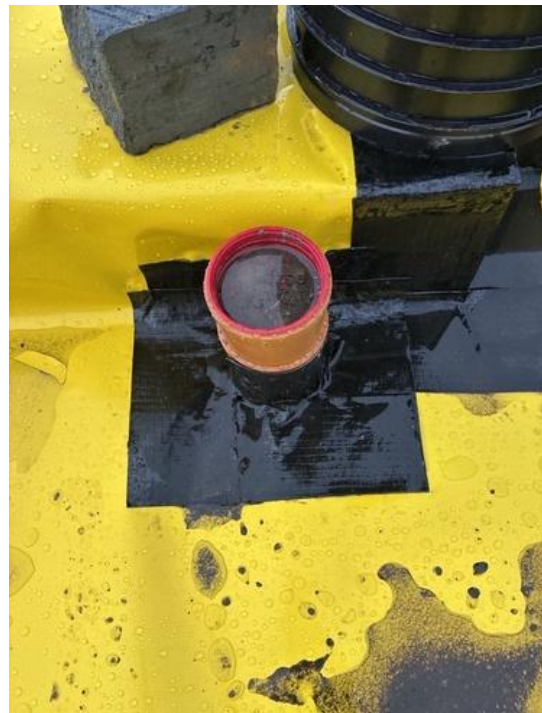
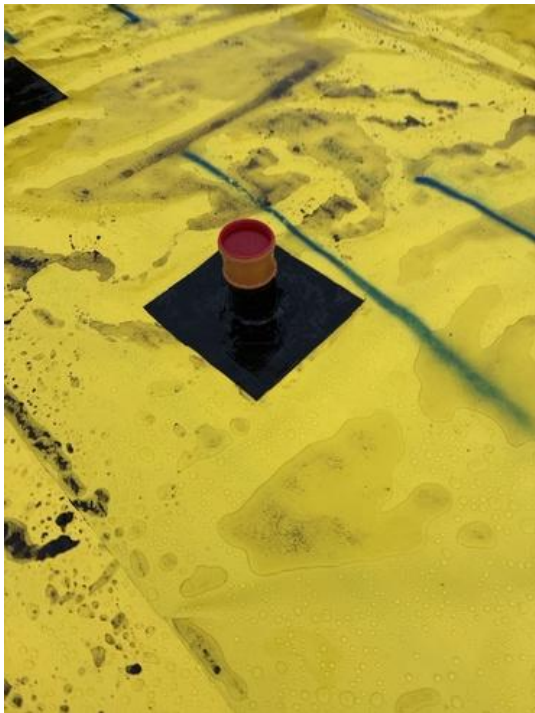
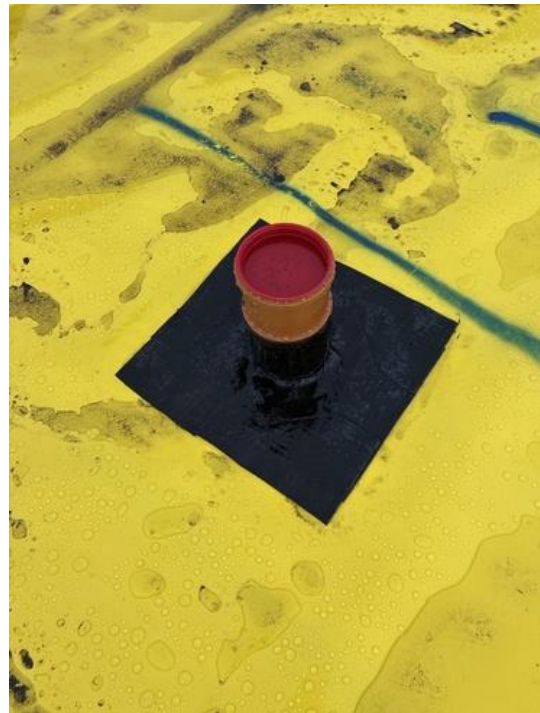
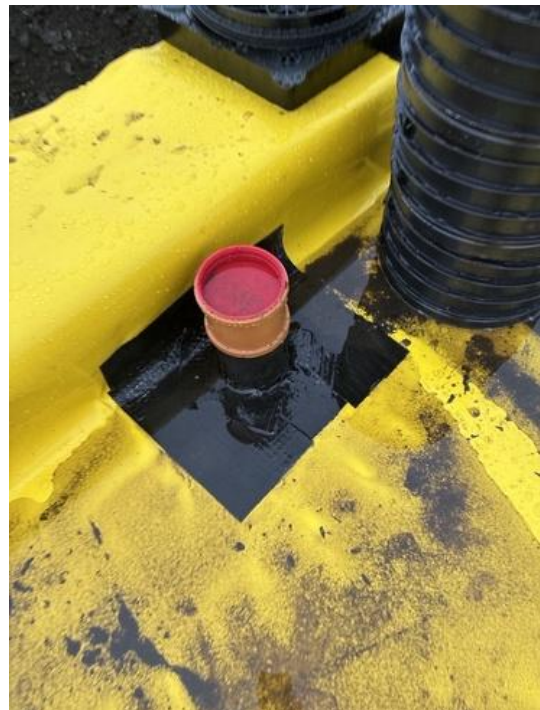
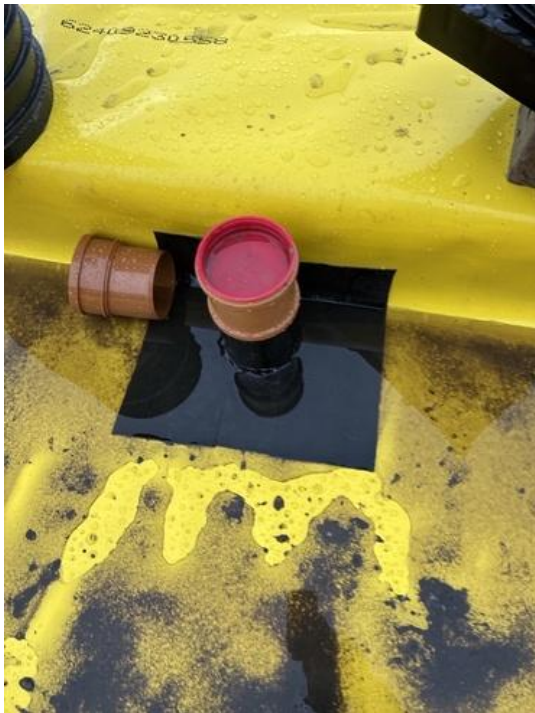
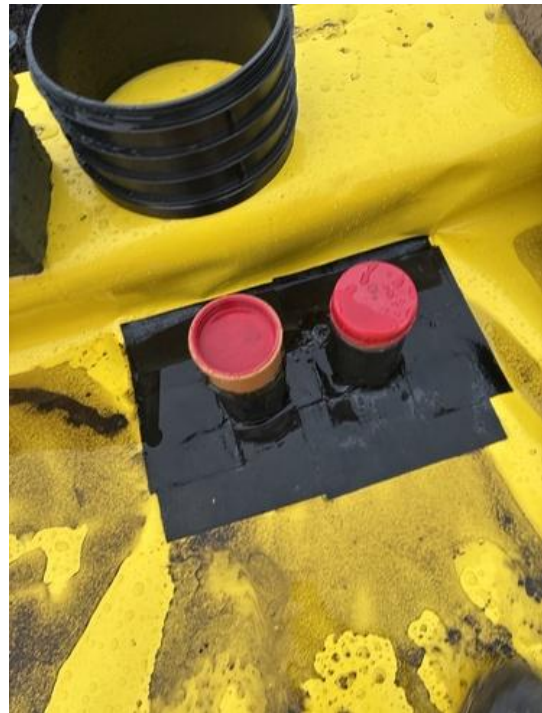
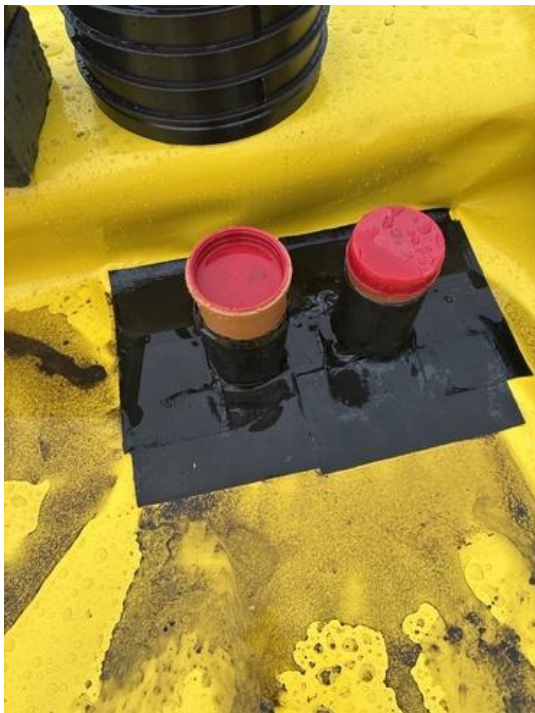
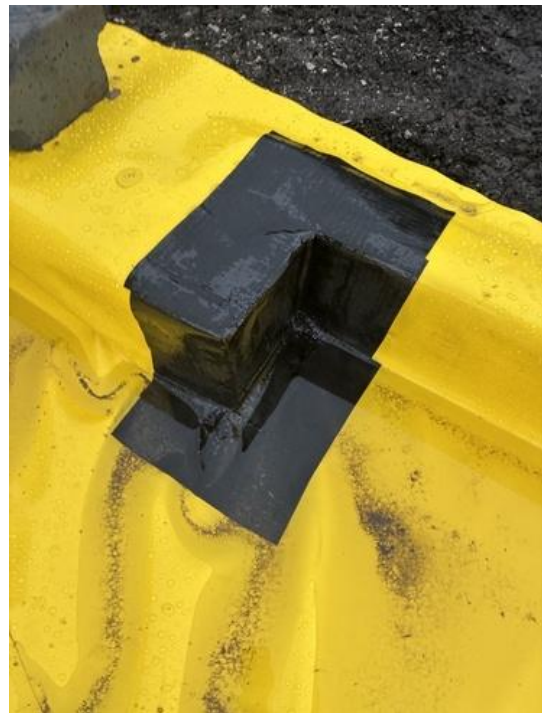
**Service entries seals: Top hats seal arrangements fixed around service entries? Use of Jubilee clips or Bitumastic Sealant**

Pass

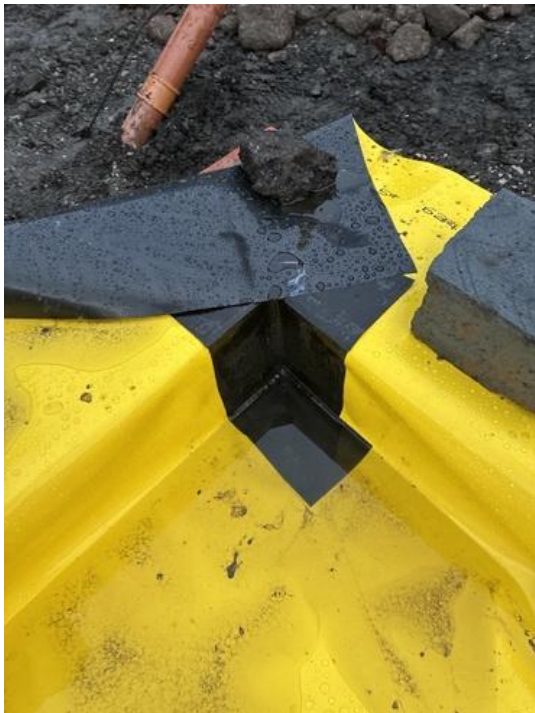
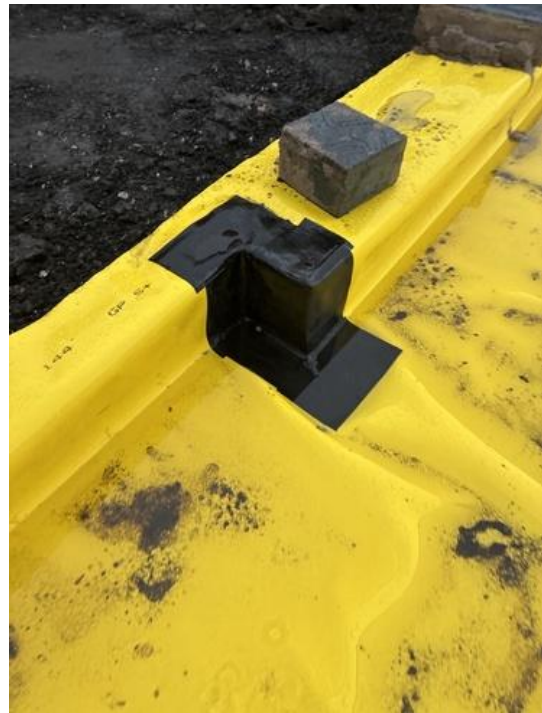
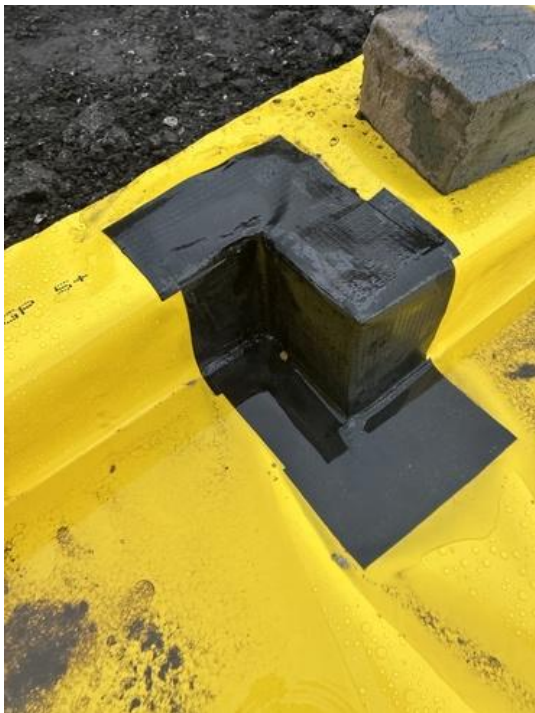
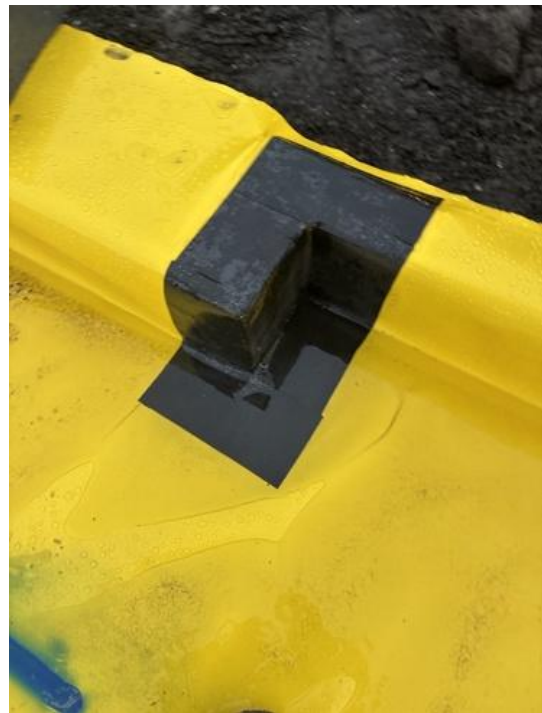
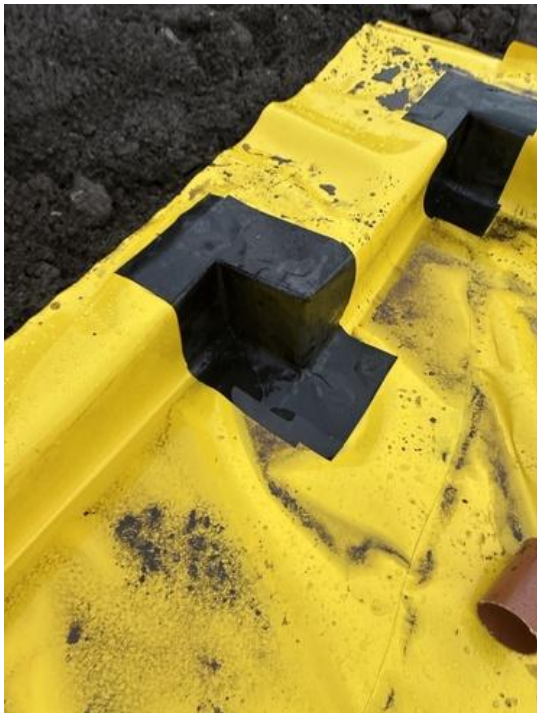
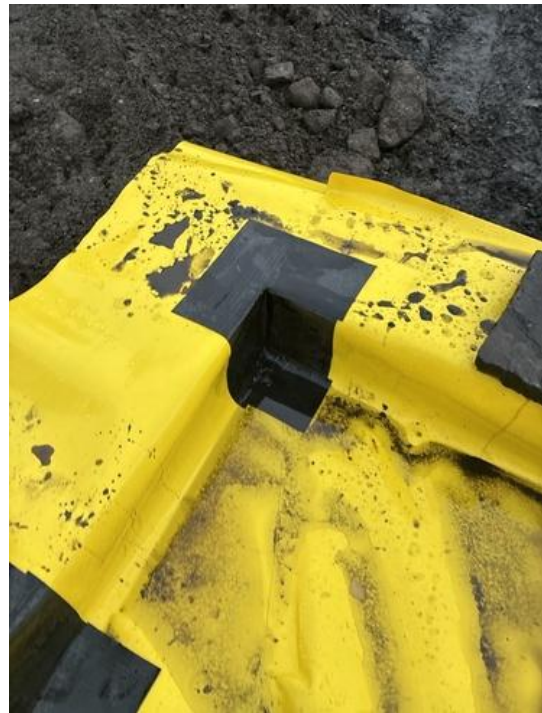
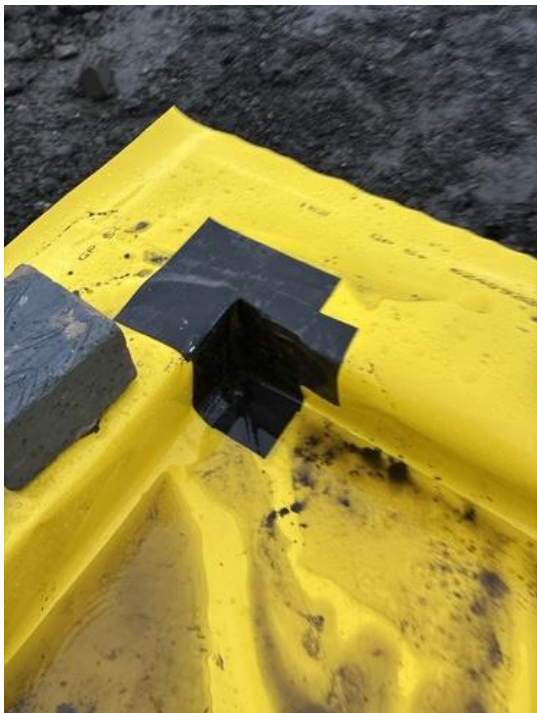
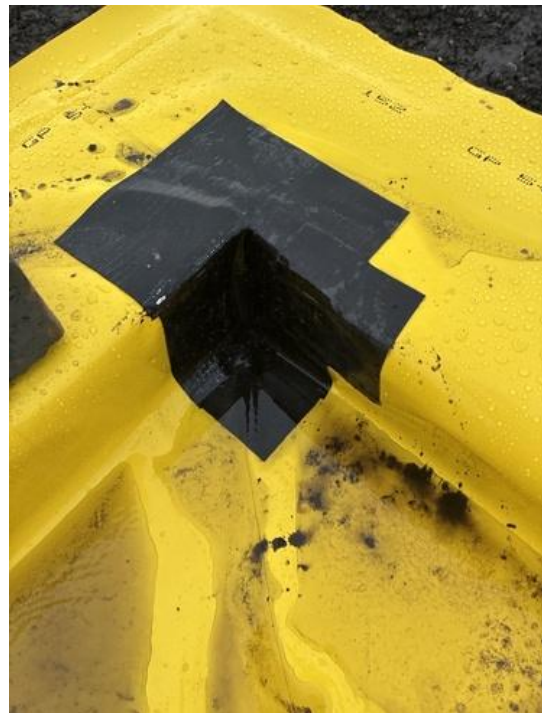
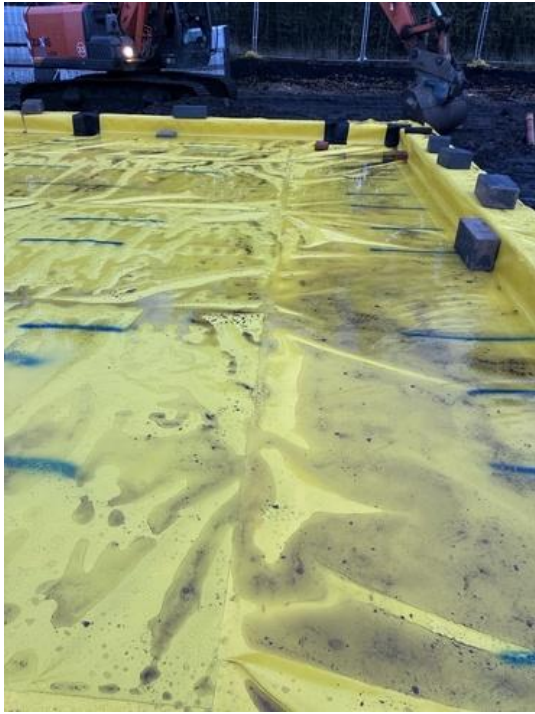
**Corners / Internal joints: Check all corners are correctly formed or contractor has used preformed corners.**

Pass

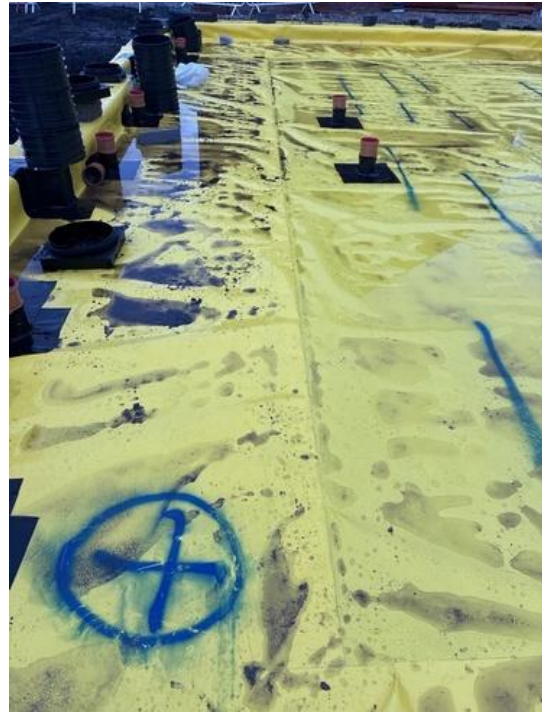
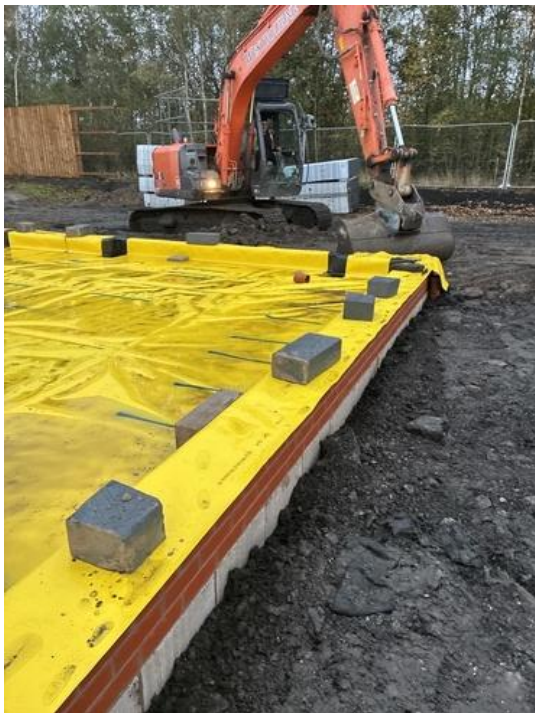
**Are folds running in line with joints? (no joints cutting across folds)**

Pass

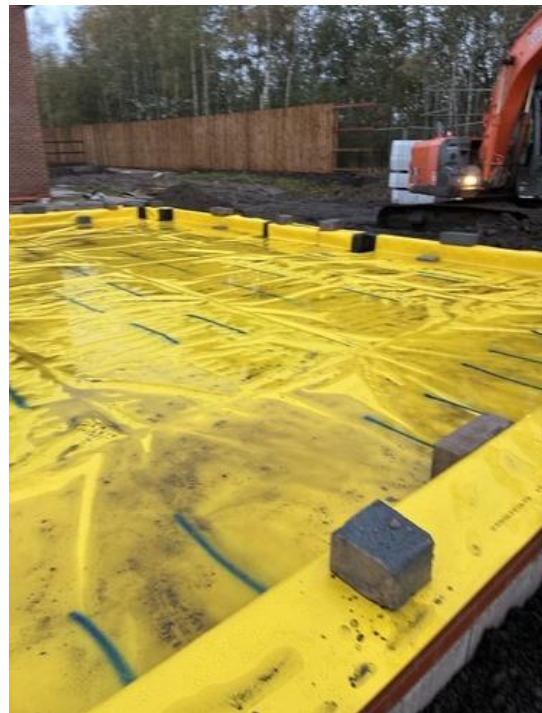
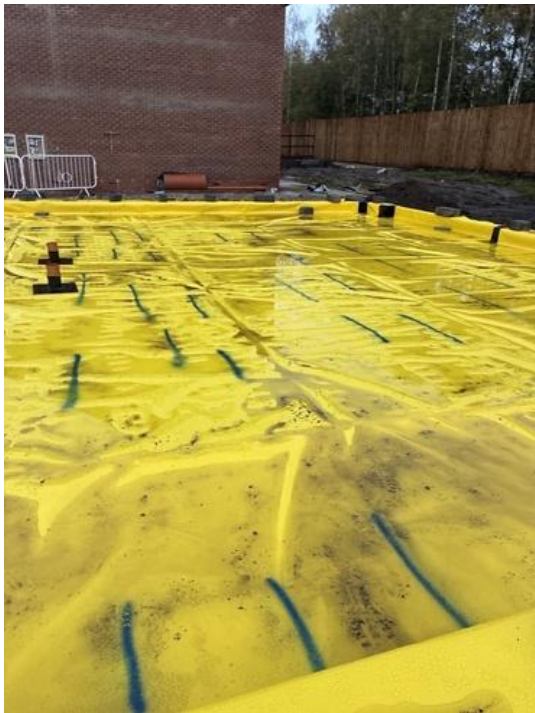
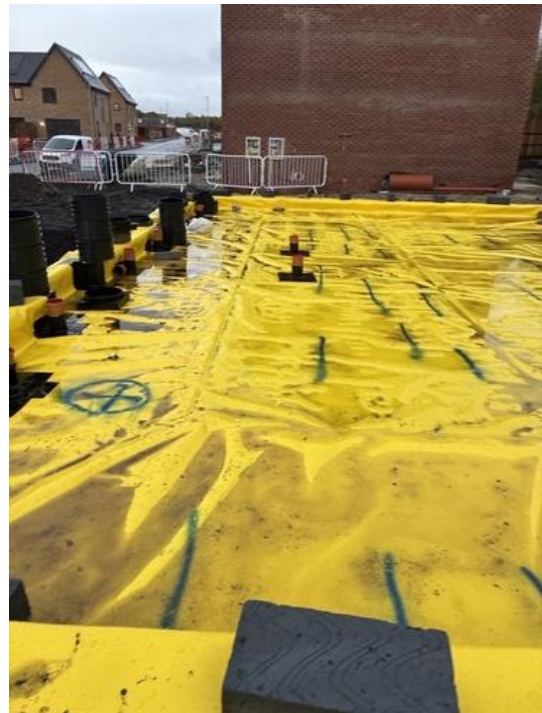
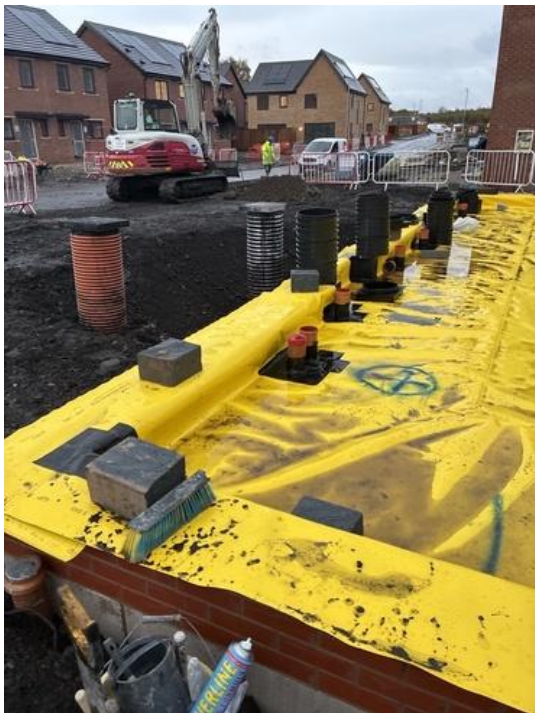
**Extent of Coverage: Is the membrane covering the entire plot? Does membrane span over outside walls?**

Yes

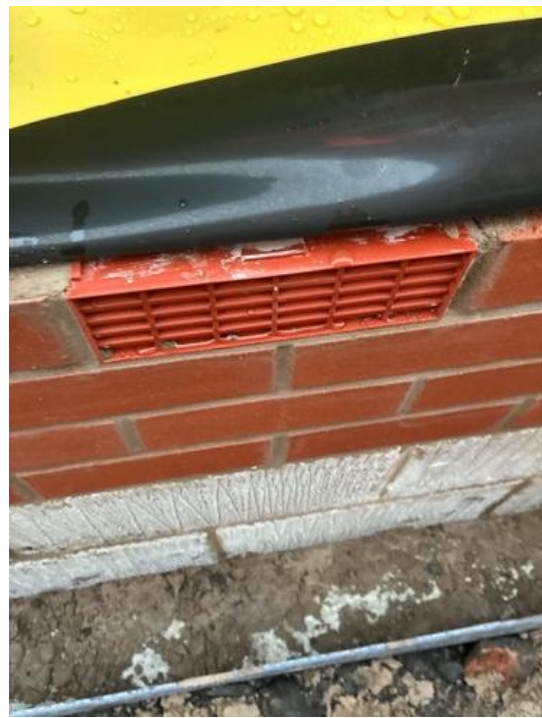
**External Wall Air bricks:** Numbers, size. positions as design drawing? (Minimum of 3 walls)

Pass

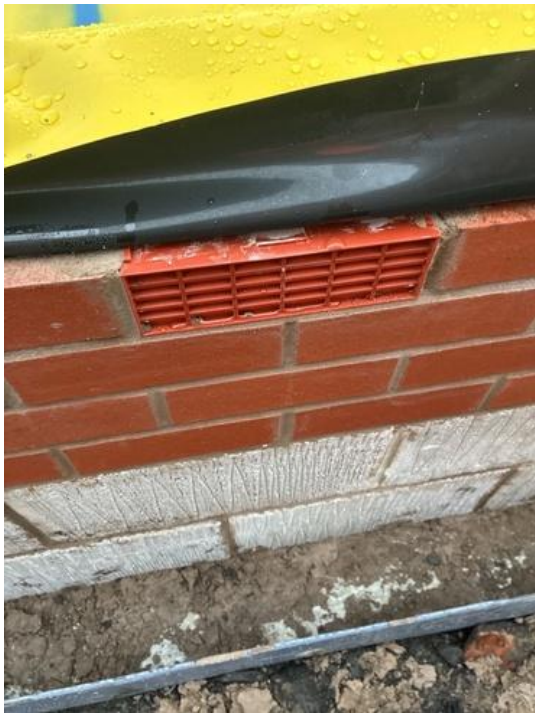
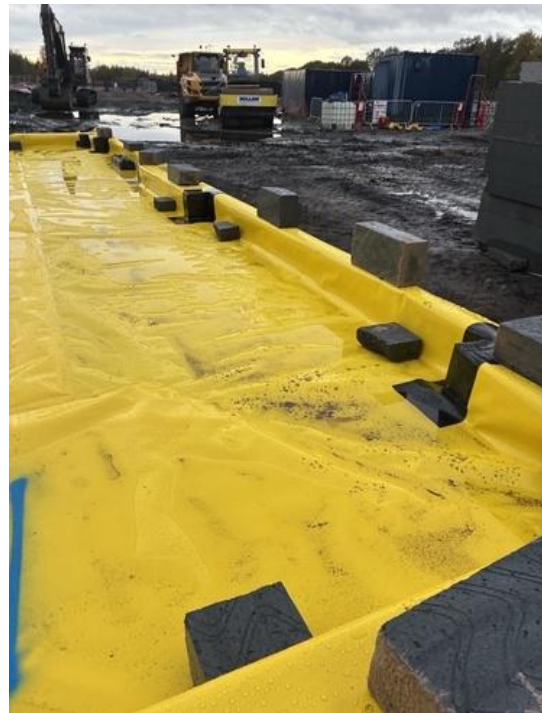
**Are telescopic vents present?**

Yes

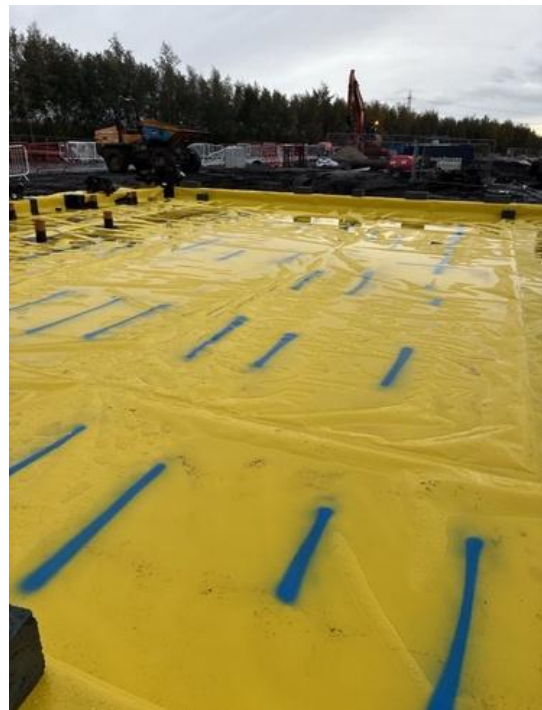
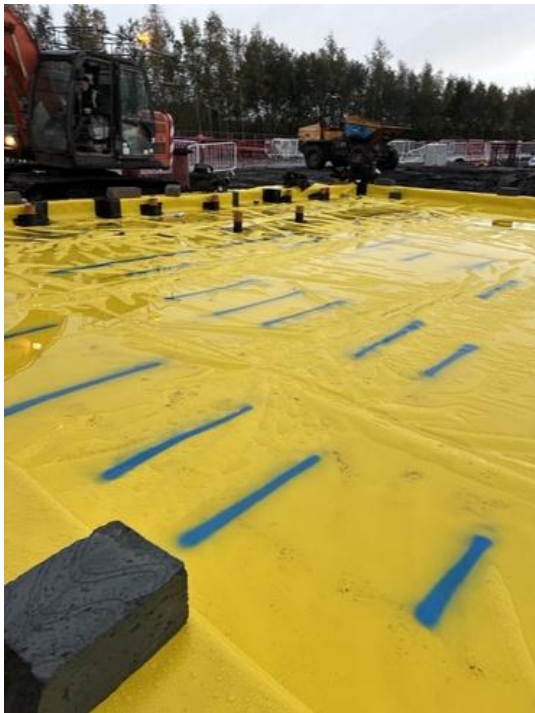
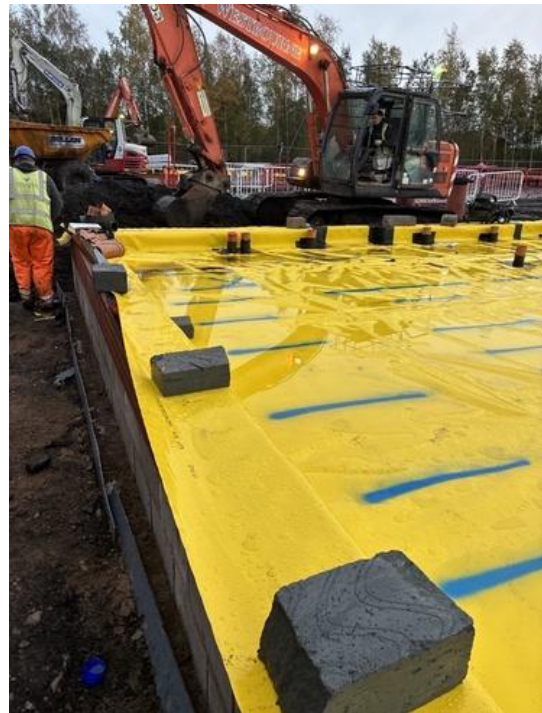
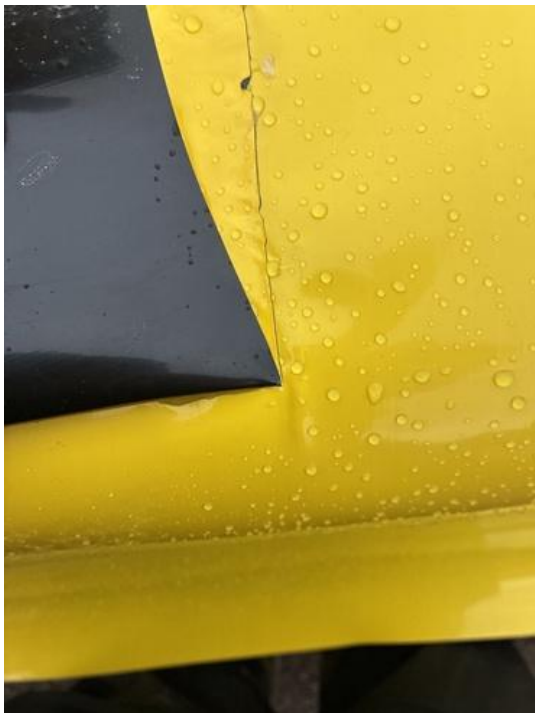
**Gas Membrane Condition:** Open punctures, tears, rips, stretching, Presence of debris, Repairs, Signs of weakness such as raised or sunken indentations, Protection plan in place to restrict access to gas membrane? IF FAIL DESCRIPTION IN ACTIONS AND PHOTOS REQUIRED

Pass

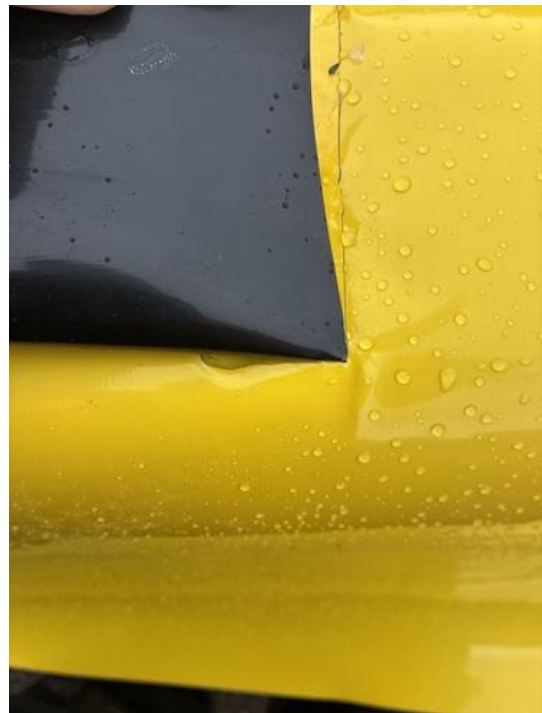
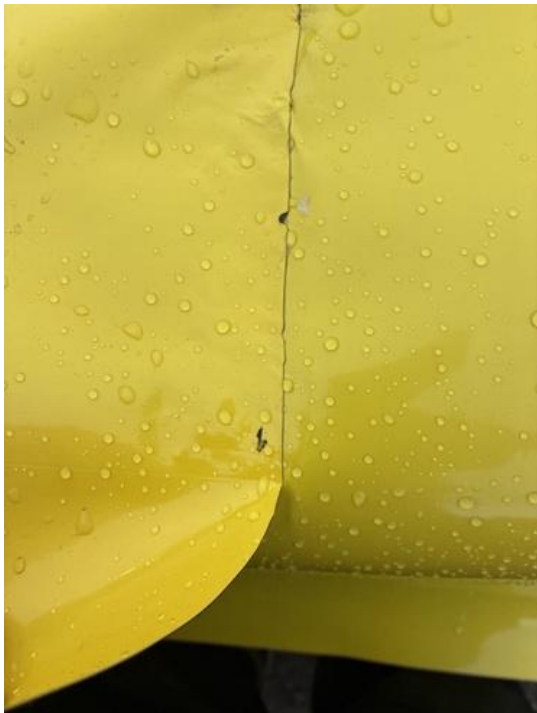
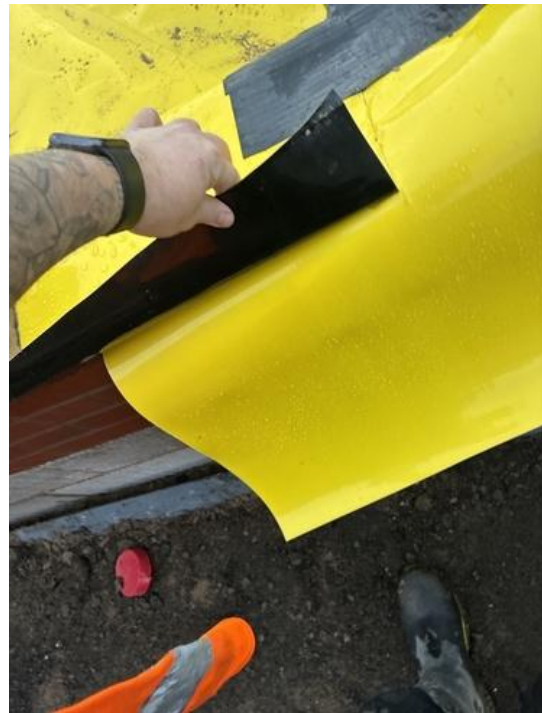
**Are welds complete?**

Yes

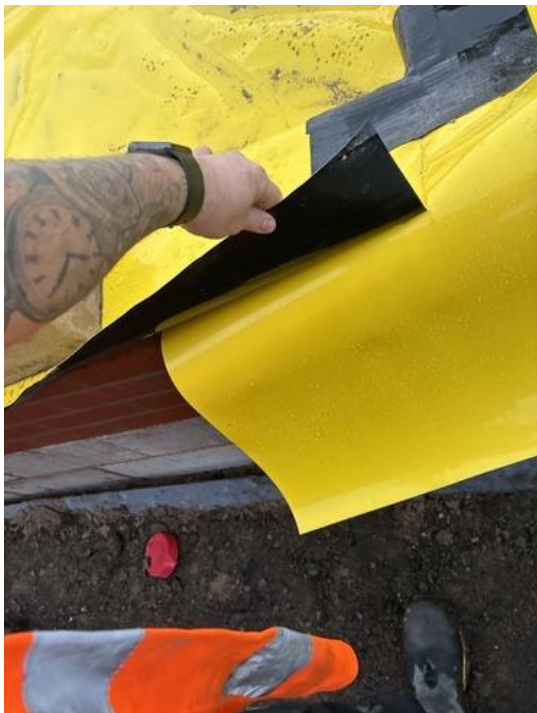
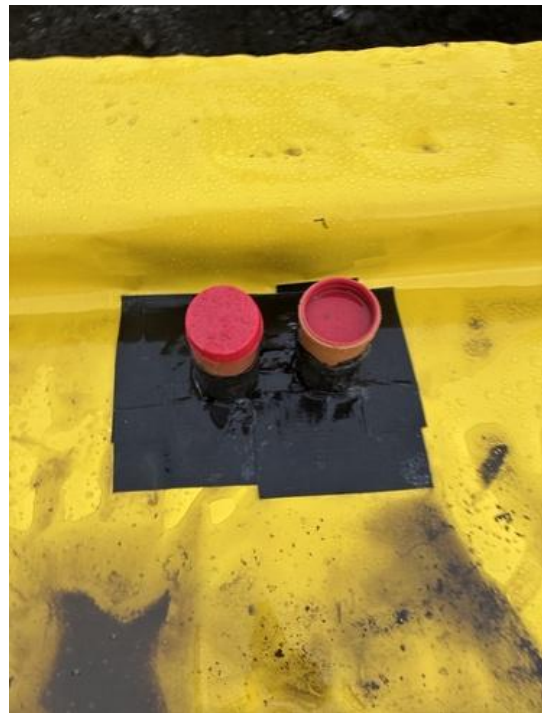
**Are Joints lapped and sealed in accordance with manufacturer's requirements/ specification?**

Yes
