## GAS MEMBRANE VALIDATION – HAWKS VIEW, CASTLETON

| <b>Project Name:</b> | Hawks View, Castleton (formerly known as Castleton Sidings) |
| <b>Project Number:</b> | 14-768 |
| <b>Plots:</b> | Membrane – Plots 119, 120, 172, 173 |

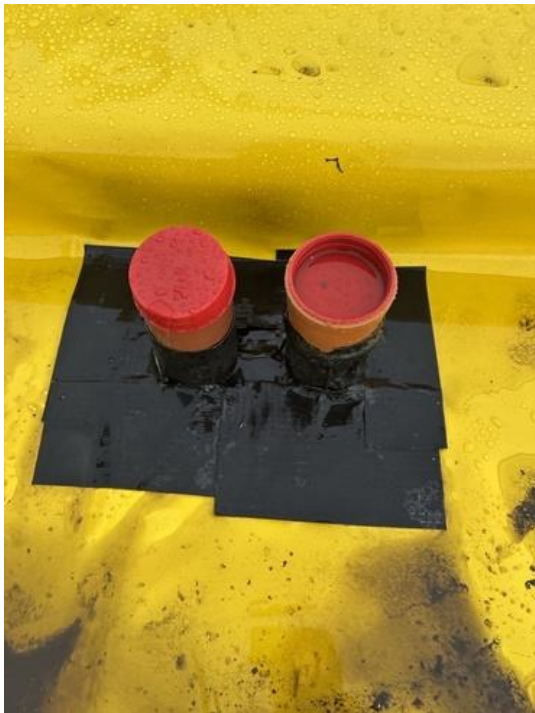
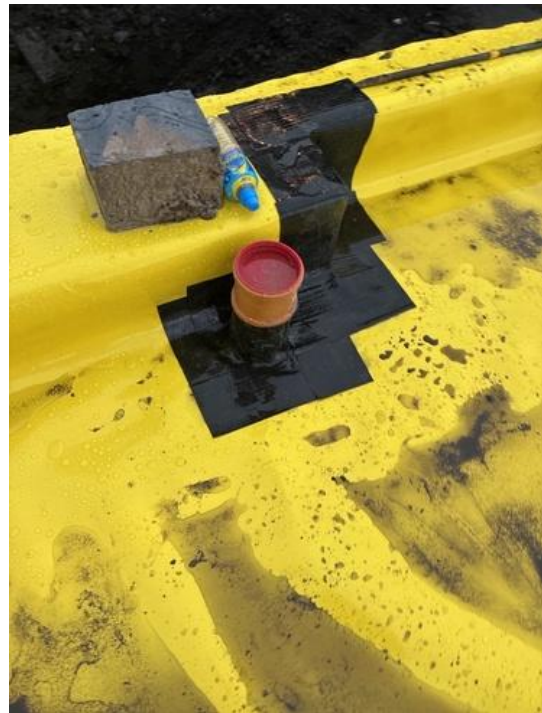
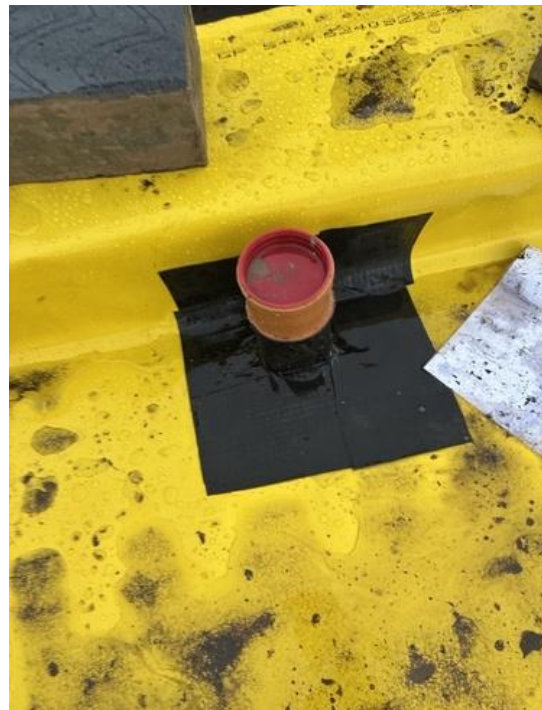
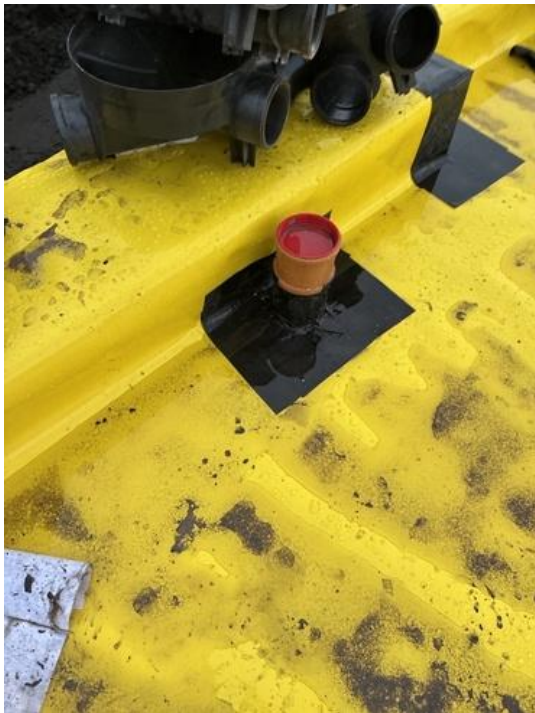
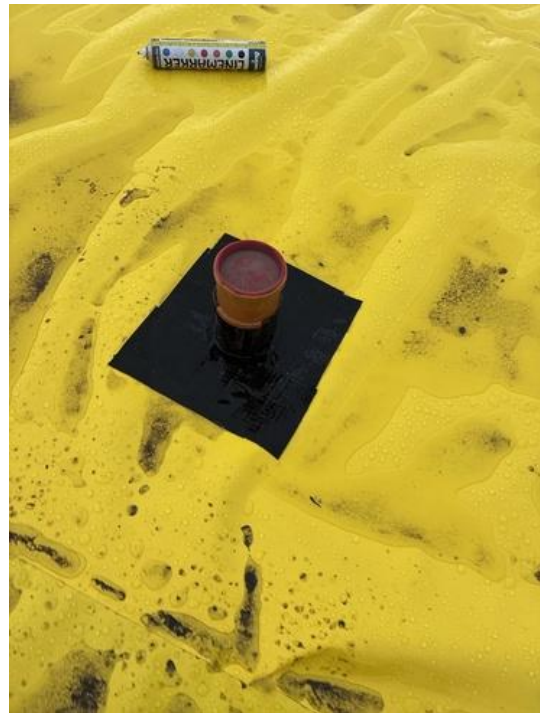
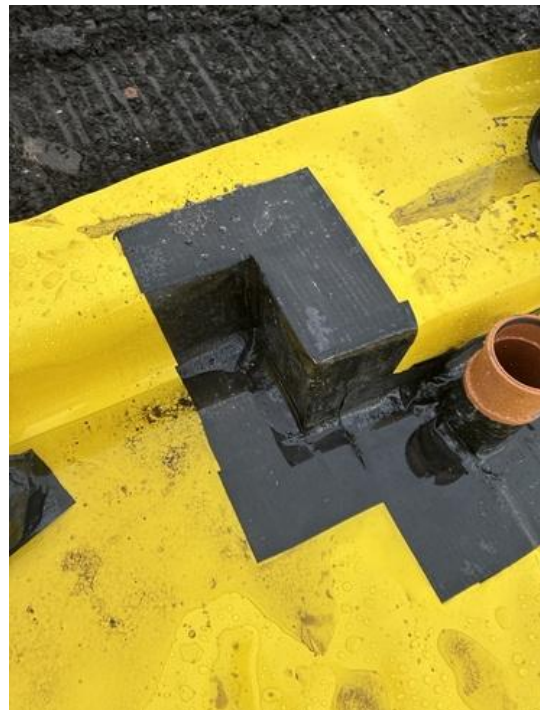
**Service entries seals: Top hats seal arrangements fixed around service entries? Use of Jubilee clips or Bitumastic Sealant**

Pass

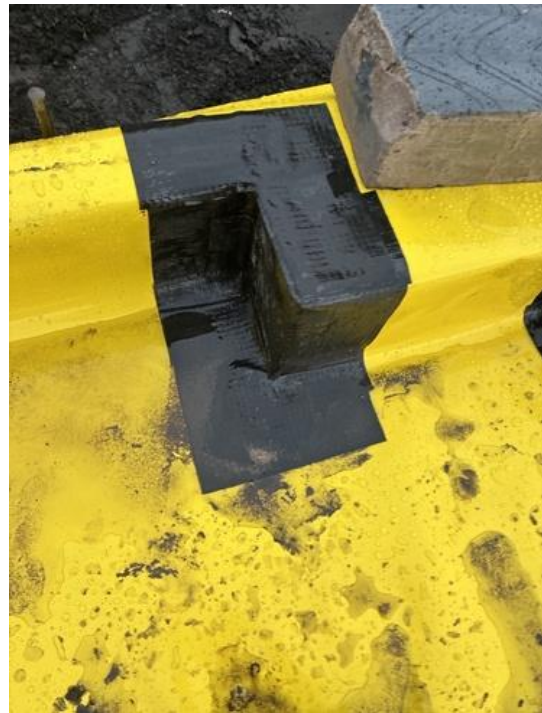
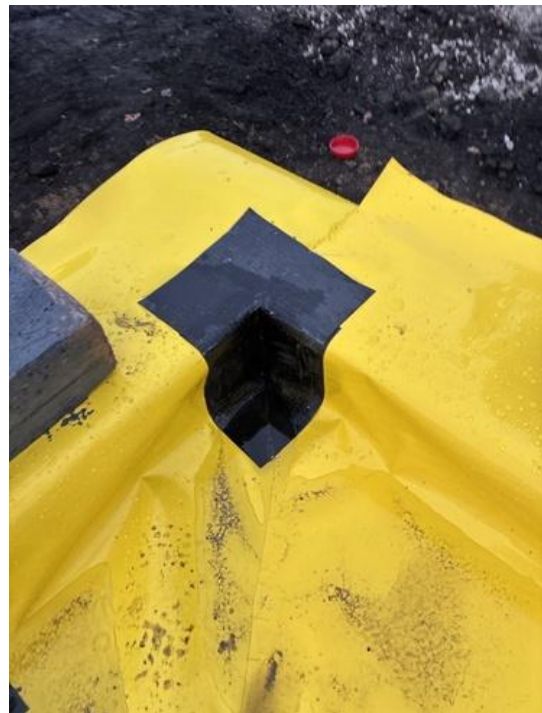
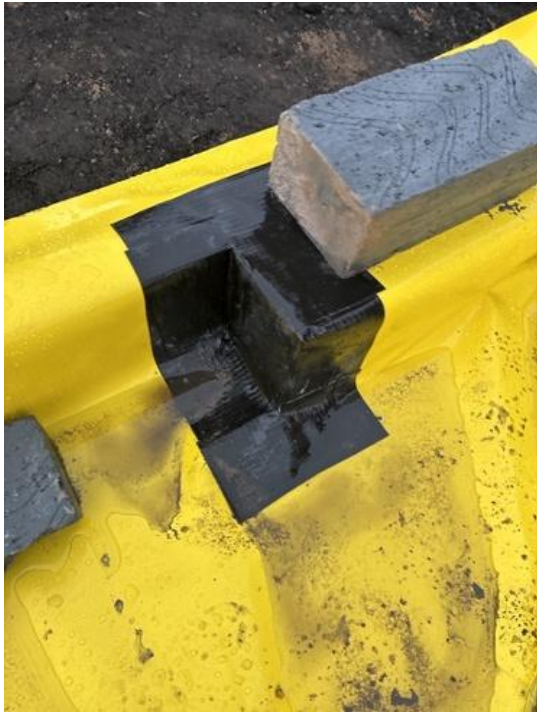
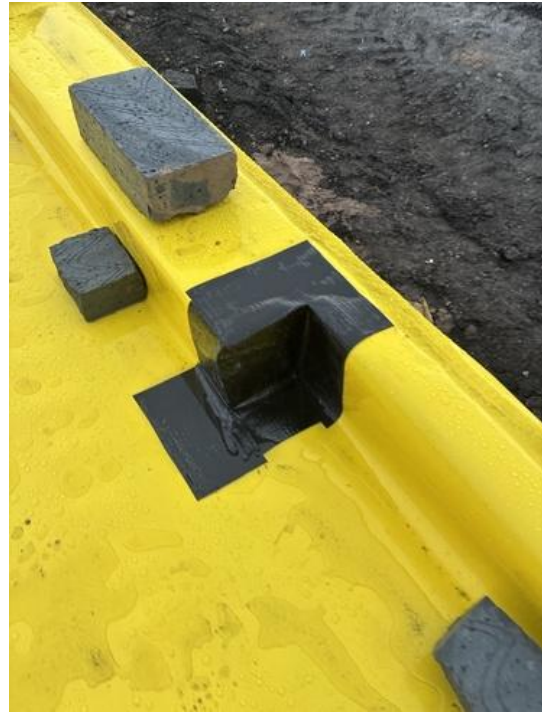
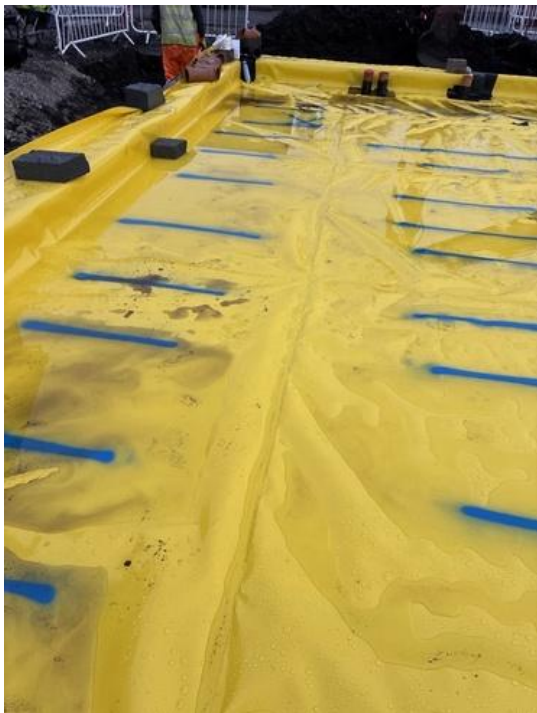
**Corners / Internal joints: Check all corners are correctly formed or contractor has used preformed corners.**

Pass

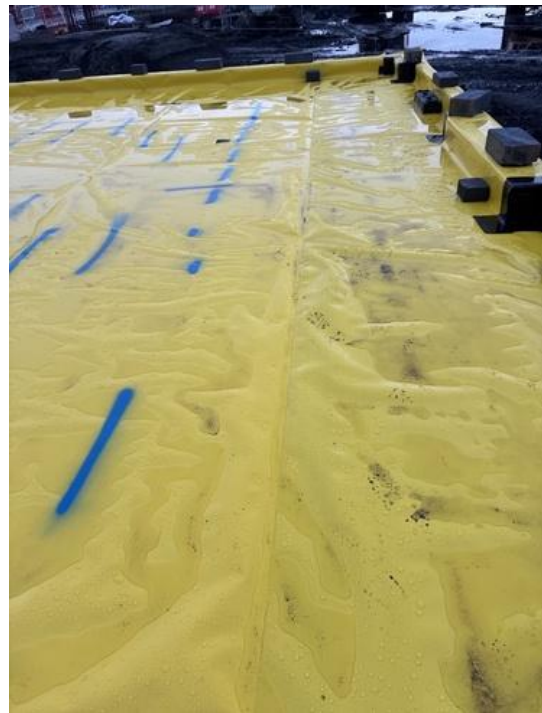
**Are folds running in line with joints? (no joints cutting across folds)**

Pass

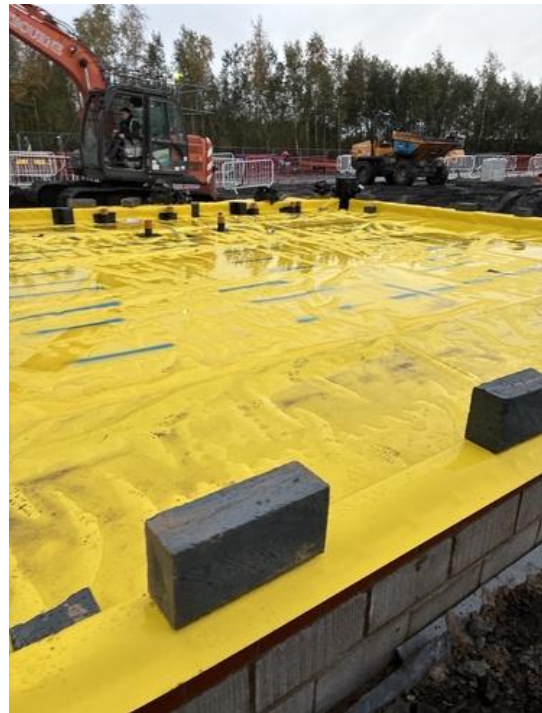
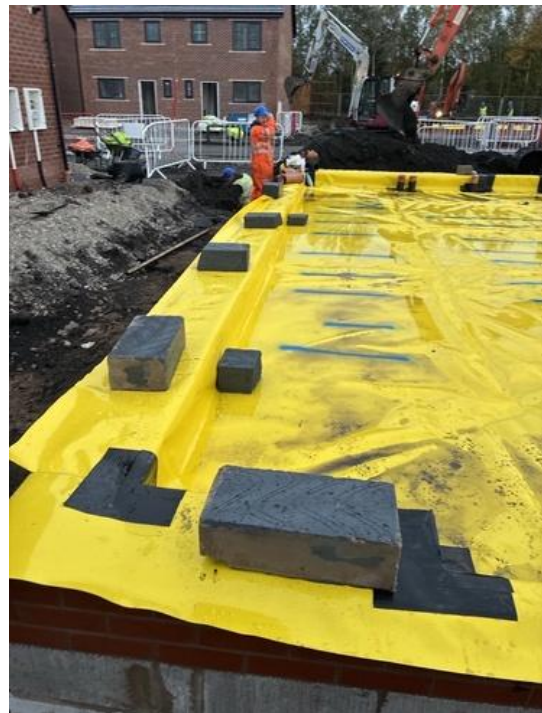
**Extent of Coverage: Is the membrane covering the entire plot? Does membrane span over outside walls?**

Yes
