Date: 21 March 2025  
Reference: 14-768-V3

## GAS MEMBRANE VALIDATION – HAWKS VIEW, CASTLETON

| <b>Project Name:</b> | Hawks View, Castleton (formerly known as Castleton Sidings) |
| <b>Plots:</b> | Membrane – Plots 9-12, 125-129 |

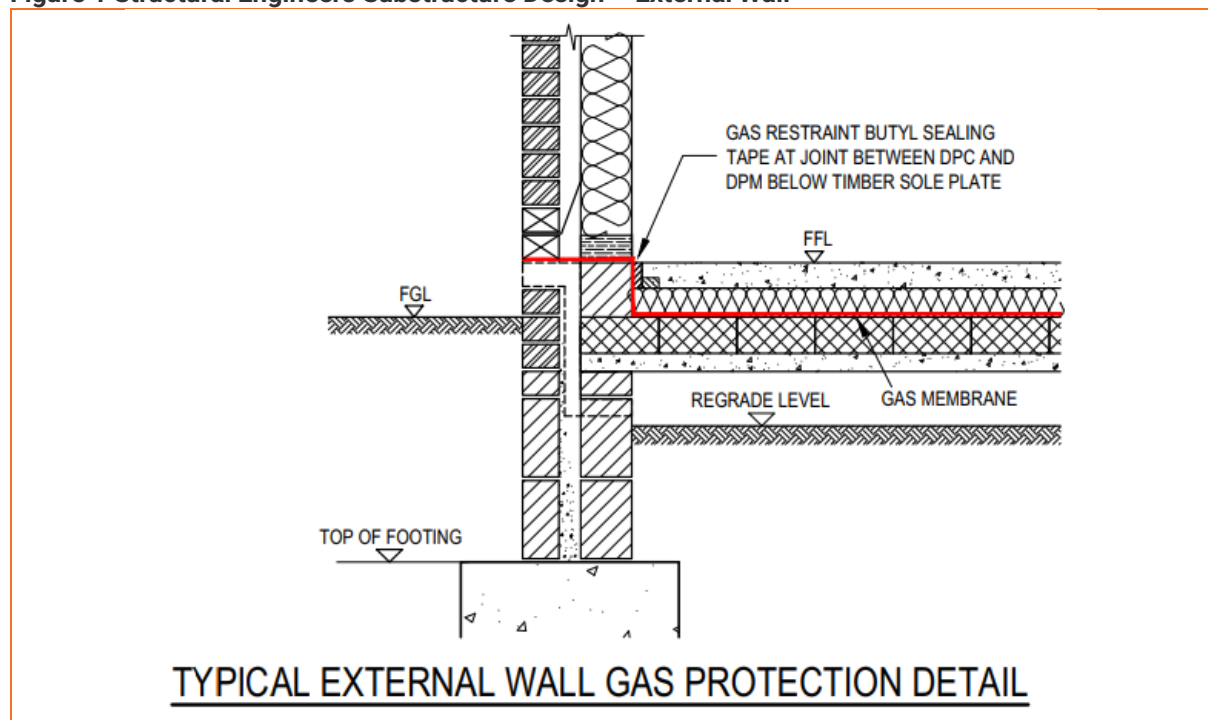
**Figure 1 Structural Engineers Substructure Design – External Wall**

The E3P Technician has inspected the installation of this membrane in line with the structural engineer's specifications in terms of placement and position (Figure 1-3), and the manufacturer's detail in terms of the workmanship.

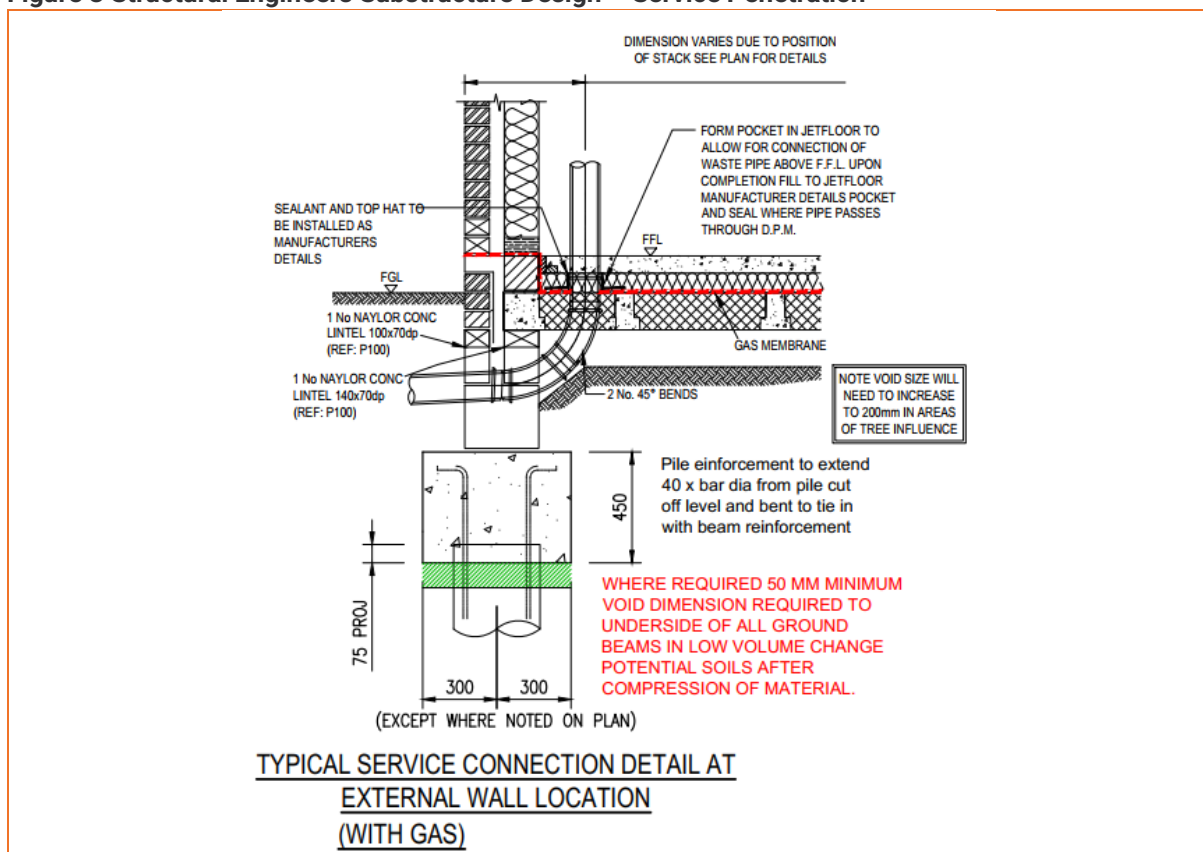
Figure 3 Structural Engineers Substructure Design – Service Penetration

Where any penetration or service duct is present within the floor area E3P inspected each one in turn and can confirm that rigid black polyethylene top hat units have been adequately sealed against the membrane with double-sided jointing tape at both the base and the protruding pipe.
