## GAS MEMBRANE VALIDATION – HAWKS VIEW, CASTLETON

| <b>Project Name:</b> | Hawks View, Castleton (formerly known as Castleton Sidings) |
| <b>Project Number:</b> | 14-768 |
| <b>Plots:</b> | Membrane – Plots 13-15 |

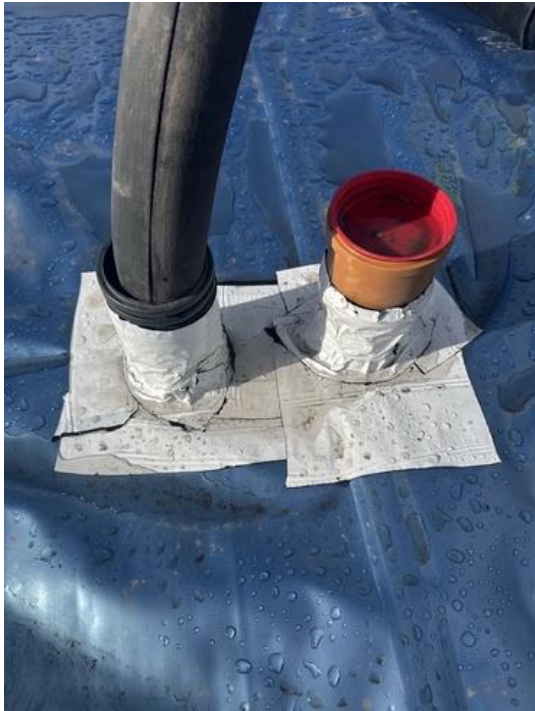
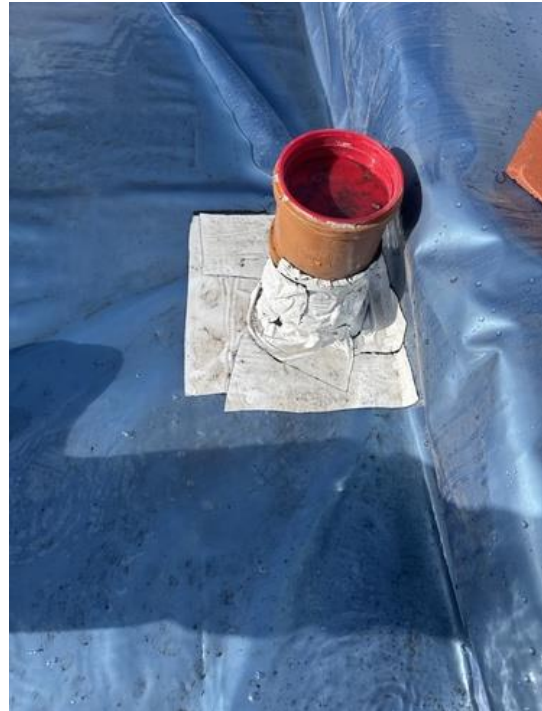
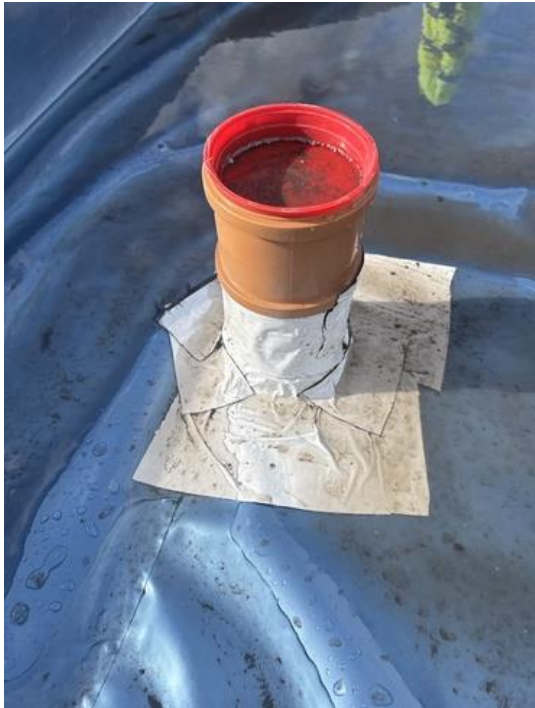
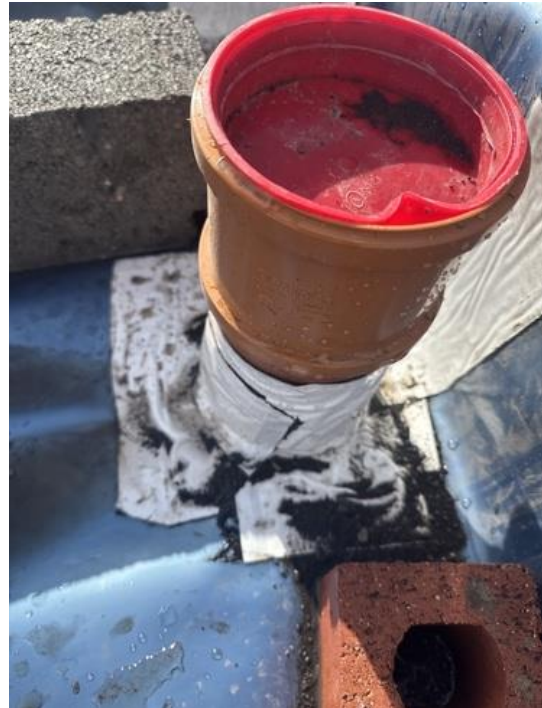
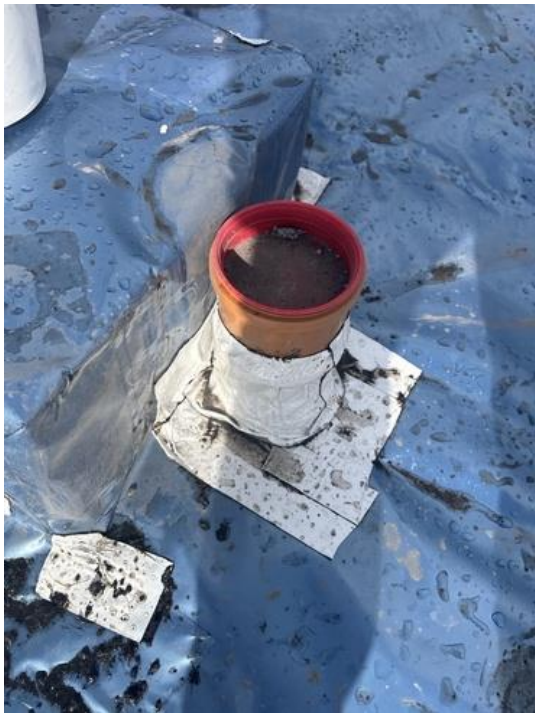
| <b>Service entries seals: Top hats seal arrangements fixed around service entries? Use of Jubilee clips or Bitumastic Sealant</b> | Pass |

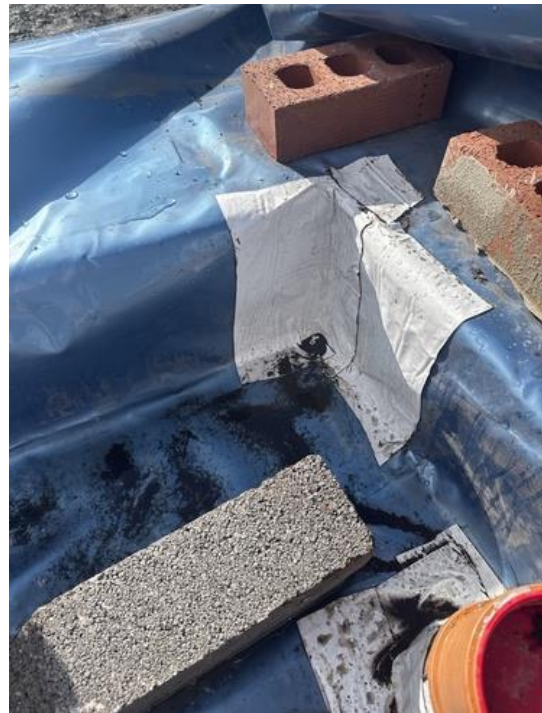
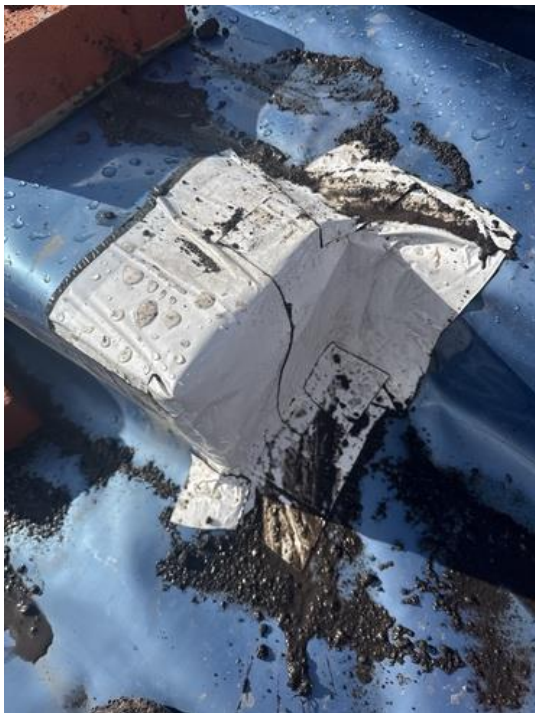
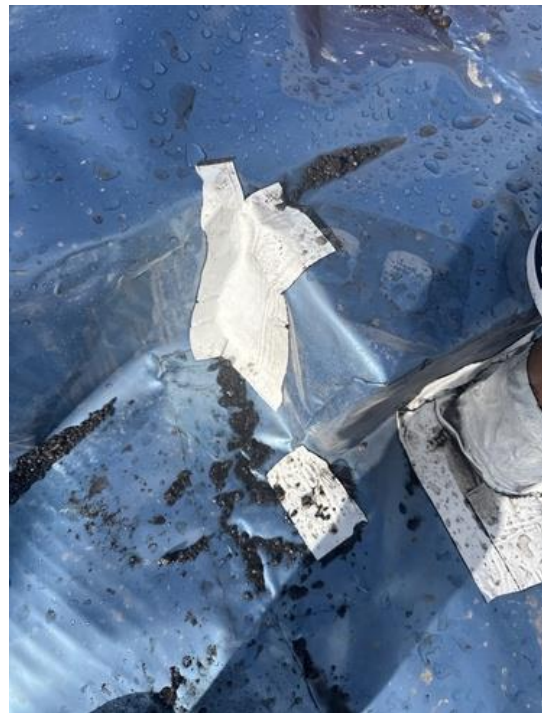
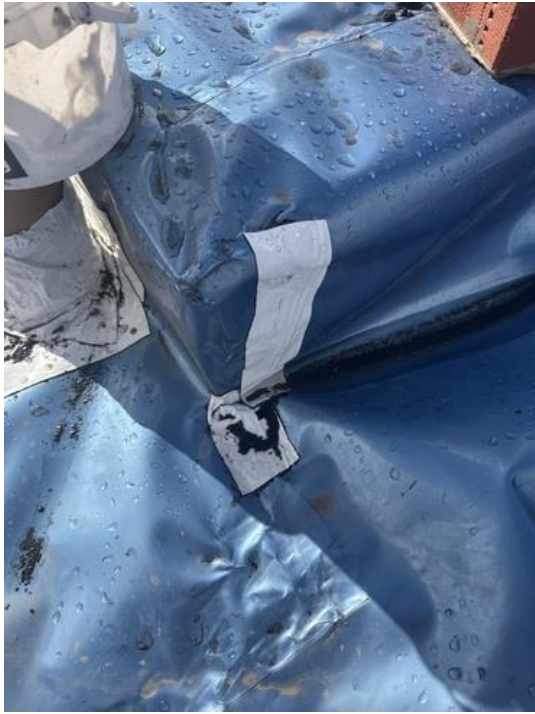
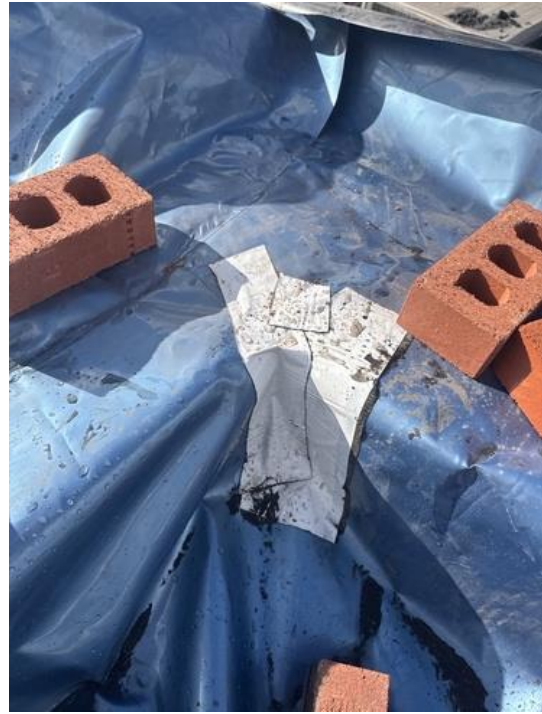
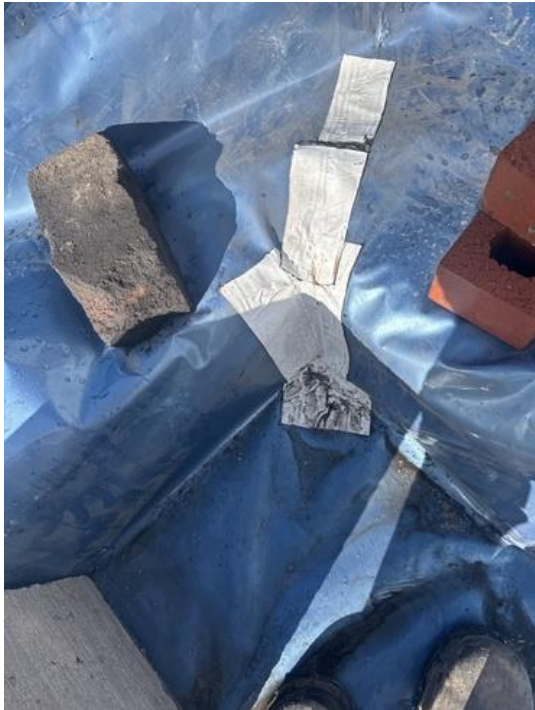
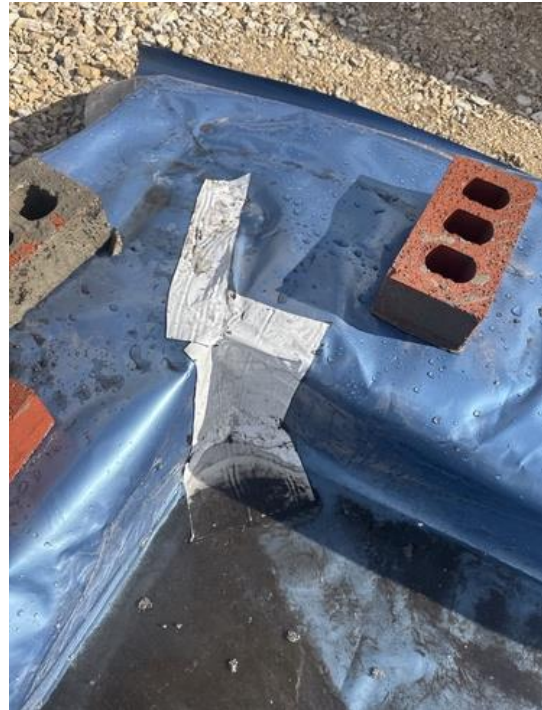
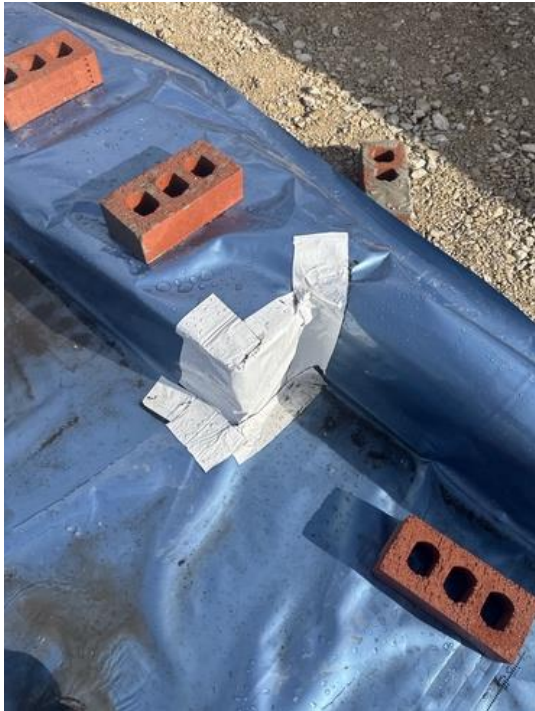
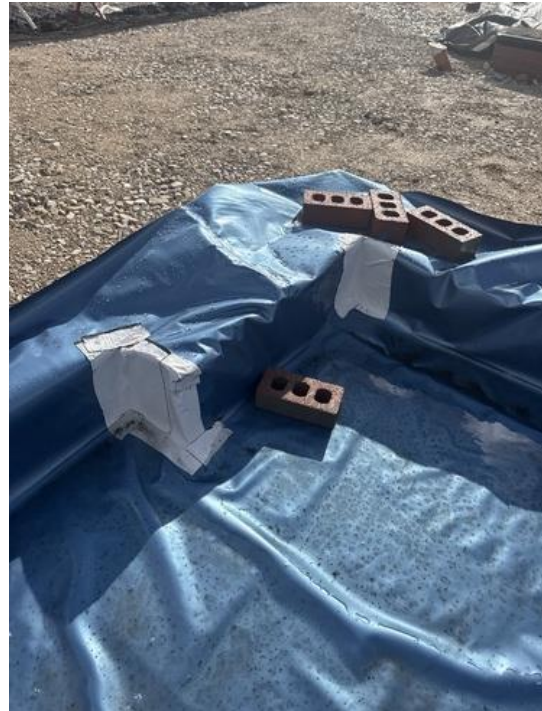
| <b>Corners / Internal joints: Check all corners are correctly formed or contractor has used preformed corners.</b> | Pass |

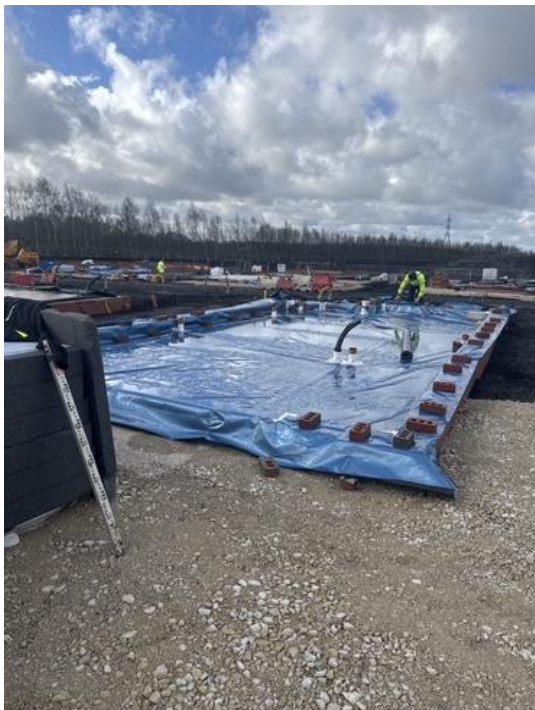
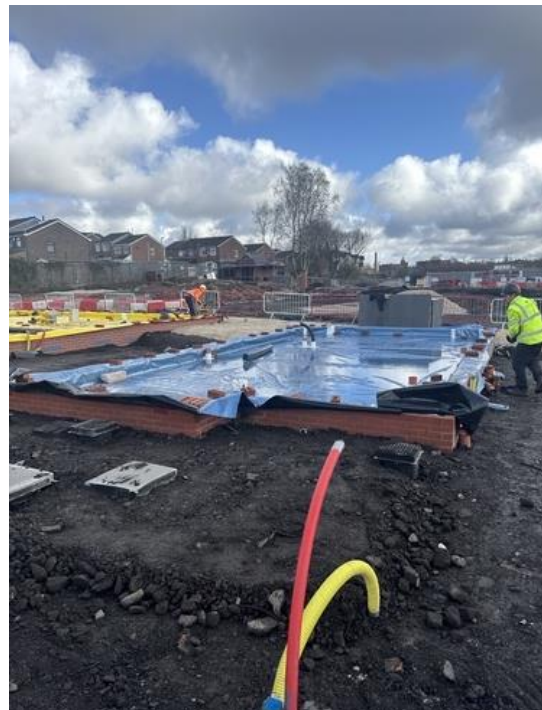
**Extent of Coverage: Is the membrane covering the entire plot?  
Does membrane span over outside walls?**

Yes

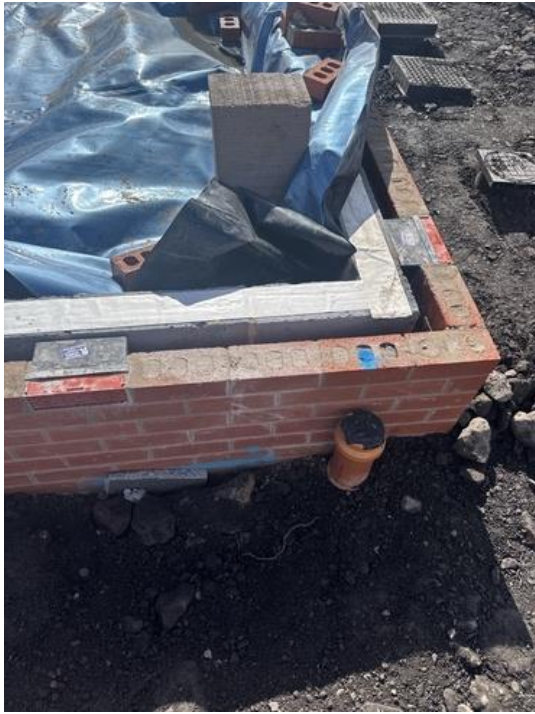
Photo 17

**Sealant to the underside of the membrane at the sole plate position (Check with PM if not noted on schedule)**

Yes

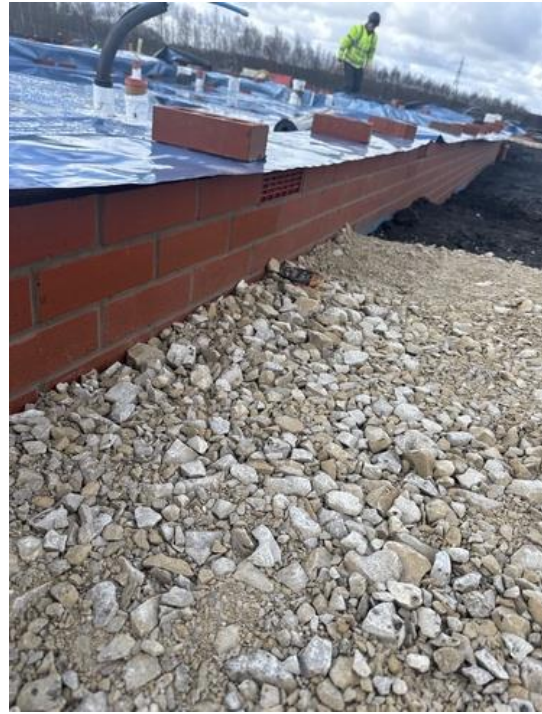
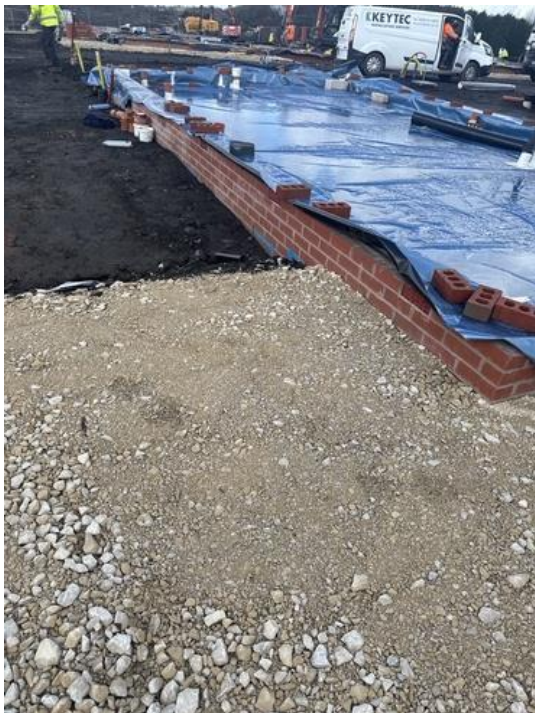
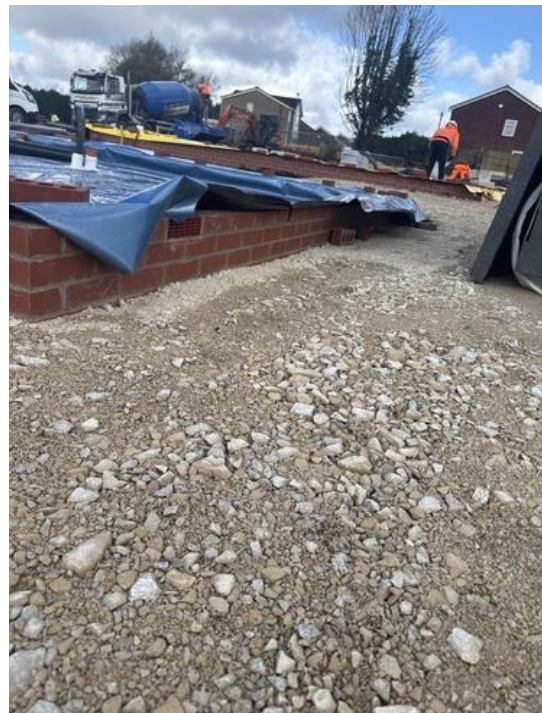
**External Wall Air bricks: Numbers, size. positions as design drawing? (Minimum of 3 walls)**

Pass

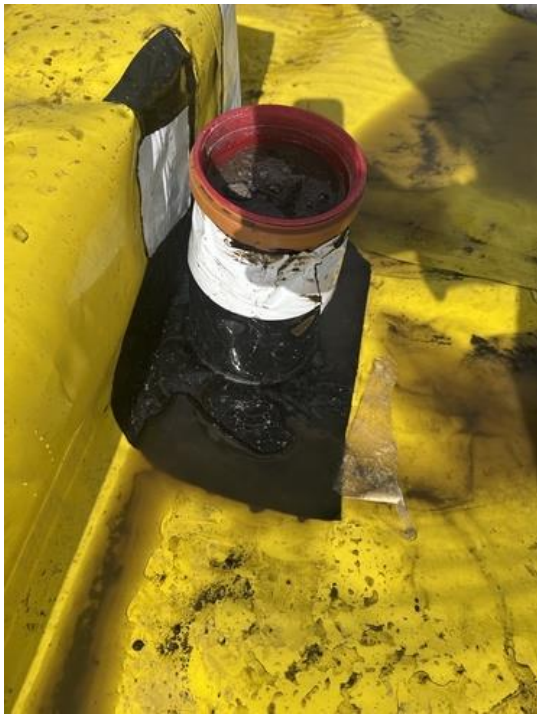
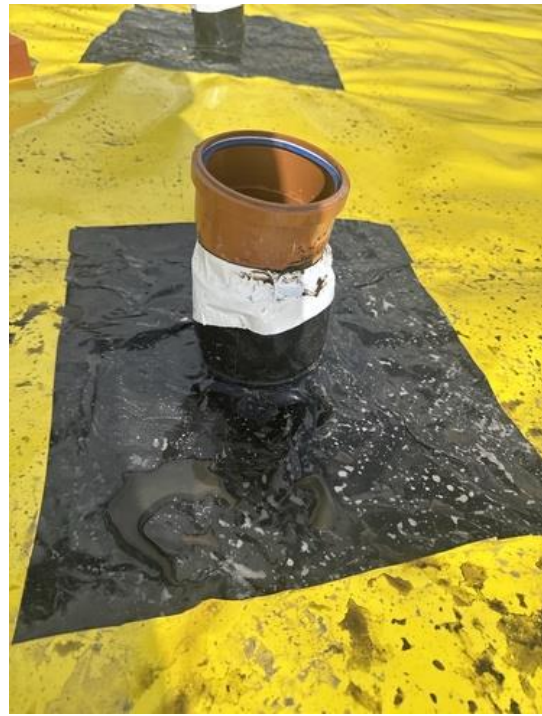
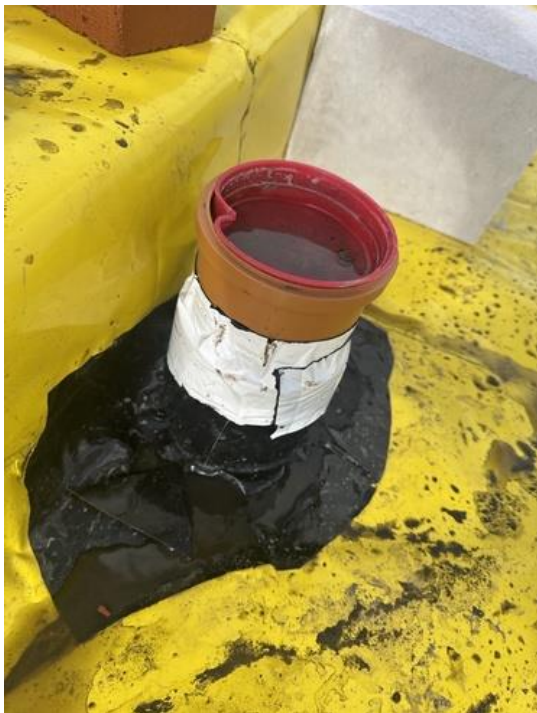
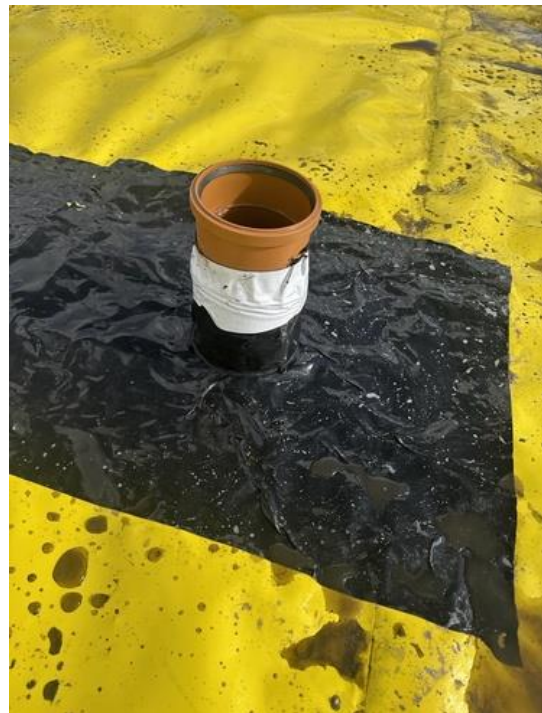
**Service entries seals: Top hats seal arrangements fixed around service entries? Use of Jubilee clips or Bitumastic Sealant**

Pass

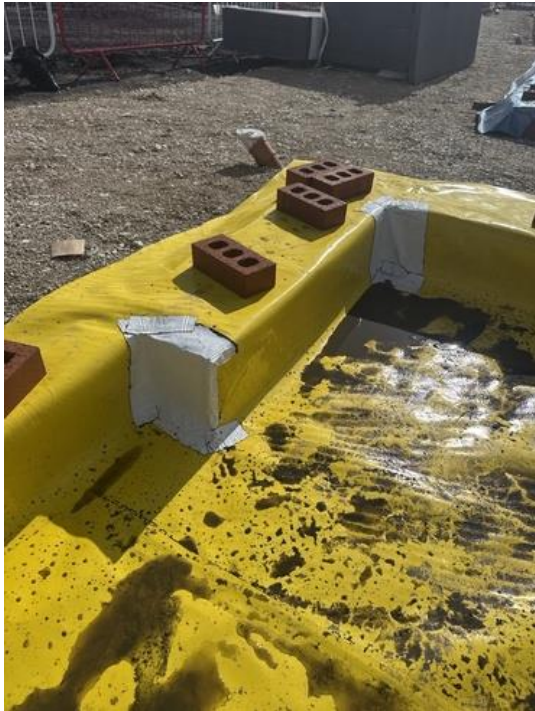
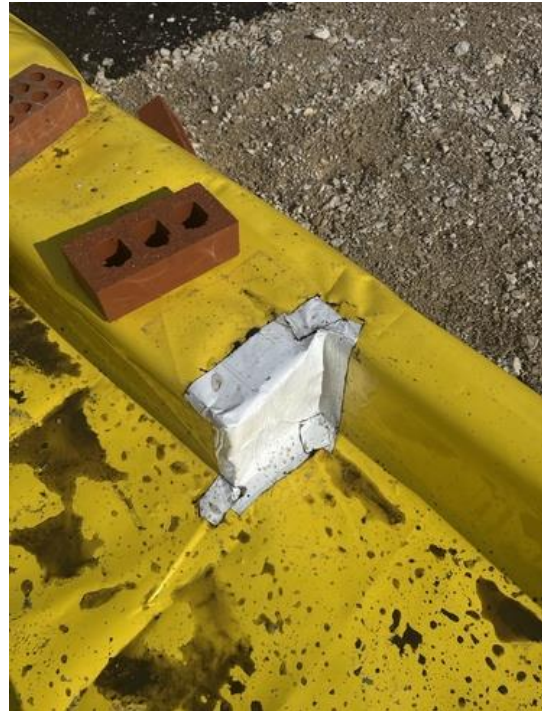
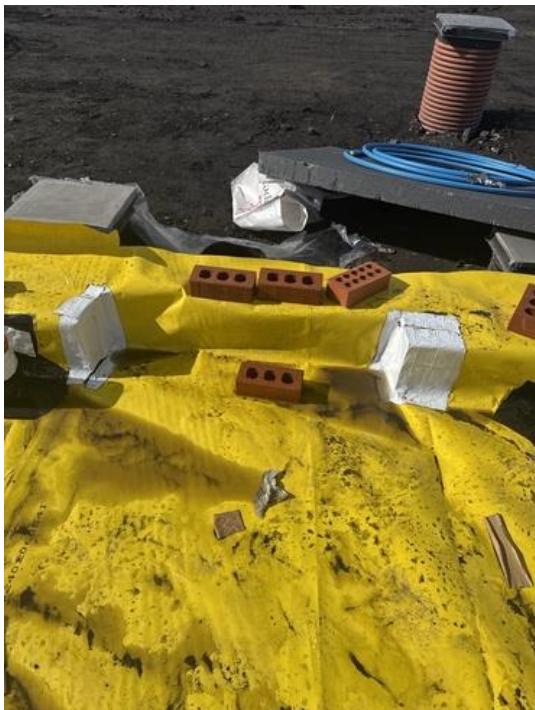
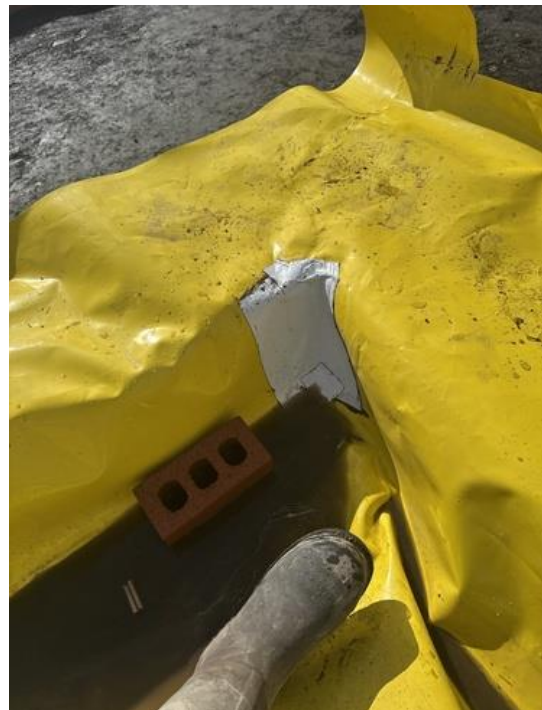
**Corners / Internal joints: Check all corners are correctly formed or contractor has used preformed corners.**

Pass

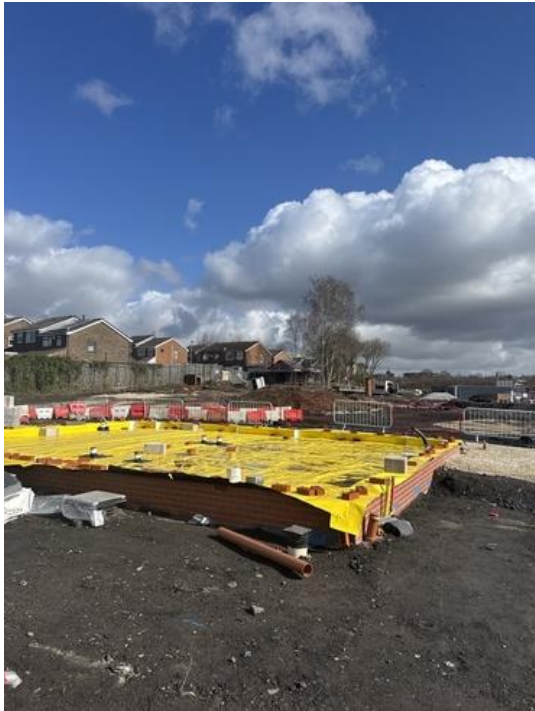
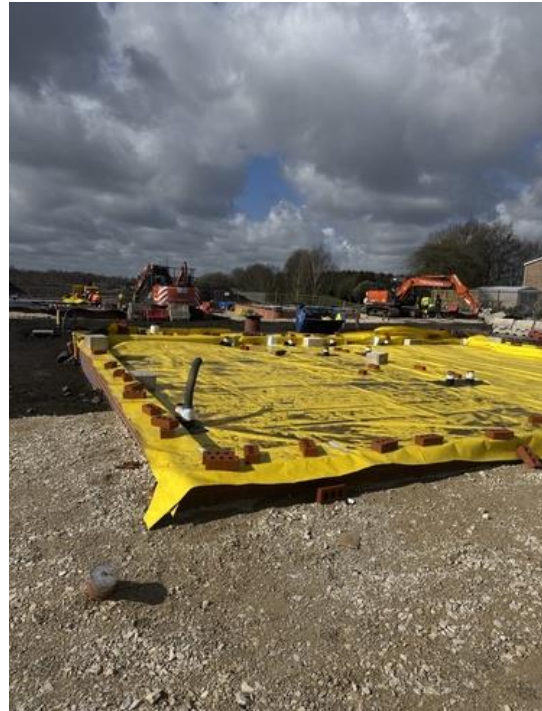
**Extent of Coverage: Is the membrane covering the entire plot? Does membrane span over outside walls?**

Yes

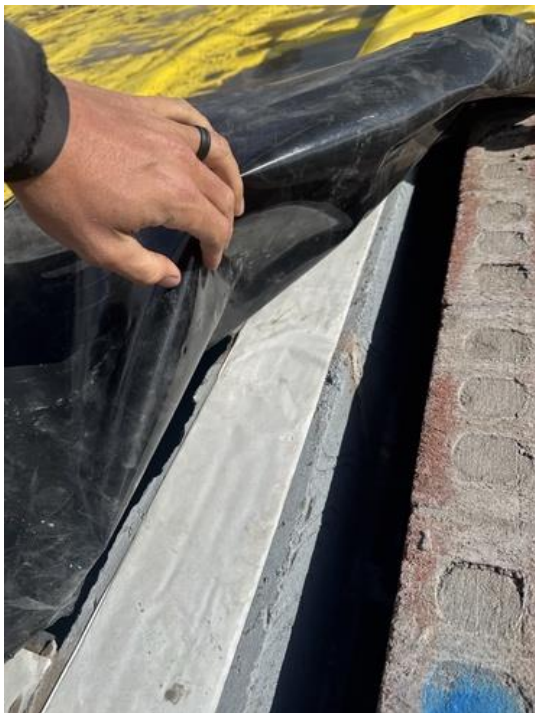
Photo 31

**Sealant to the underside of the membrane at the sole plate position (Check with PM if not noted on schedule)**

Yes

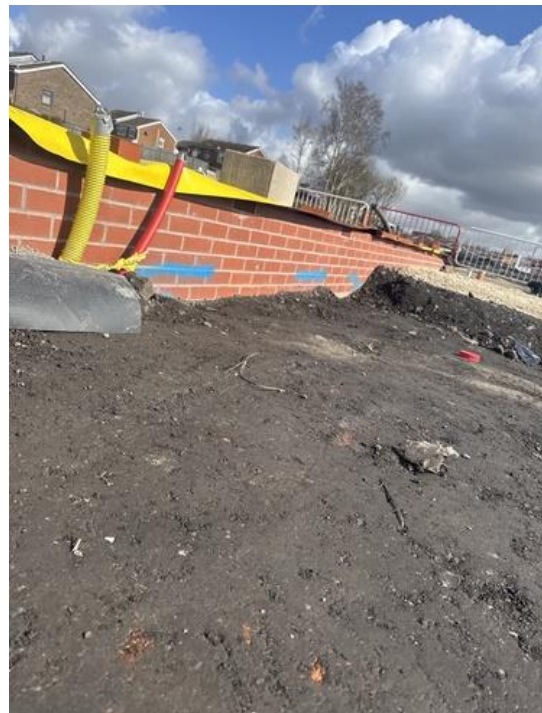
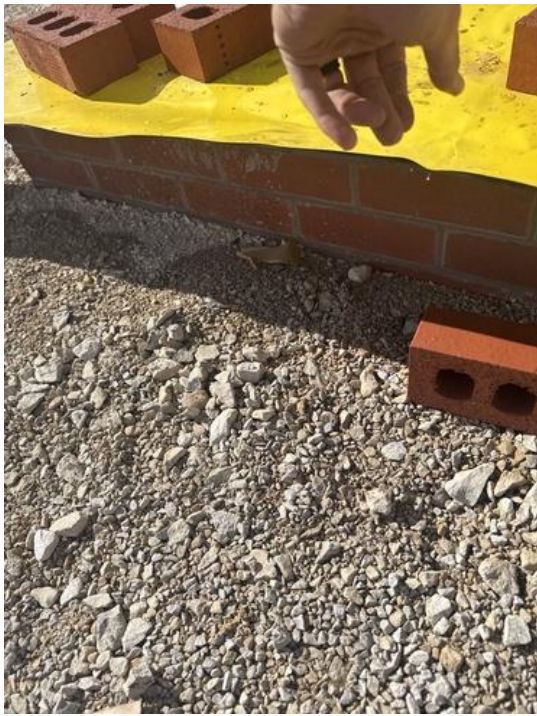
**External Wall Air bricks: Numbers, size, positions as design drawing? (Minimum of 3 walls)**

Pass

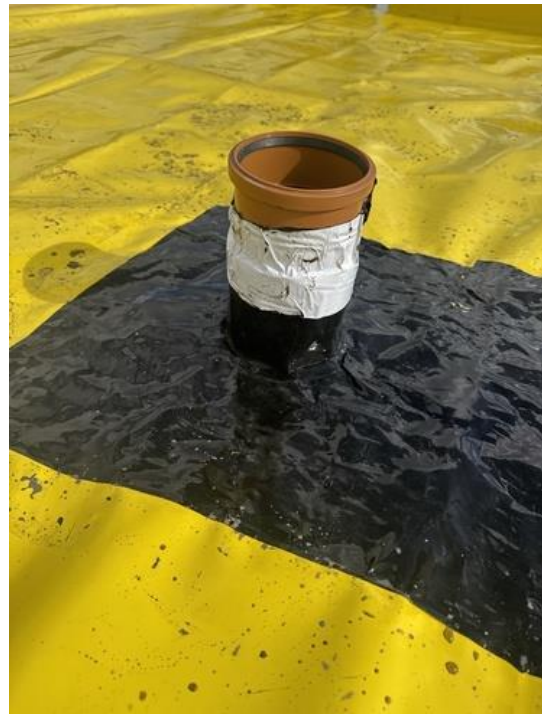
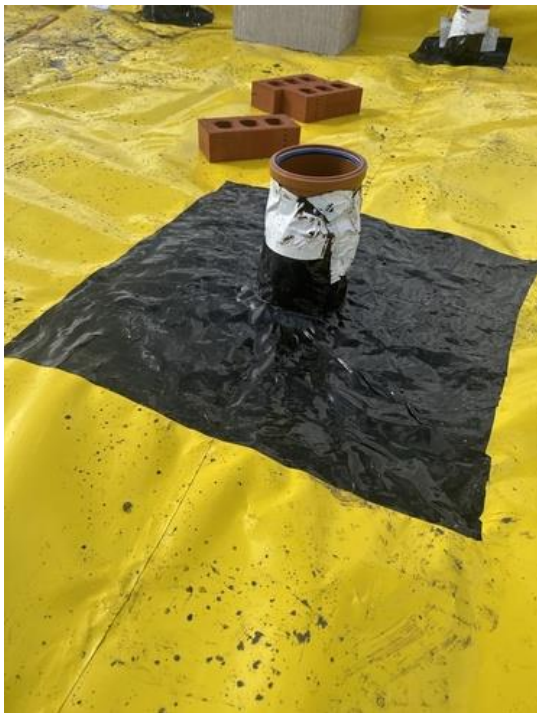
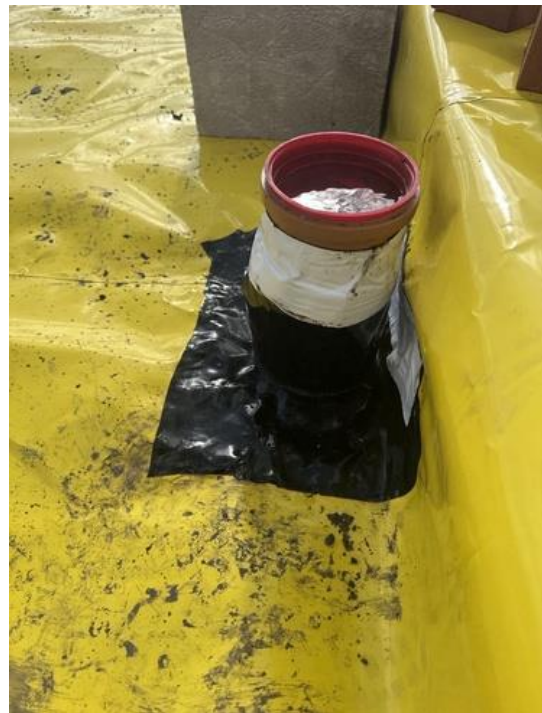
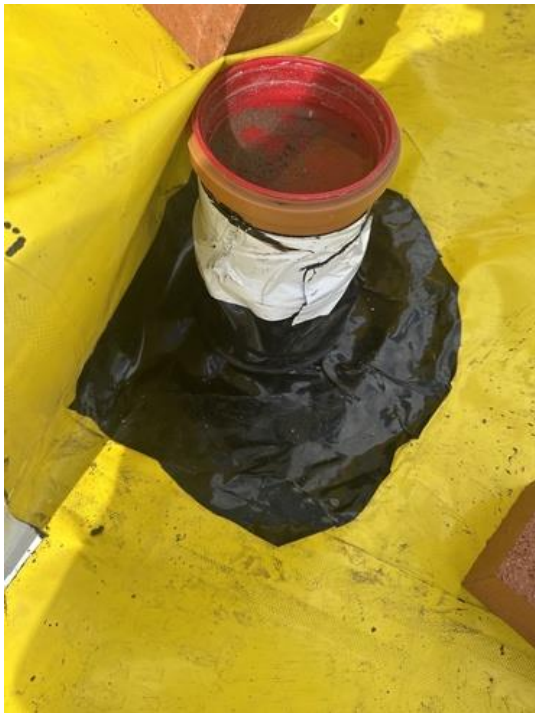
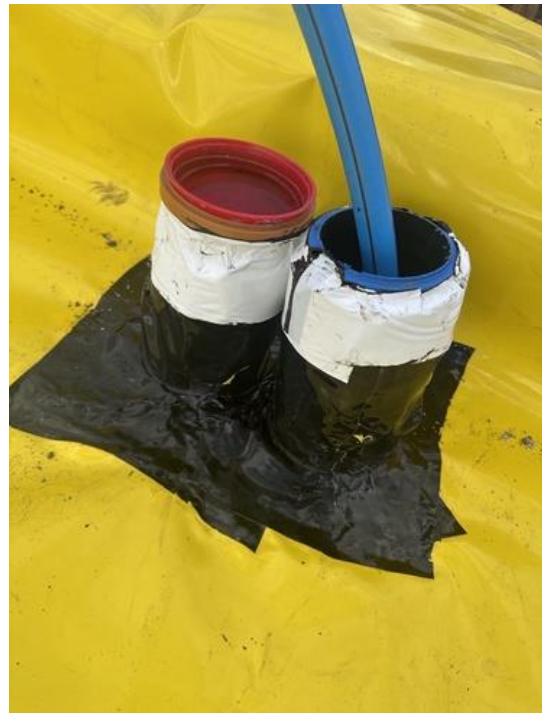
**Service entries seals: Top hats seal arrangements fixed around service entries? Use of Jubilee clips or Bitumastic Sealant**

Pass

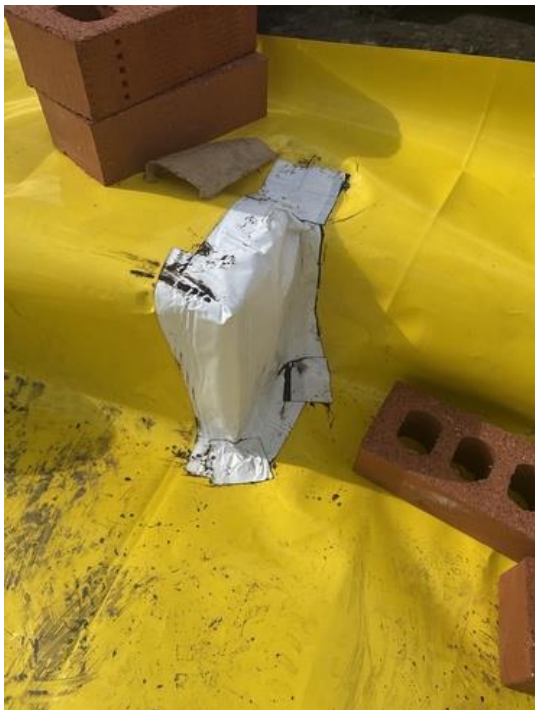
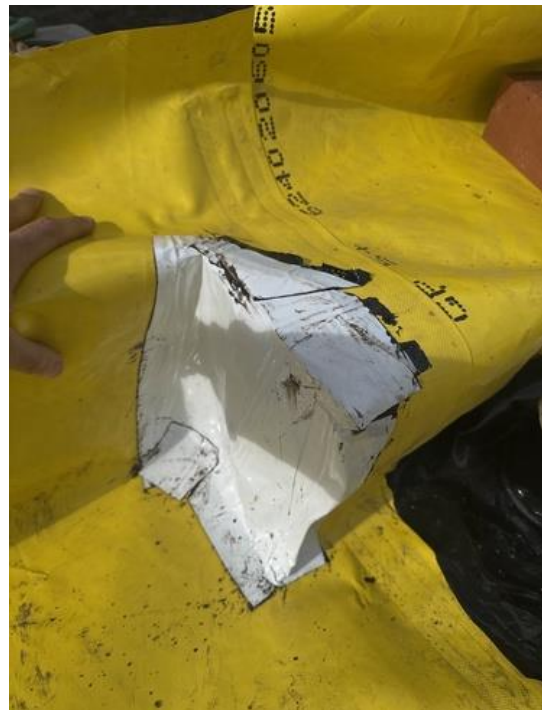
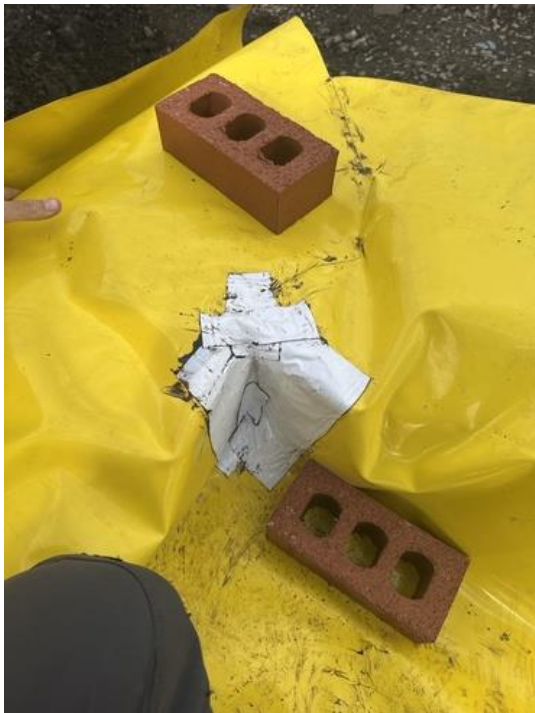
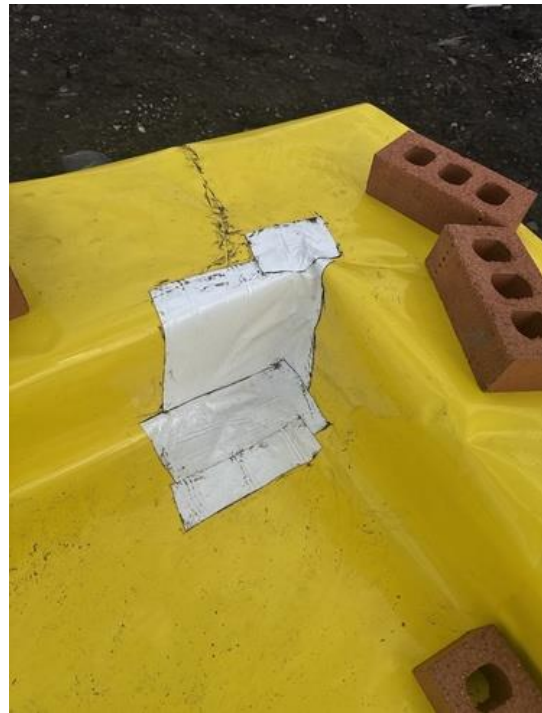
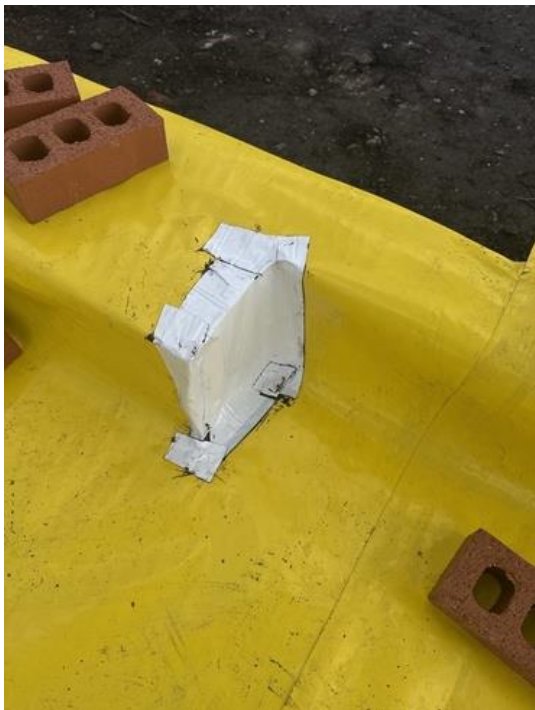
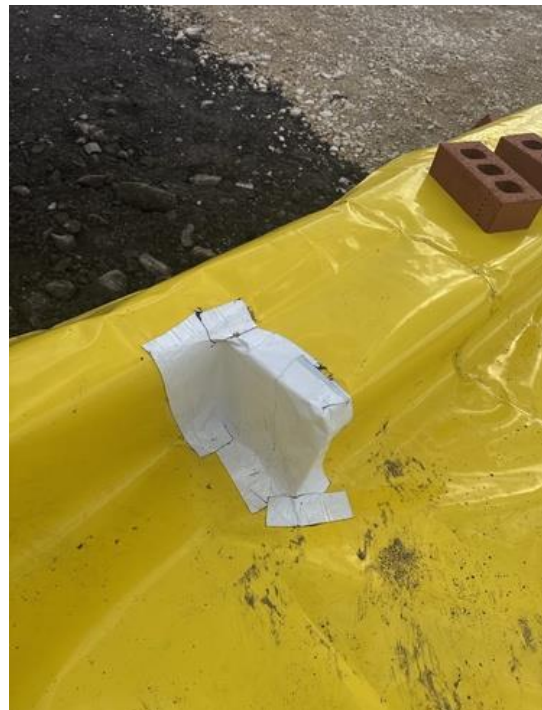
**Corners / Internal joints: Check all corners are correctly formed or contractor has used preformed corners.**

Pass

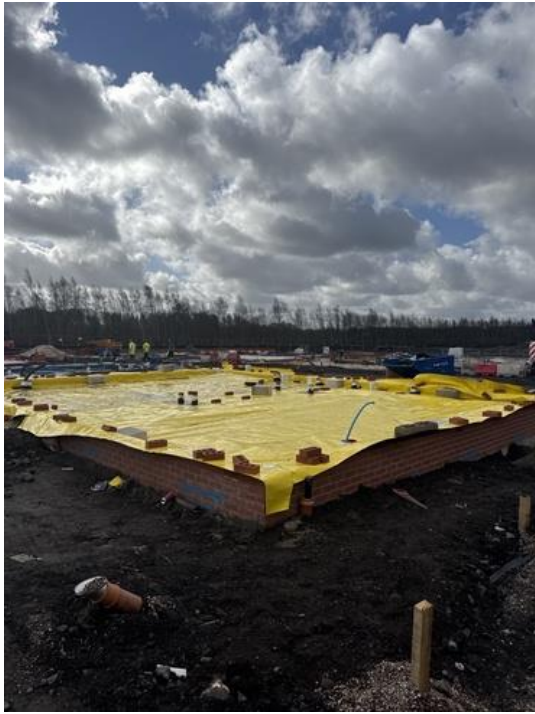
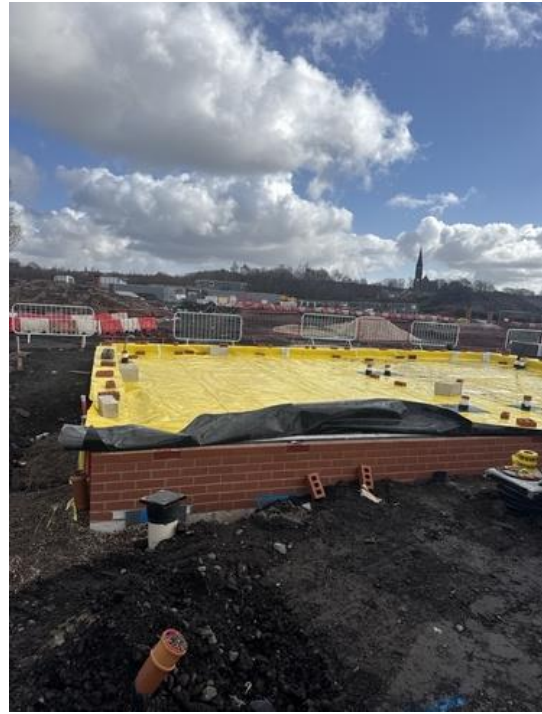
**Extent of Coverage: Is the membrane covering the entire plot?  
Does membrane span over outside walls?**

Yes

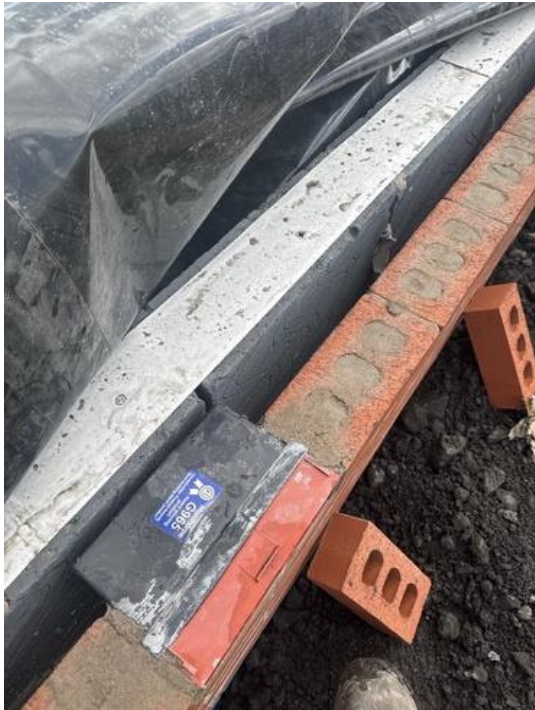
Photo 47

**Sealant to the underside of the membrane at the sole plate position (Check with PM if not noted on schedule)**

Yes

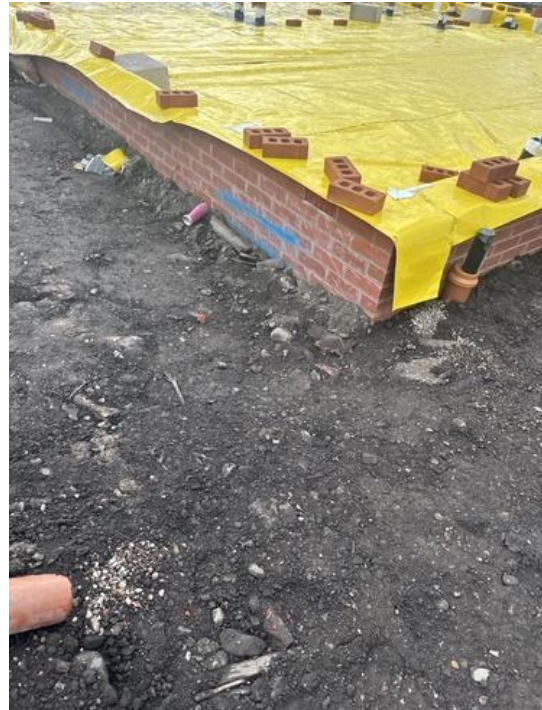
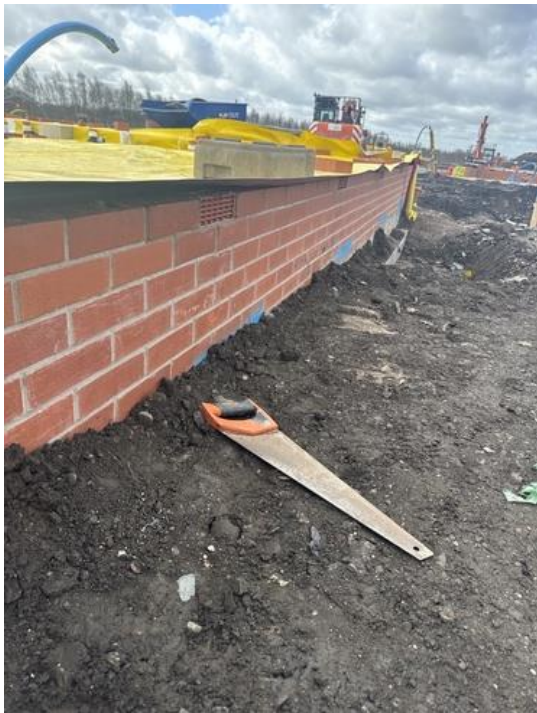
**External Wall Air bricks: Numbers, size. positions as design drawing? (Minimum of 3 walls)**

Pass
