Date: 1 April 2025  
Reference: 14-768-V5

## GAS MEMBRANE VALIDATION – HAWKS VIEW, CASTLETON

| <b>Plots:</b> | Membrane – Plots 130-131 |

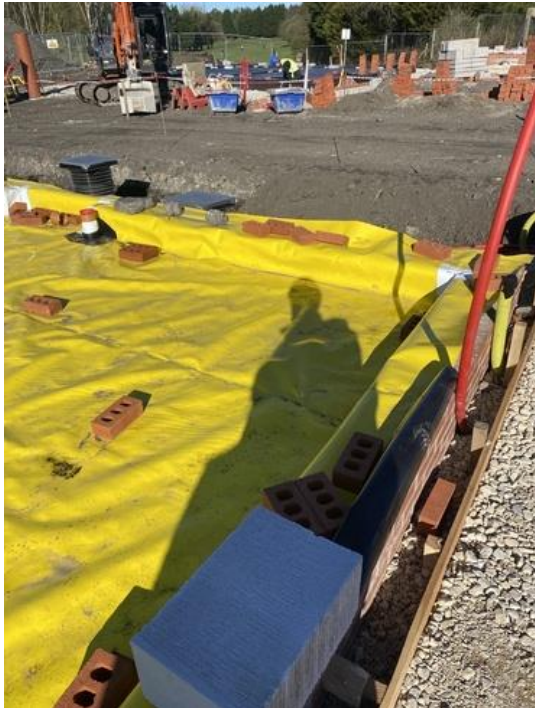
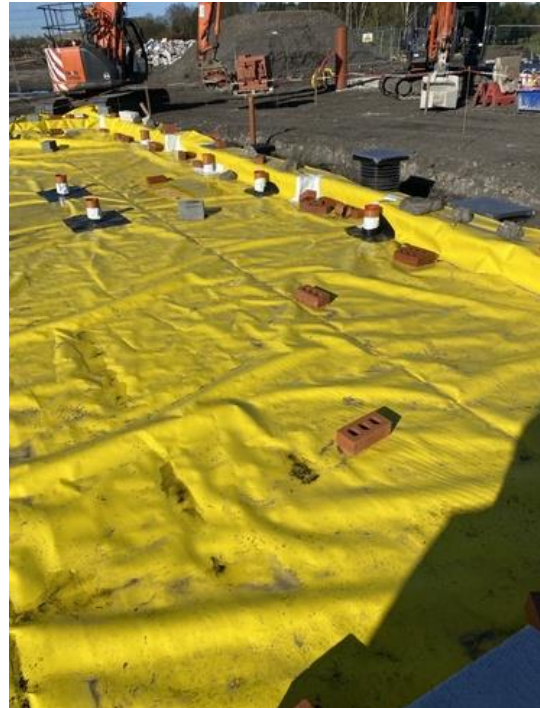
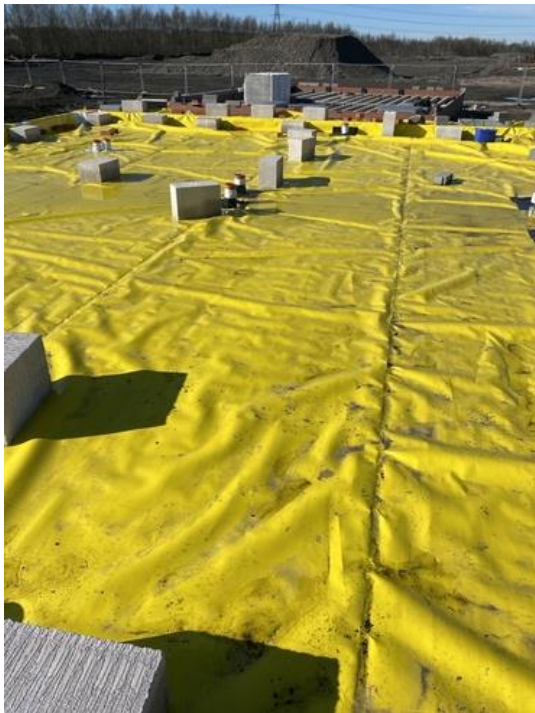
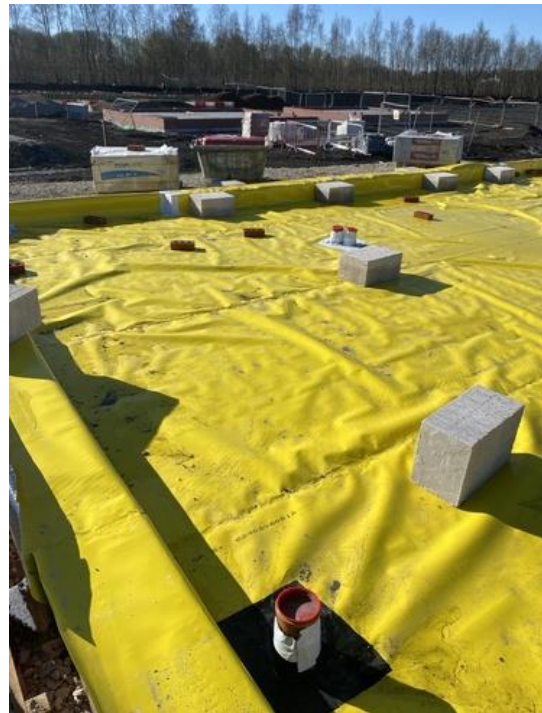
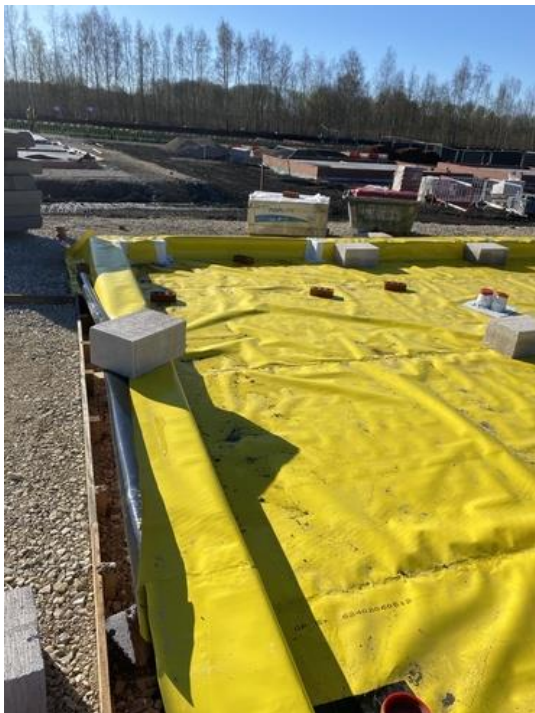
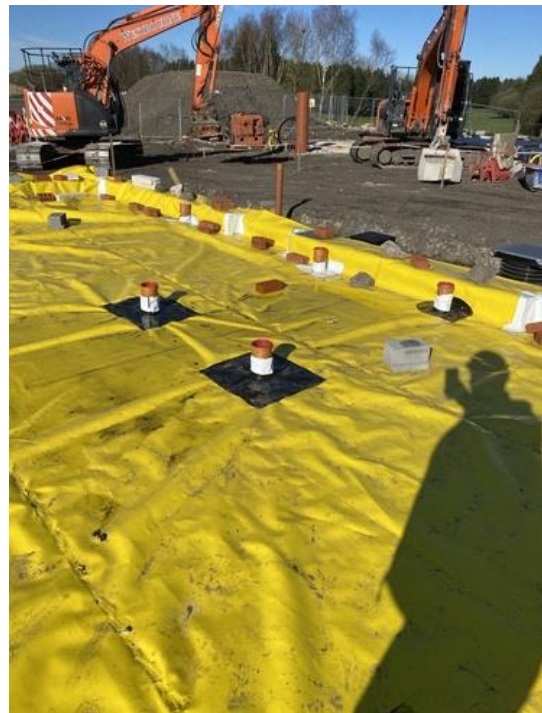
E3P can confirm that there were no holes or rips at the inspection time.

**Gas Membrane Condition: Open punctures, tears, rips, stretching, Presence of debris, Repairs, Signs of weakness such as raised or sunken indentations, Protection plan in place to restrict access to lain gas membrane? IF FAIL DESCRIPTION IN ACTIONS AND PHOTOS REQUIRED**

Pass

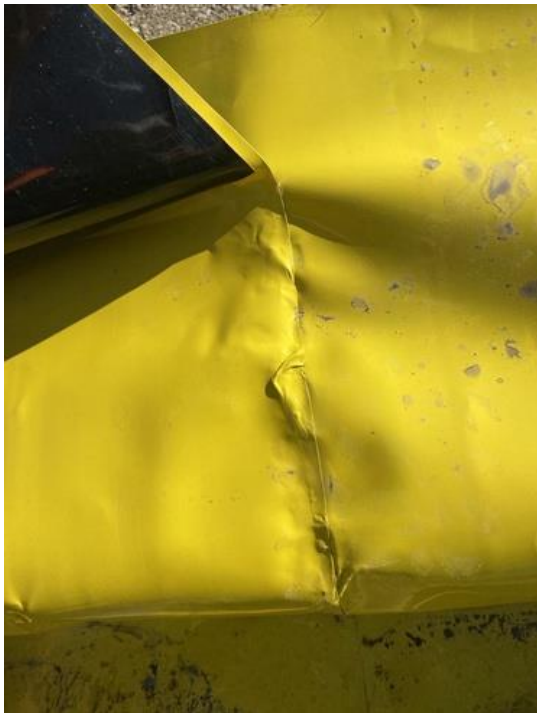
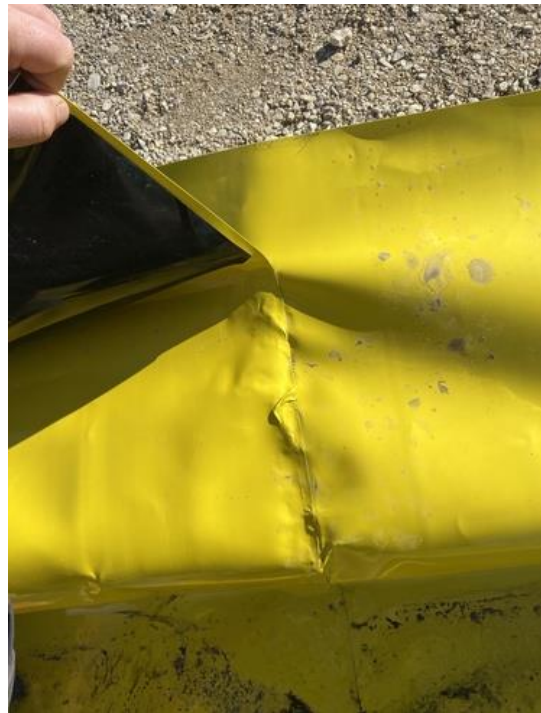
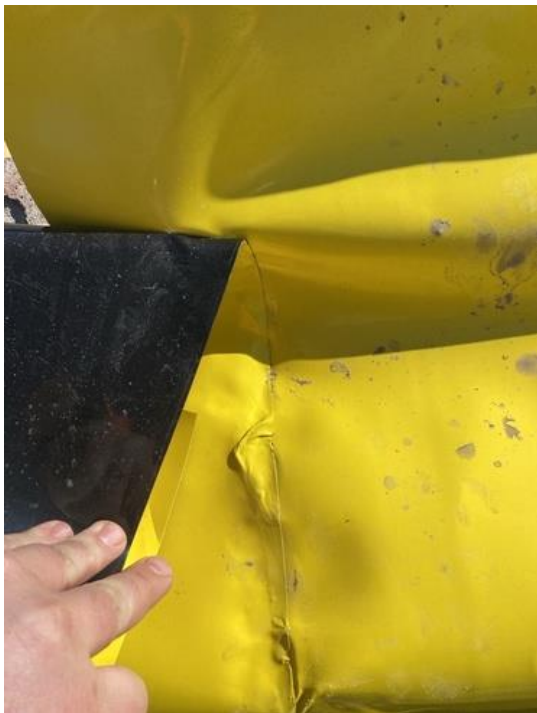
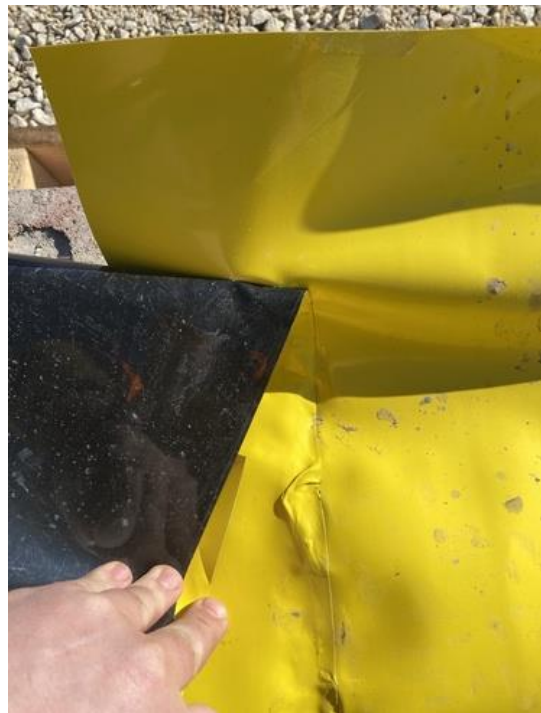
E3P inspected all joints including corner details and can confirm that the membrane was overlapped in accordance with the manufacturer's specification and heat welded.

| <b>Are welds complete?</b> | Yes |

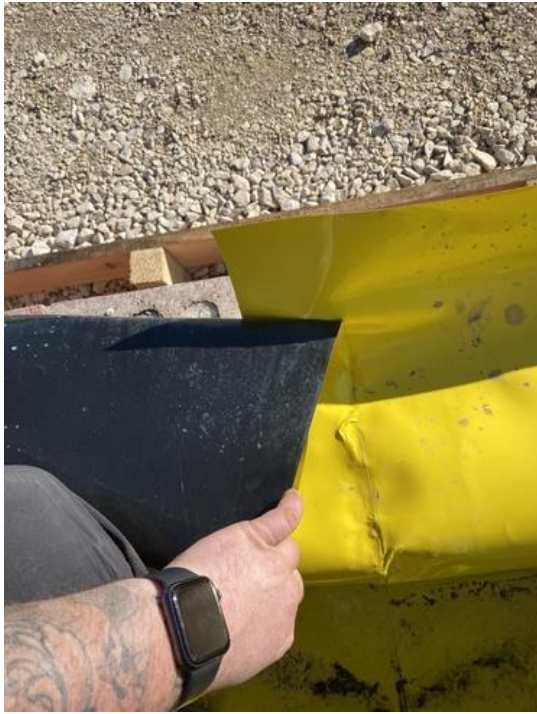
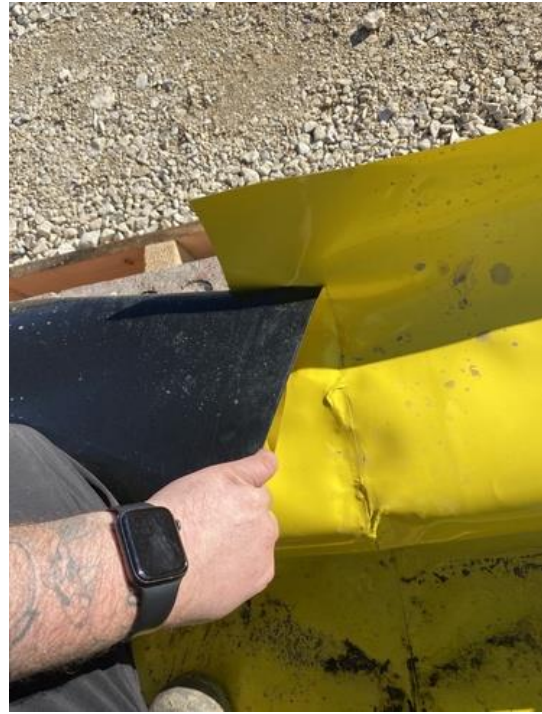
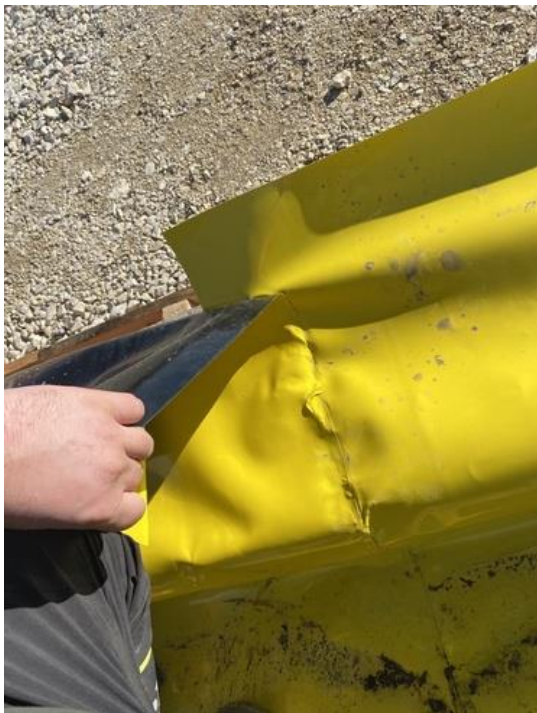
**Are Joints lapped and sealed in accordance with manufacturer's requirements/ specification?**

Yes

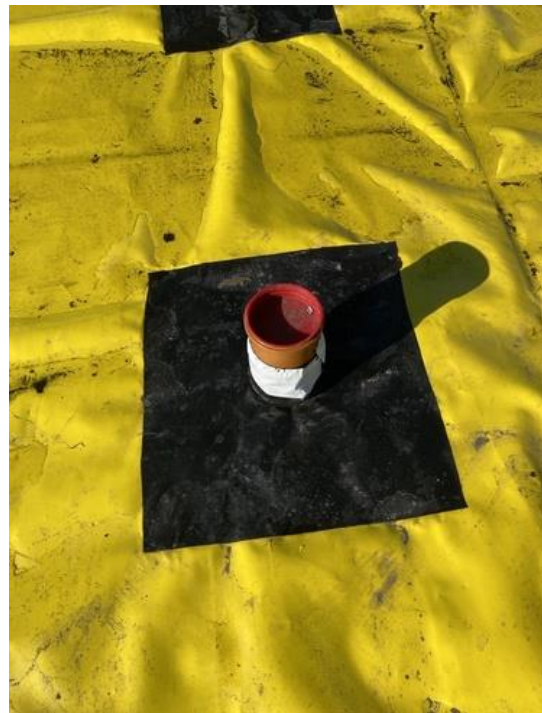
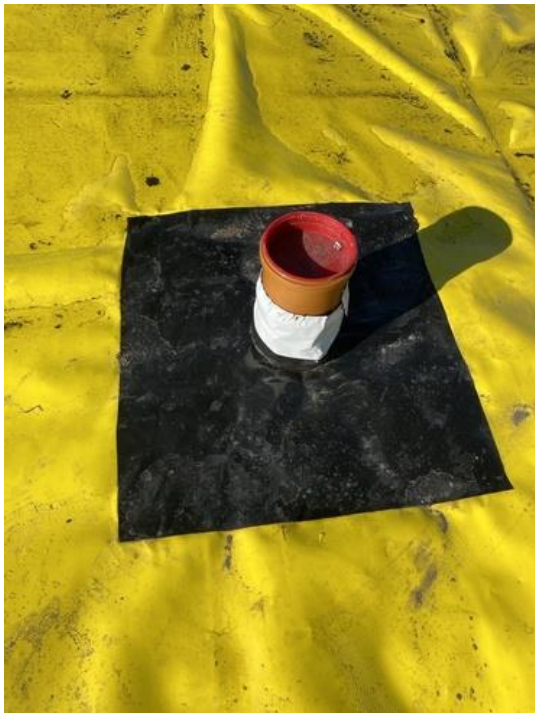
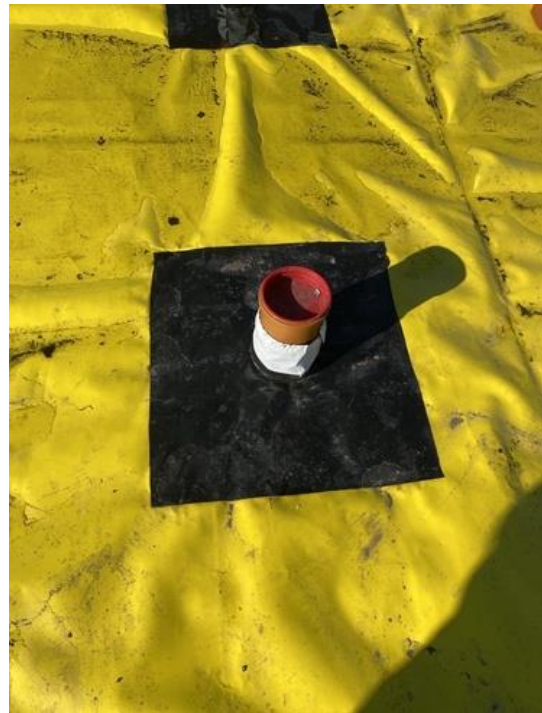
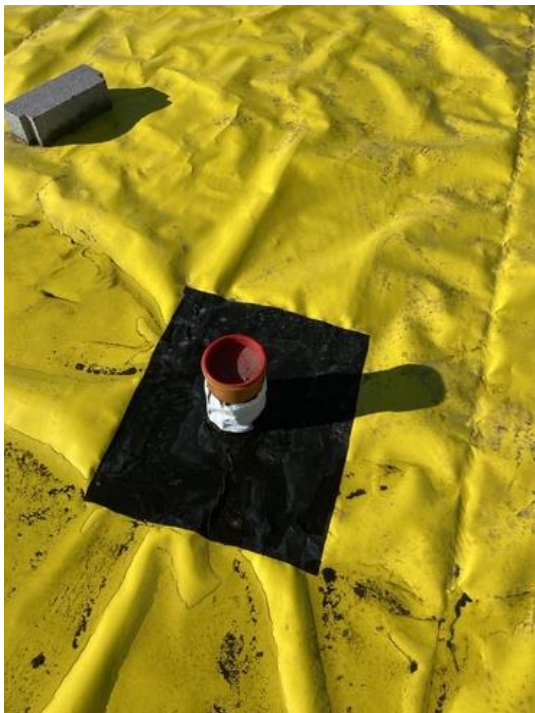
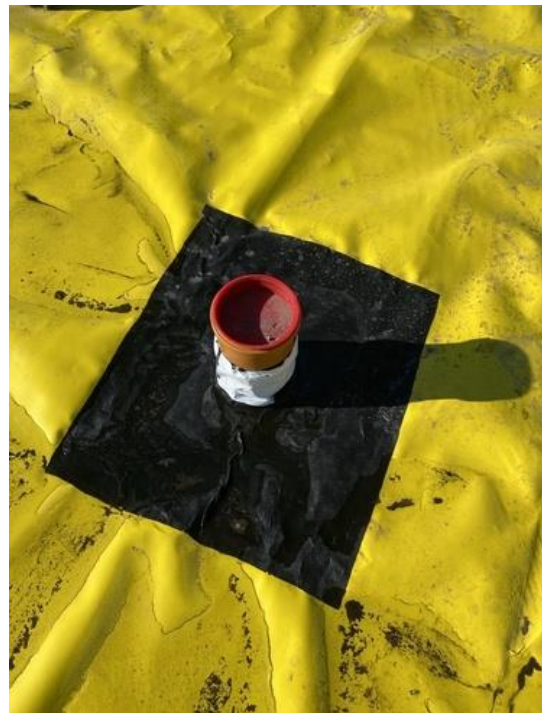
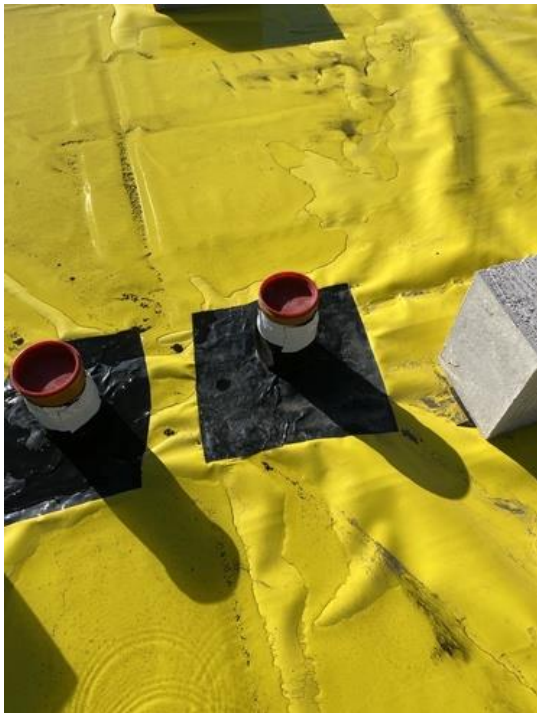
Where any penetration or service duct is present within the floor area E3P inspected each one in turn and can confirm that rigid black polyethylene top hat units have been adequately sealed against the membrane with double-sided jointing tape at both the base and the protruding pipe.

**Service entries seals: Top hats seal arrangements fixed around service entries? Use of Jubilee clips or Bitumastic Sealant**

Pass

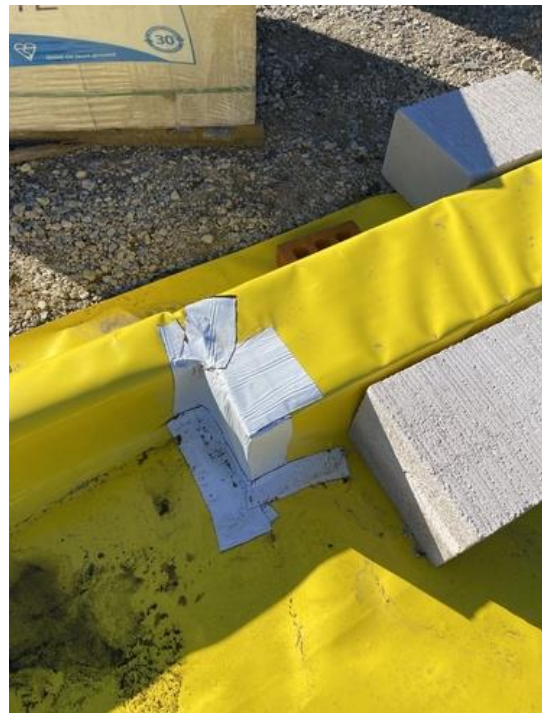
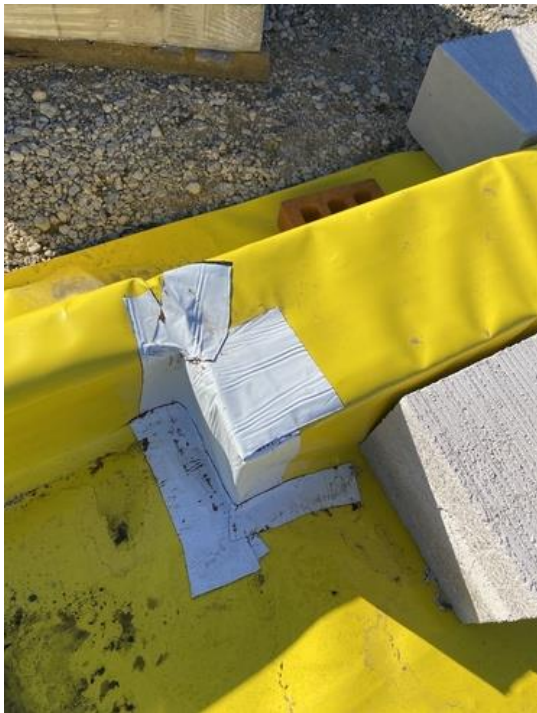
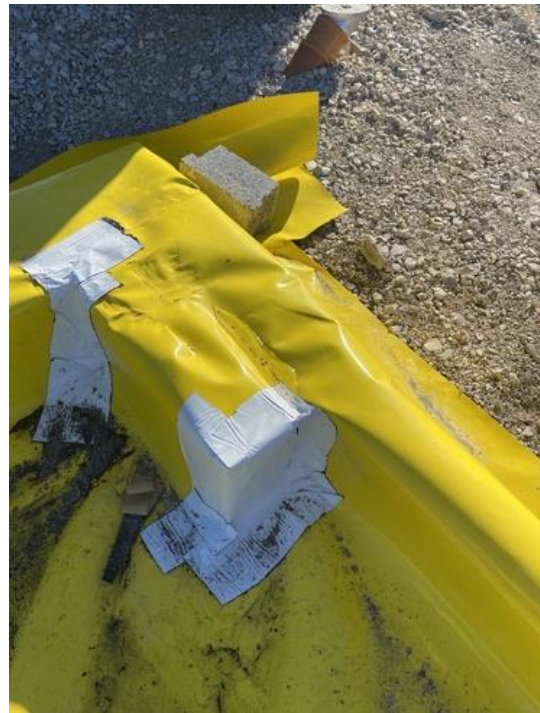
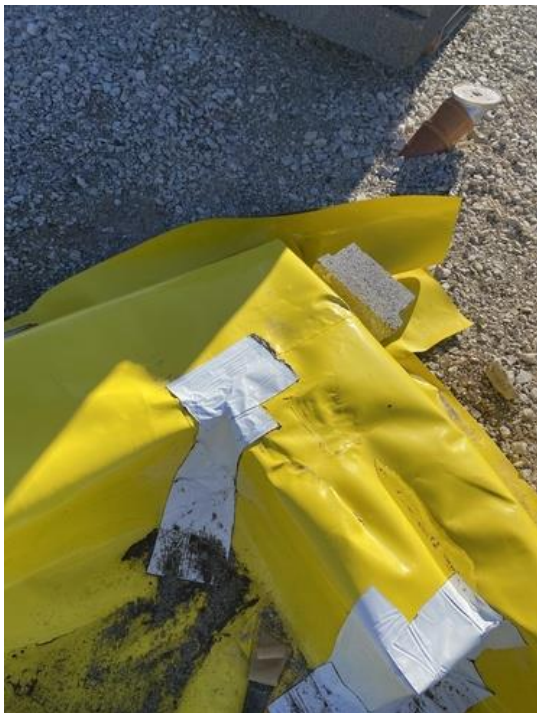
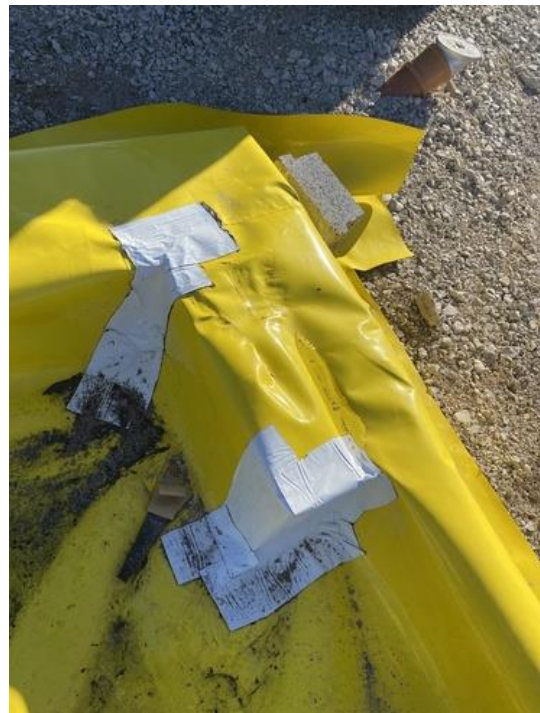
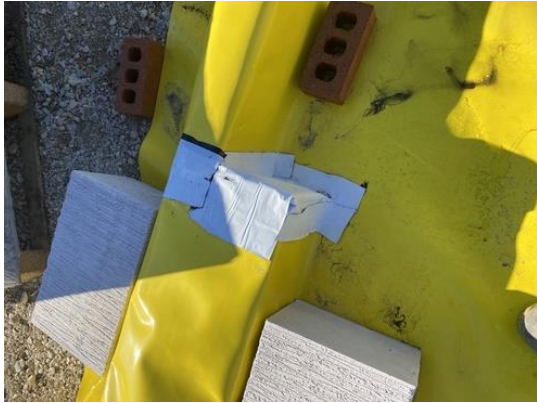
**Corners / Internal joints: Check all corners are correctly formed or contractor has used preformed corners.**

Pass

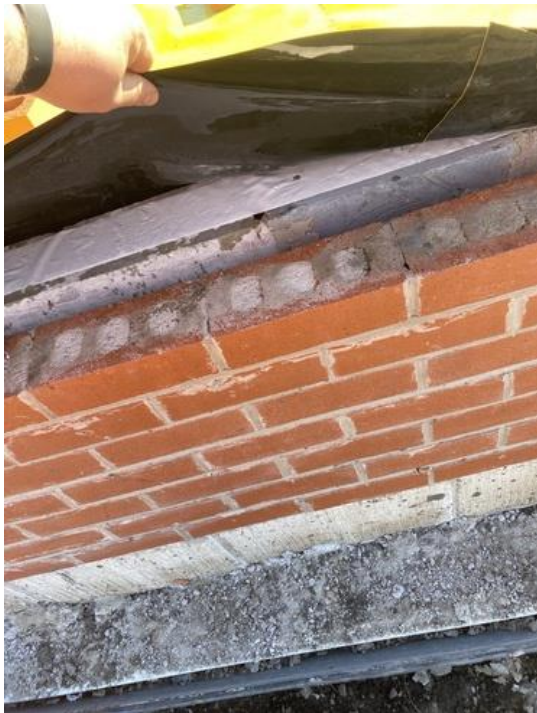
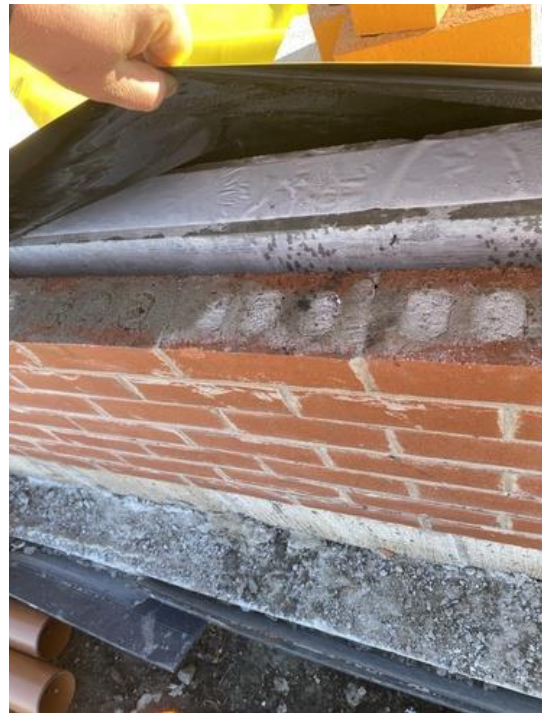
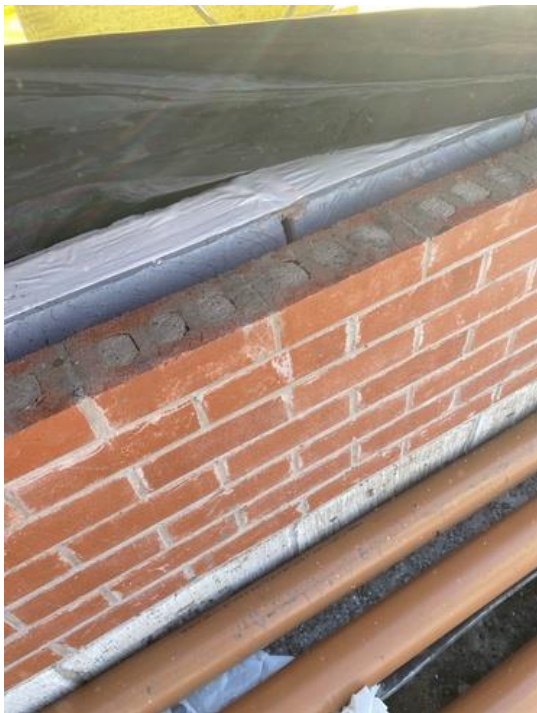
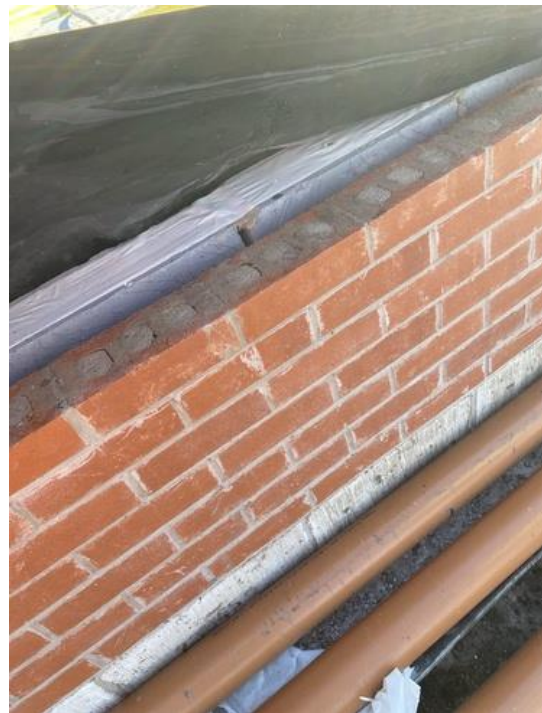
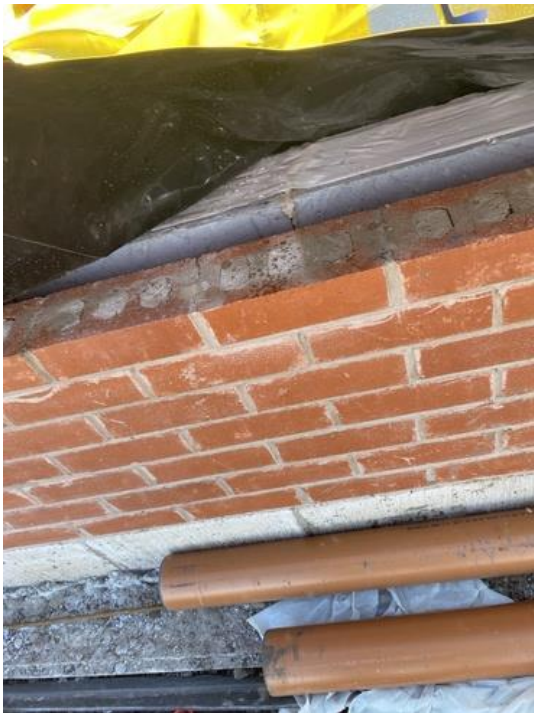
In accordance with the design, gas resistant butyl sealing tape is required beneath the membrane on the inner wall beneath the timber frame sole plate. E3P can confirm the butyl sealing tape has been installed accordingly.

**Sealant to the underside of the membrane at the sole plate position (Check with PM if not noted on schedule)**

Yes

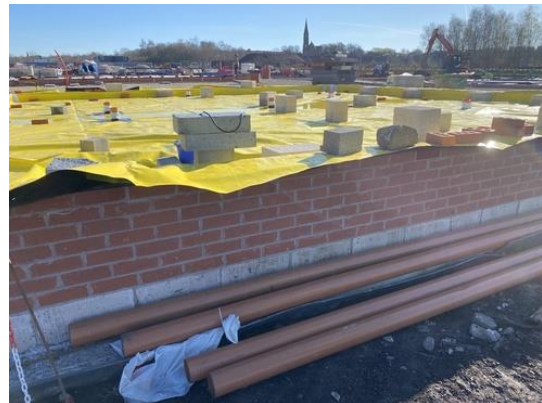
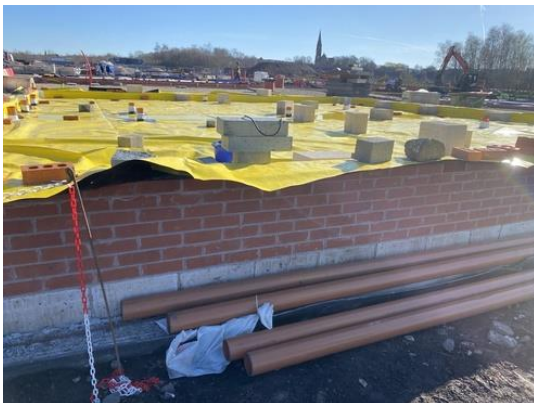
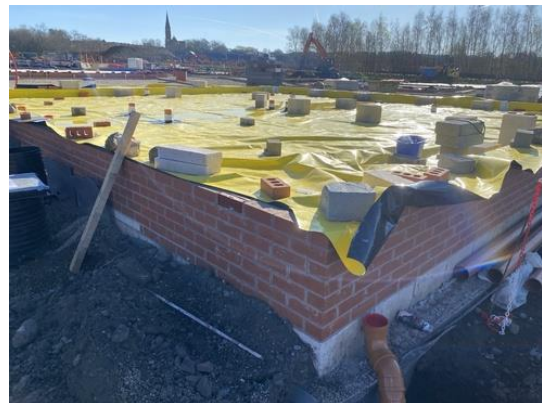
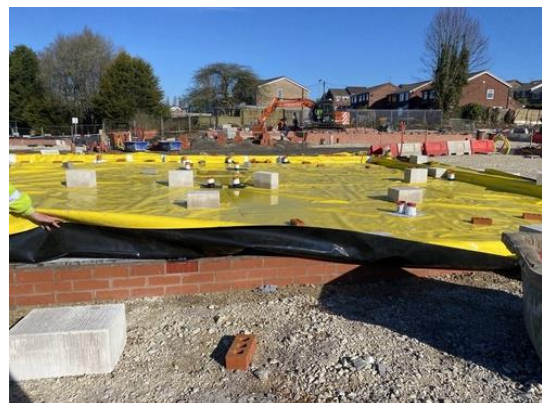
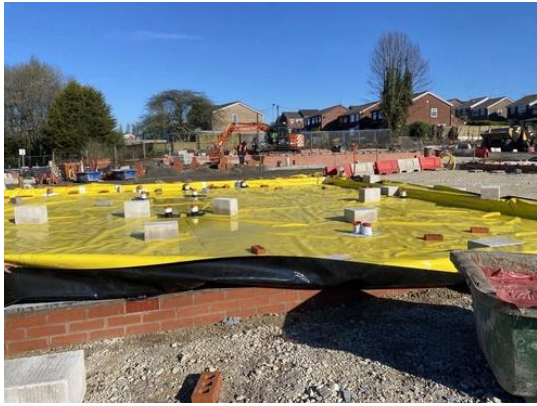
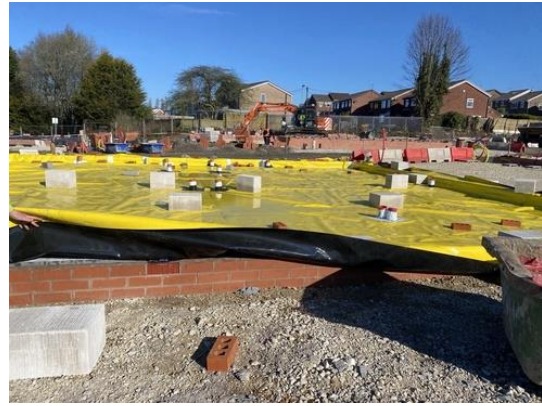
As per NHBC guidance and the structural engineers design as part of the mitigation a telescopic vent and vent brick is required at 2 m intervals in the brick course. E3P can confirm these have also been fitted accurately on all elevations of the plot to allow the sufficient function of the passive sub-floor ventilation system.

**External Wall Air bricks: Numbers, size. positions as design drawing? (Minimum of 3 walls)**

Pass
