Date: 19 March 2025  
Reference: 14-768-V2

## GAS MEMBRANE VALIDATION – HAWKS VIEW, CASTLETON

| <b>Project Name:</b> | Hawks View, Castleton (formerly known as Castleton Sidings) |
| <b>Plots:</b> | Membrane – Plots 18-21 |

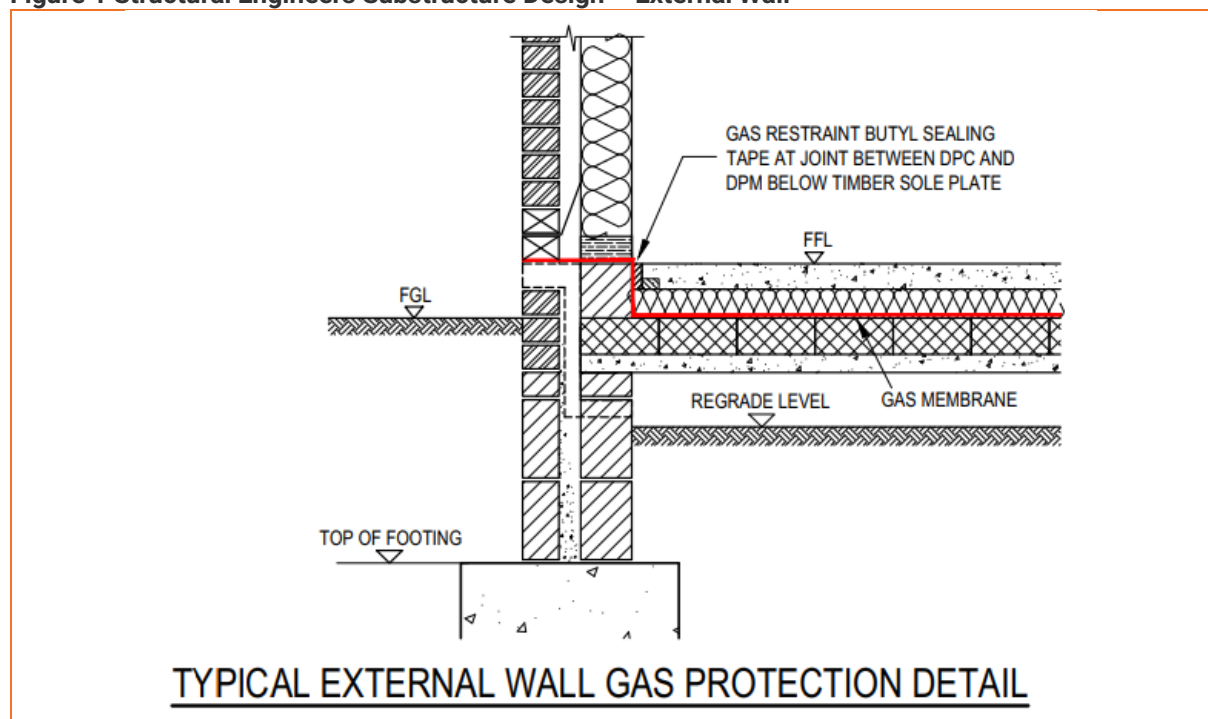
Figure 1 Structural Engineers Substructure Design – External Wall

The E3P Technician has inspected the installation of this membrane in line with the structural engineer's specifications in terms of placement and position (Figure 1-3), and the manufacturer's detail in terms of the workmanship.

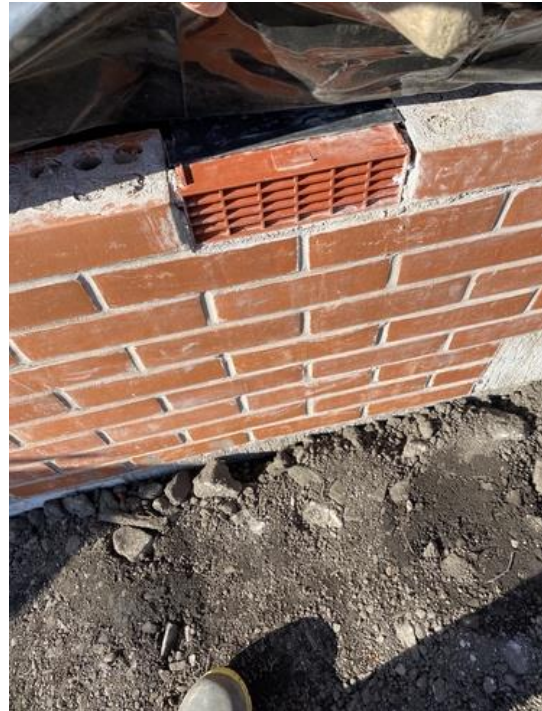
Photo 1

| <b>Are telescopic vents present?</b> | Yes |

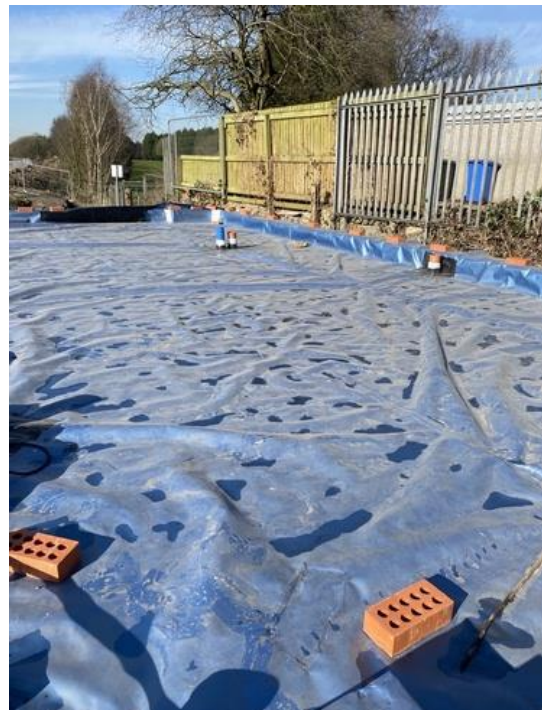
Photo 3

| <b>Gas Membrane Condition: Open punctures, tears, rips, stretching, Presence of debris, Repairs, Signs of weakness such as raised or sunken indentations, Protection plan in place to restrict access to lain gas membrane? IF FAIL DESCRIPTION IN ACTIONS AND PHOTOS REQUIRED</b> | Pass |

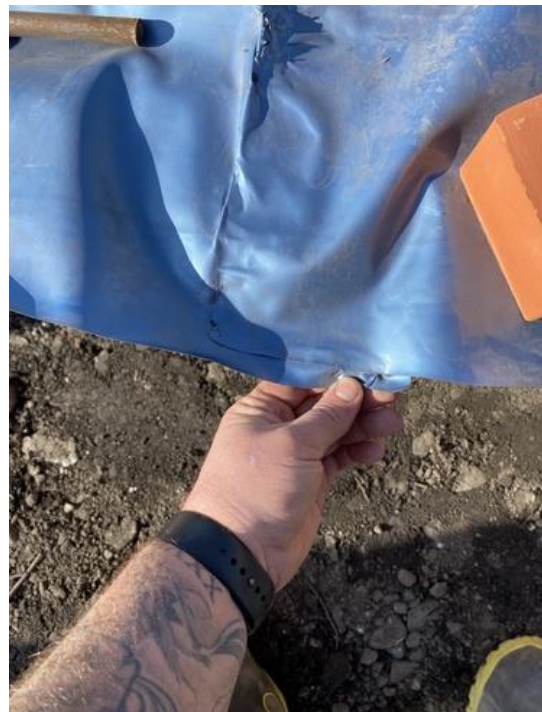
Photo 7

| <b>Are welds complete?</b> | Yes |

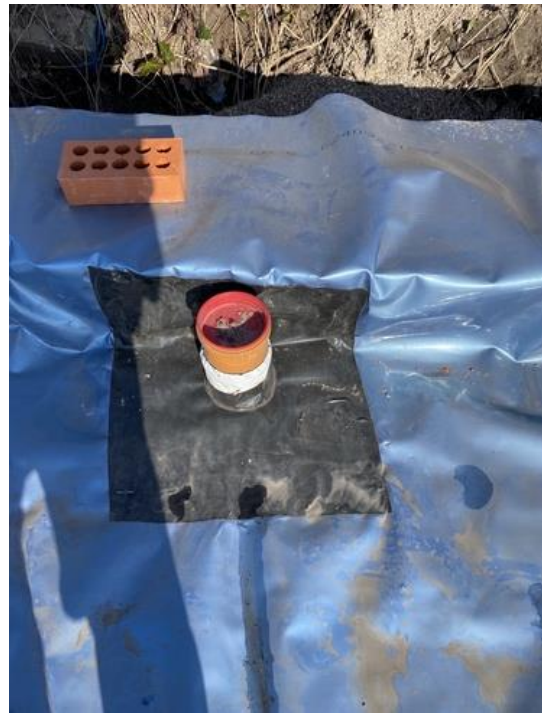
Photo 9

**Service entries seals: Top hats seal arrangements fixed around service entries? Use of Jubilee clips or Bitumastic Sealant**

Pass

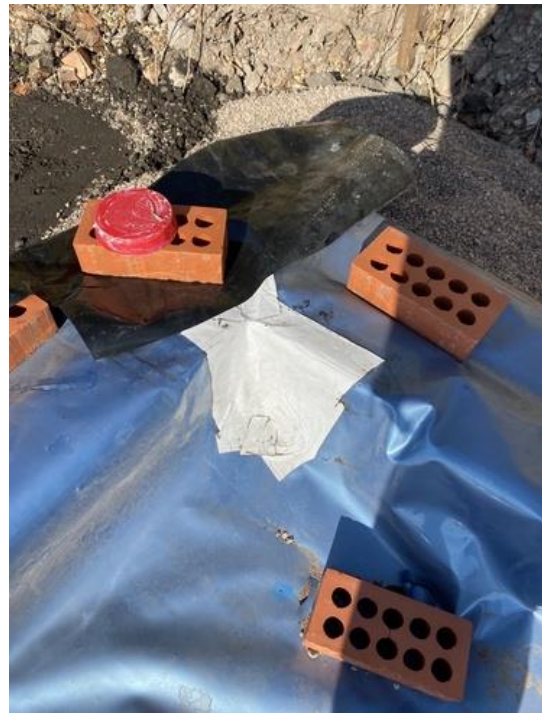
Photo 17

**Corners / Internal joints: Check all corners are correctly formed or contractor has used preformed corners.**

Pass
