Date: 29th April 2025  
Reference: 14-768-V10

## GAS MEMBRANE VALIDATION – HAWKS VIEW, CASTLETON

| <b>Project Name:</b> | Hawks View, Castleton (formerly known as Castleton Sidings) |
| <b>Plots:</b> | Membrane – Plots 181-184 |

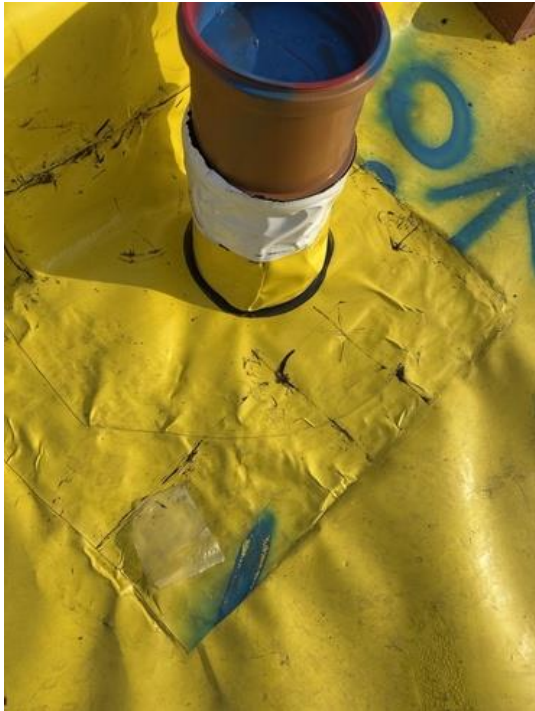
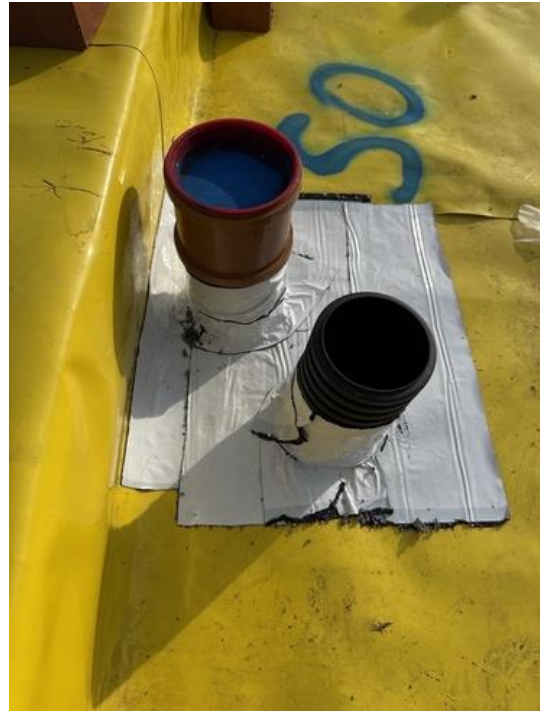
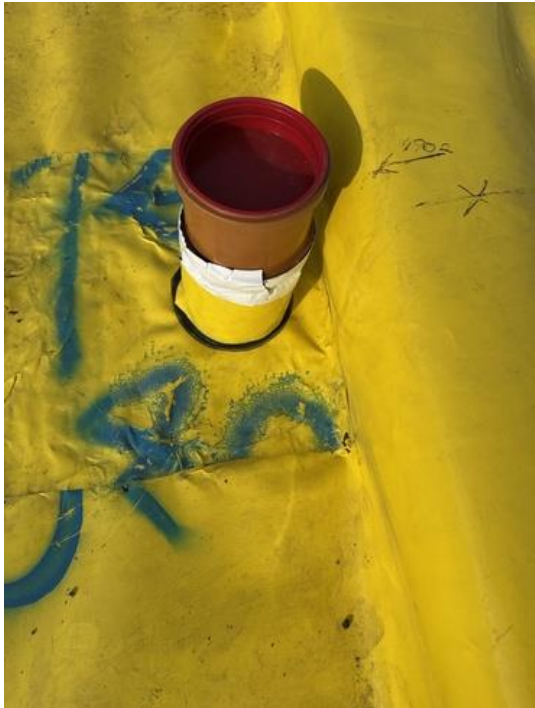
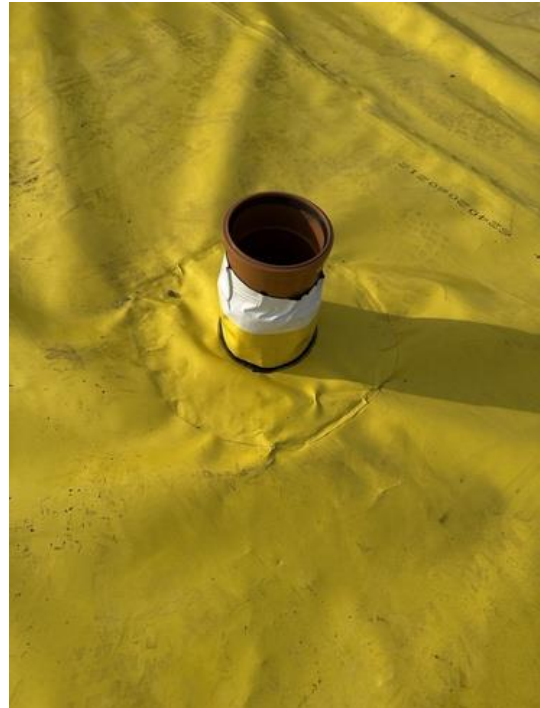
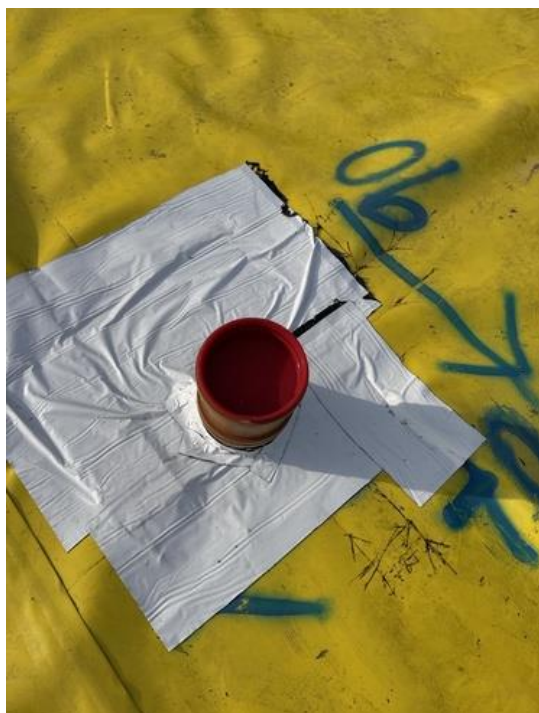
| <b>Service entries seals: Top hats seal arrangements fixed around service entries? Use of Jubilee clips or Bitumastic Sealant</b> | Pass |

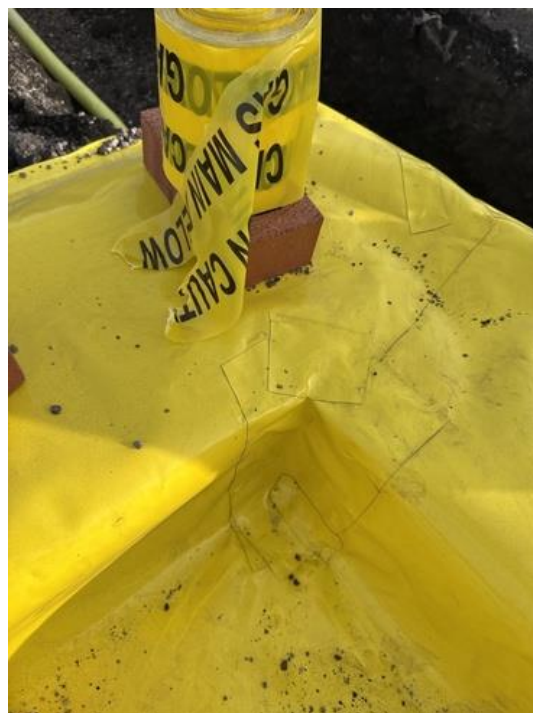
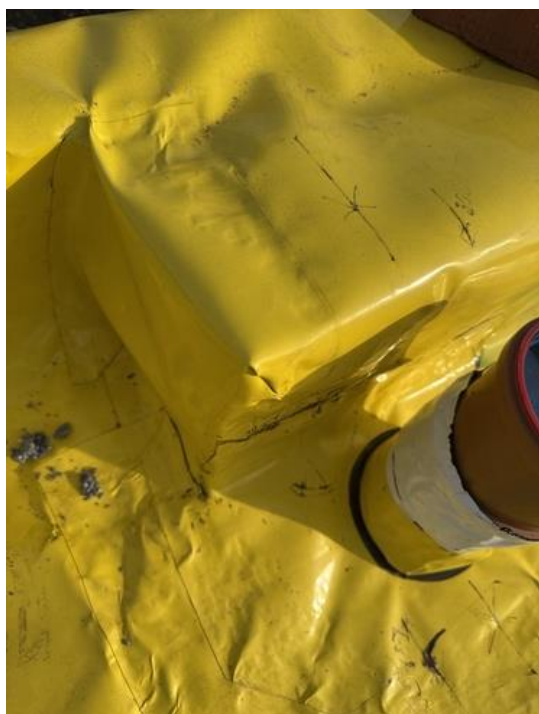
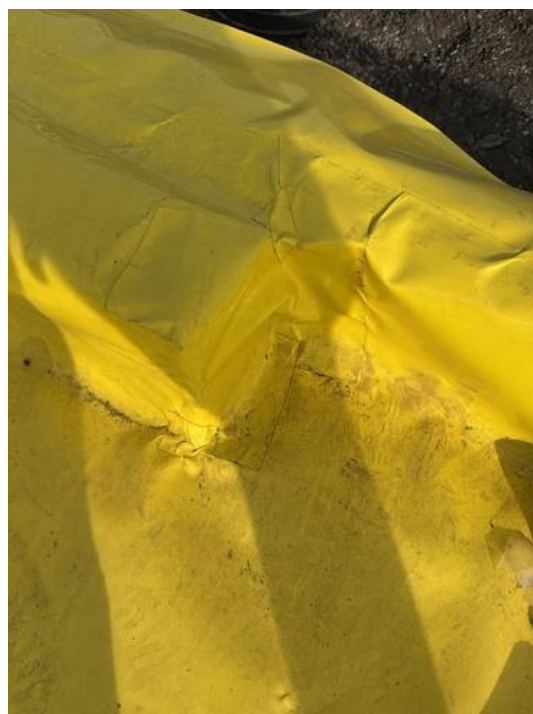
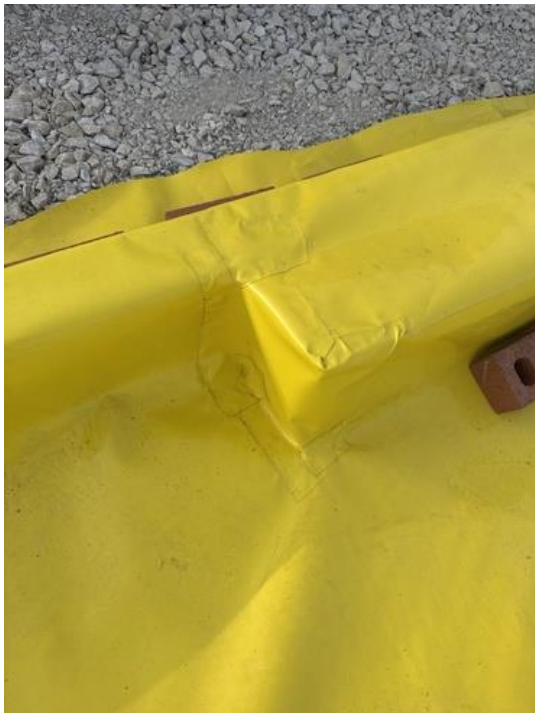
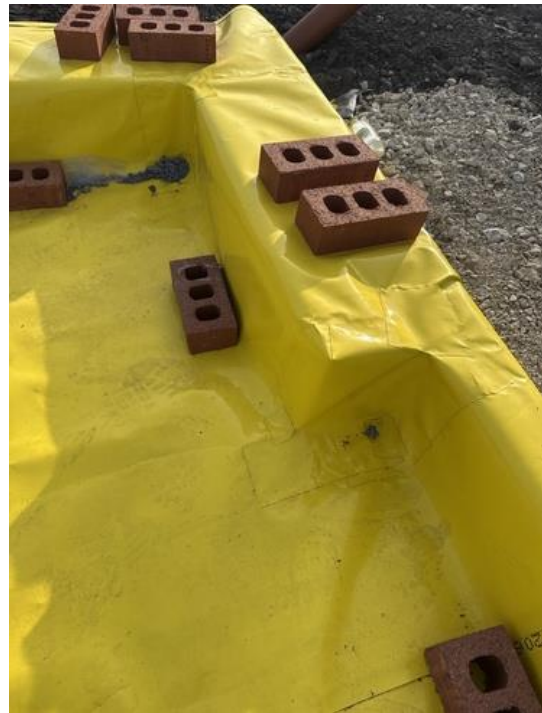
| <b>Corners / Internal joints: Check all corners are correctly formed or contractor has used preformed corners.</b> | Pass |

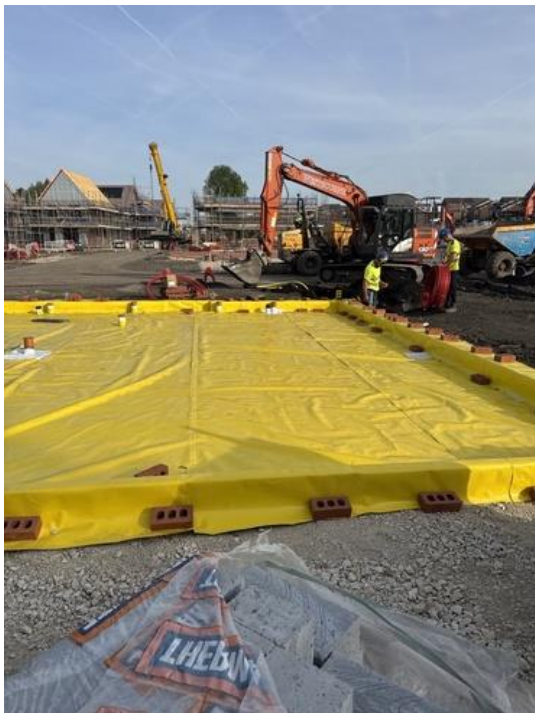
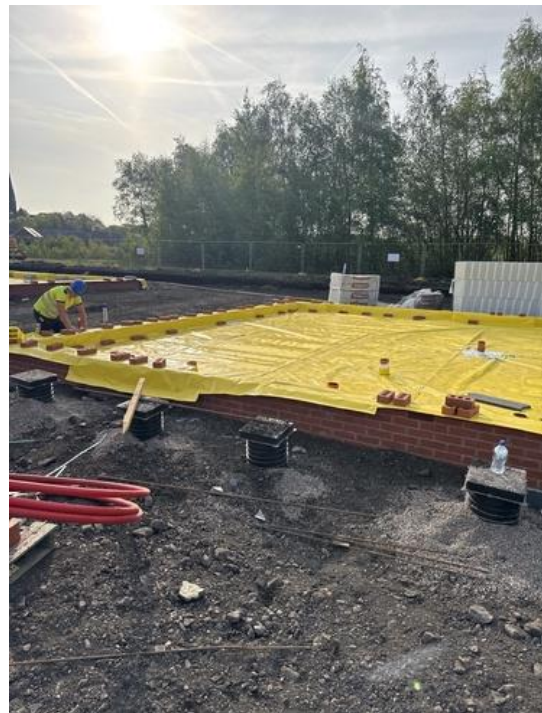
**Extent of Coverage: Is the membrane covering the entire plot? Does membrane span over outside walls?**

Yes

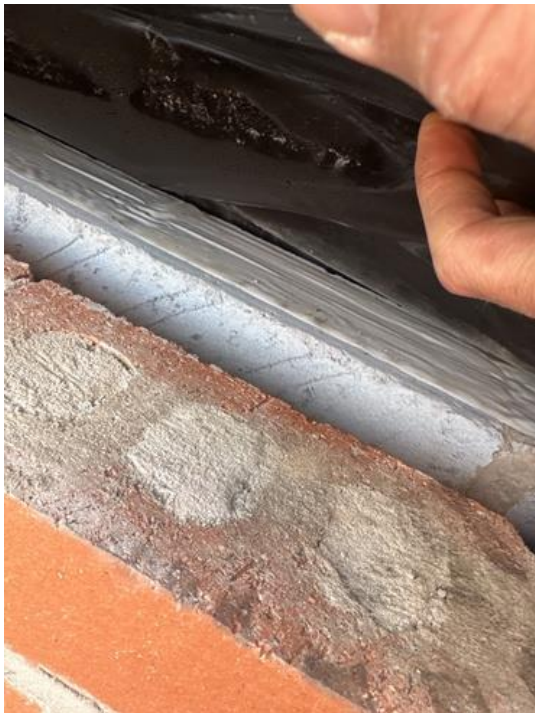
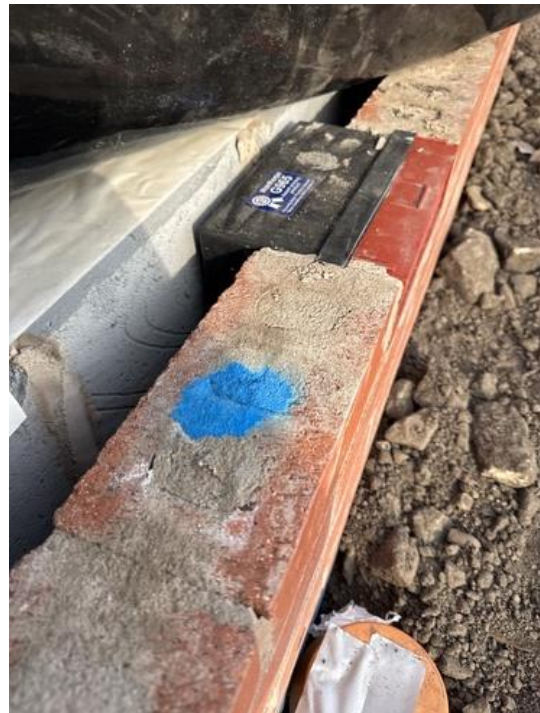
**Sealant to the underside of the membrane at the sole plate position (Check with PM if not noted on schedule)**

Yes

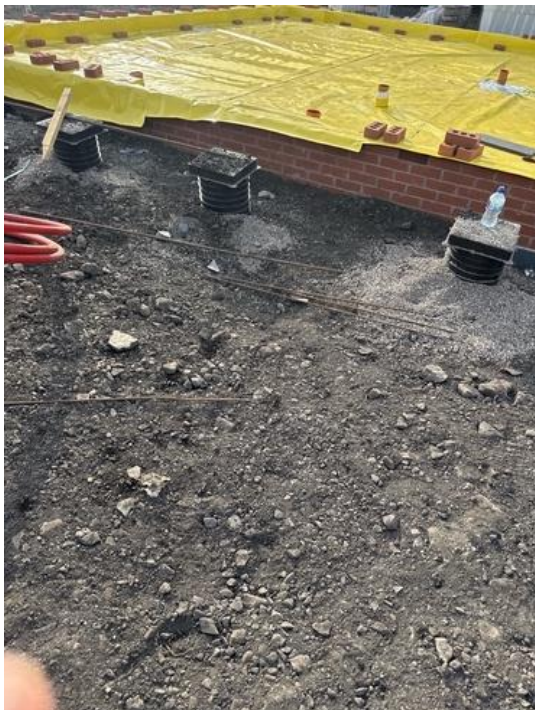
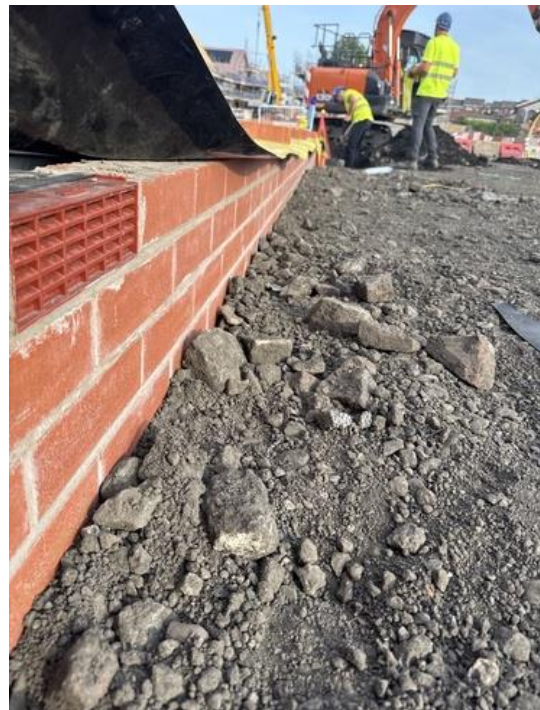
**External Wall Air bricks: Numbers, size. positions as design drawing? (Minimum of 3 walls)**

Pass

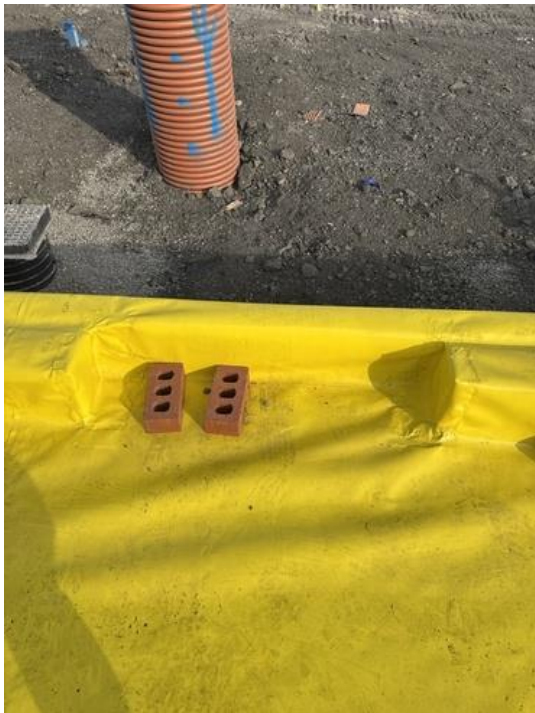
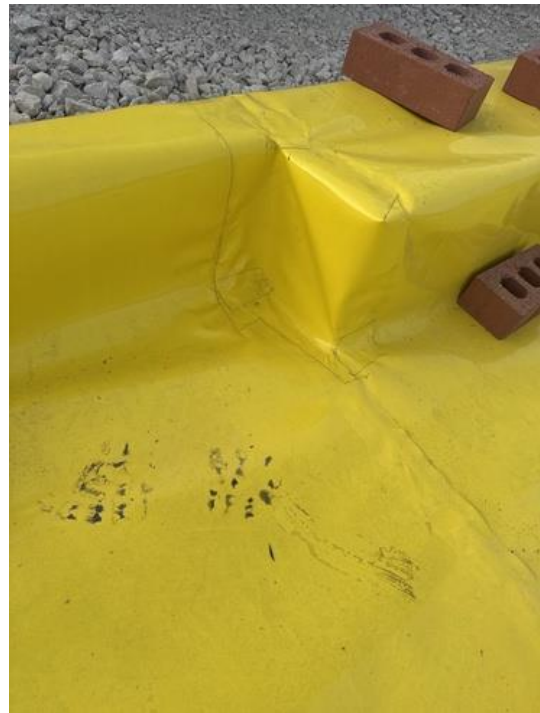
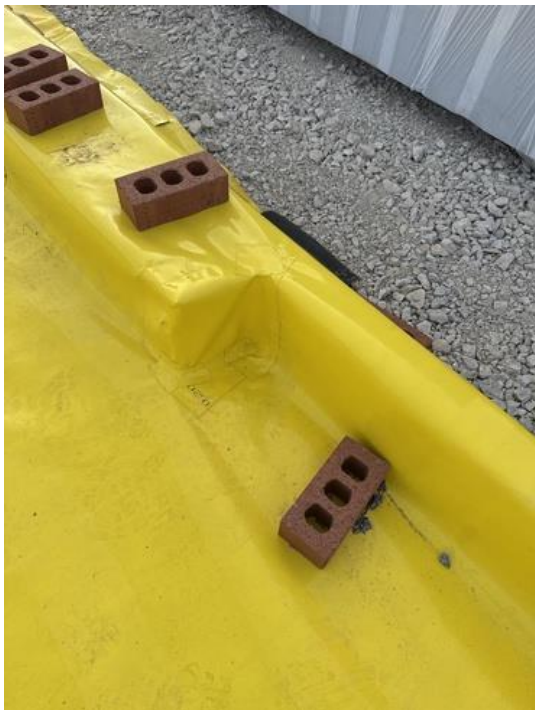
| Corners / Internal joints: Check all corners are correctly formed or contractor has used preformed corners. | Pass | |

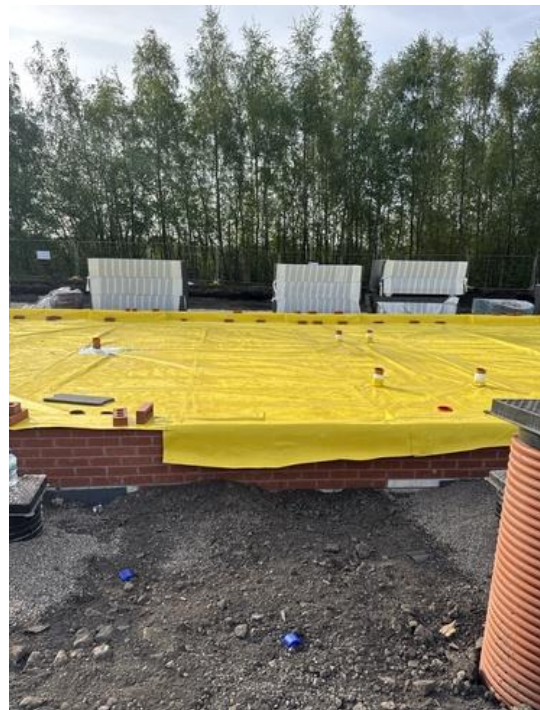
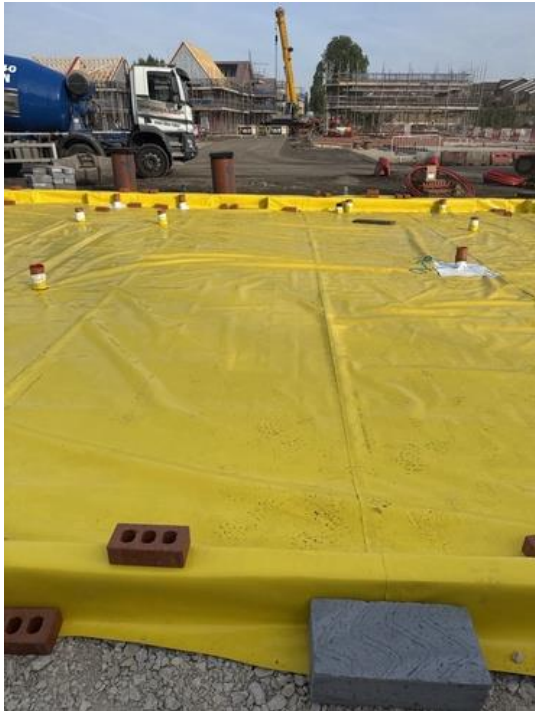
**Extent of Coverage: Is the membrane covering the entire plot?  
Does membrane span over outside walls?**

Yes

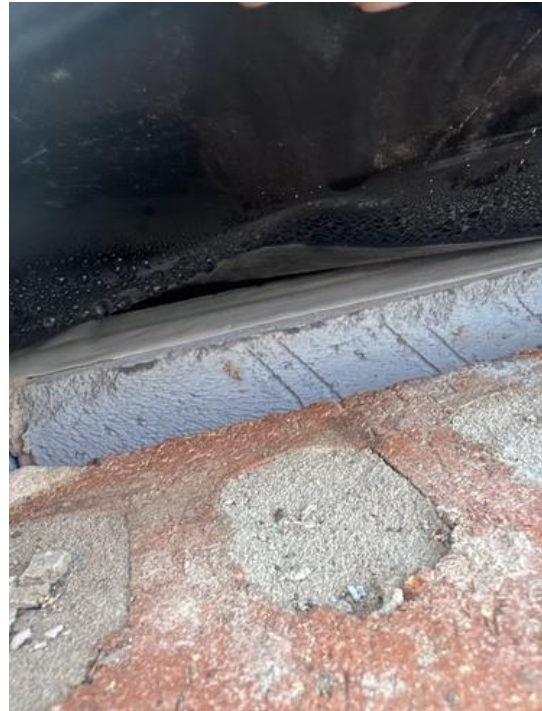
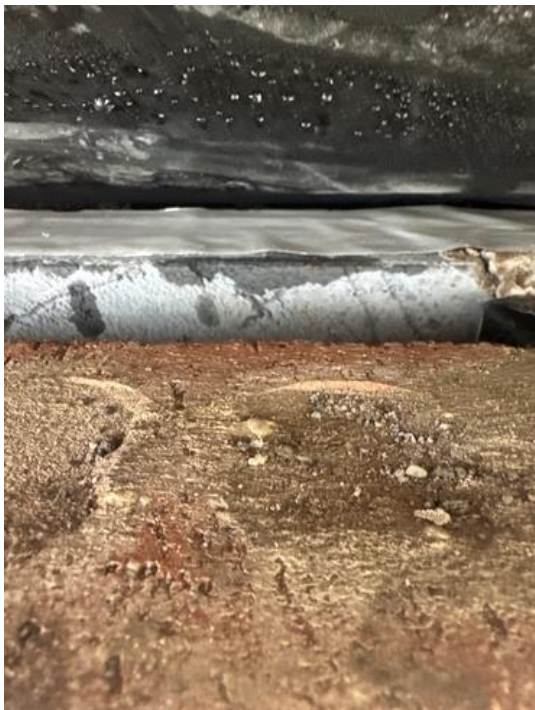
**Sealant to the underside of the membrane at the sole plate position (Check with PM if not noted on schedule)**

Yes

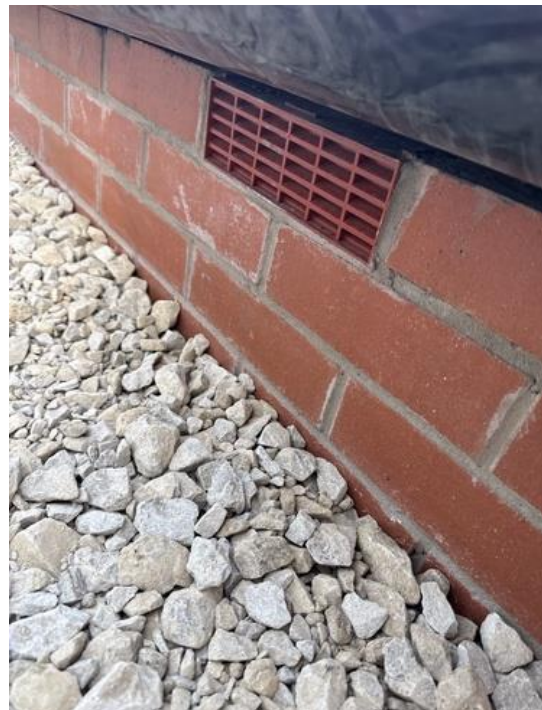
Photo 28

**External Wall Air bricks: Numbers, size. positions as design drawing? (Minimum of 3 walls)**

Pass

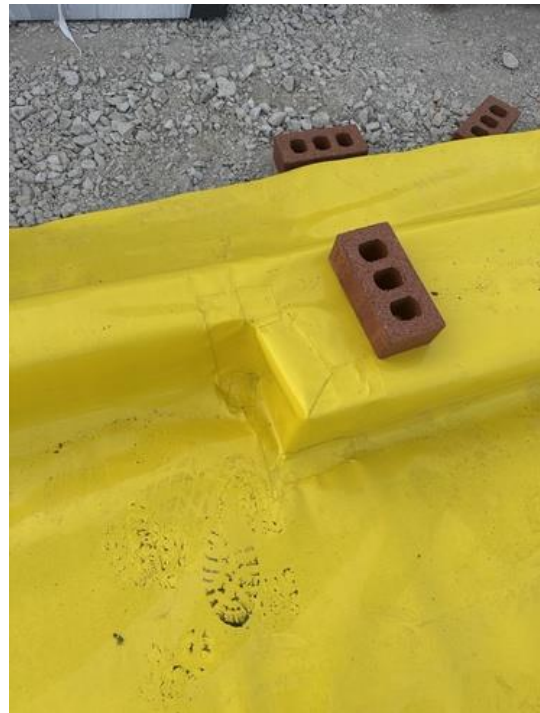
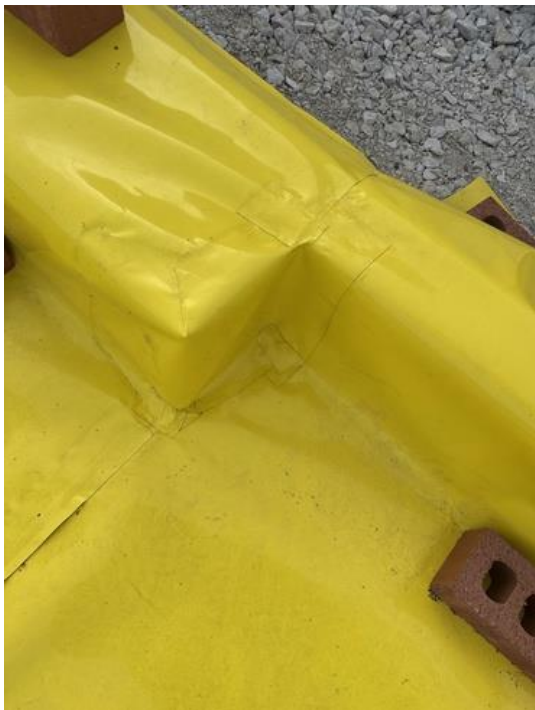
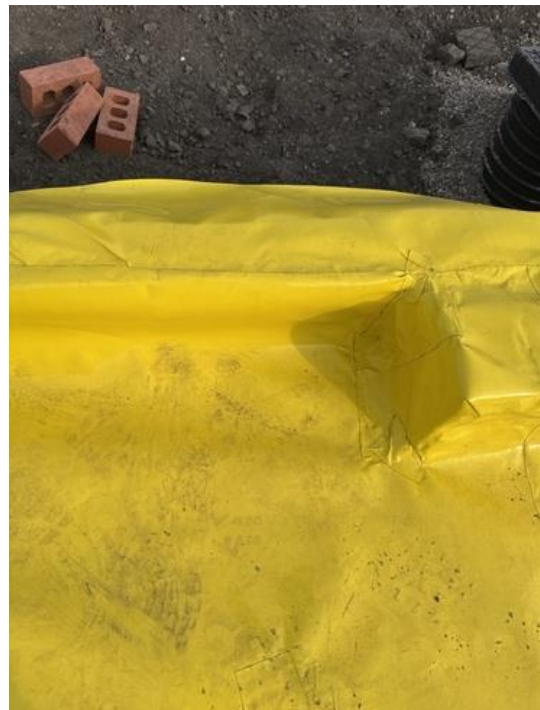
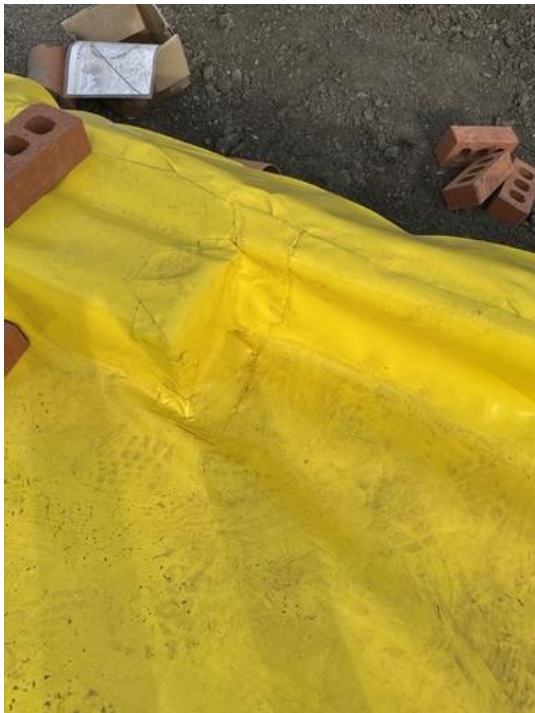
| Corners / Internal joints: Check all corners are correctly formed or contractor has used preformed corners. | Pass | |

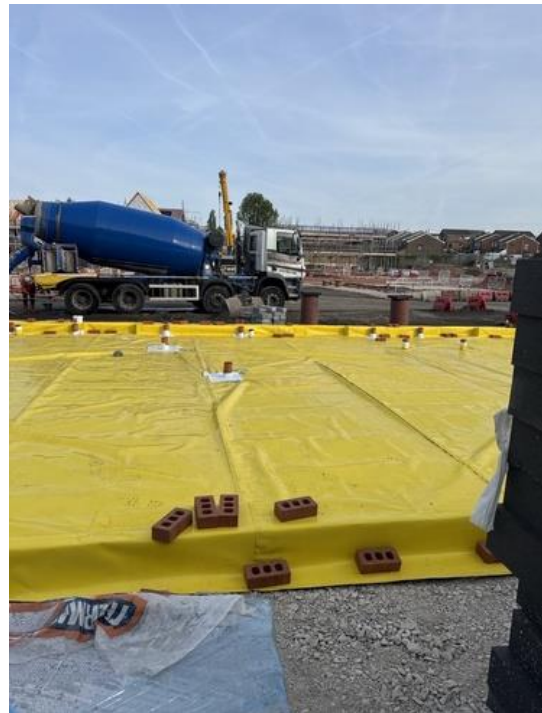
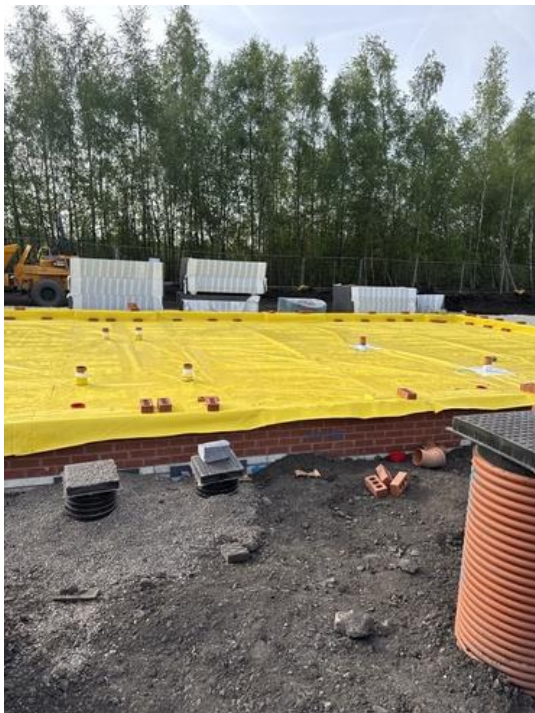
**Extent of Coverage: Is the membrane covering the entire plot?  
 Does membrane span over outside walls?**

Yes

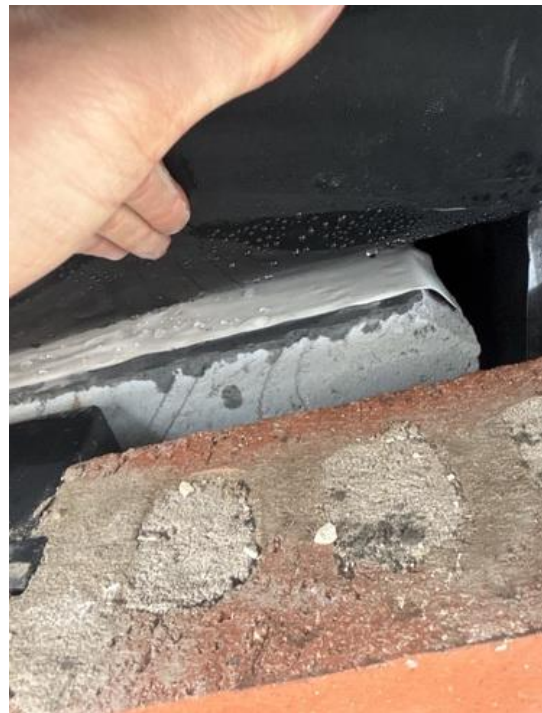
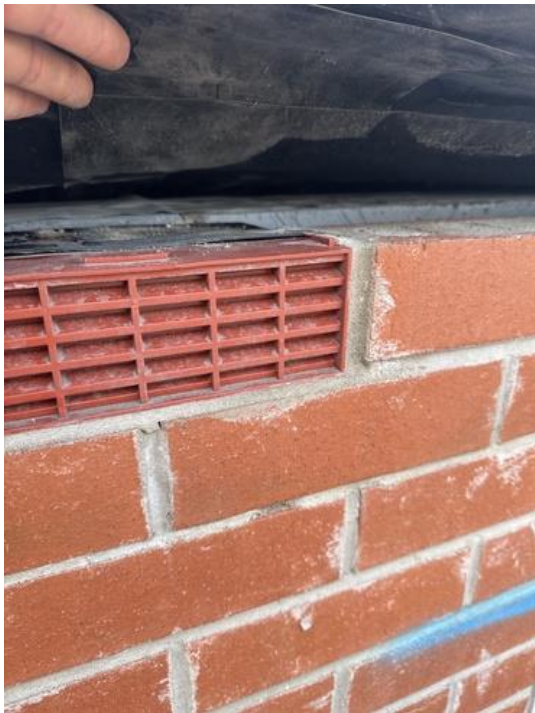
**Sealant to the underside of the membrane at the sole plate position (Check with PM if not noted on schedule)**

Yes

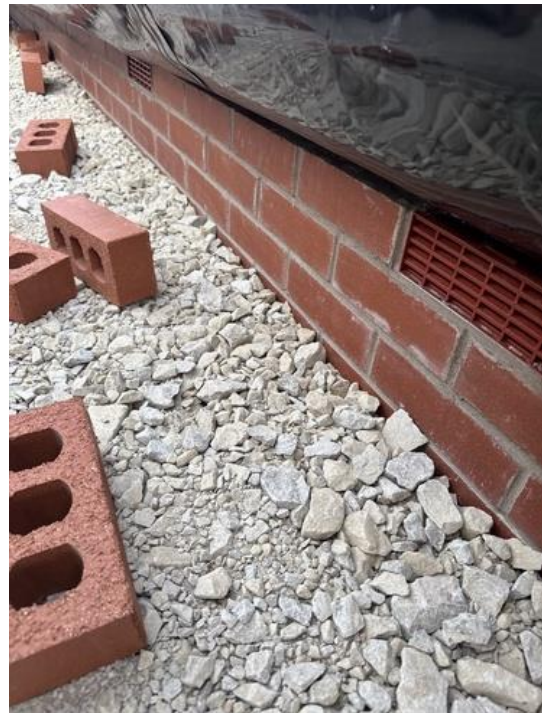
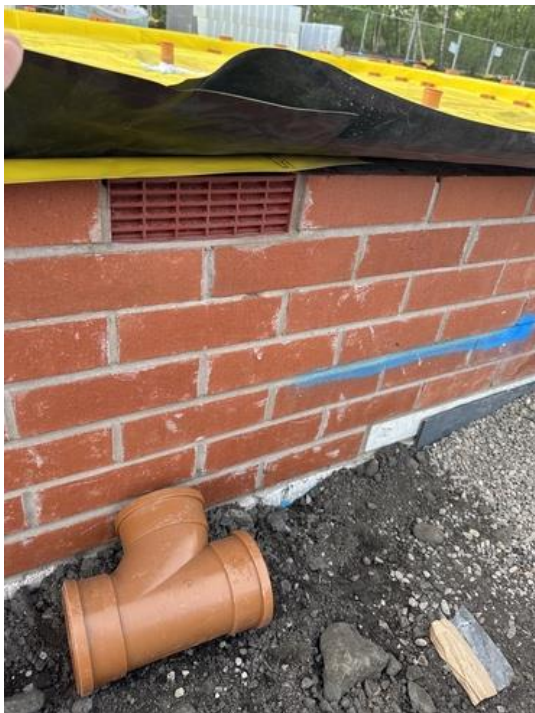
**External Wall Air bricks: Numbers, size. positions as design drawing? (Minimum of 3 walls)**

Pass

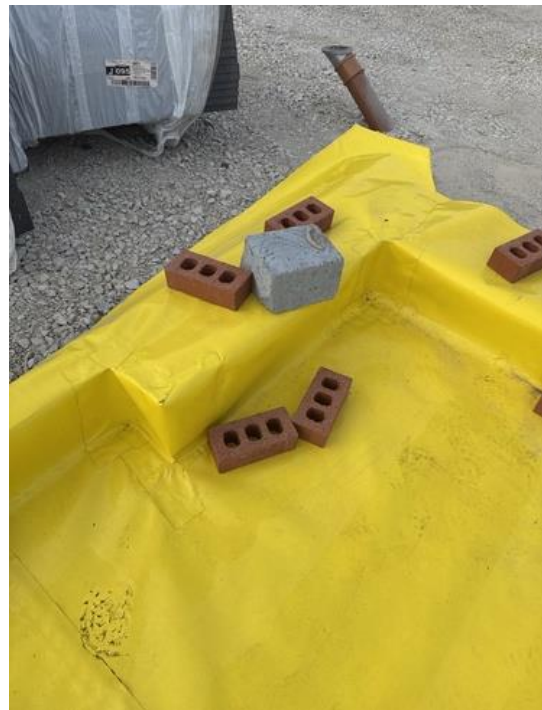
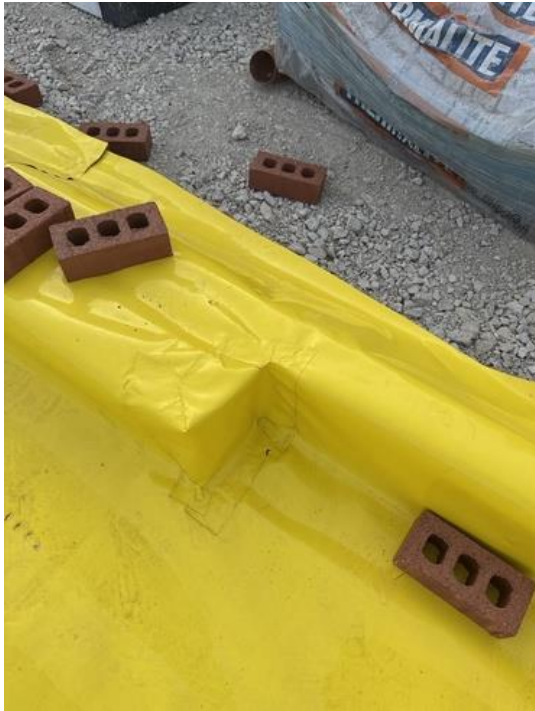
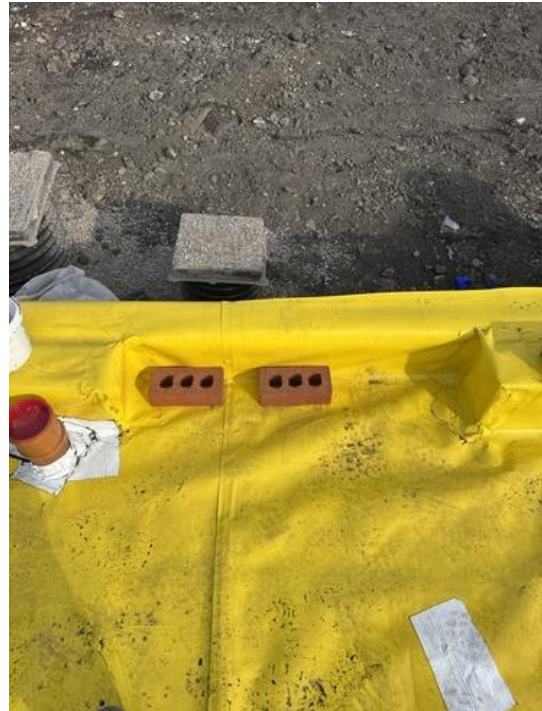
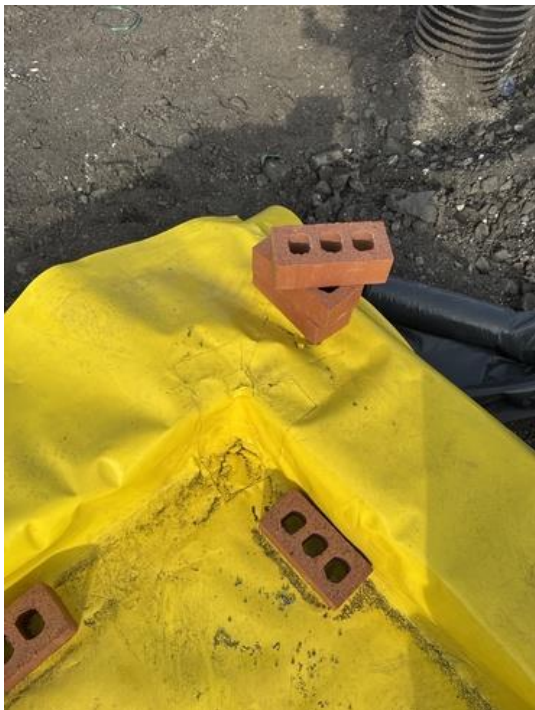
| Corners / Internal joints: Check all corners are correctly formed or contractor has used preformed corners. | Pass | |

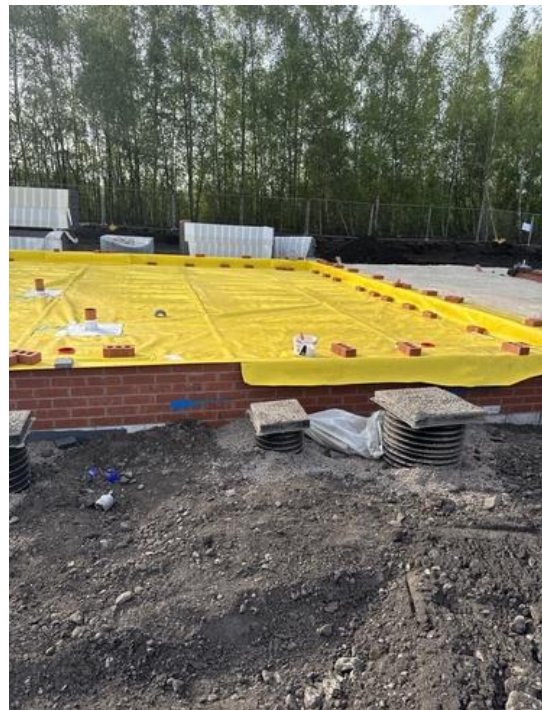
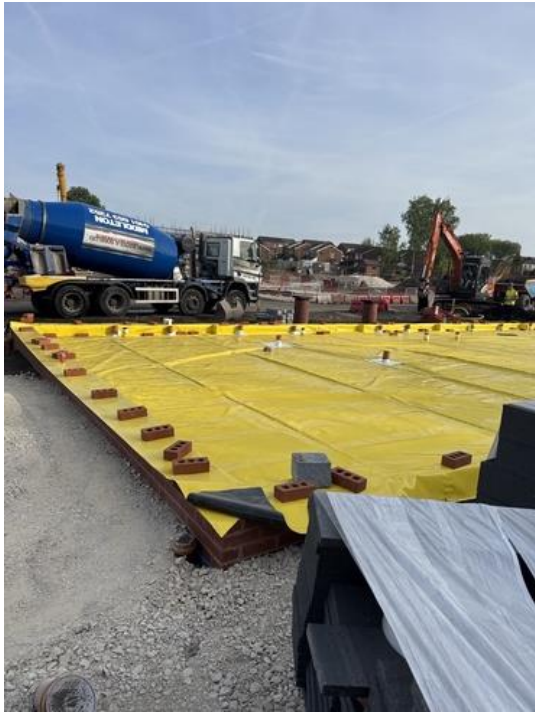
**Extent of Coverage: Is the membrane covering the entire plot? Does membrane span over outside walls?**

Yes

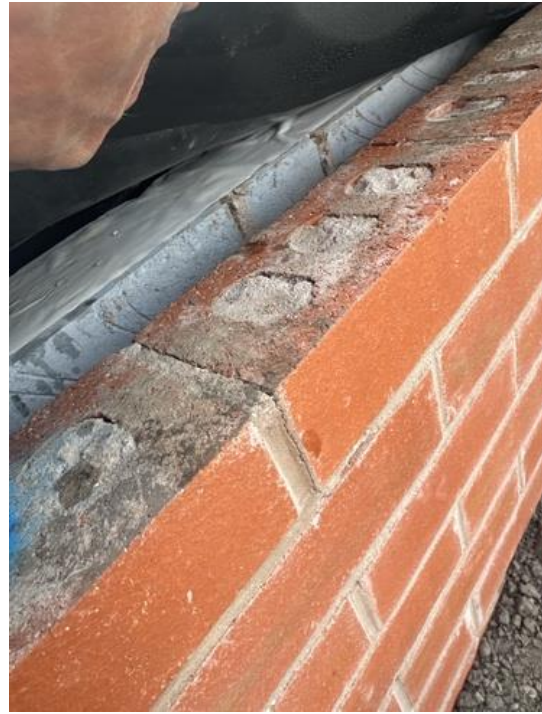
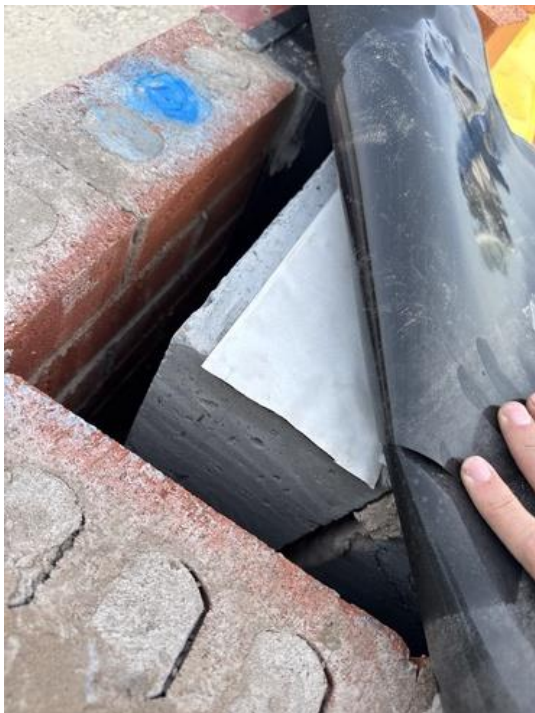
**Sealant to the underside of the membrane at the sole plate position (Check with PM if not noted on schedule)**

Yes

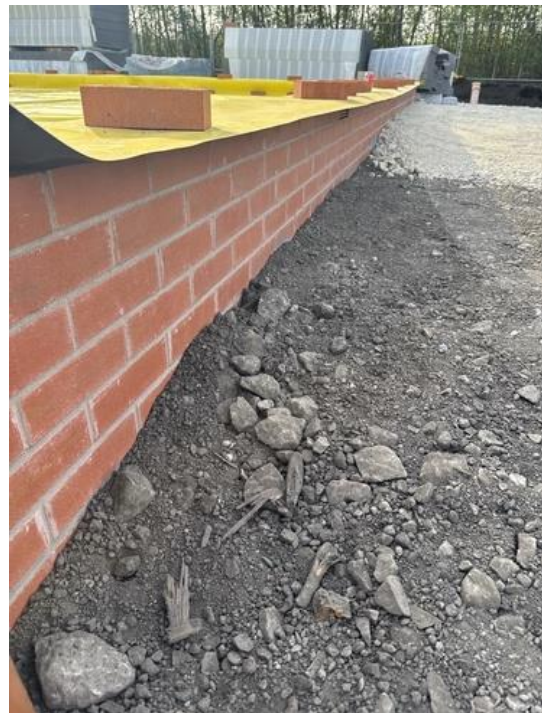
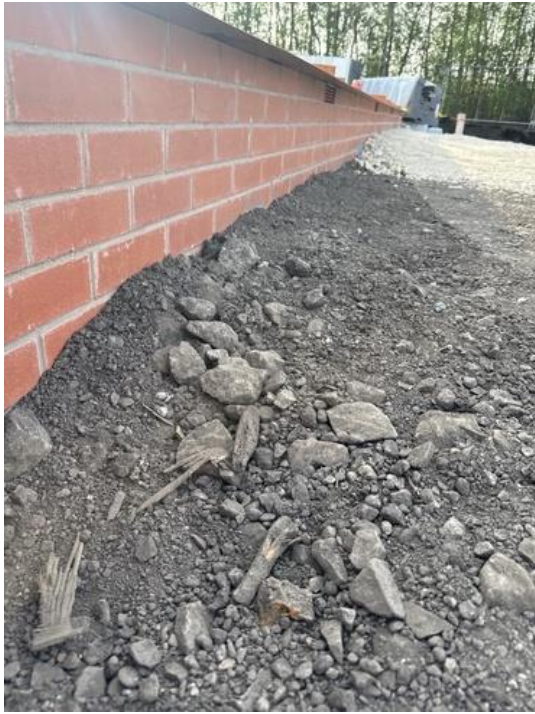
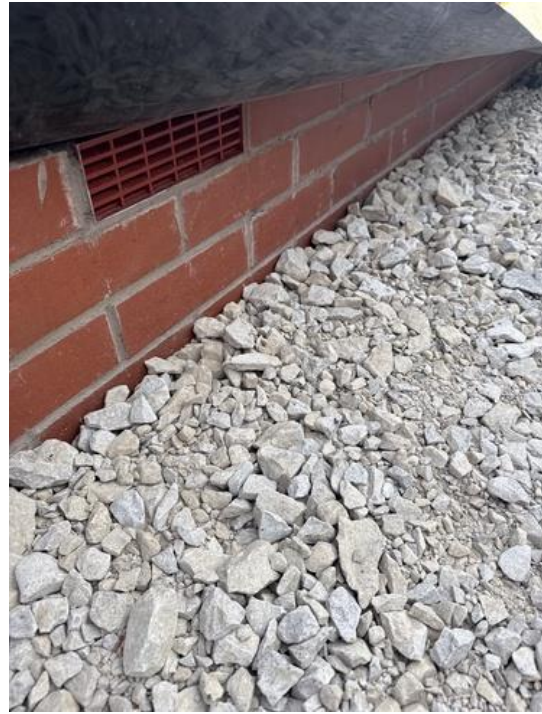
**External Wall Air bricks: Numbers, size. positions as design drawing? (Minimum of 3 walls)**

Pass
