Date: 24<sup>th</sup> April 2025  
Reference: 14-768-V8

## GAS MEMBRANE VALIDATION – HAWKS VIEW, CASTLETON

| <b>Project Name:</b> | Hawks View, Castleton (formerly known as Castleton Sidings) |
| <b>Plots:</b> | Membrane – Plots 174-180 |

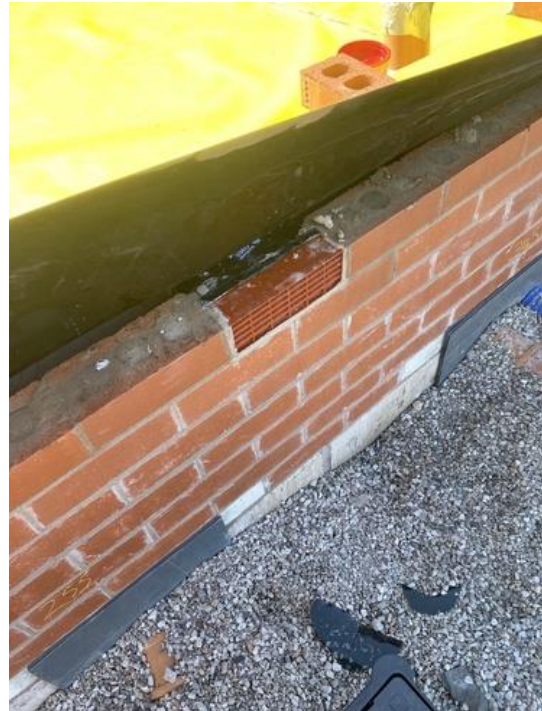
Photo 1

| <b>Are telescopic vents present?</b> | Yes |

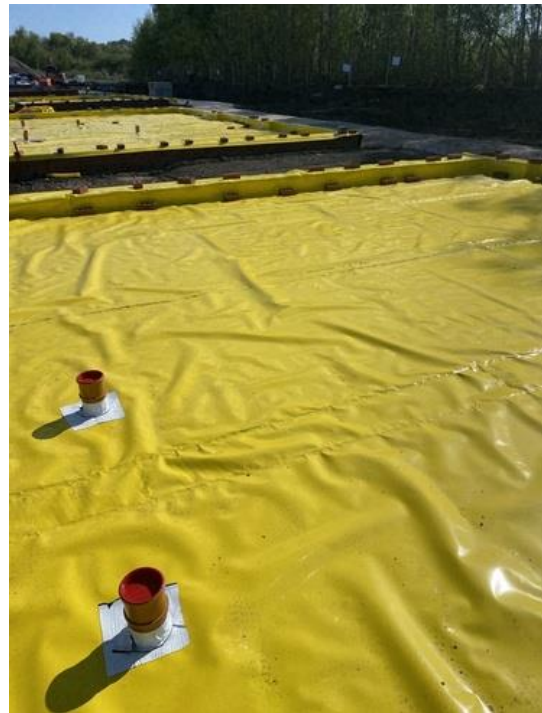
Photo 5

| <b>Gas Membrane Condition: Open punctures, tears, rips, stretching, Presence of debris, Repairs, Signs of weakness such as raised or sunken indentations, Protection plan in place to restrict access to lain gas membrane? IF FAIL DESCRIPTION IN ACTIONS AND PHOTOS REQUIRED</b> | Pass |

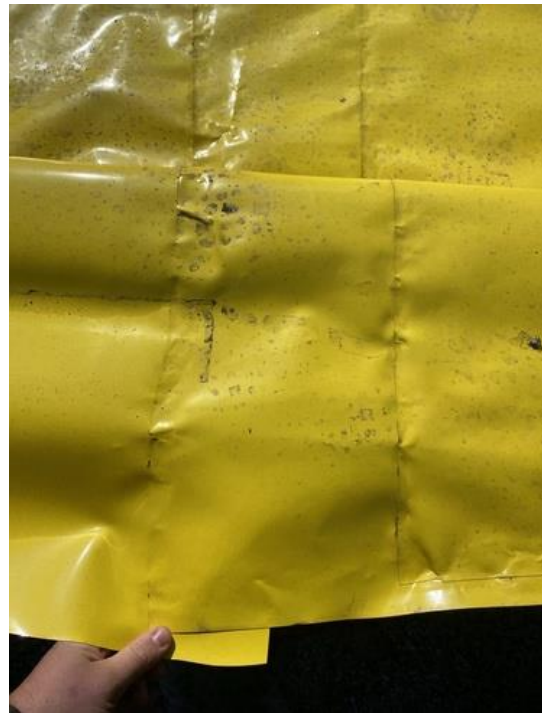
Photo 9

| <b>Are welds complete?</b> | Yes |

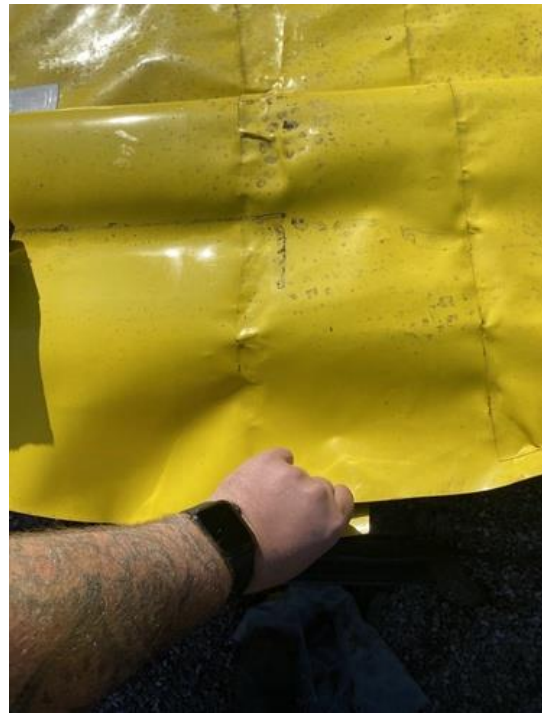
Photo 13

**Are Joints lapped and sealed in accordance with manufacturer's requirements/ specification?**

Yes

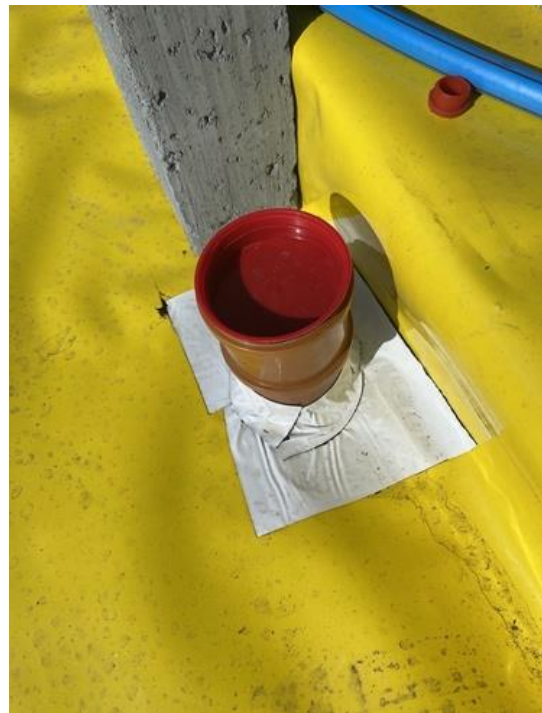
Photo 15

**Service entries seals: Top hats seal arrangements fixed around service entries? Use of Jubilee clips or Bitumastic Sealant**

Pass

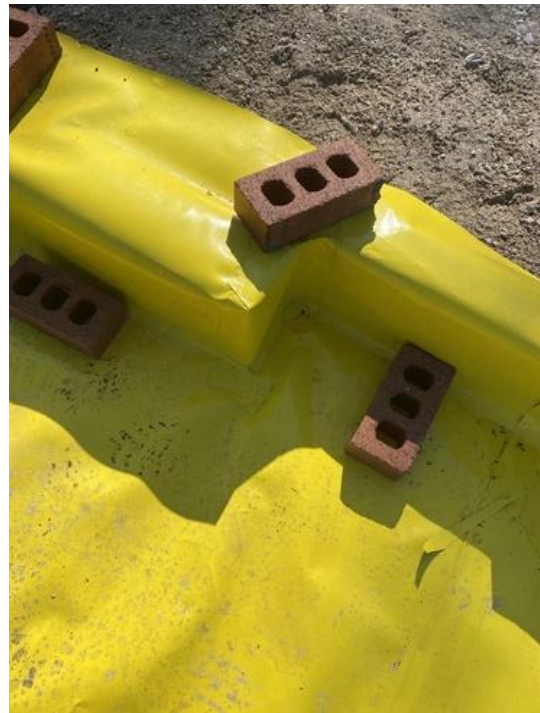
Photo 25

**Corners / Internal joints: Check all corners are correctly formed or contractor has used preformed corners.**

Pass

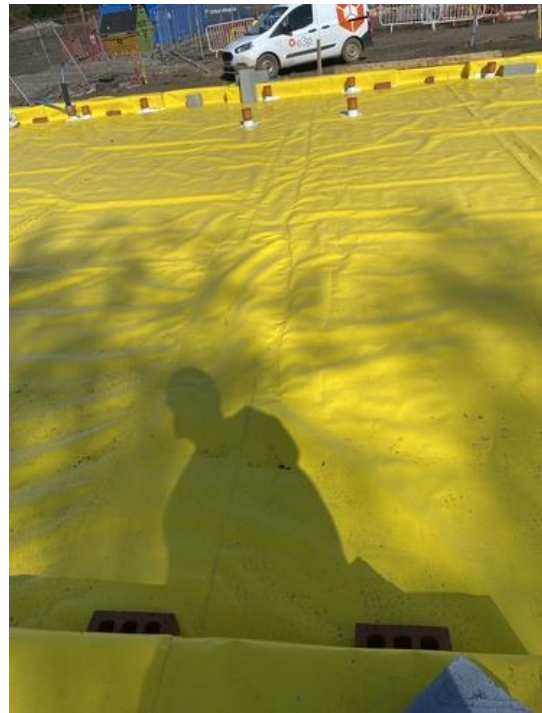
Photo 33

**Are folds running in line with joints? (no joints cutting across folds)**

Pass

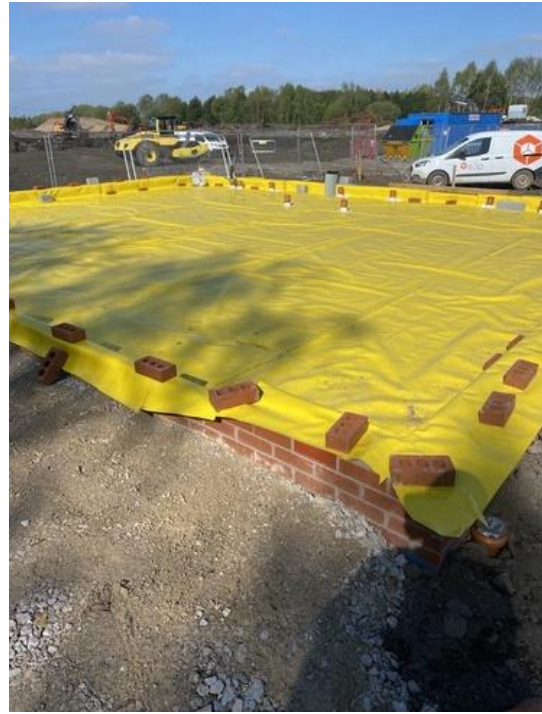
Photo 47

**External Wall Air bricks: Numbers, size. positions as design drawing? (Minimum of 3 walls)**

Pass

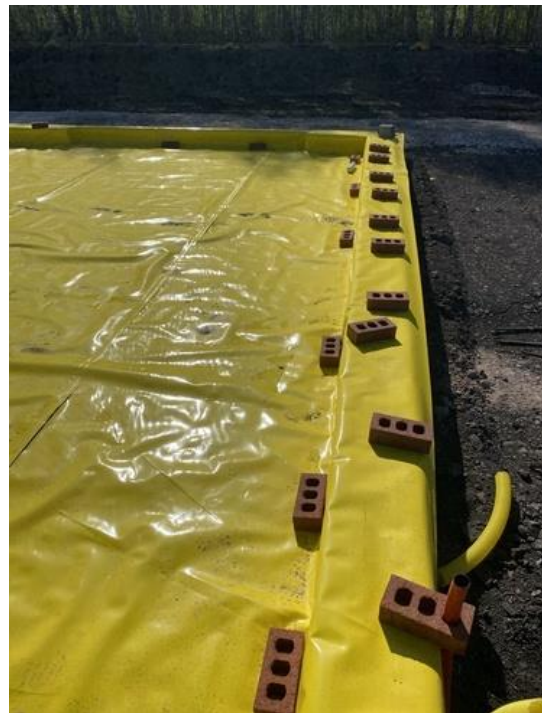
Photo 53

Are telescopic vents present?

Yes

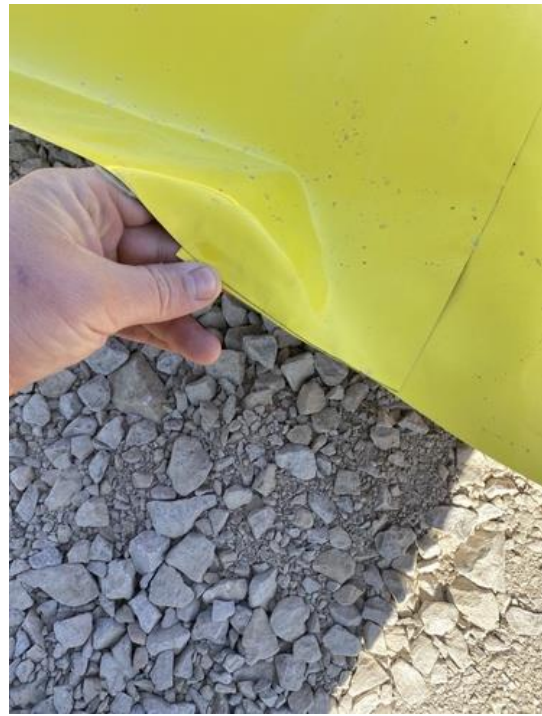
Photo 71

Are welds complete?

Yes

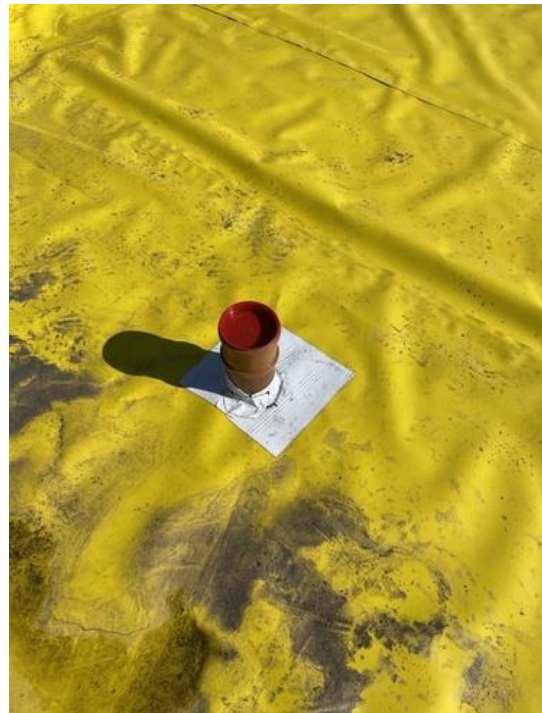
Photo 79

**Service entries seals: Top hats seal arrangements fixed around service entries? Use of Jubilee clips or Bitumastic Sealant**

Pass

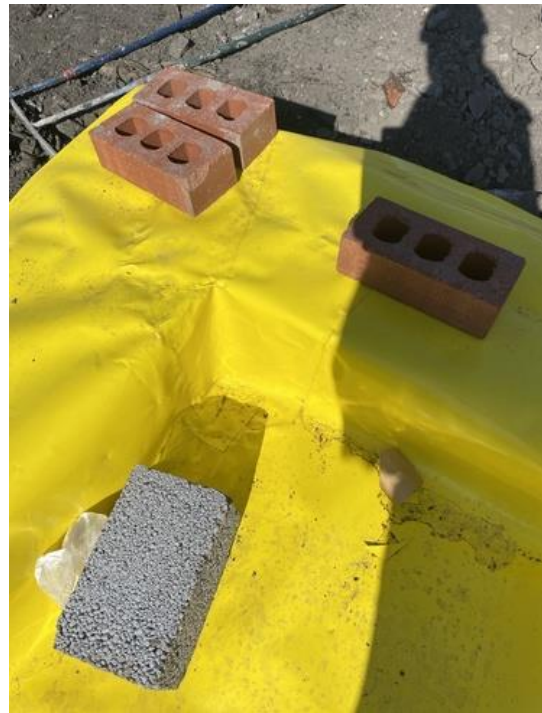
Photo 95

**Corners / Internal joints: Check all corners are correctly formed or contractor has used preformed corners.**

Pass

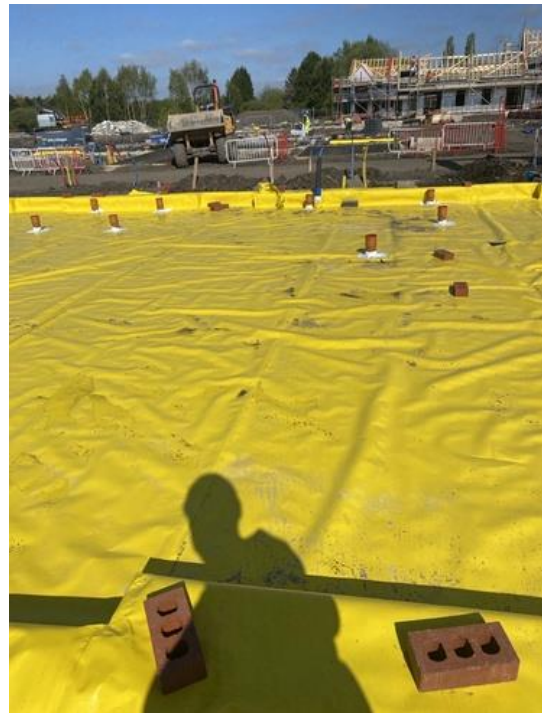
Photo 111

**Are folds running in line with joints? (no joints cutting across folds)**

Pass

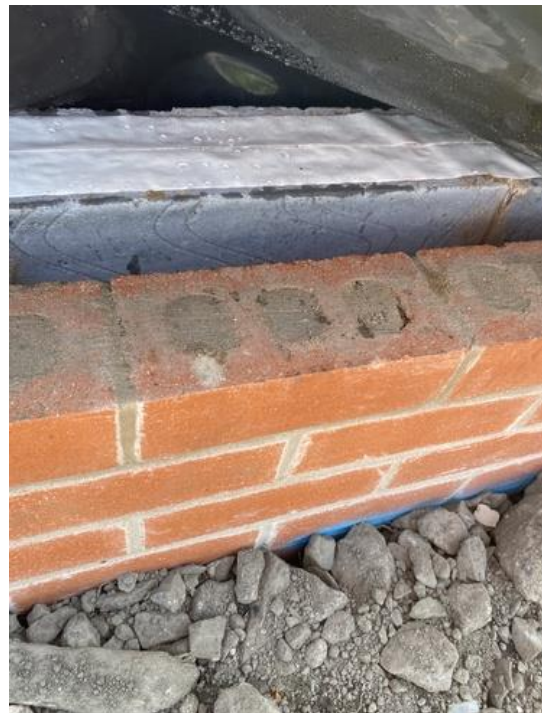
Photo 125

**Sealant to the underside of the membrane at the sole plate  
position (Check with PM if not noted on schedule)**

Yes

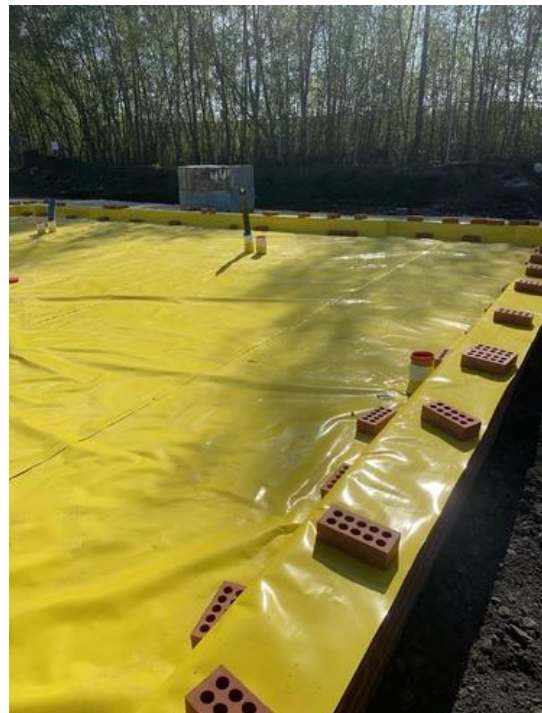
Photo 135

Are telescopic vents present?

Yes

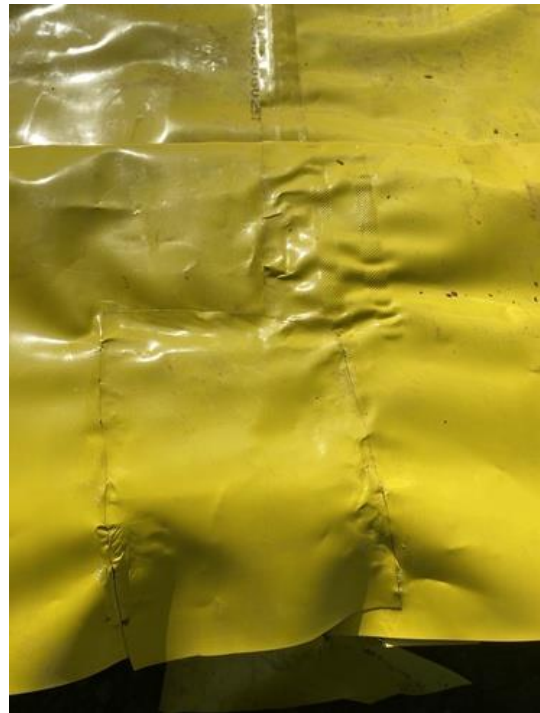
Photo 149

**Are welds complete?**

Yes

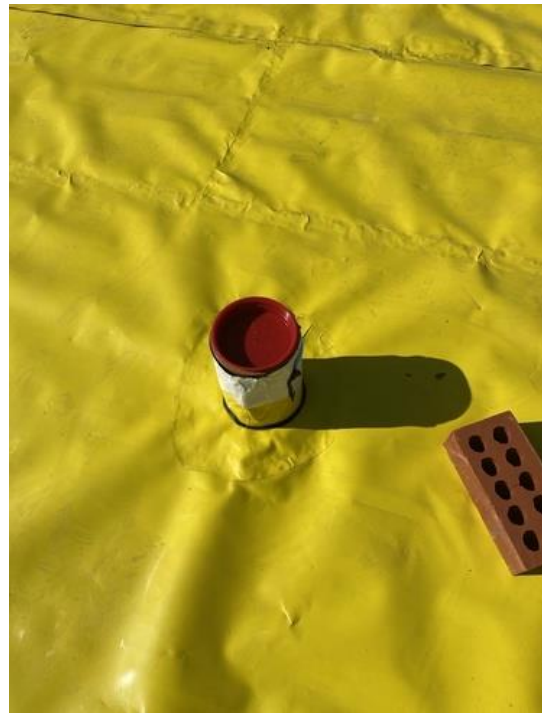
Photo 157

**Service entries seals: Top hats seal arrangements fixed around service entries? Use of Jubilee clips or Bitumastic Sealant**

Pass

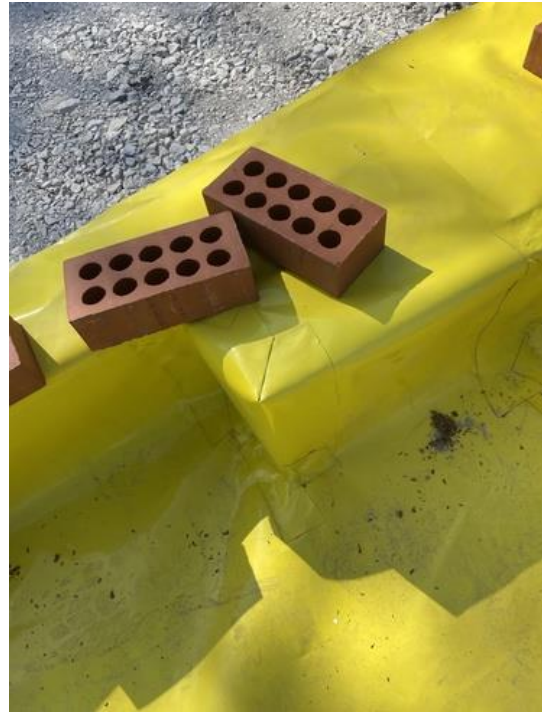
Photo 173

**Corners / Internal joints: Check all corners are correctly formed or contractor has used preformed corners.**

Pass

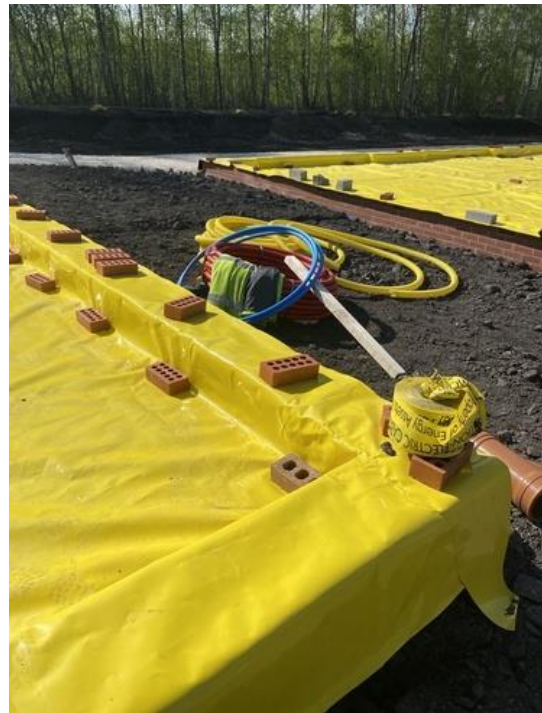
Photo 185

**Are folds running in line with joints? (no joints cutting across folds)**

Pass
