Date: 28<sup>th</sup> April 2025  
Reference: 14-768-V9

## GAS MEMBRANE VALIDATION – HAWKS VIEW, CASTLETON

| <b>Project Name:</b> | Hawks View, Castleton (formerly known as Castleton Sidings) |
| <b>Plots:</b> | Membrane – Plots 185-186 |

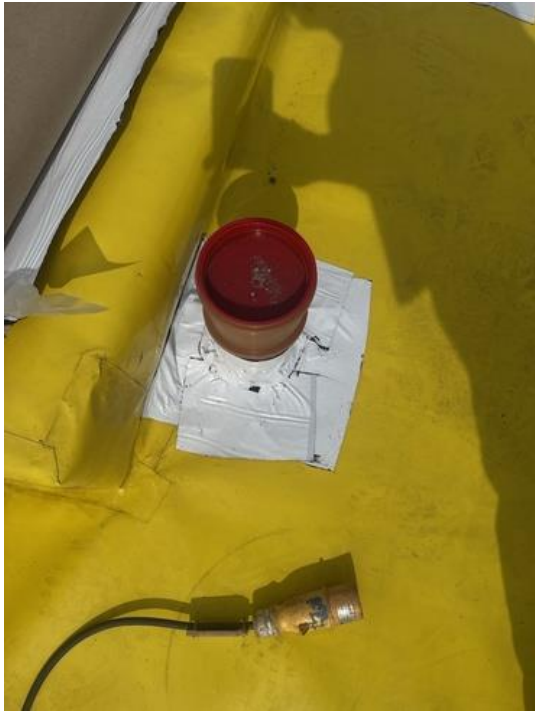
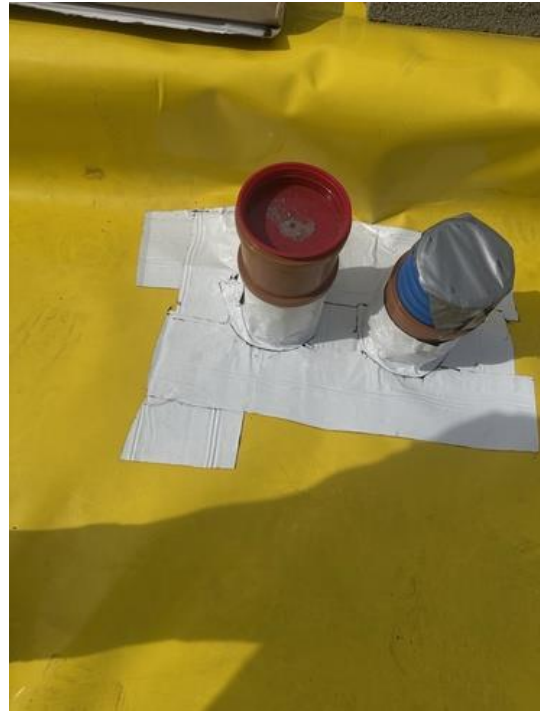
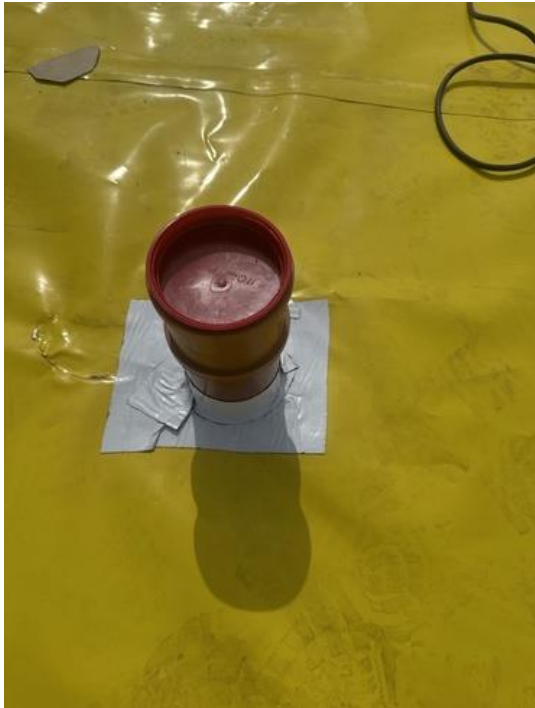
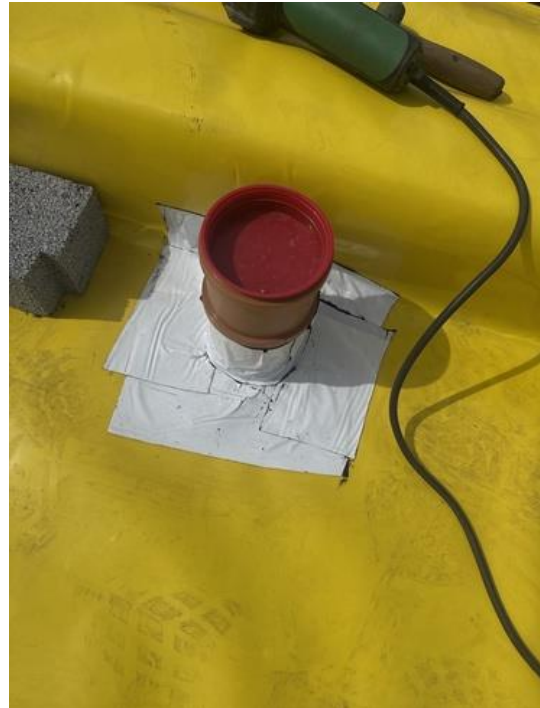
| <b>Service entries seals: Top hats seal arrangements fixed around service entries? Use of Jubilee clips or Bitumastic Sealant</b> | Pass |

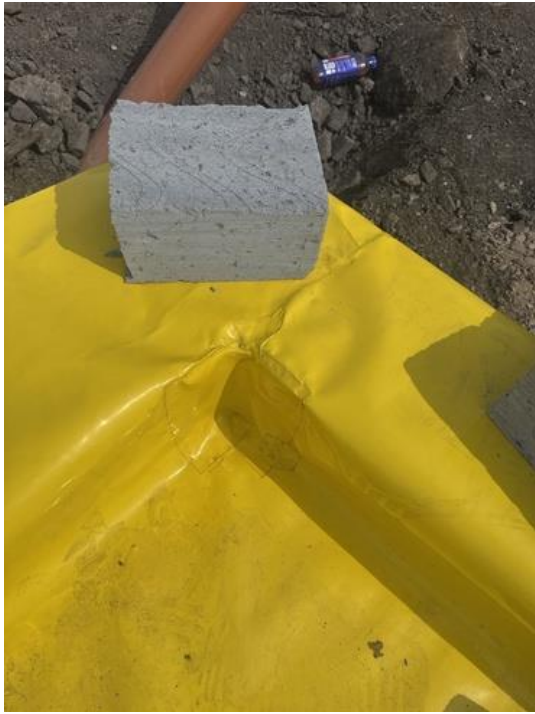
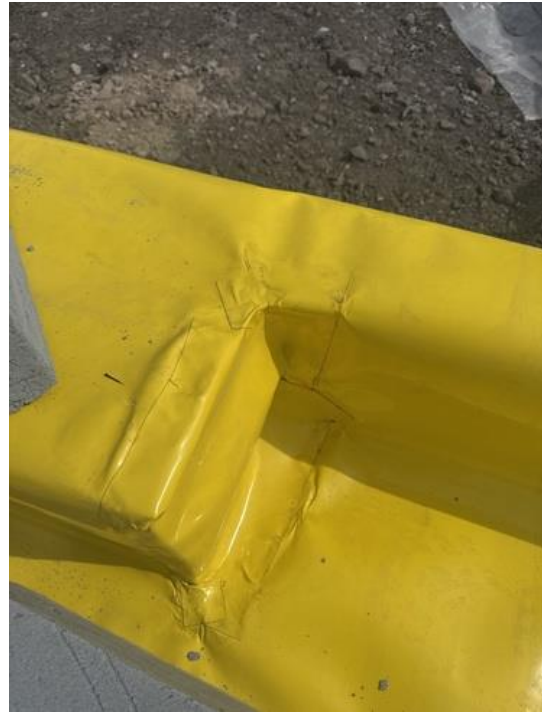
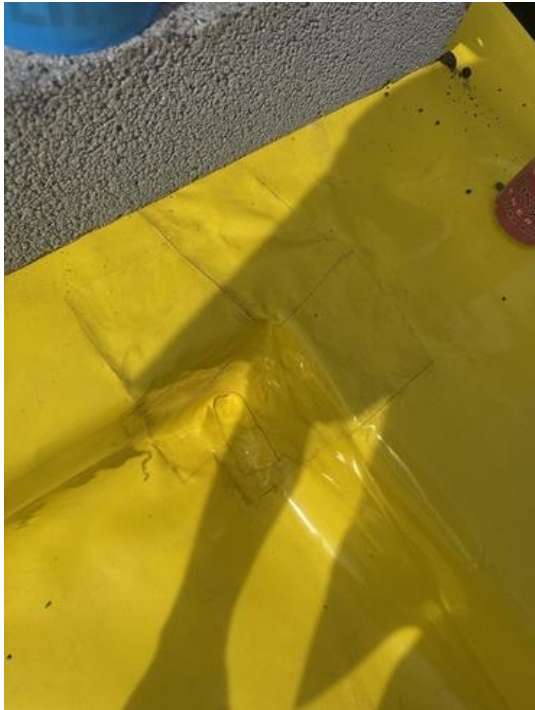
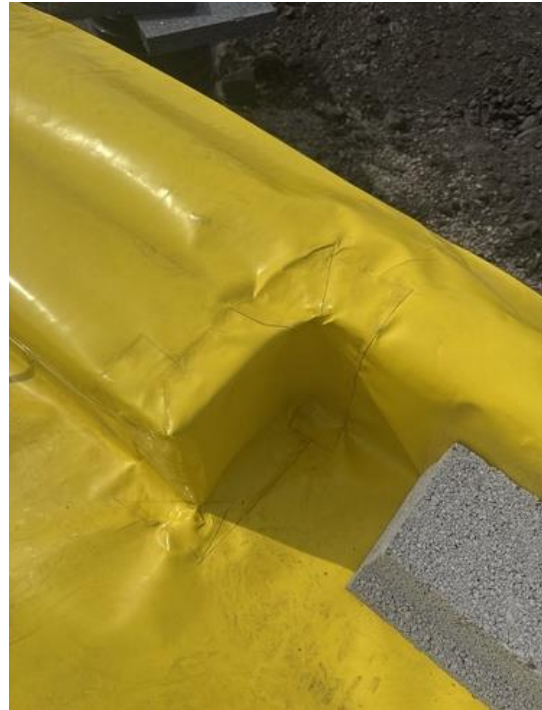
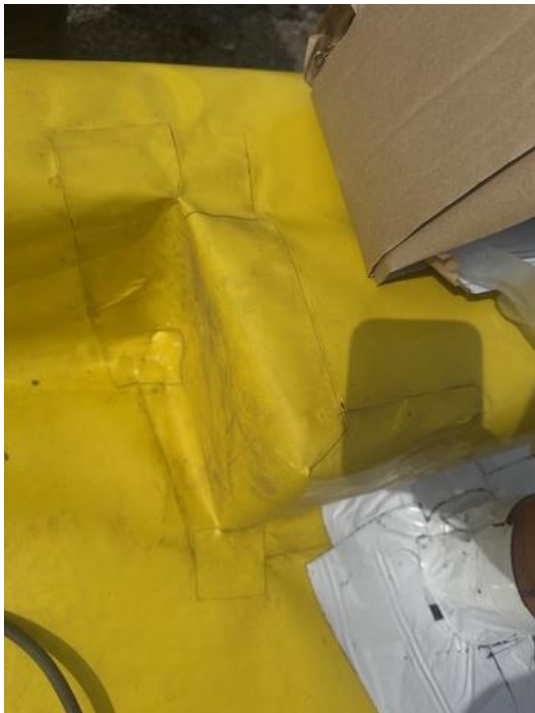
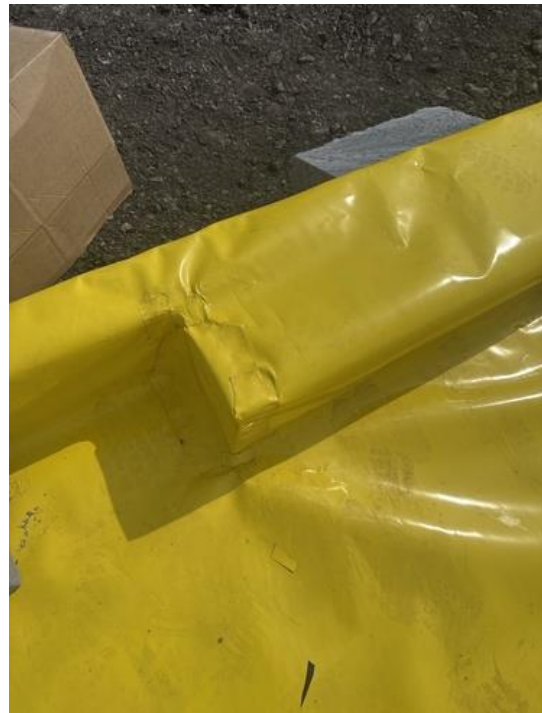
| <b>Corners / Internal joints: Check all corners are correctly formed or contractor has used preformed corners.</b> | Pass |

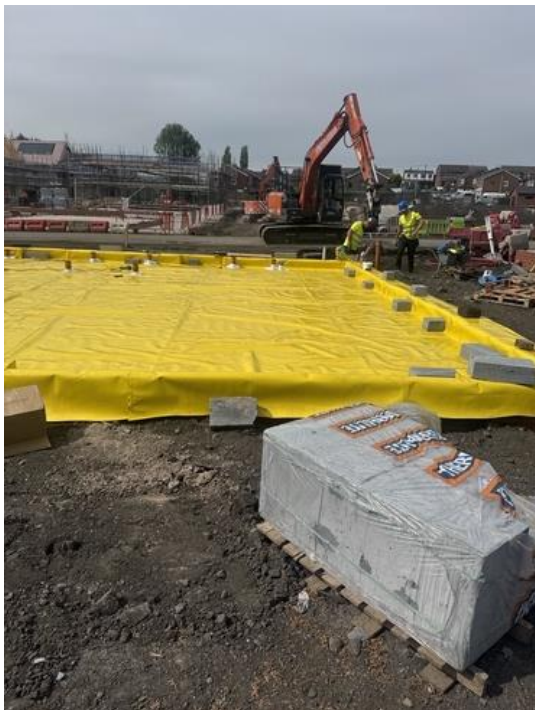
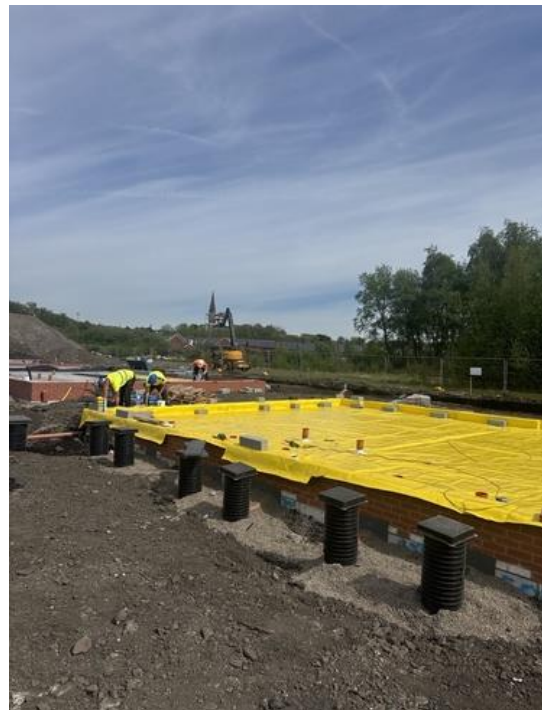
**Extent of Coverage: Is the membrane covering the entire plot?  
Does membrane span over outside walls?**

Yes

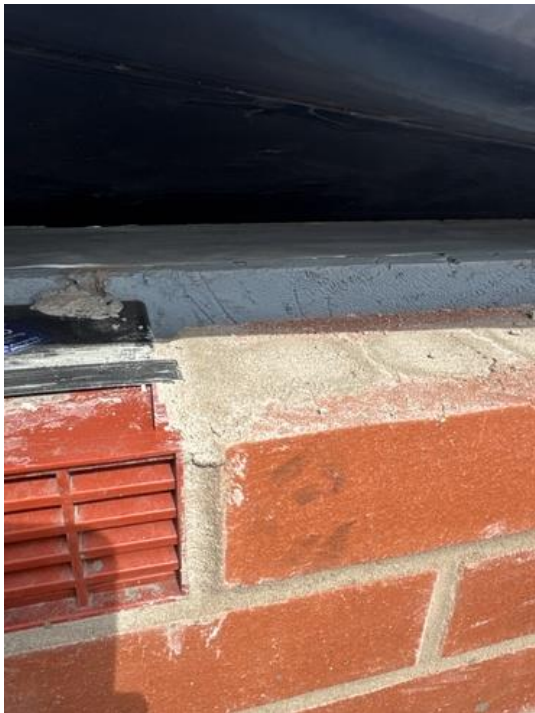
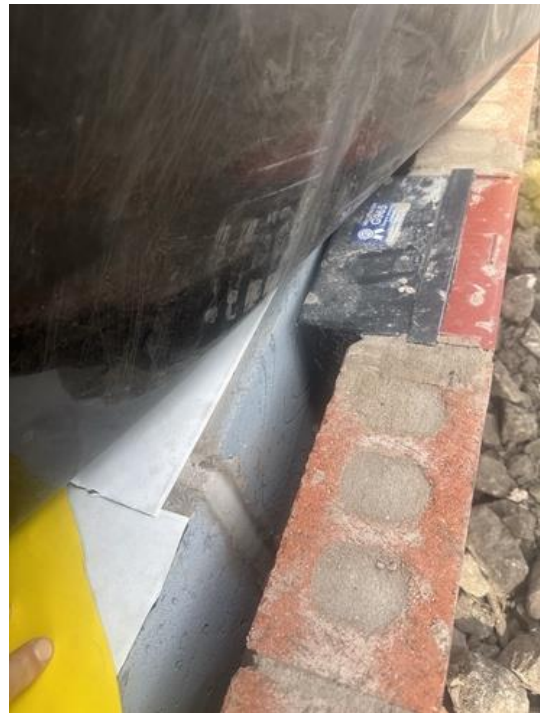
**Sealant to the underside of the membrane at the sole plate position (Check with PM if not noted on schedule)**

Yes

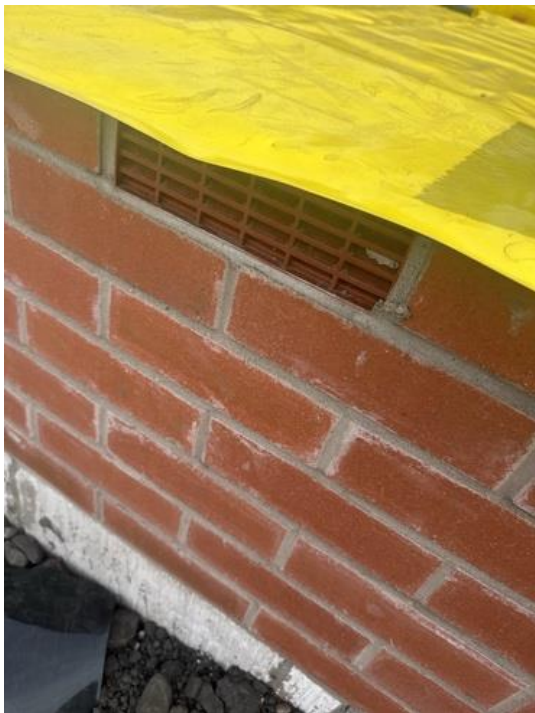
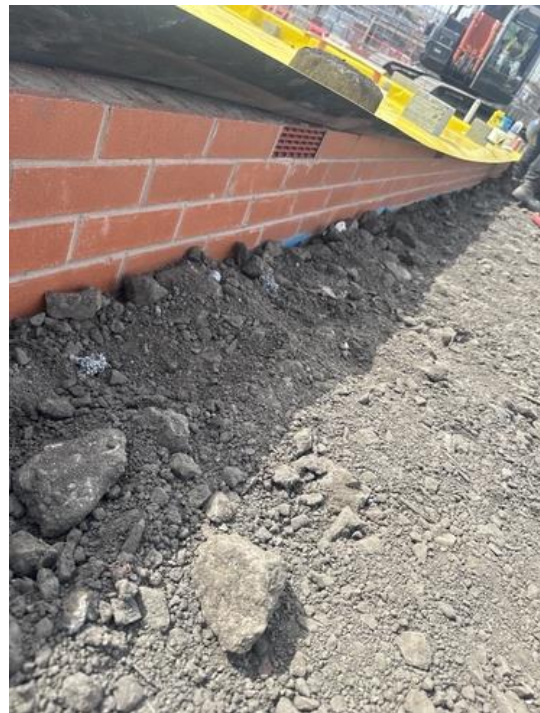
**External Wall Air bricks: Numbers, size. positions as design drawing? (Minimum of 3 walls)**

Pass

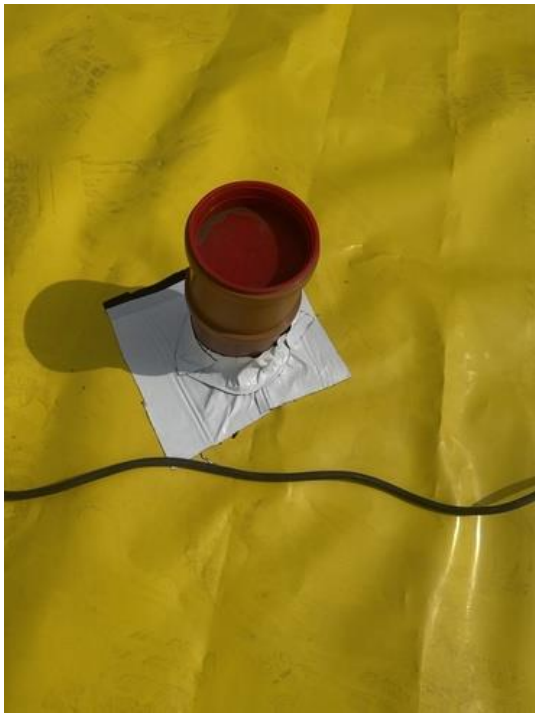
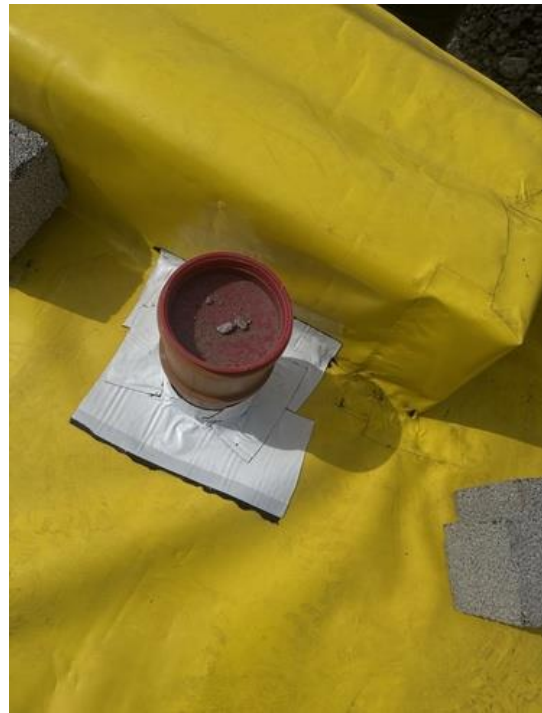
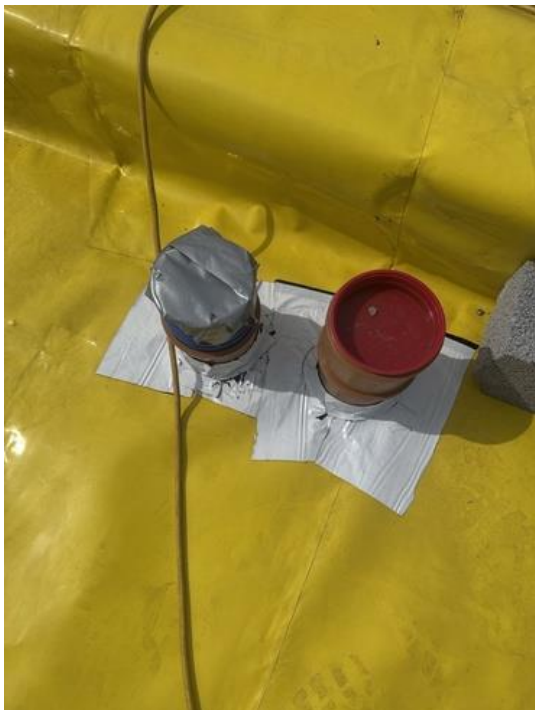
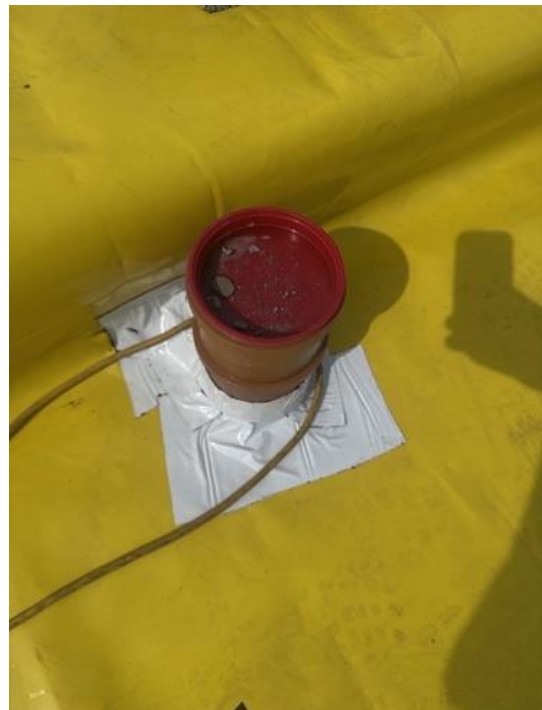
| Service entries seals: Top hats seal arrangements fixed around service entries? Use of Jubilee clips or Bitumastic Sealant | Pass | |

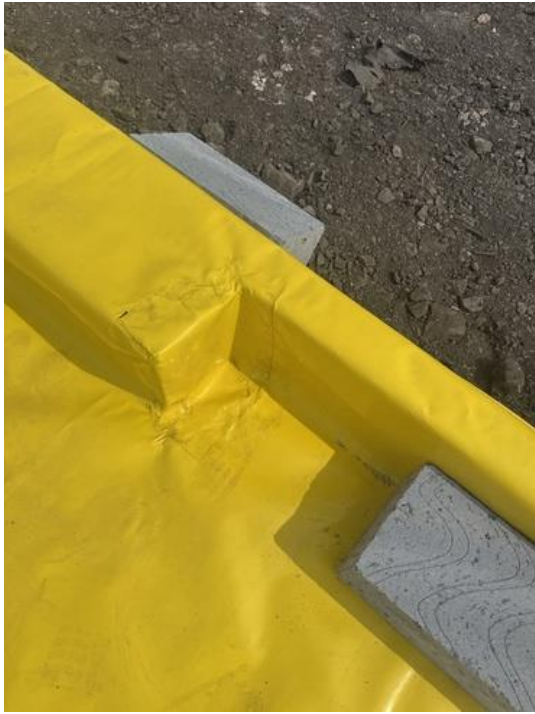
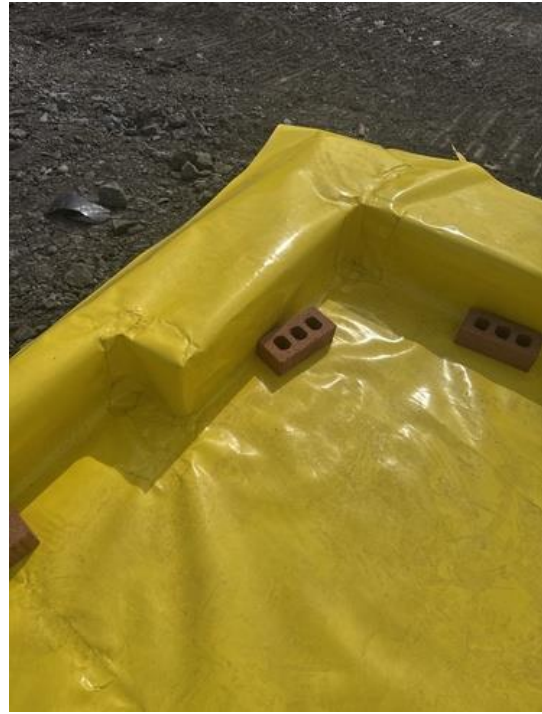
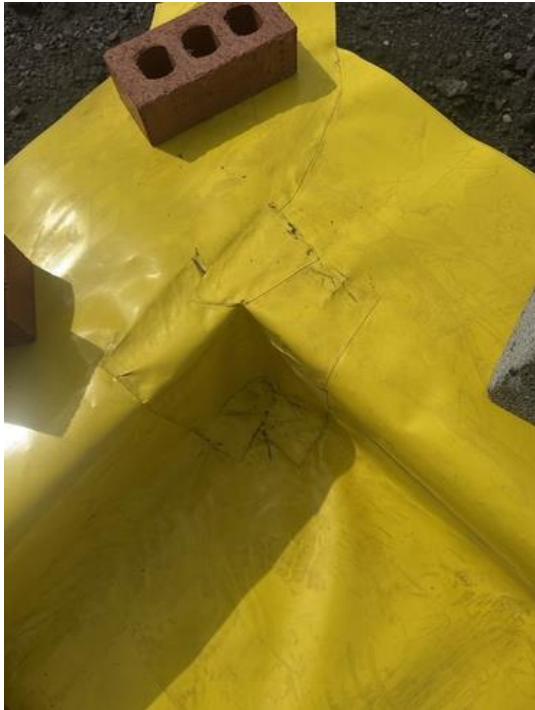
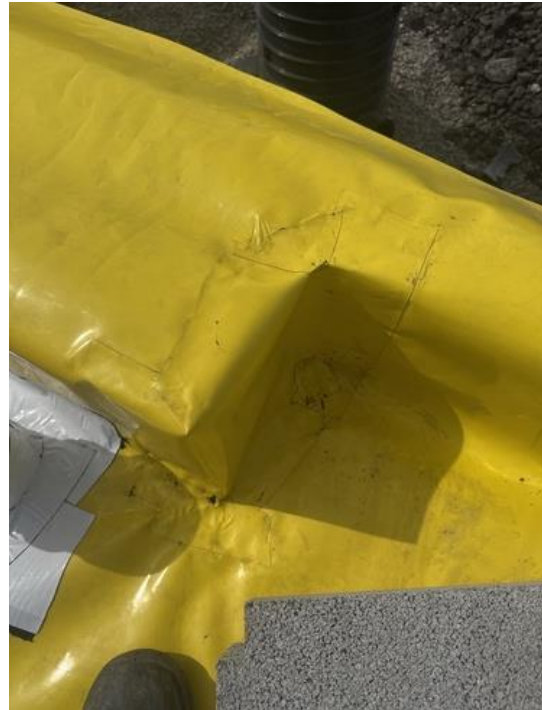
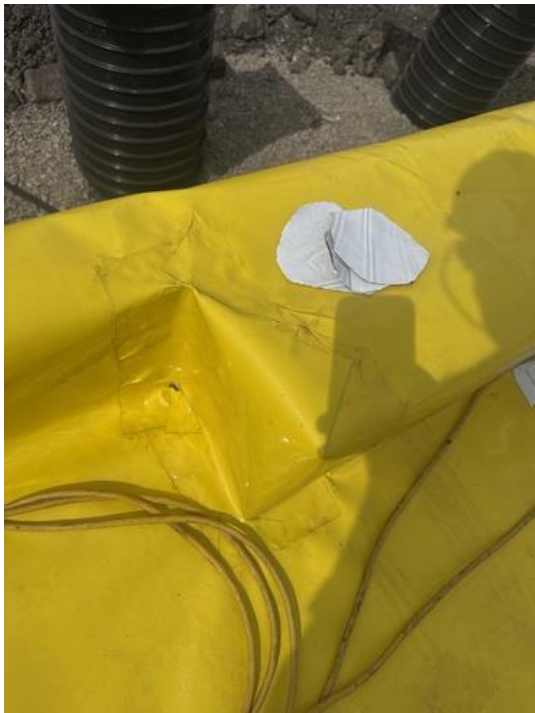
| Corners / Internal joints: Check all corners are correctly formed or contractor has used preformed corners. | Pass | |

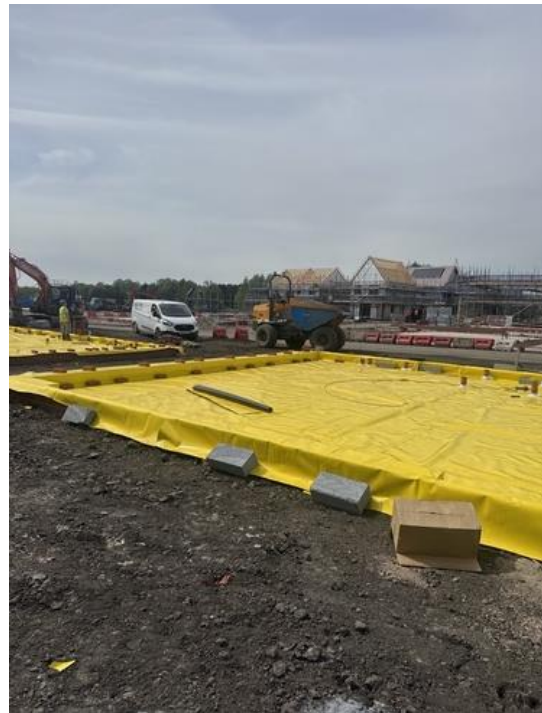
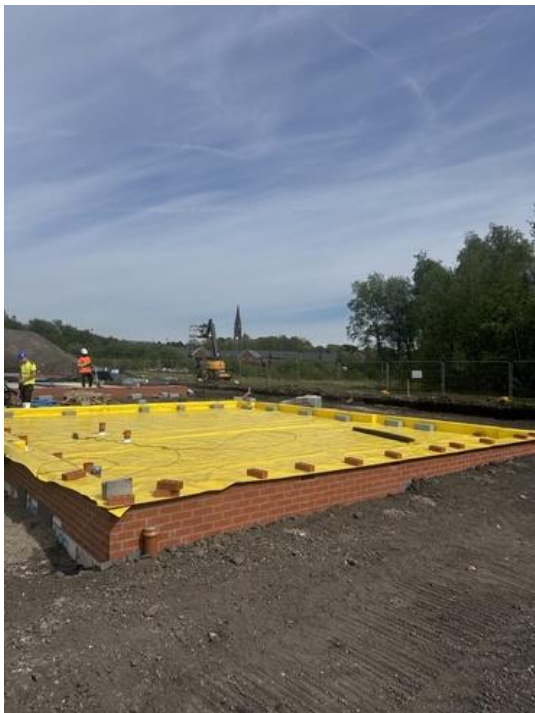
**Extent of Coverage: Is the membrane covering the entire plot?  
Does membrane span over outside walls?**

Yes

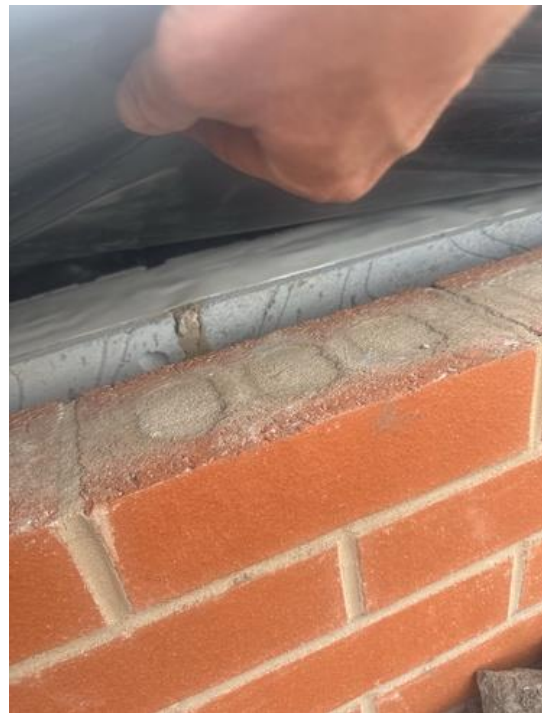
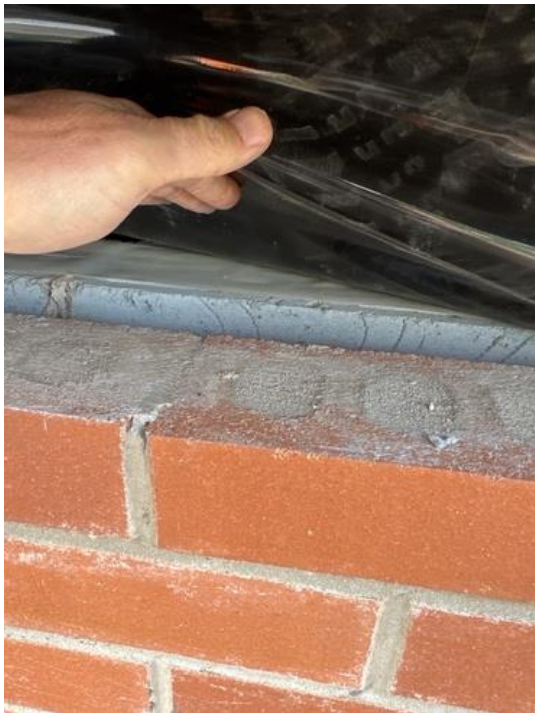
**Sealant to the underside of the membrane at the sole plate position (Check with PM if not noted on schedule)**

Yes

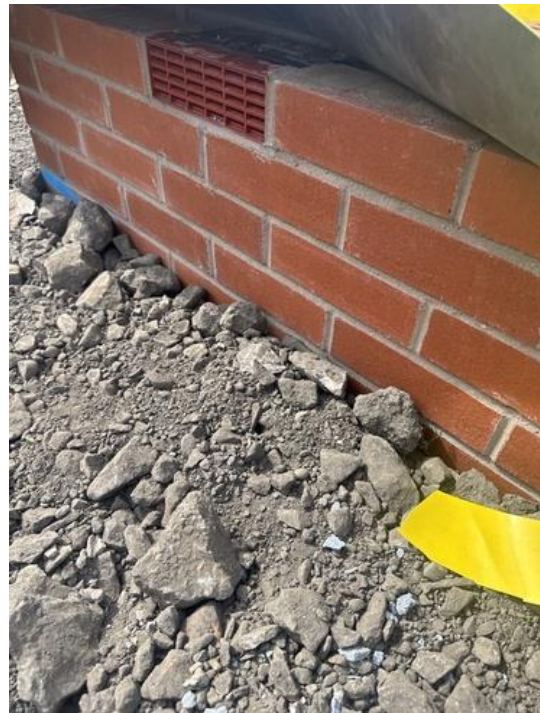
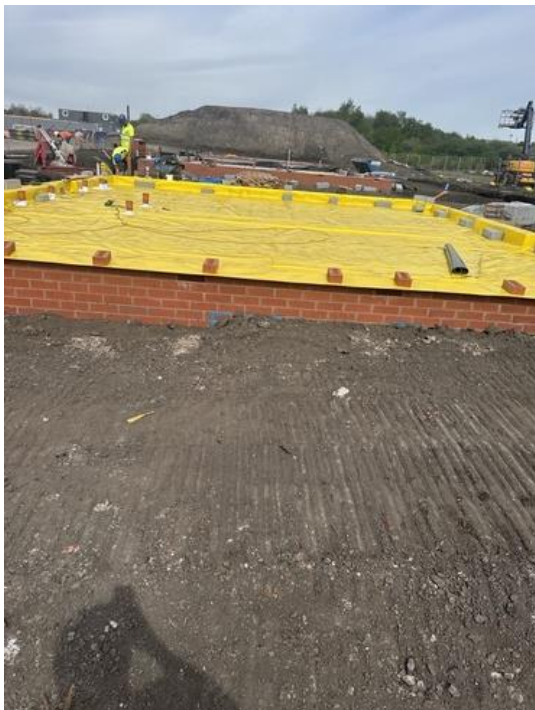
**External Wall Air bricks: Numbers, size. positions as design drawing? (Minimum of 3 walls)**

Pass
