Date: 16<sup>th</sup> December 2025  
Reference: 16465-V15

## GAS MEMBRANE VALIDATION – EDENFIELD ROAD, NORDEN

| <b>Project Name:</b> | Edenfield Road, Norden |
| <b>Plots:</b> | 31-35 |

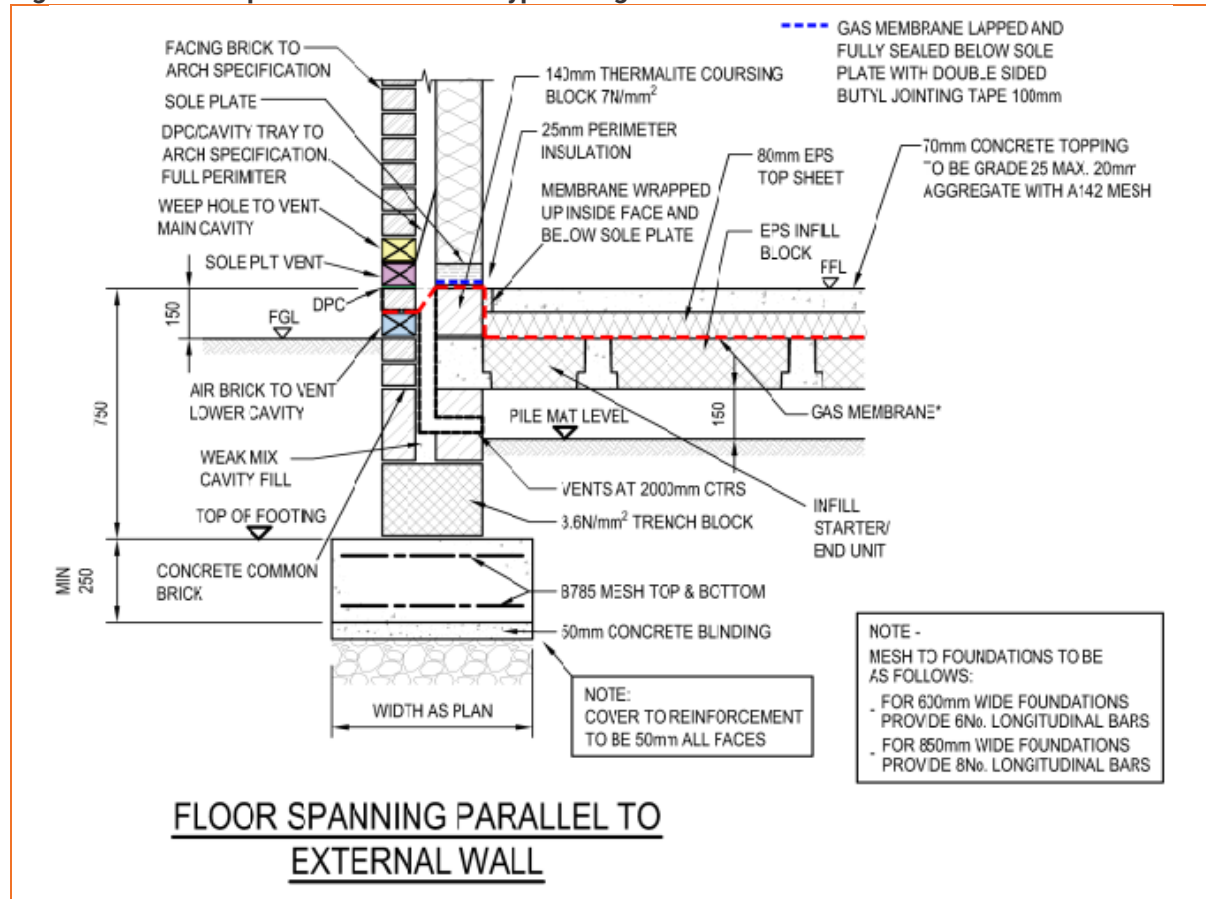
**Figure 1**      **Suspended Floor Slab – Typical Edge – VSC**

It has been confirmed as part of the validation that the membrane utilised in the plots discussed herein matches that of **Figures 1-4**.

The E3P Technician has inspected the installation of this membrane in line with the structural engineer's specifications in terms of placement and position (**Figures 1-4**), and the manufacturer's detail in terms of the workmanship.

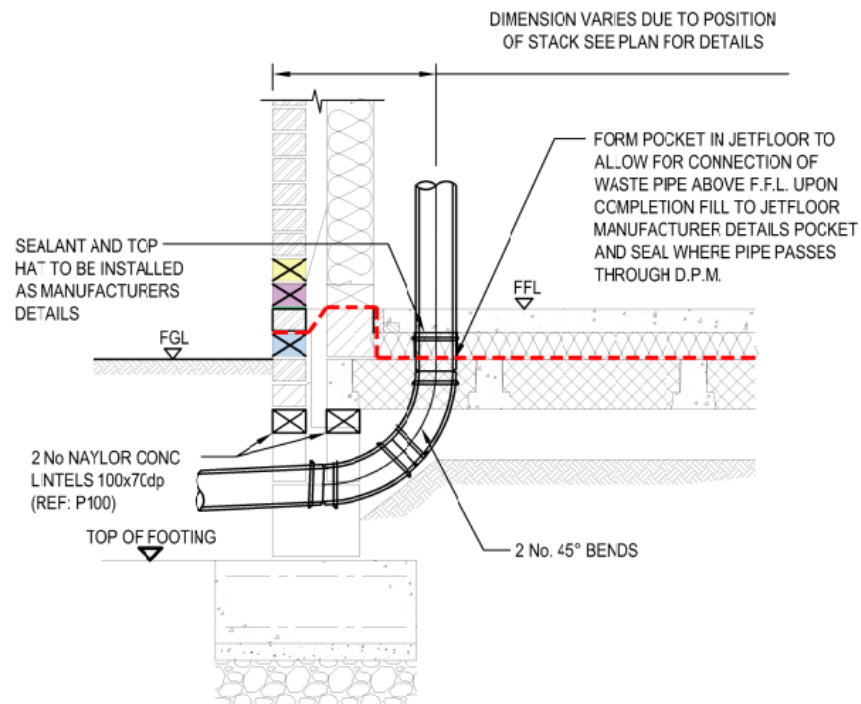
**Figure 4**      **Suspended Floor Slab – Typical Service Penetration - VSC**

Where any penetration or service duct is present within the floor area, E3P inspected each one in turn and can confirm that rigid black polyethylene top hat units have been adequately sealed against the membrane with double-sided jointing tape at both the base and the protruding pipe as well as being secured against the pipe with a metal jubilee clip.

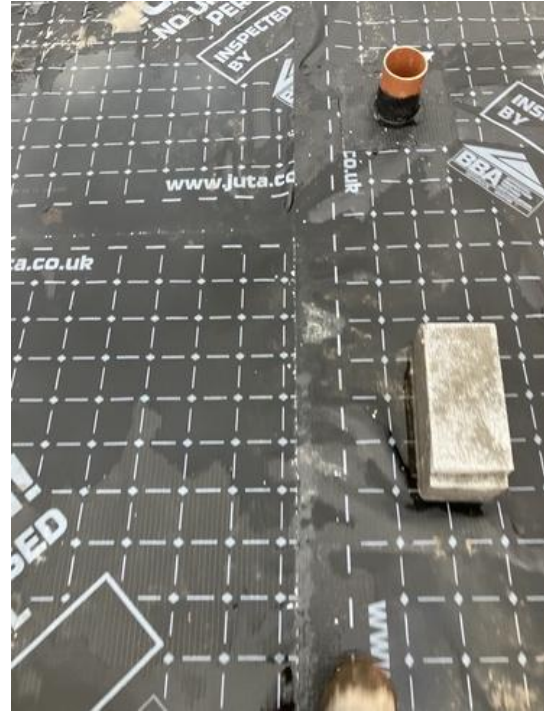
Photo 1

**Gas Membrane Condition: Open punctures, tears, rips, stretching, Presence of debris, Repairs, Signs of weakness such as raised or sunken indentations, Protection plan in place to restrict access to lain gas membrane? IF FAIL DESCRIPTION IN ACTIONS AND PHOTOS REQUIRED**

Pass

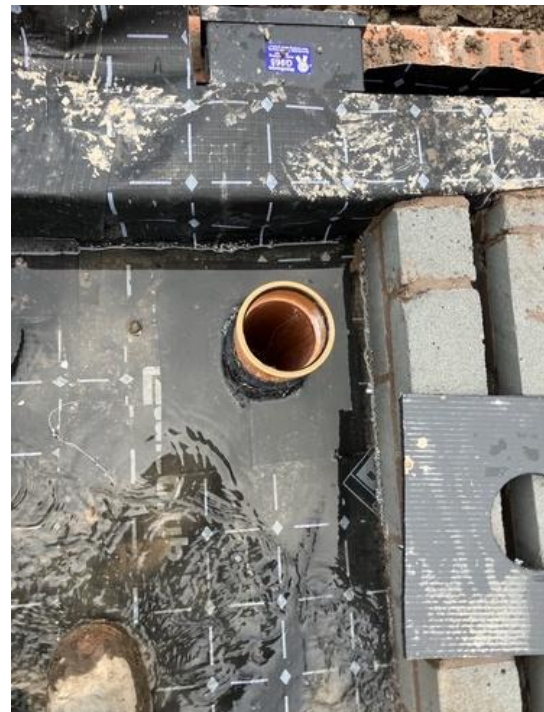
Photo 19

**Service entries seals: Top hats seal arrangements fixed around service entries? Use of Jubilee clips or Bitumastic Sealant**

Pass

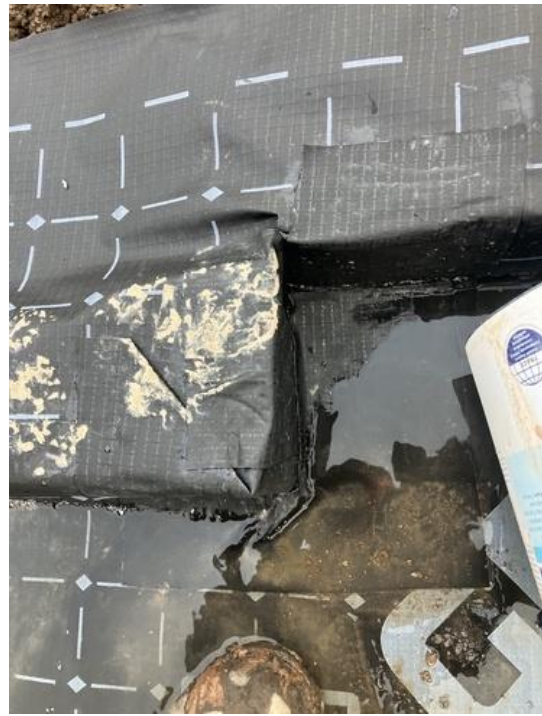
Photo 21

**Corners / Internal joints: Check all corners are correctly formed or contractor has used preformed corners.**

Pass

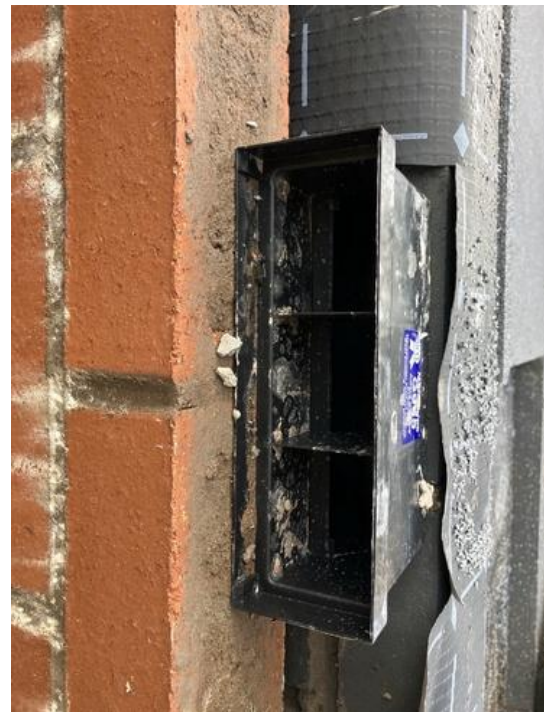
Photo 31

**External Wall Air bricks: Numbers, size. positions as design drawing? (Minimum of 3 walls)**

Pass
