Gas Membrane Installation  
Validation Report  
Fourways Projects  
Longley Hey Farm  
Halifax Road  
Littleborough  
OL15 0LB

## Appendix 1 – Site Survey Sheets

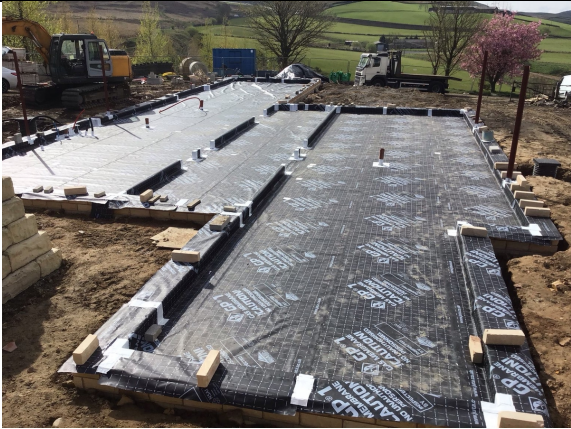
Detached property full line out installation overview

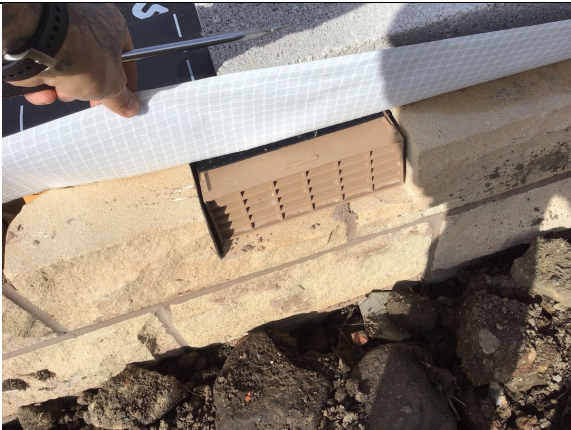
| Housebuilder Name: Fourways Projects | | | Date: 23/04/2025 |
|---|---|---|---|
| <b>Cavity Vent Seal Method:</b> The cavity vents sit below the membrane that seals the cavity and do not require a specialist seal | | | |

Perimeter cavity air bricks installed under the gas membrane

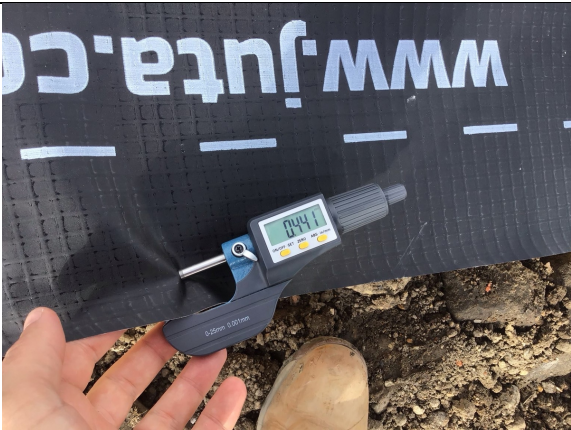
Testing the thickness of the membrane

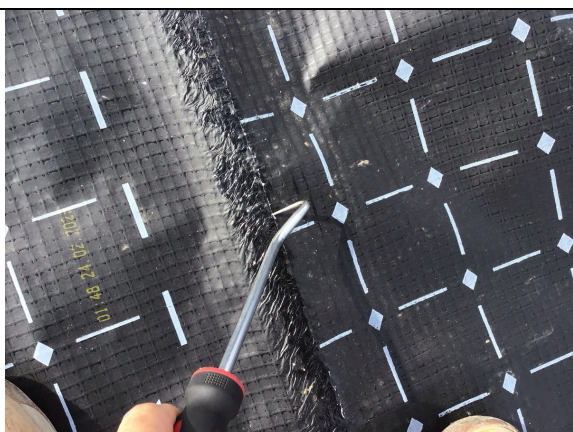
Testing the hand welded membrane lap joints

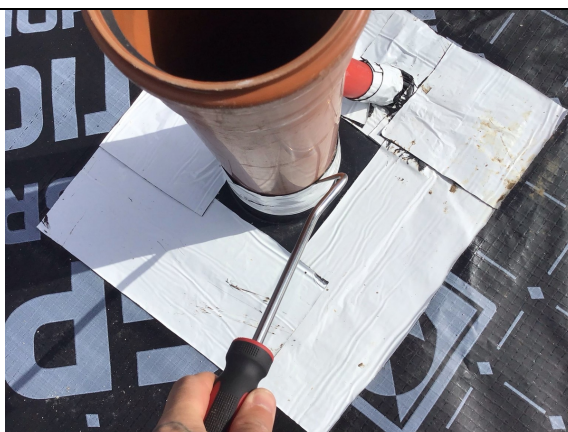
Testing the pipe detailing

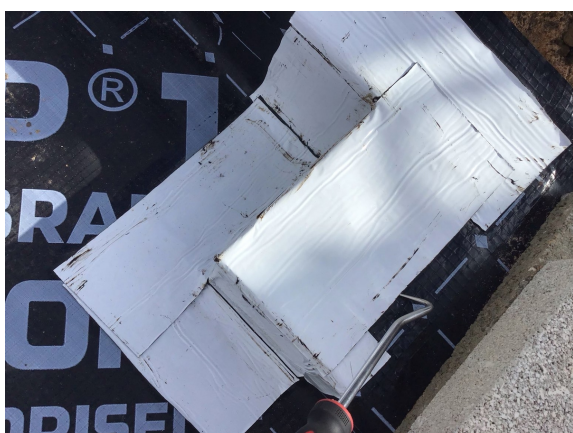
Testing the threshold detailing

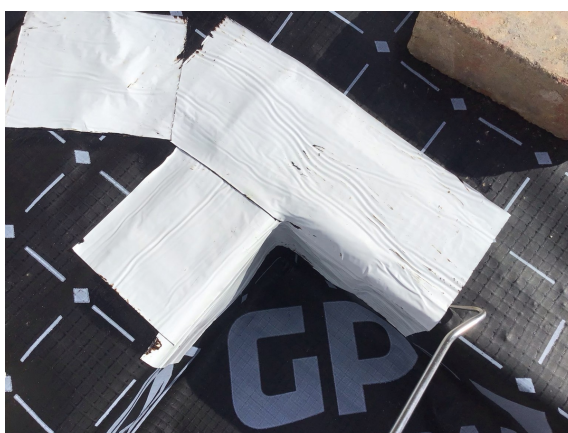
Testing the corner detailing

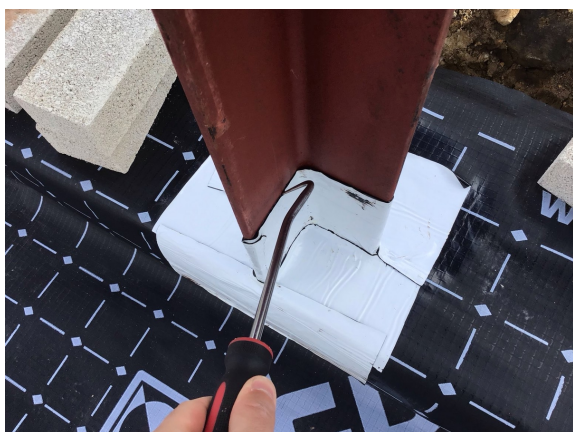
Testing the windpost detailing

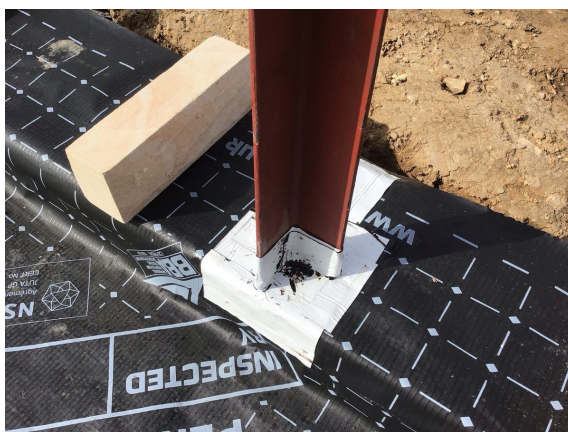
| Housebuilder Name: Fourways Projects | | | Date: 23/04/2025 |
|---|---|---|---|
| <b>Others Please List:</b> 4no wind posts are detailed using Juta GP SAM | | | |

Windpost detailing

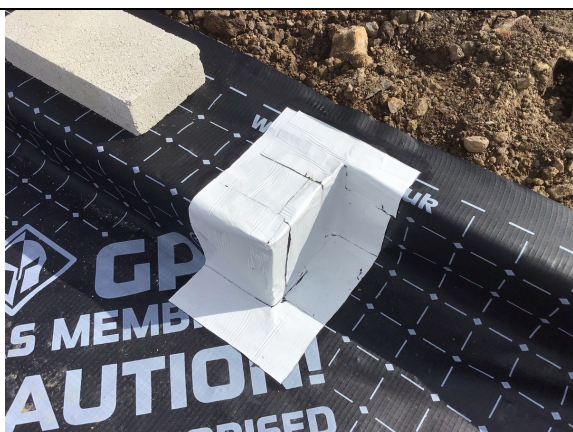
| Housebuilder Name: Fourways Projects | | | Date: 23/04/2025 |
|---|---|---|---|
| <b>Door Threshold Seal Method:</b> Door Thresholds have been sealed using strips of self-adhesive gas membrane, this is an approved and recognised method in CIRIA C735 | | | |

Threshold detailing

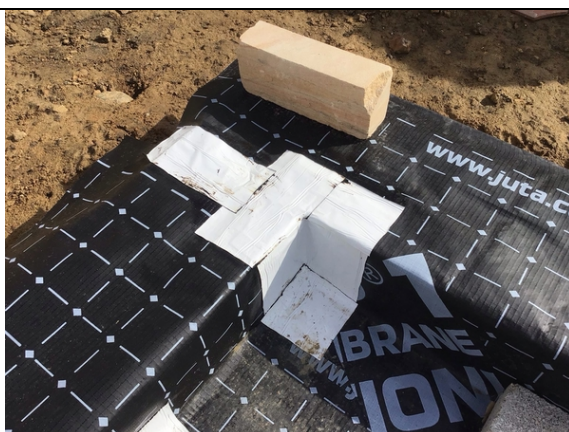
| Housebuilder Name: Fourways Projects | | | Date: 23/04/2025 |
|---|---|---|---|
| <b>Corner Seal Method:</b> Corners have been sealed using strips of self-adhesive gas membrane, this is an approved and recognised method in CIRIA C735 | | | |

Corner detailing

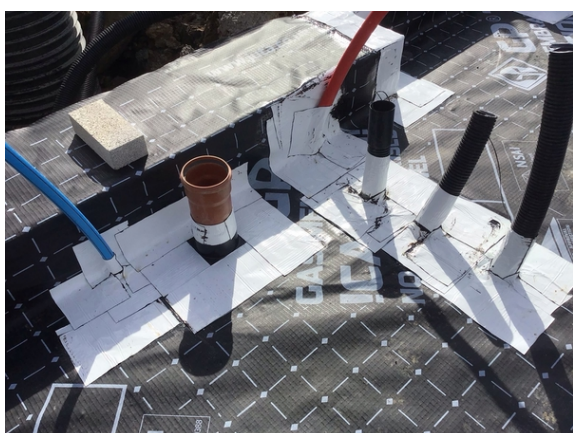
| Housebuilder Name: Fourways Projects | | | Date: 23/04/2025 |
|---|---|---|---|
| <b>Service Entry Seal Method:</b> The external of the pipe/ducts have been sealed using strips of self-adhesive gas membrane, this is an approved and recognised method in CIRIA C735, The external of the pipes/ducts have been sealed using preformed tophats that have been hand welded into place, this is an approved and recognised method in CIRIA C735 | | | |

Pipe detailing

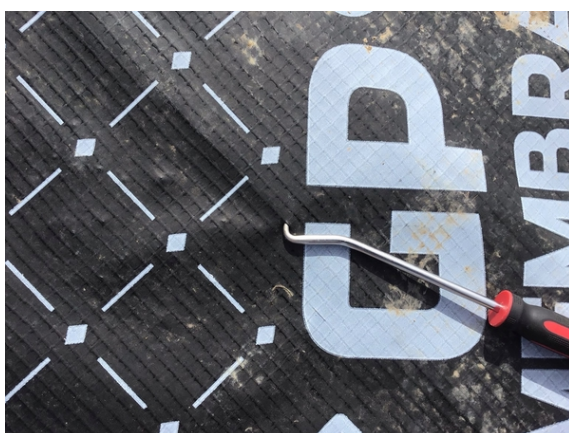
| 1no private property | MEC recorded and repaired 1no defect using Juta GP SAM | N/A |

Recorded defect
