**Proposed Jet Wash, Vacuum, Laundrette, Dog-Wash & Vending Development  
311 Kingsways,  
Rochdale OL16 5BX**

**Flood Risk Assessment and Drainage Strategy Report  
PI5789-DSR-01 rev -**

**Project No: PI5789**

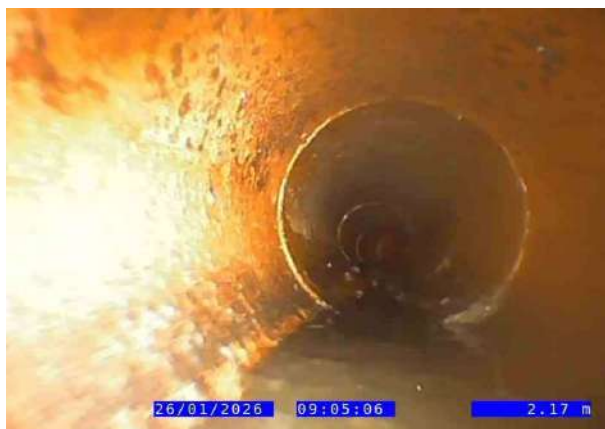
1, 00:00:22, 2.30 m  
Encrustation, medium at joint from 4 o'clock to 7 o'clock

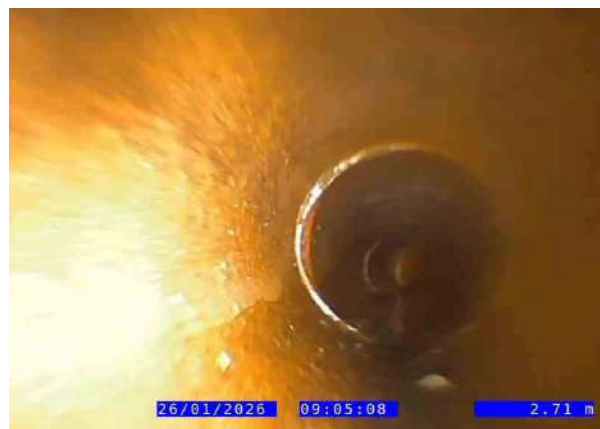
2, 00:00:24, 2.80 m  
Joint displaced, medium (between 1.0 and 1.5 times the pipe wall thickness)

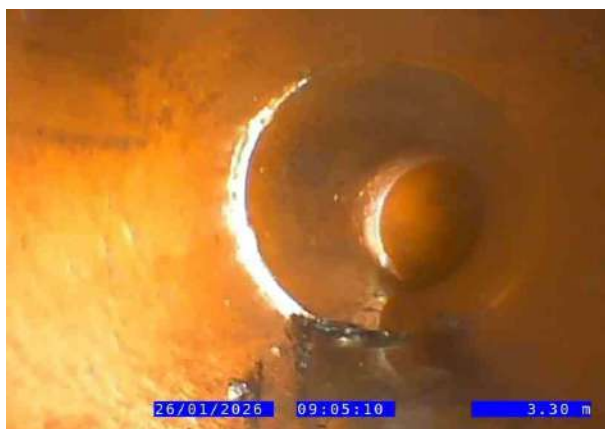
3, 00:00:26, 3.50 m  
Joint displaced, medium (between 1.0 and 1.5 times the pipe wall thickness)

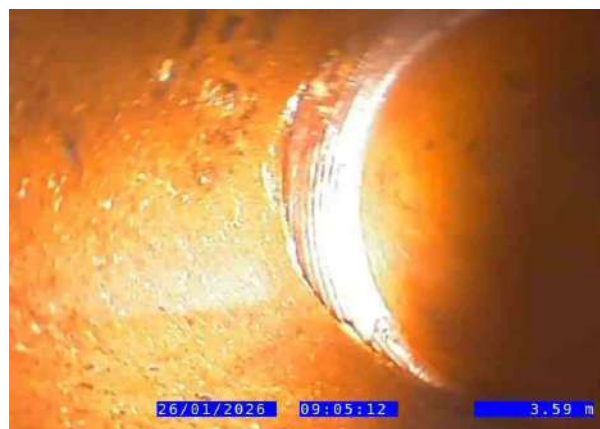
| Scale: | 1:69 | Position [m] | Code | Observation | MPEG | Photo | Grade |
|---|---|---|---|---|---|---|---|
| 3.60 | CCJ | Crack, circumferential at joint from 6 o'clock to 10 o'clock | 00:00:28 | 4 | 2 | | |

4, 00:00:28, 3.60 m  
Crack, circumferential at joint from 6 o'clock to 10 o'clock

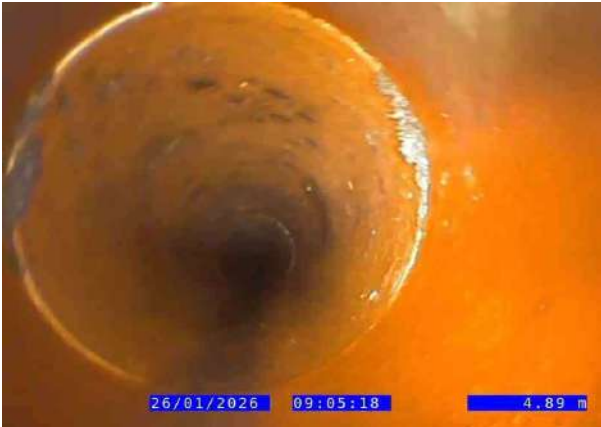
5, 00:00:35, 4.90 m  
Encrustation, light at joint from 12 o'clock to 12 o'clock

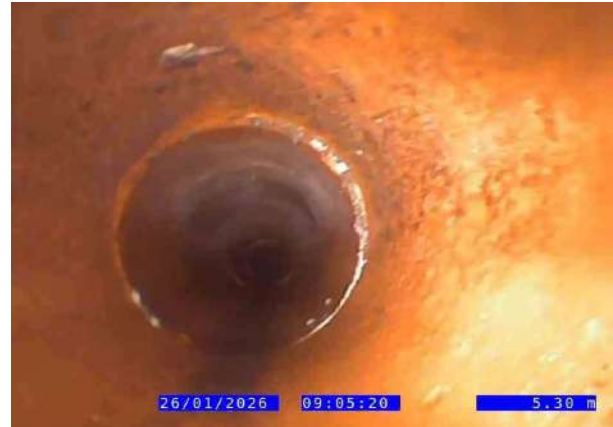
6, 00:00:37, 5.50 m  
Joint displaced, medium (between 1.0 and 1.5 times the pipe wall thickness)

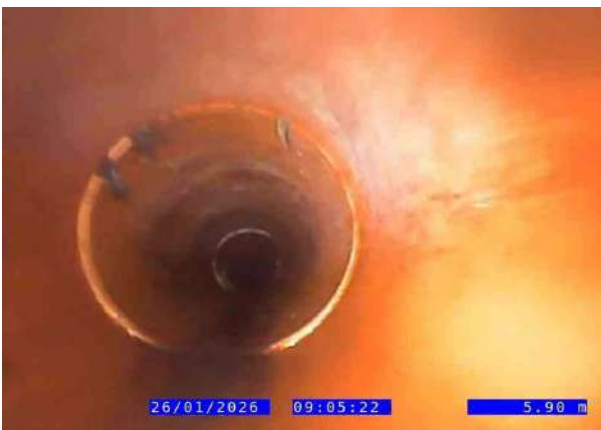
7, 00:00:39, 6.00 m  
Joint displaced, medium (between 1.0 and 1.5 times the pipe wall thickness)

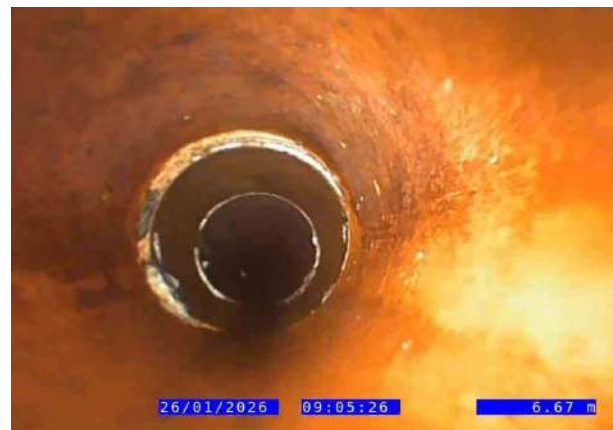
8, 00:00:43, 6.80 m  
Joint displaced, large (over 1.5 times the pipe wall thickness)

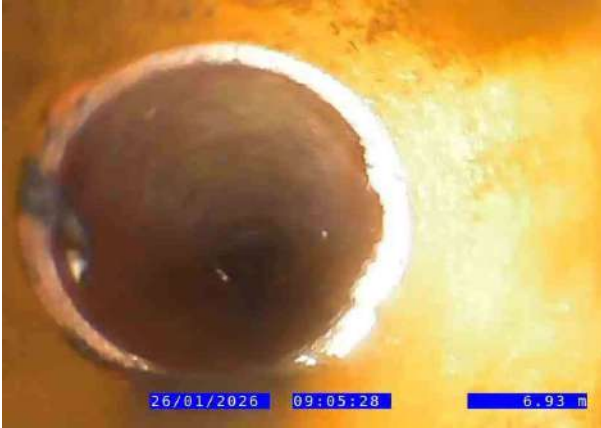
9, 00:00:44, 7.00 m  
Joint displaced, large (over 1.5 times the pipe wall tickness)

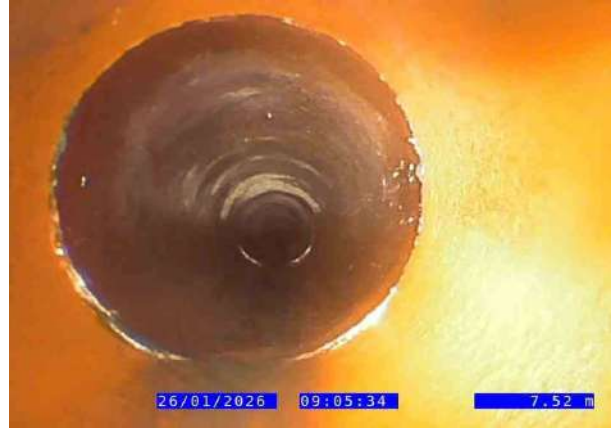
10, 00:00:51, 7.60 m  
Joint displaced, medium (between 1.0 and 1.5 times the pipe wall thickness)

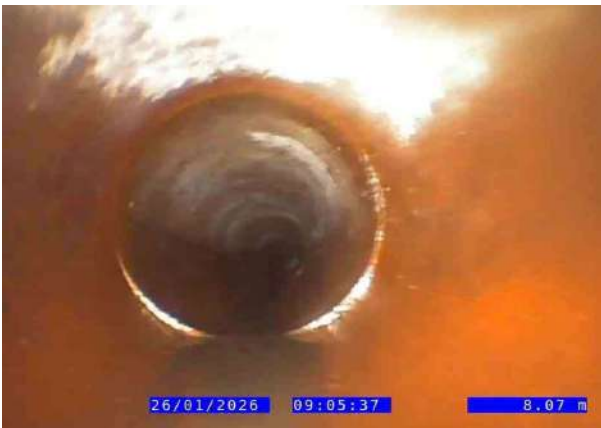
11, 00:00:53, 8.20 m  
Joint displaced, medium (between 1.0 and 1.5 times the pipe wall thickness)

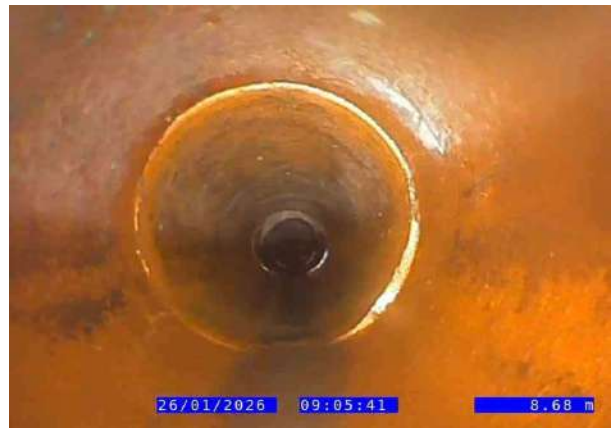
12, 00:00:58, 8.70 m  
Joint displaced, medium (between 1.0 and 1.5 times the pipe wall thickness)

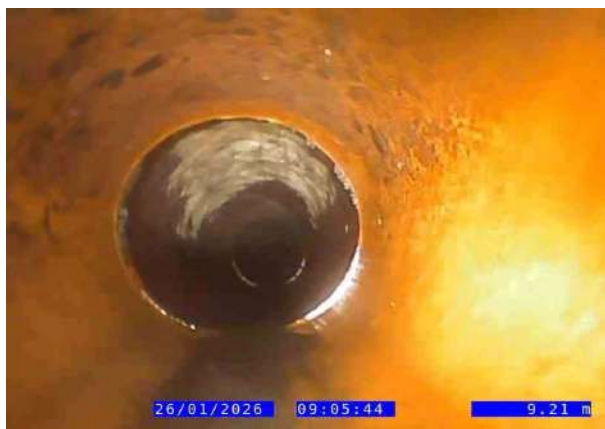
13, 00:01:00, 9.35 m  
Joint displaced, medium (between 1.0 and 1.5 times the pipe wall thickness)

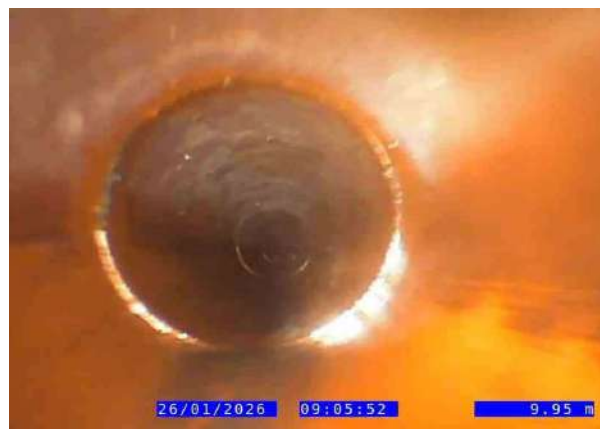
14, 00:01:08, 9.95 m  
Joint displaced, medium (between 1.0 and 1.5 times the pipe wall thickness)

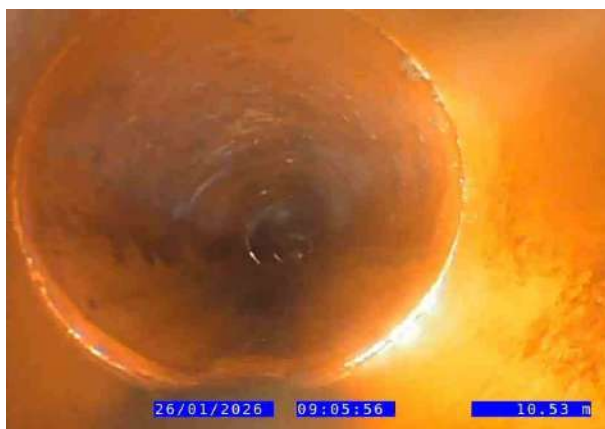
15, 00:01:12, 10.55 m  
Joint displaced, medium (between 1.0 and 1.5 times the pipe wall thickness)

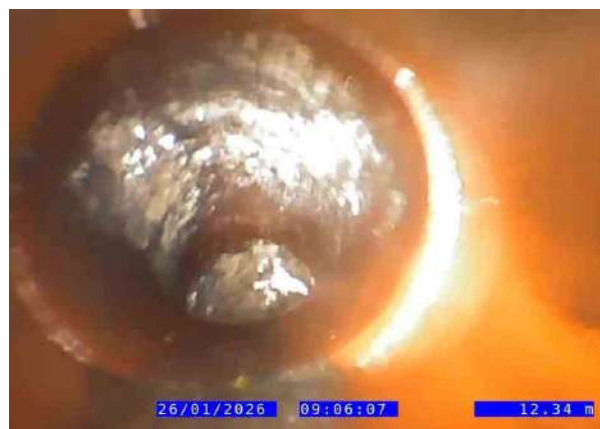
16, 00:01:23, 12.34 m  
Joint displaced, medium (between 1.0 and 1.5 times the pipe wall thickness)

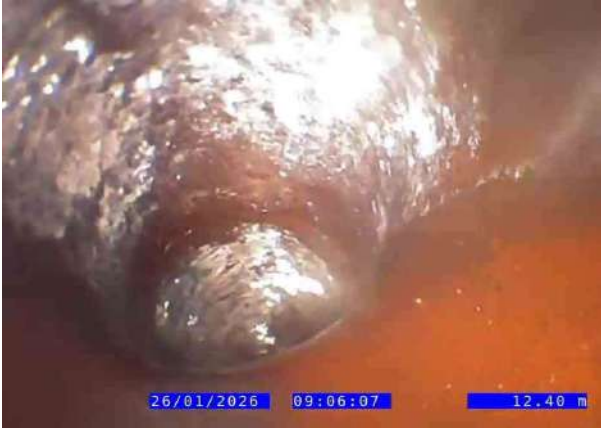
17, 00:01:24, 12.40 m  
Encrustation, medium from 12 o'clock to 12 o'clock, start

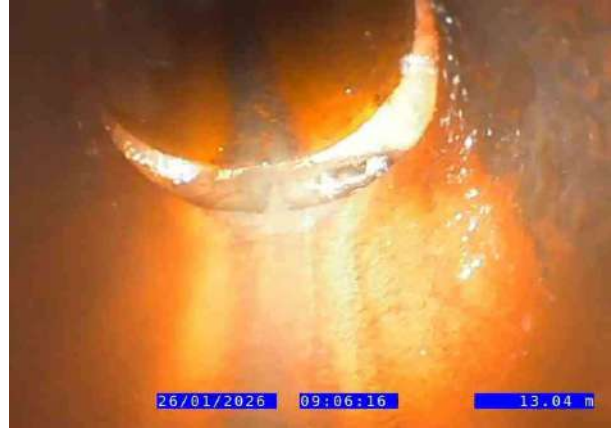
18, 00:01:32, 13.10 m  
Joint displaced, large (over 1.5 times the pipe wall thickness)

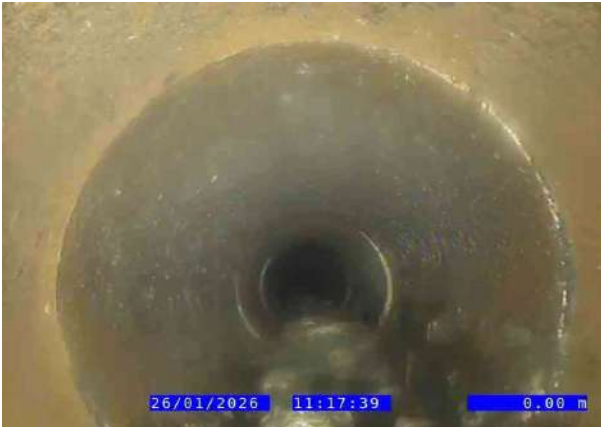
1, 00:00:00, 0.00 m  
Encrustation, heavy from 6 o'clock to 6 o'clock, start
