# **PHASE 2 SITE INVESTIGATION &**

# **GEO-ENVIRONMENTAL APPRAISAL**

**LAND AT CRIMBLE HALL CRIMBLE LANE  
HEYWOOD OL11 4AD**

**Investigation date: March 2026**

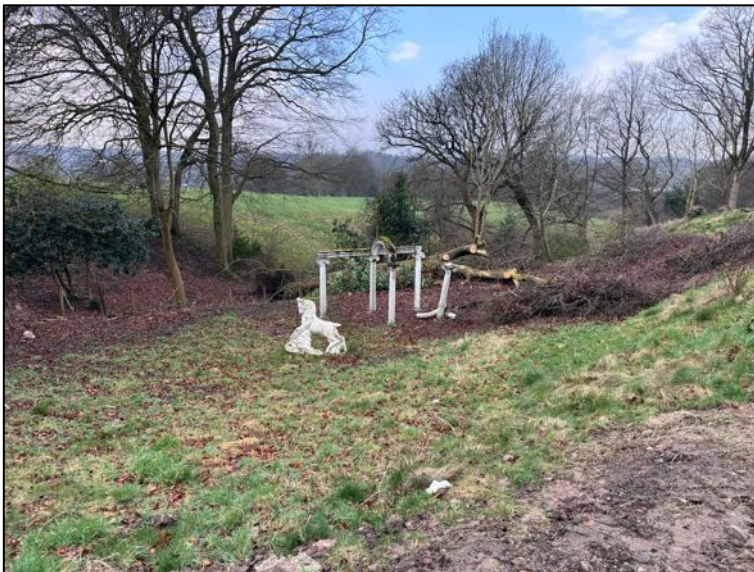
General view to the west showing the lowest elevation area in the south west of the site

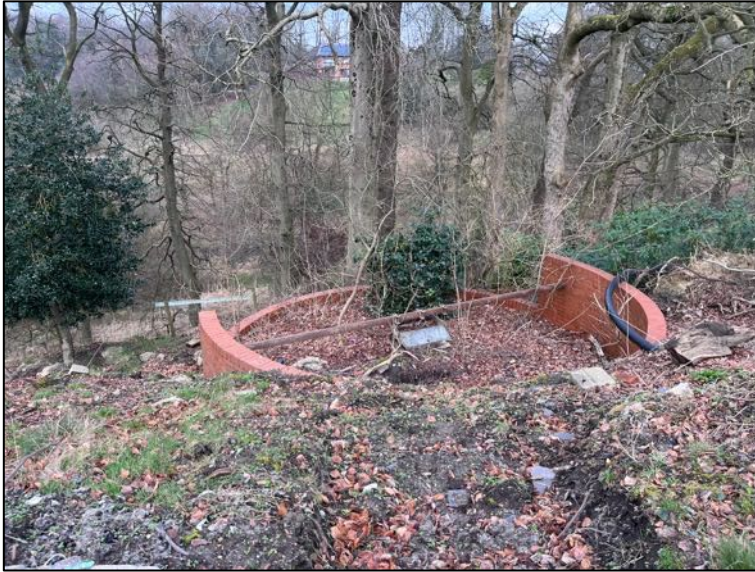
View to the west of a disused drainage structure land immediately west of the site – attempting to highlight ground level falling steeply on adjacent land

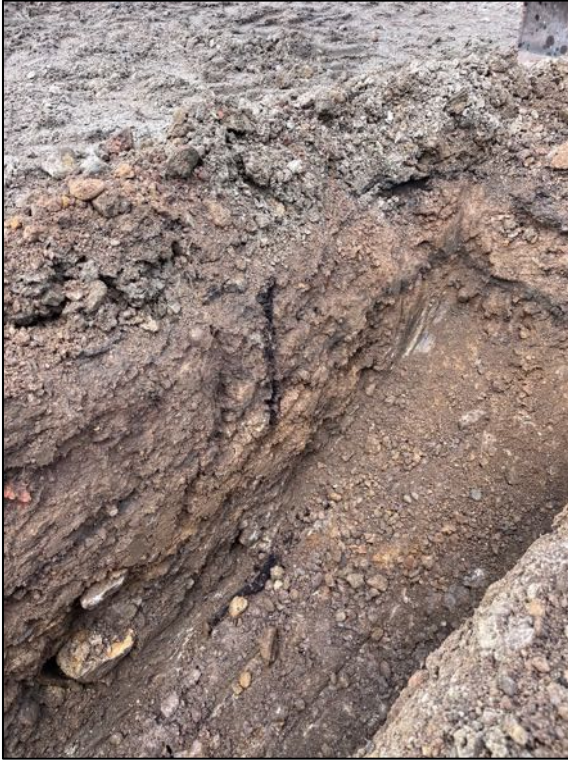
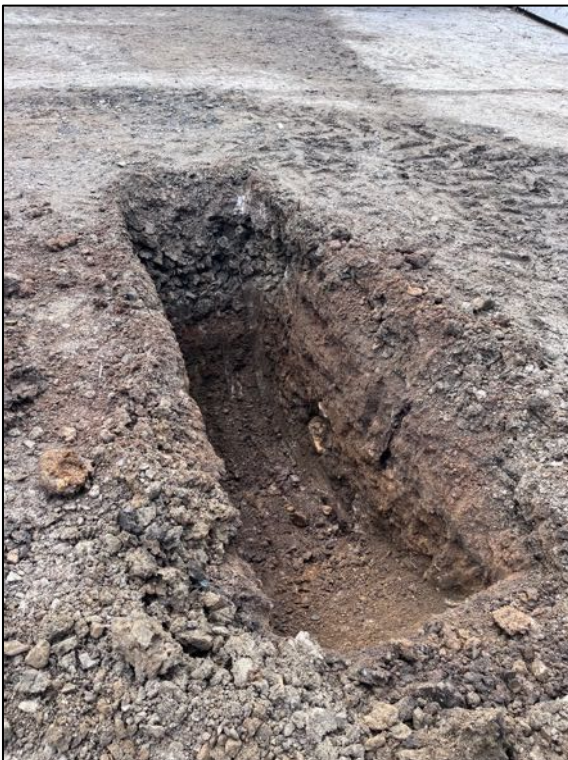
TP1 pit

At TP1, from ground level made ground was recorded to approximately 0.4m bgl comprising a grey and dark grey slightly clayey silty sandy gravel. From 0.4m bgl a firm brown and pale yellow slightly fine sandy slightly gravelly clay was recovered to approximately 1.4m bgl. The trial pit was terminated within competent strata at approximately 1.4m bgl and was dry upon completion. It was backfilled with arisings upon completion.

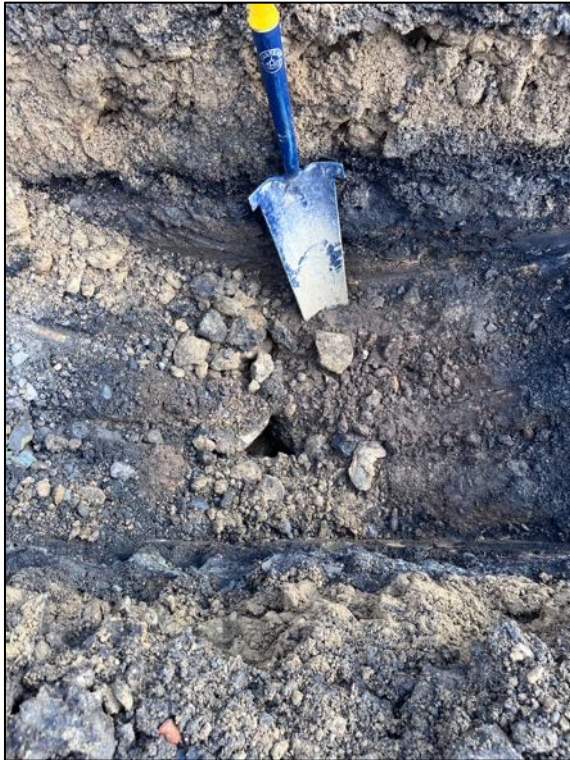
TP4 old land drain exposed
