# KHAN & THOMPSON LTD

External Boundary Wall-  
Crescent Nurseries,  
Crescent Hall, Edmund Street,  
Rochdale, OL12 6QG

Khan & Thompson Ltd  
Structural Engineers  
Initial Business Centre,  
Wilson Park,  
Manchester,  
M40 8WN

22<sup>nd</sup> February, 2026

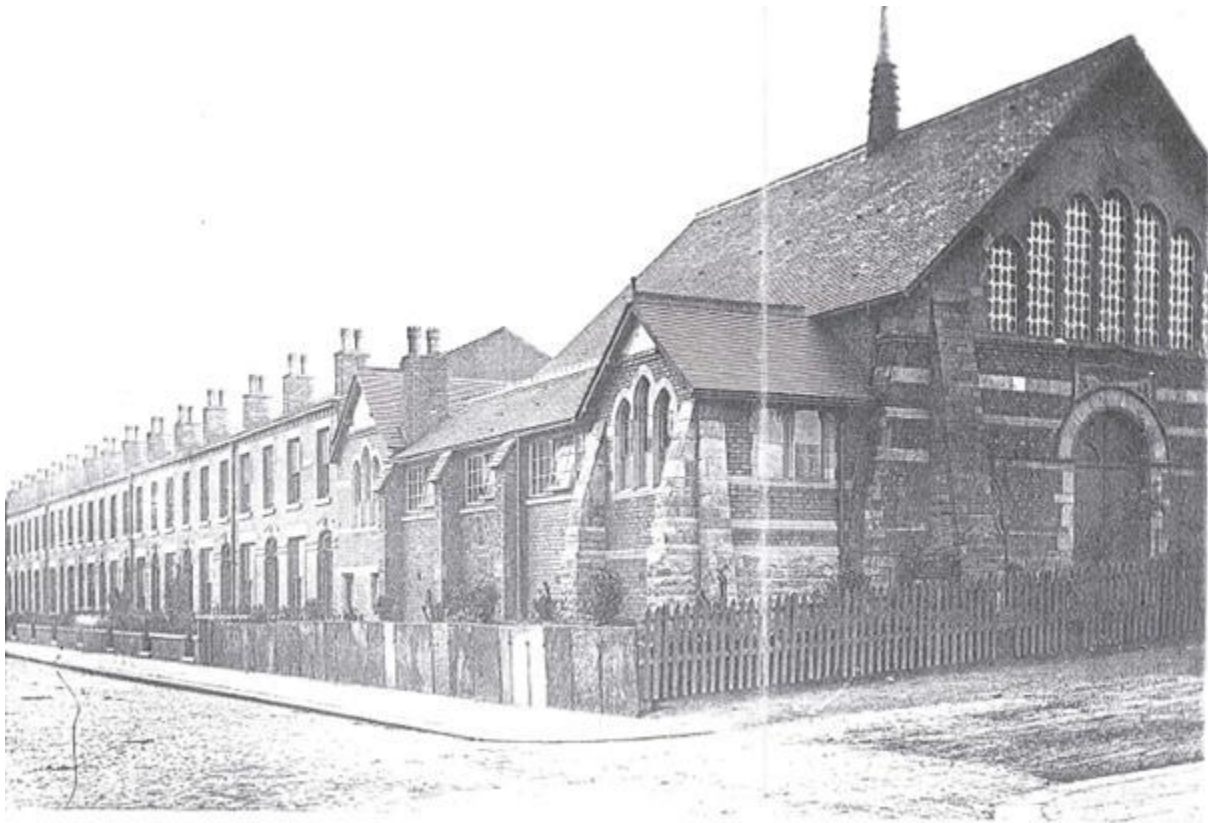
Historical Photo taken from CCR Report of the Edmund Street Side Elevation

The existing wall around the church was constructed c1926 and replaced an earlier wall constructed of standing York stones, which are a feature of the area, and a picket fence (see image below)

The above Photo appears to have captured the original appearance and construction of this Church Building and its Grounds. It clearly shows natural stone slabs used as a wall to the Edmund Street Elevation. The Vertical Stone Slabs are typical through ough Rochdale for the period of construction. There is a simple timber fence to the Front Boundary Elevation.

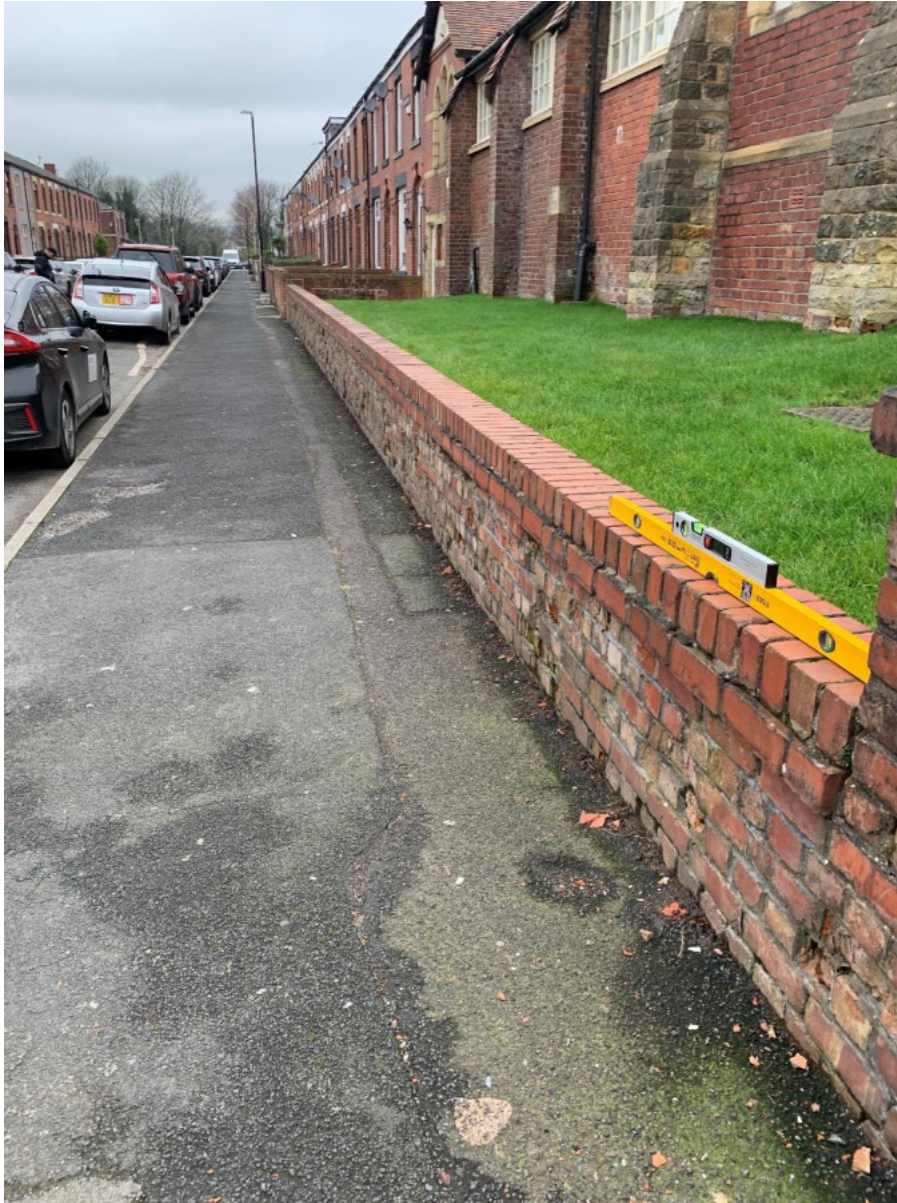
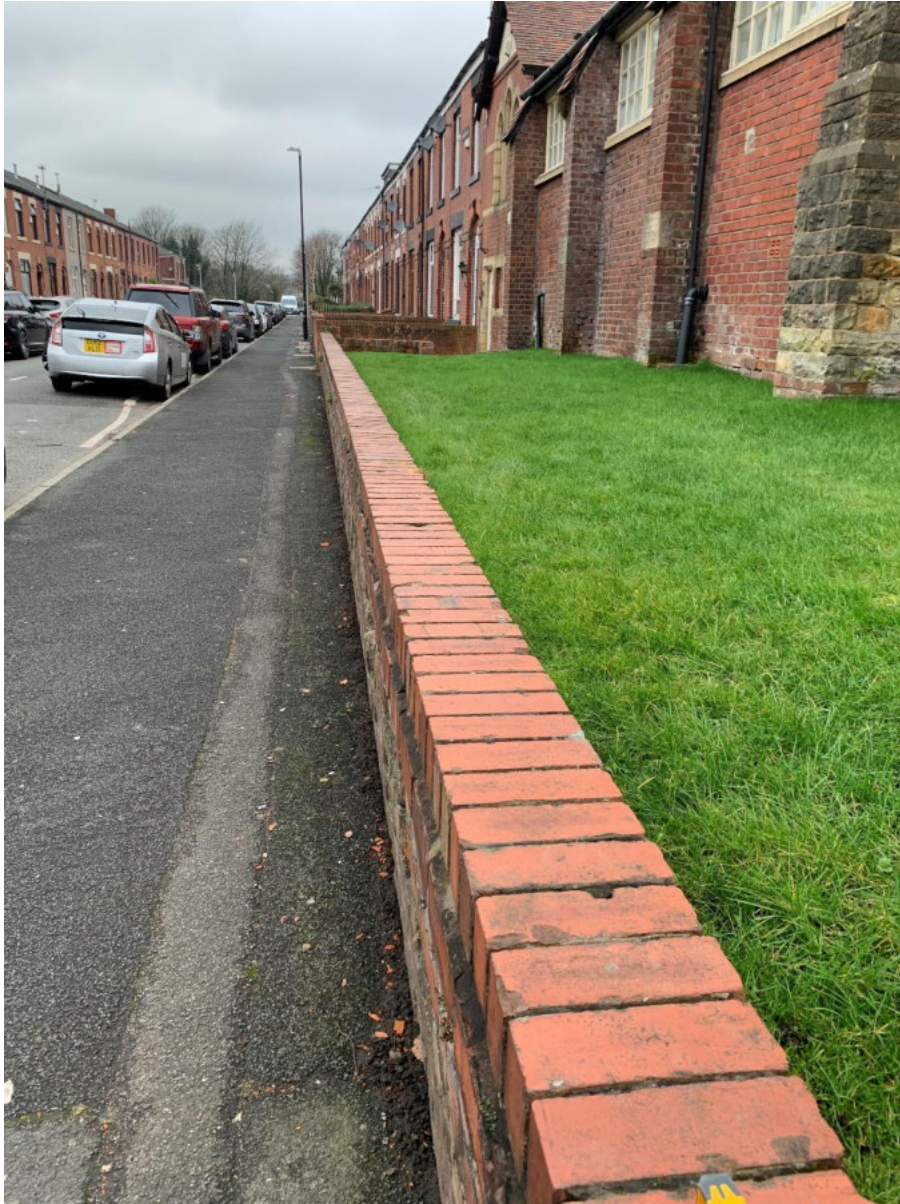
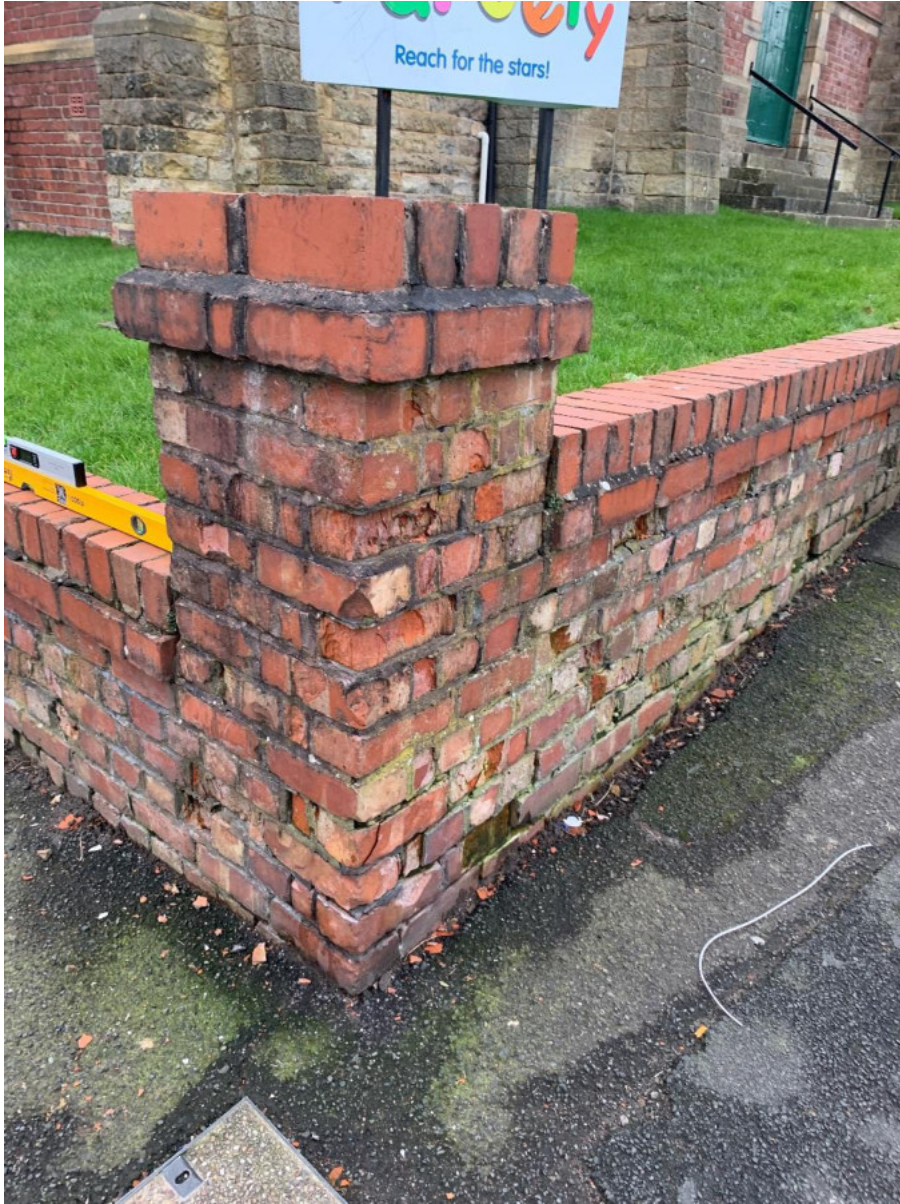
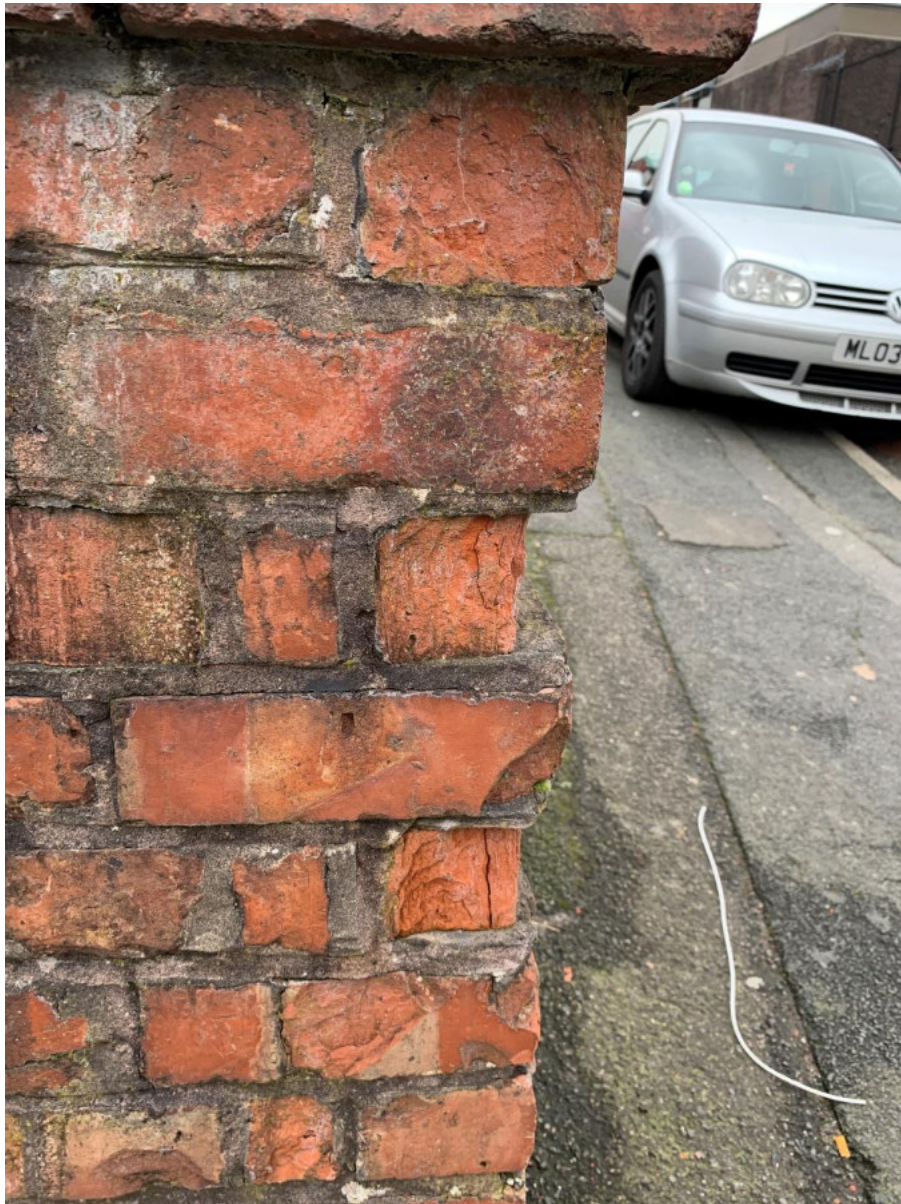
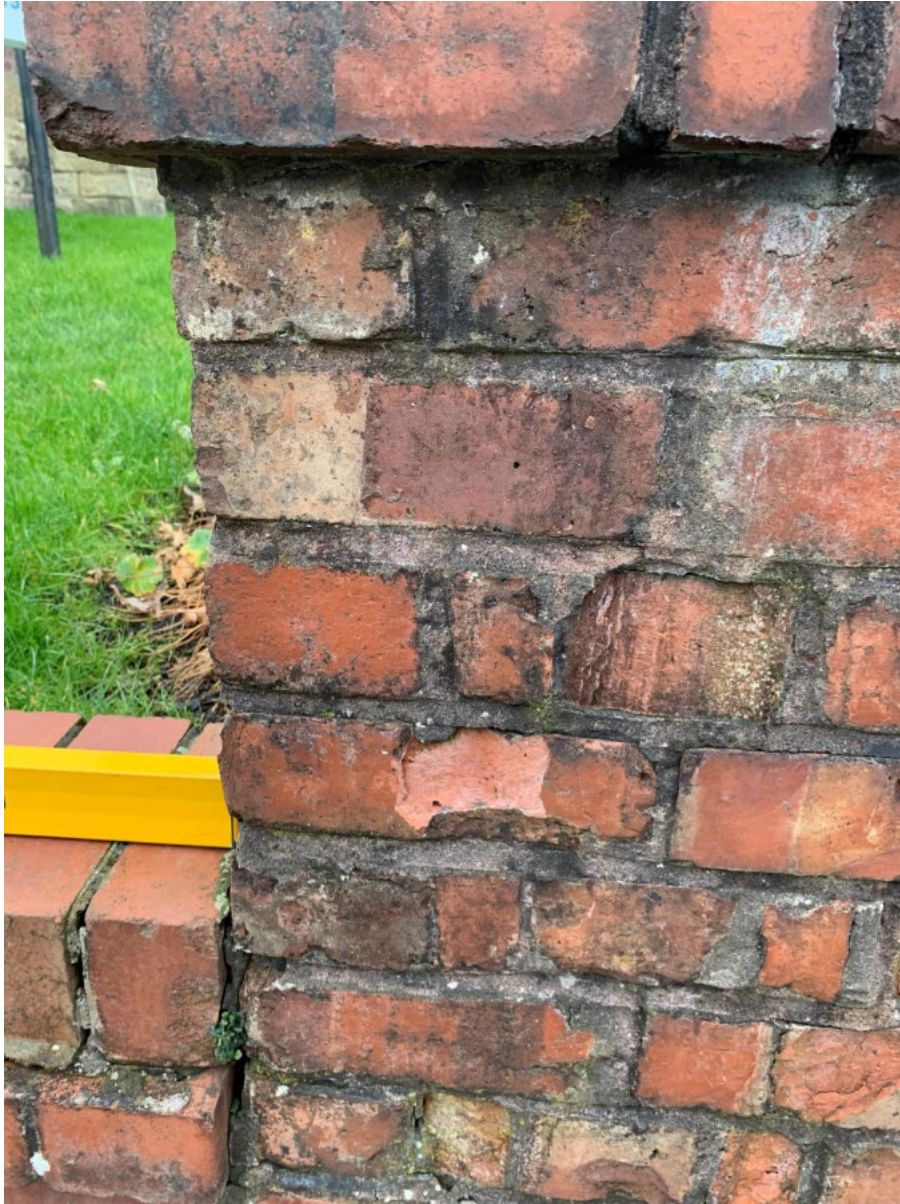
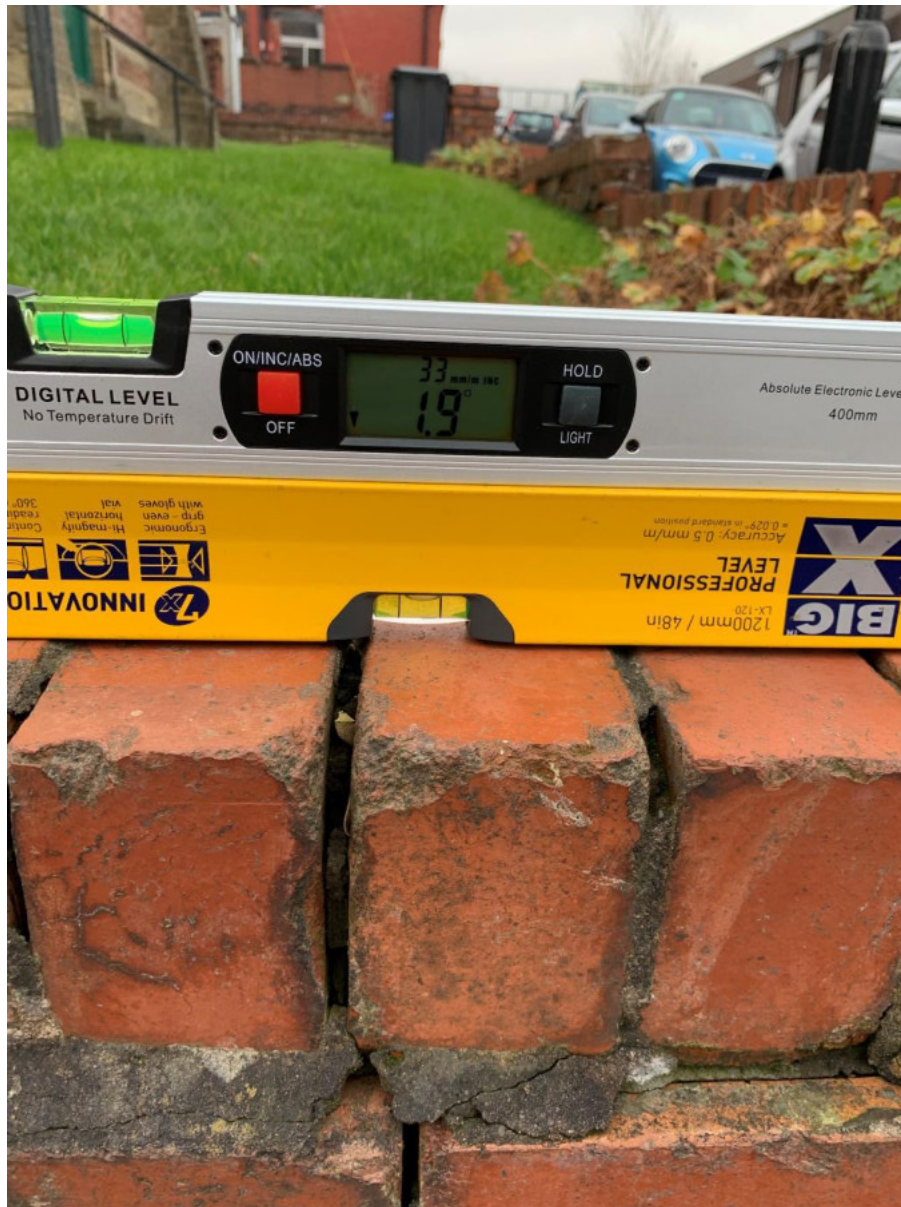
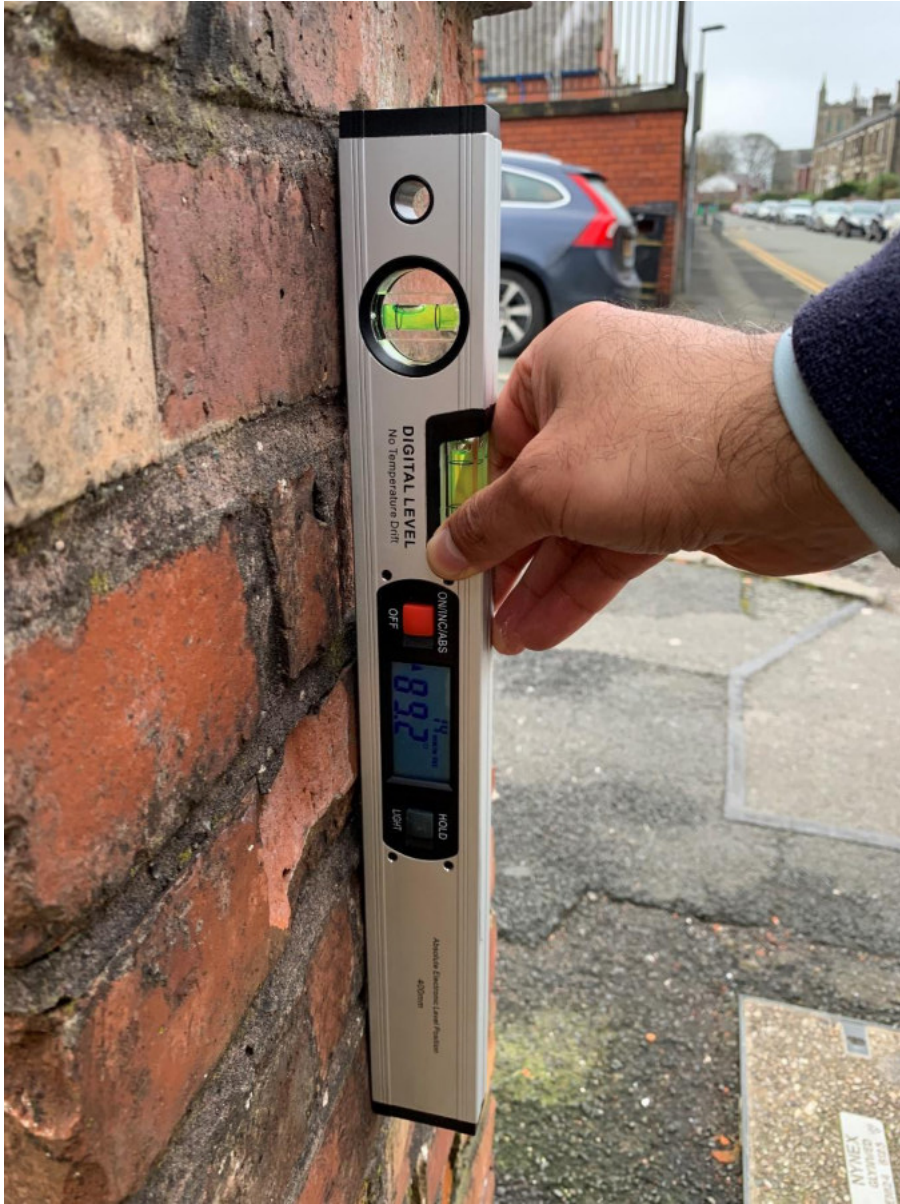
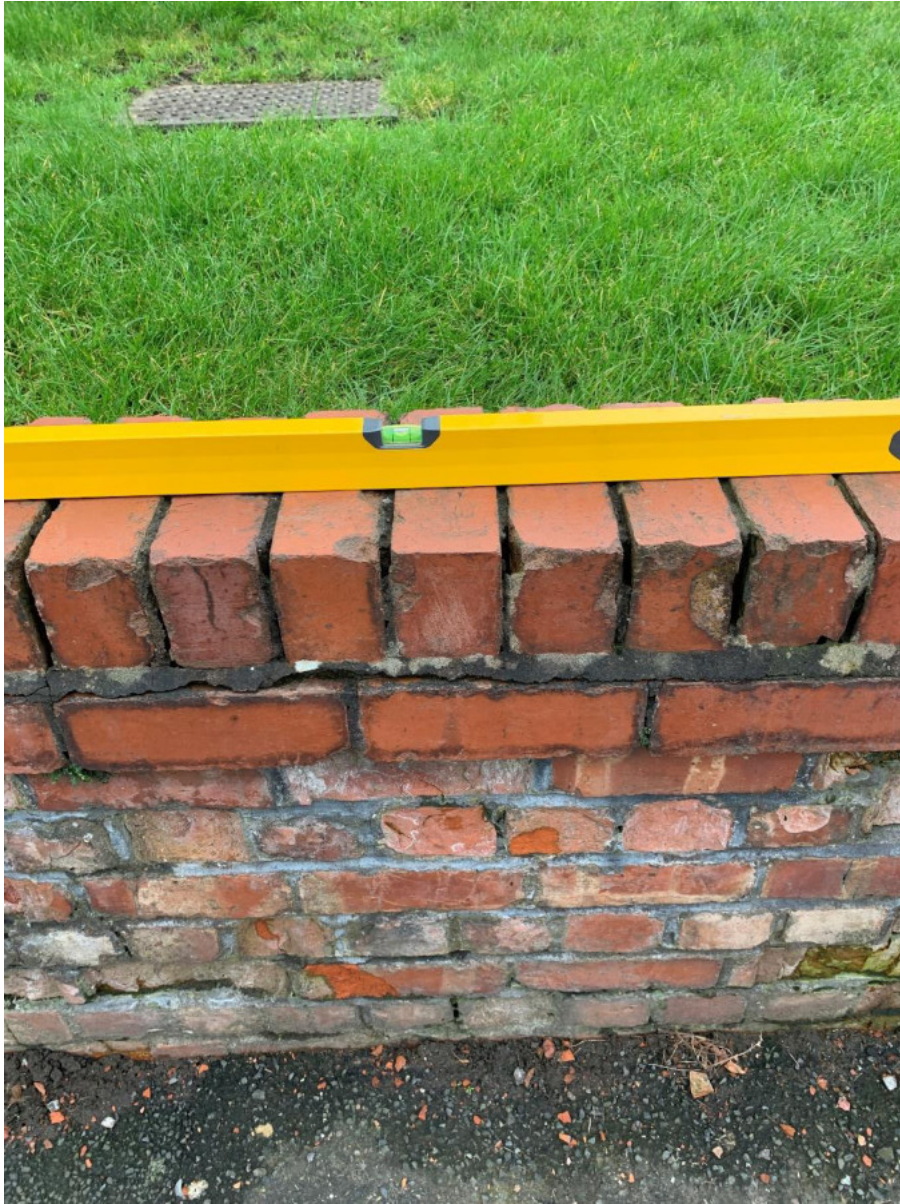
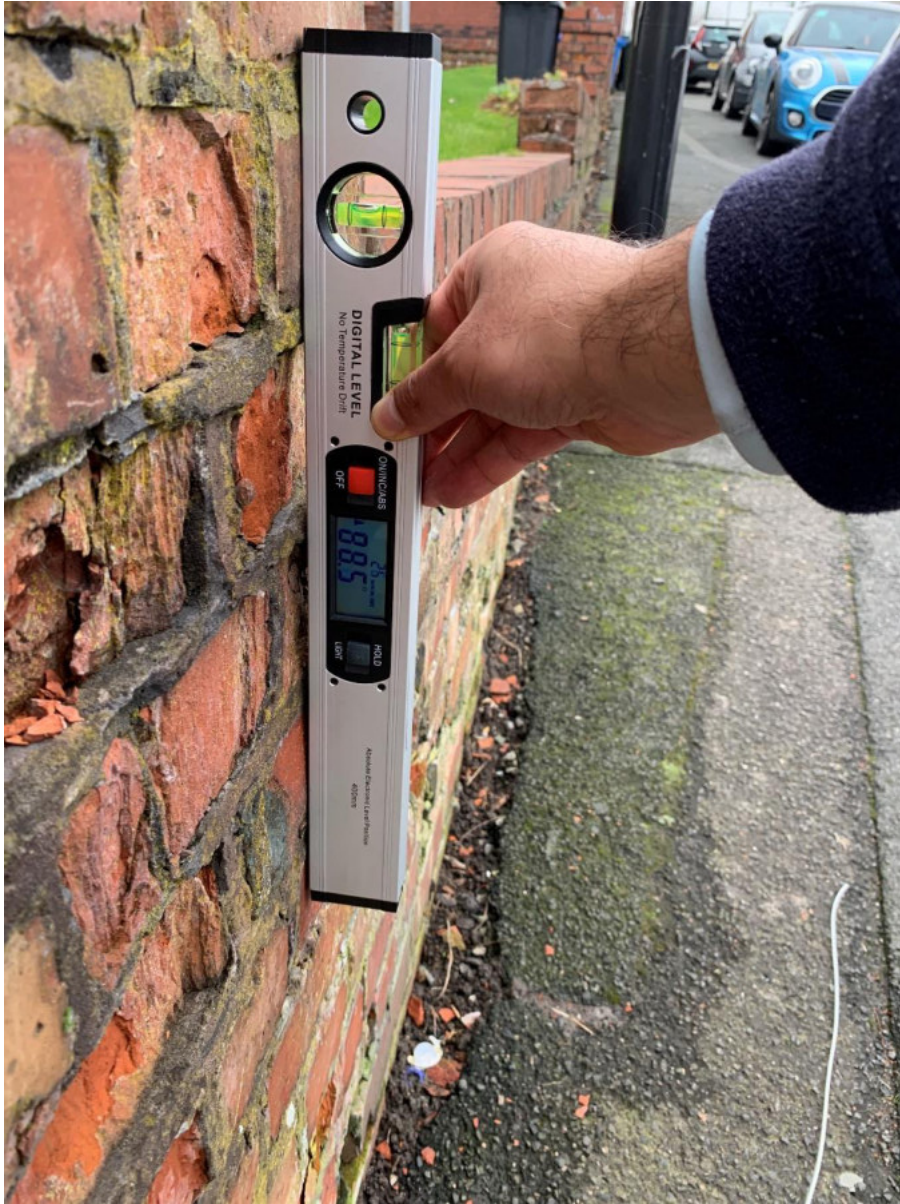
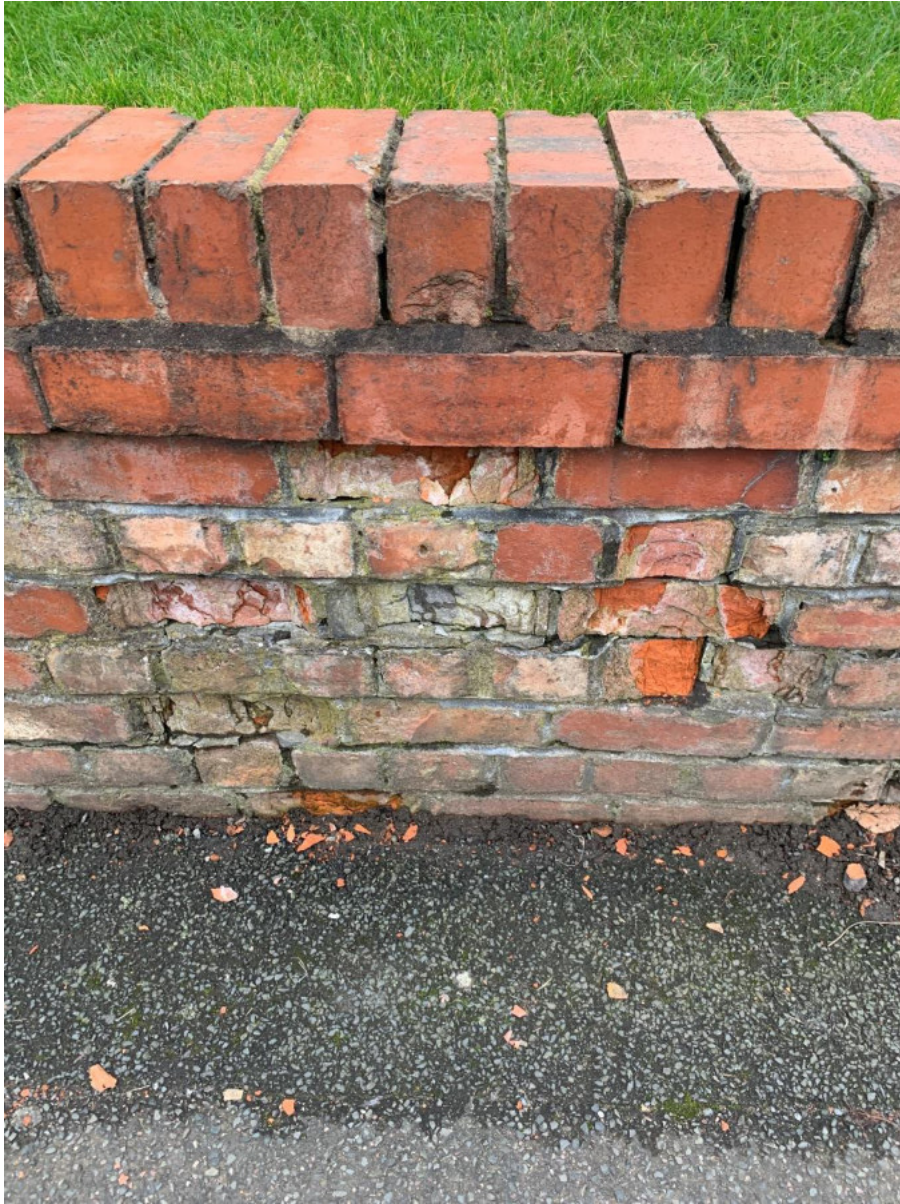
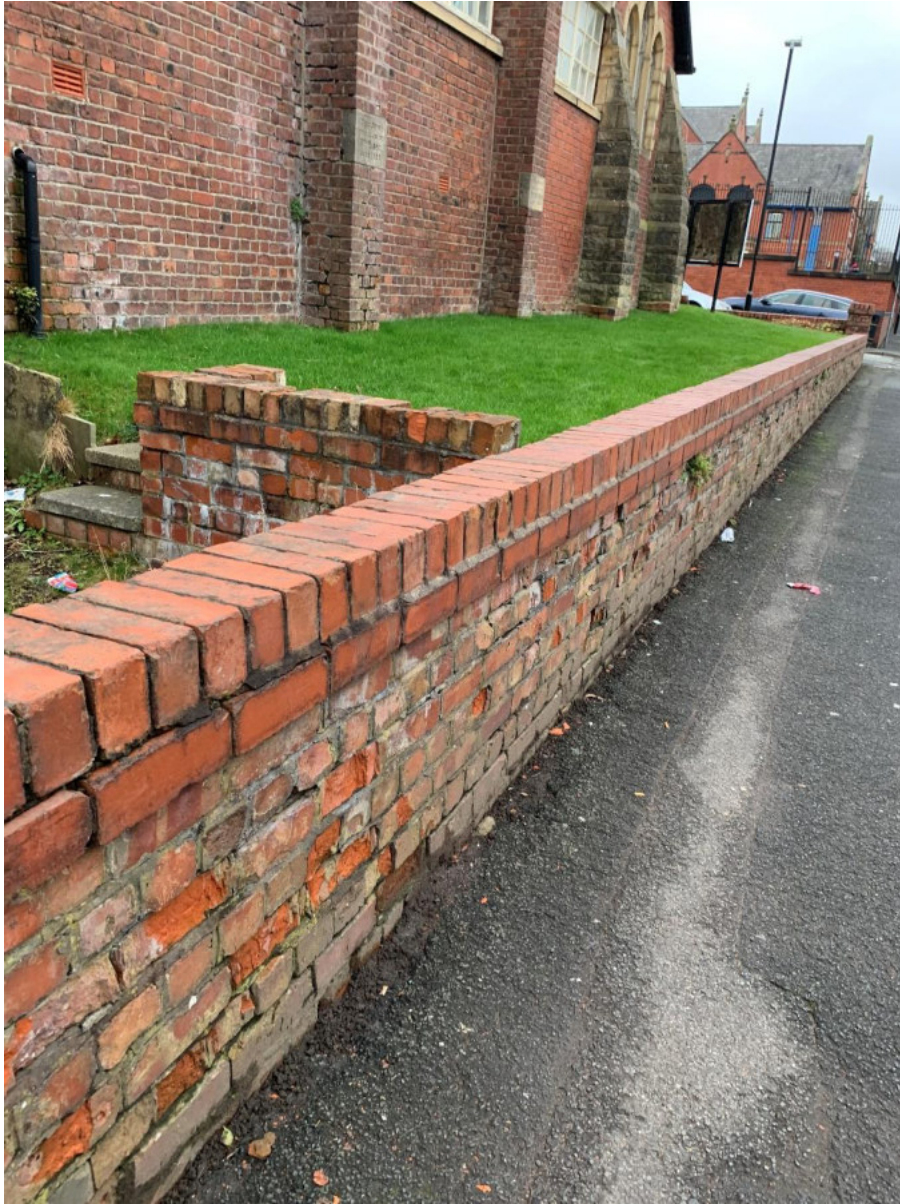
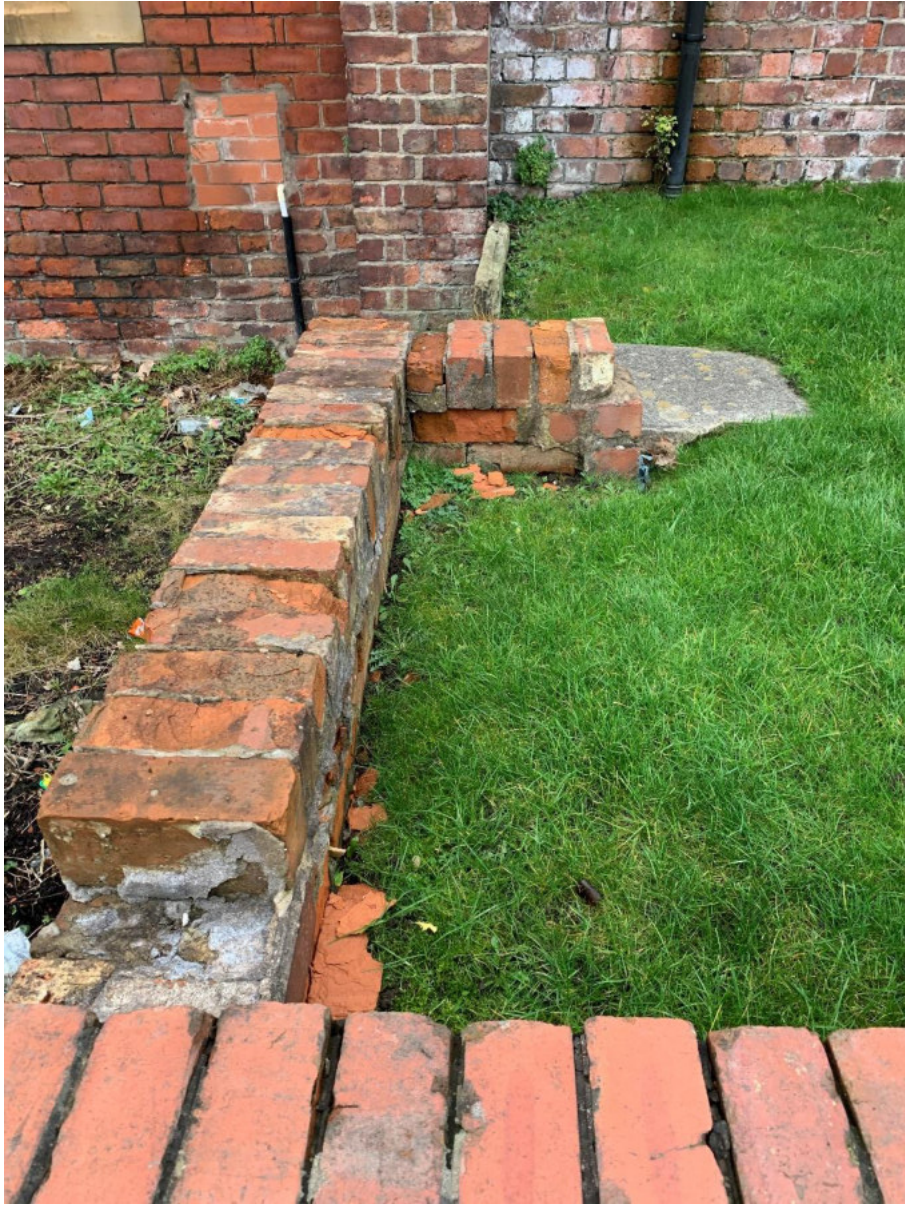
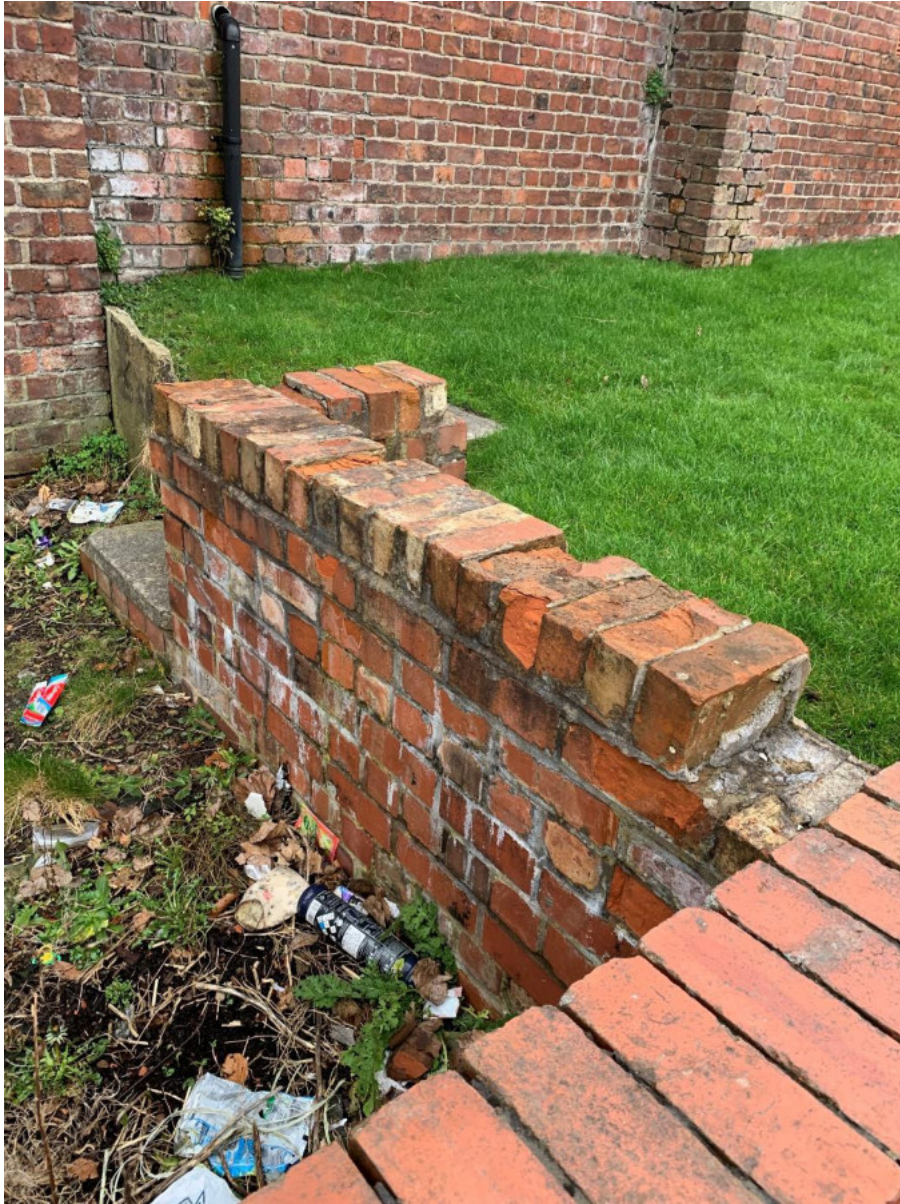
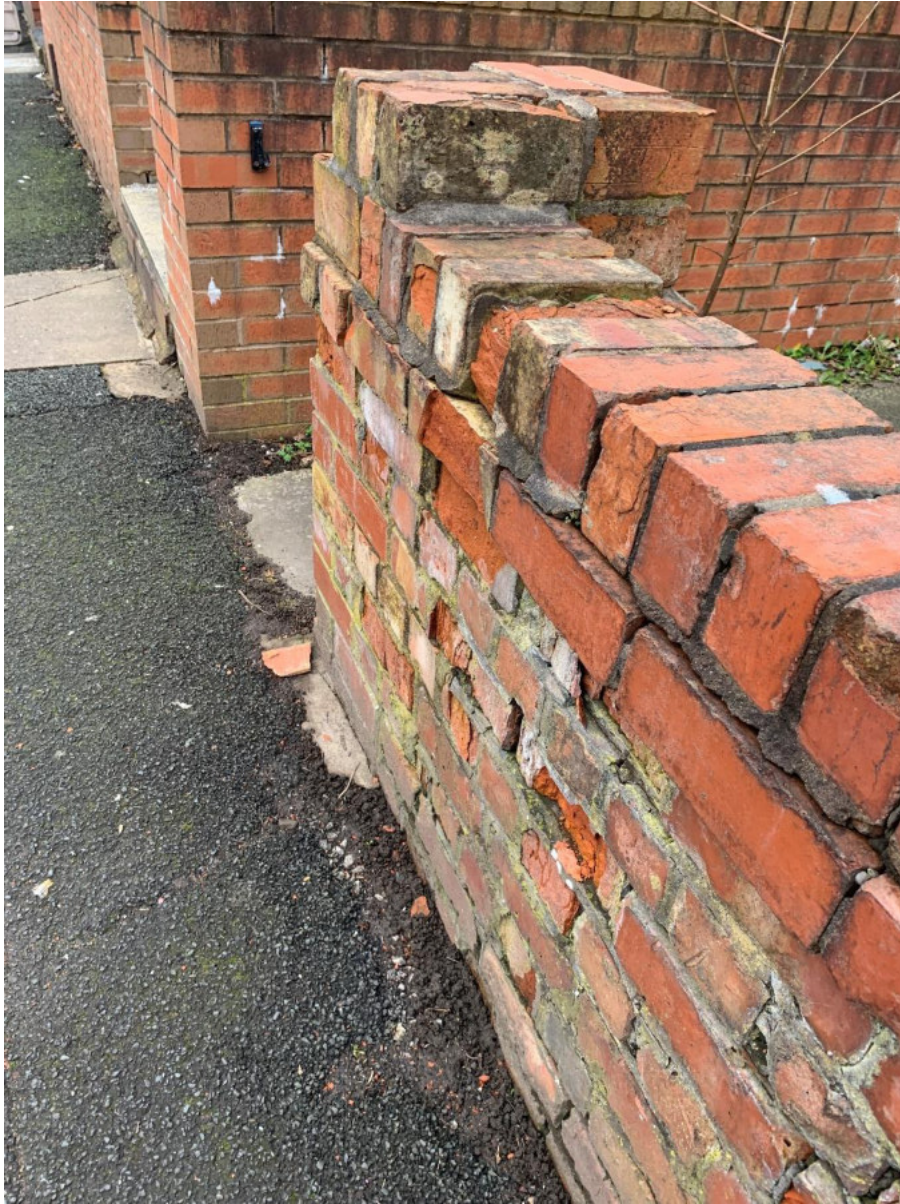
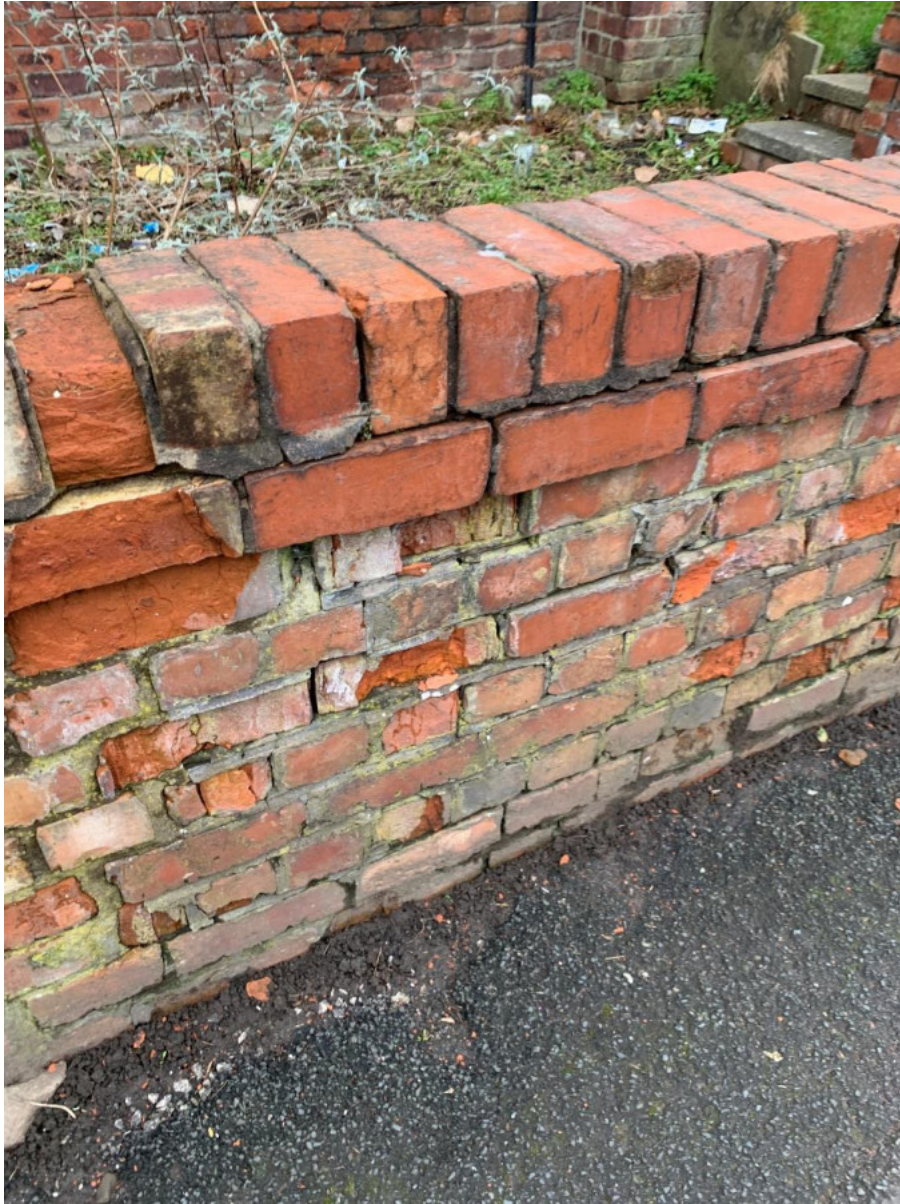
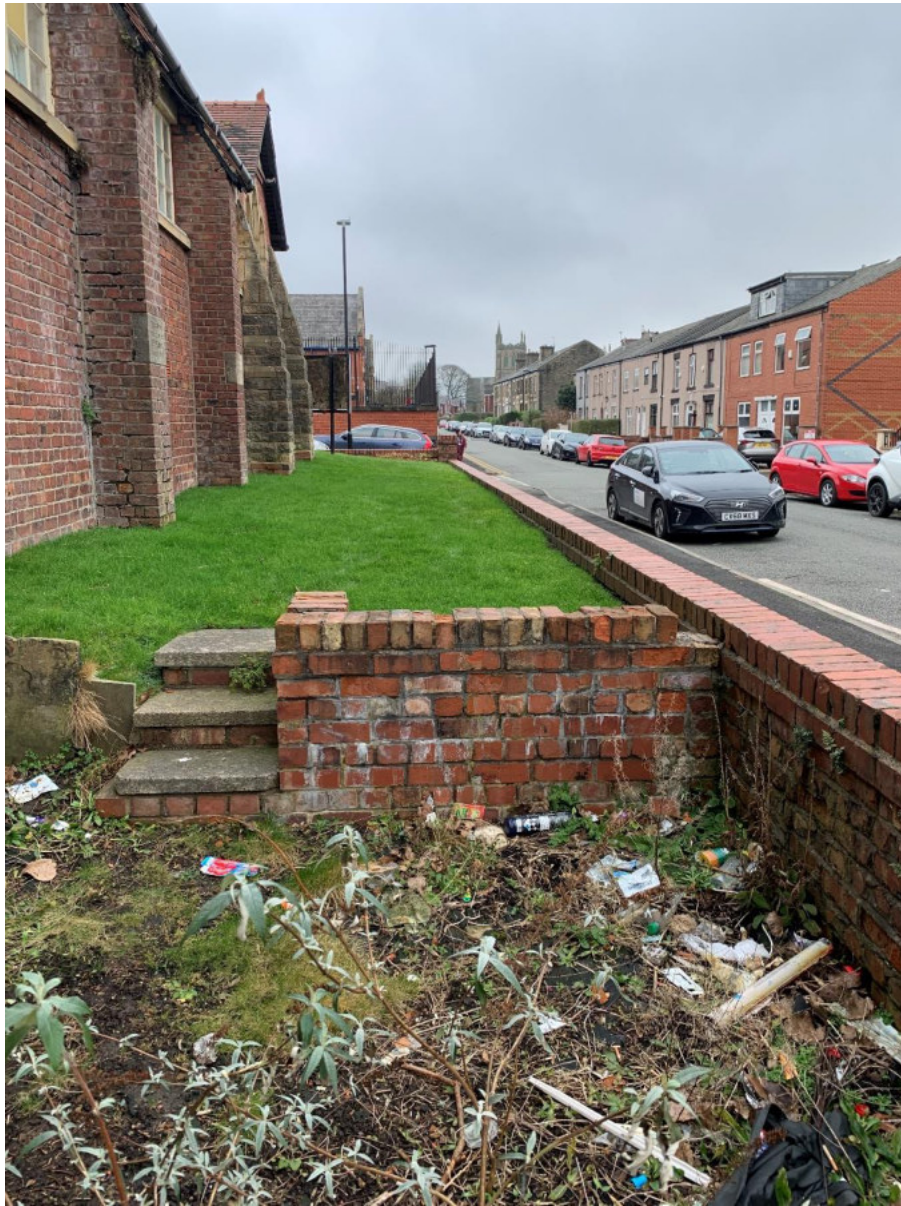
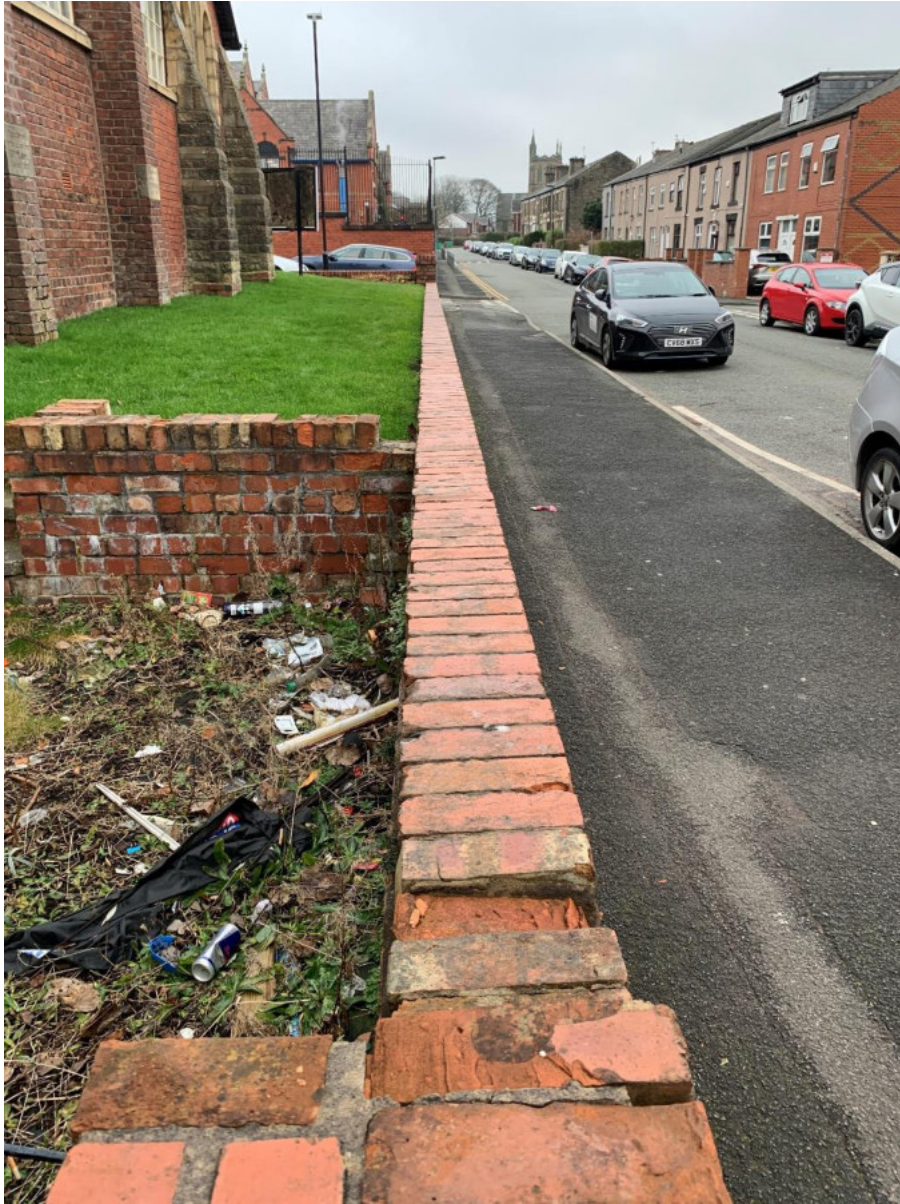
Edmund Street Elevation-

- The brickwork below the 2 top capping courses have severely deteriorated which is self-evident and can be clearly seen by the photographs.
- The brick faces have spalled across a large and consistent area of the front visible wall. This is very unsightly and does not benefit at all the appearance or heritage of the Church or this area.

- The factors that may have contributed to the above-
  - This is typical of the continuous process over many years of constant wet brickwork and freezing temperatures causing the wet brickwork to freeze. Once frozen the bricks will then expand, crack, loosen and spall onto the footway.

- Sources of water ingress to the wall and saturation of the brickwork would mostly be from the retained soil / ground. This type of wall will not be adequately waterproofed at its rear underground and appears not to have a back of wall drainage system or any weepholes. In addition to rain directly onto the wall.

Therefore my recommendation is to ideally demolish and remove the existing wall and replace with a new wall of either similar appearance or an appearance that fits in very well for this location and the Church's architectural heritage appearance.
