# Rochdale Borough Council

| <b>Survey Type:</b> | | HSG264 Refurb/Demo Asbestos Survey | |
| <b>Building Name:</b> | | Lakeside centre (Mid Gymnastics) | |

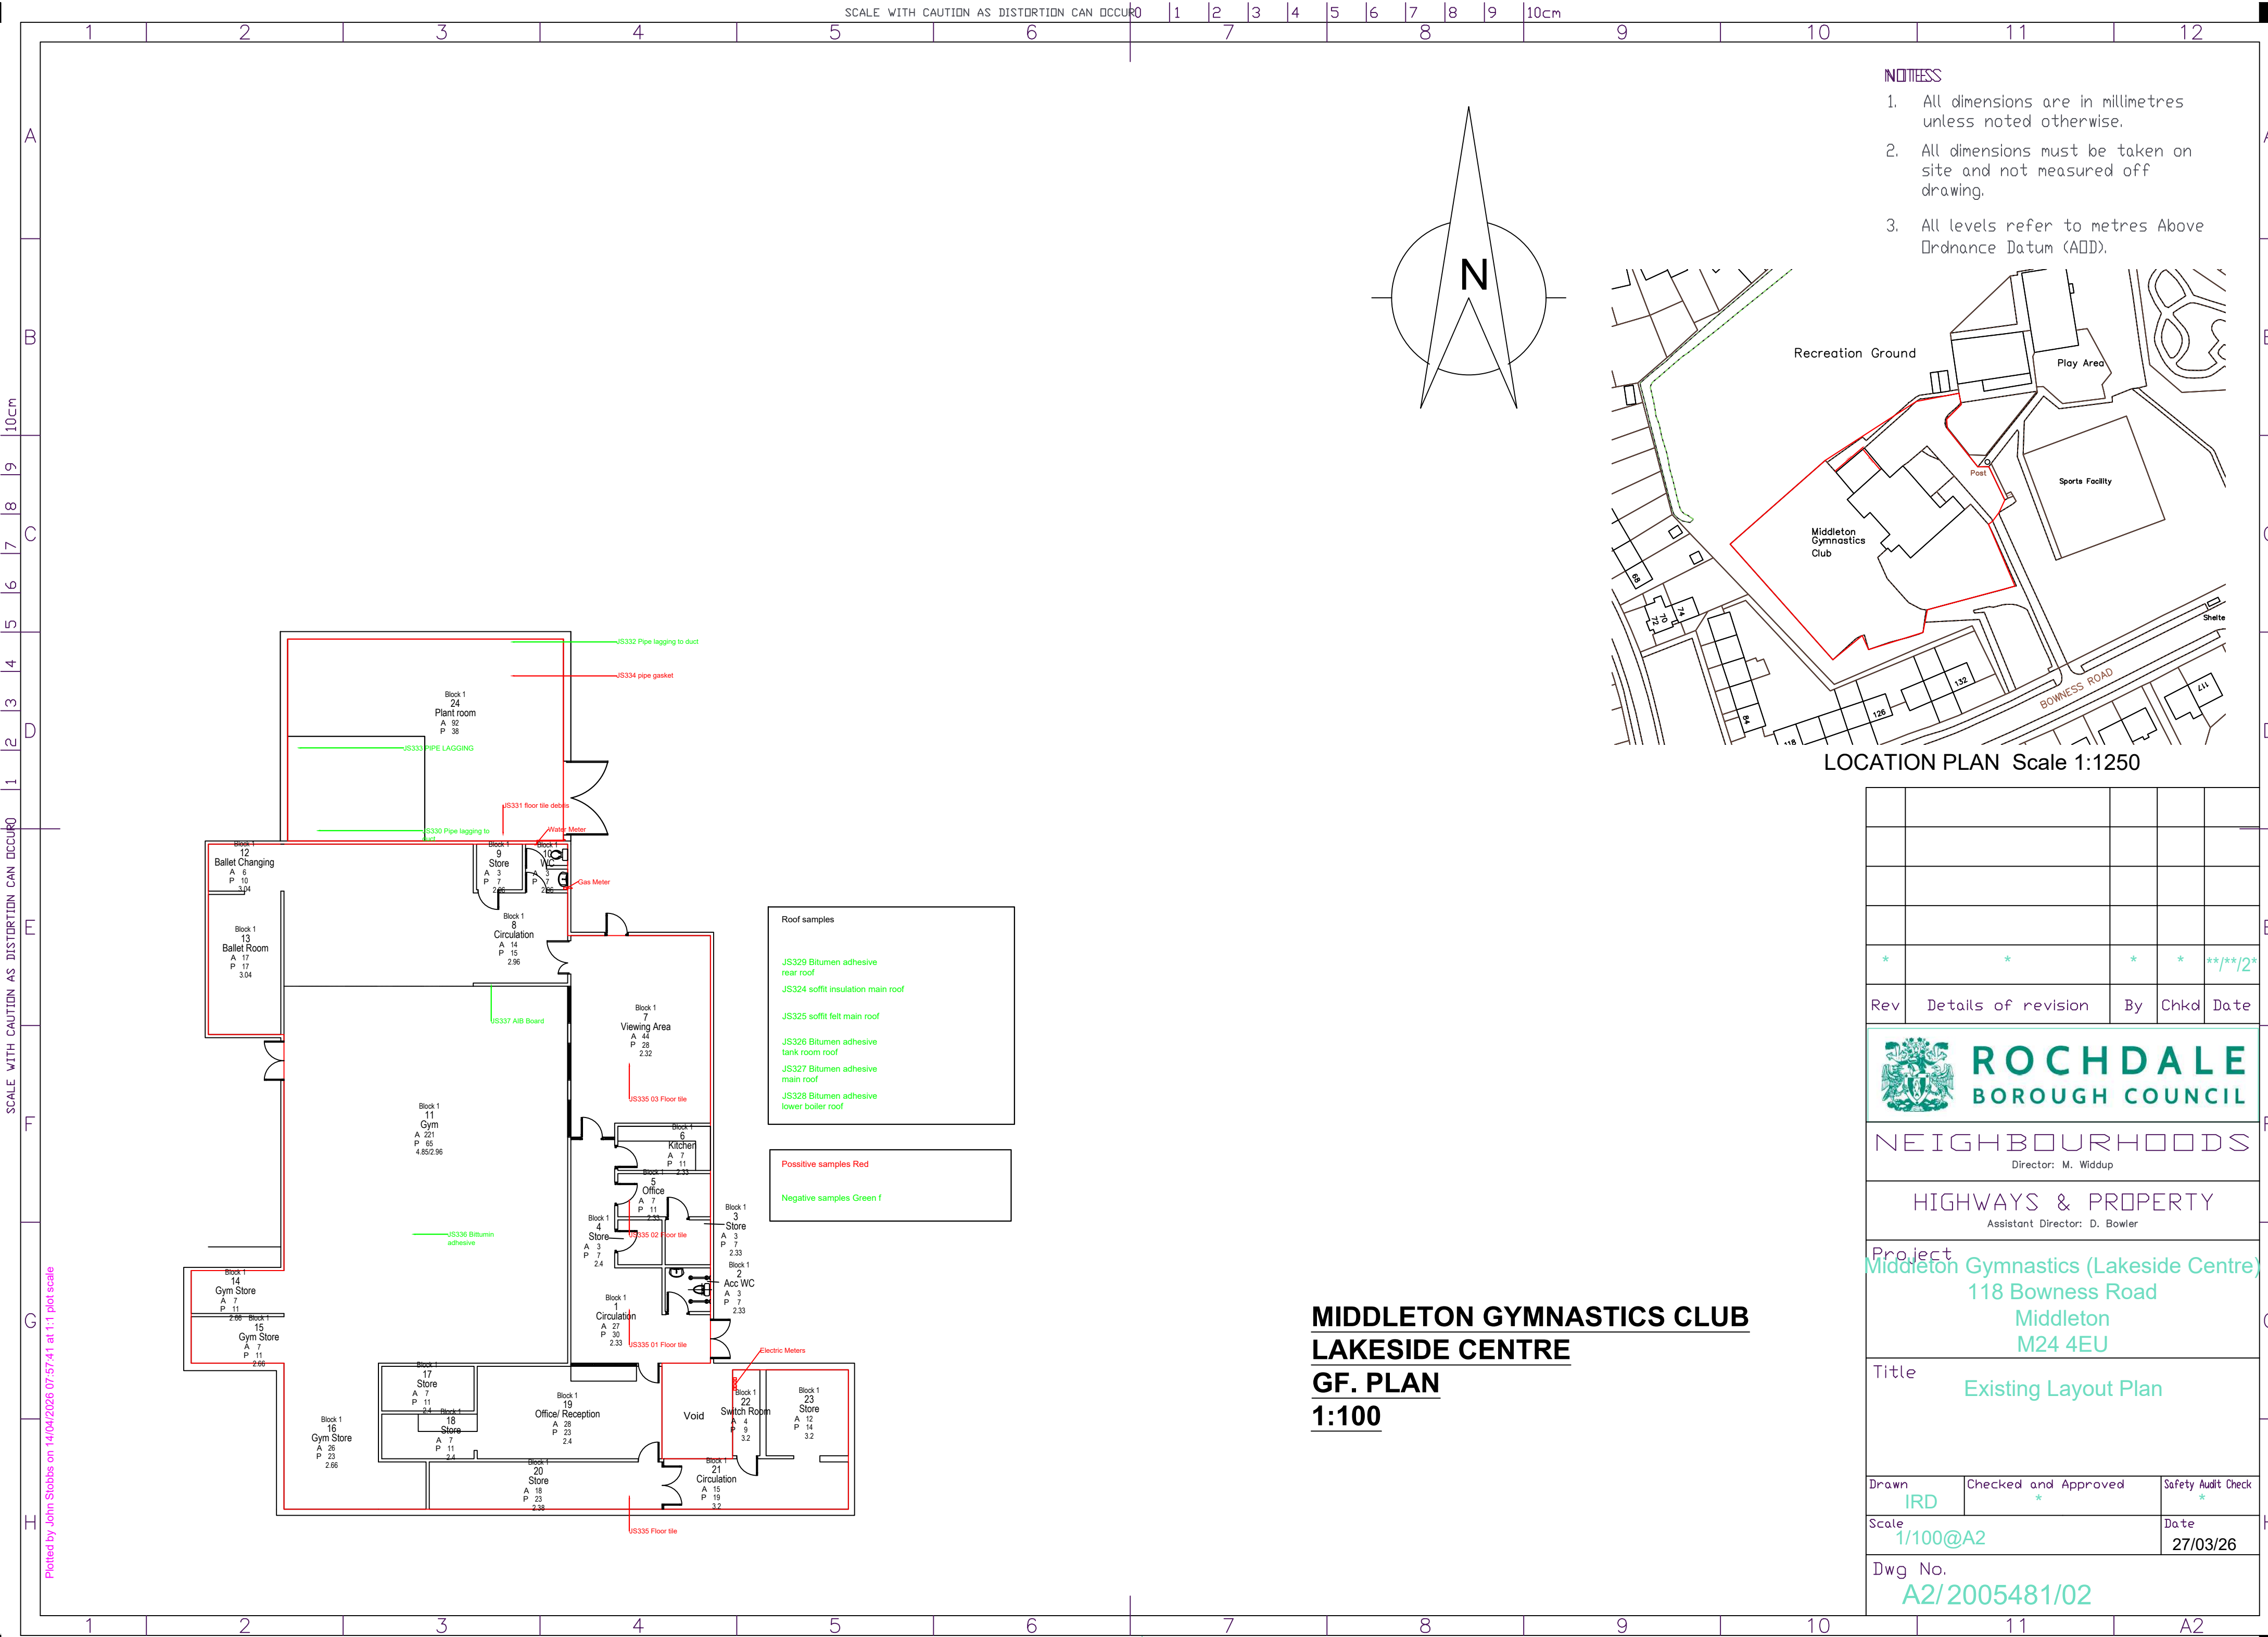
**MIDDLETON GYMNASTICS CLUB  
LAKESIDE CENTRE  
GF. PLAN  
1:100**

- Floor tiles throughout ( see drawing)- Chrysotile.
- Floor tile debris in boiler room – Chrysotile.
- Pipe gasket on redundant pipework in boiler room – Chrysotile

Floor ducts were accessed where possible in 4 areas, there were no ACMs located and samples taken to confirm but care should be taken when non accessible areas are disturbed.

| <b>Items requiring immediate remedial action:</b> | <ol style="list-style-type: none"><li>1. Remove asbestos floor tiles in circ 20, circ 21, circ 1, store 4 office 5 and viewing 7</li><li>2. Remove debris in boiler room containing asbestos floor tiles</li><li>3. Remove pipe gaskets to old pipework.</li></ol> |
