## **1.0 Property description:**

Grade 2 listed building, former hotel and public house, of brick construction with stone detailing. Proposed for conversion to apartments.

## **2.0 Design strategy:**

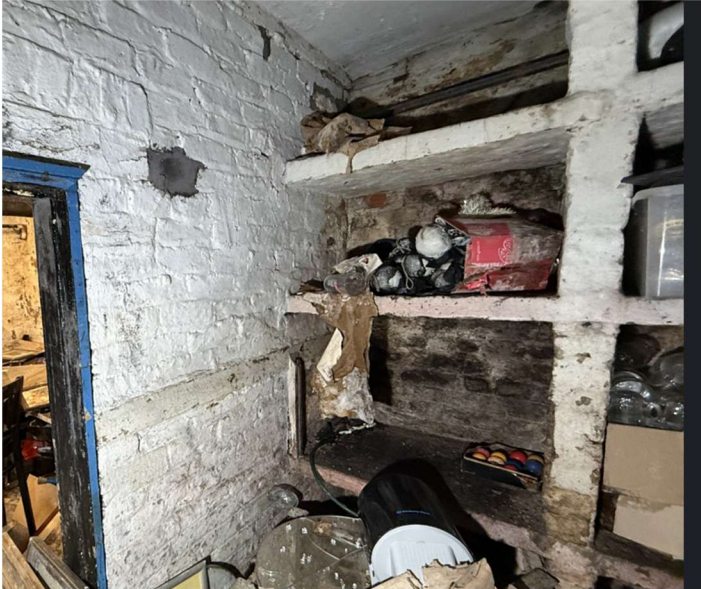
Condition of retaining wall to right, versus internal dividing wall to left:

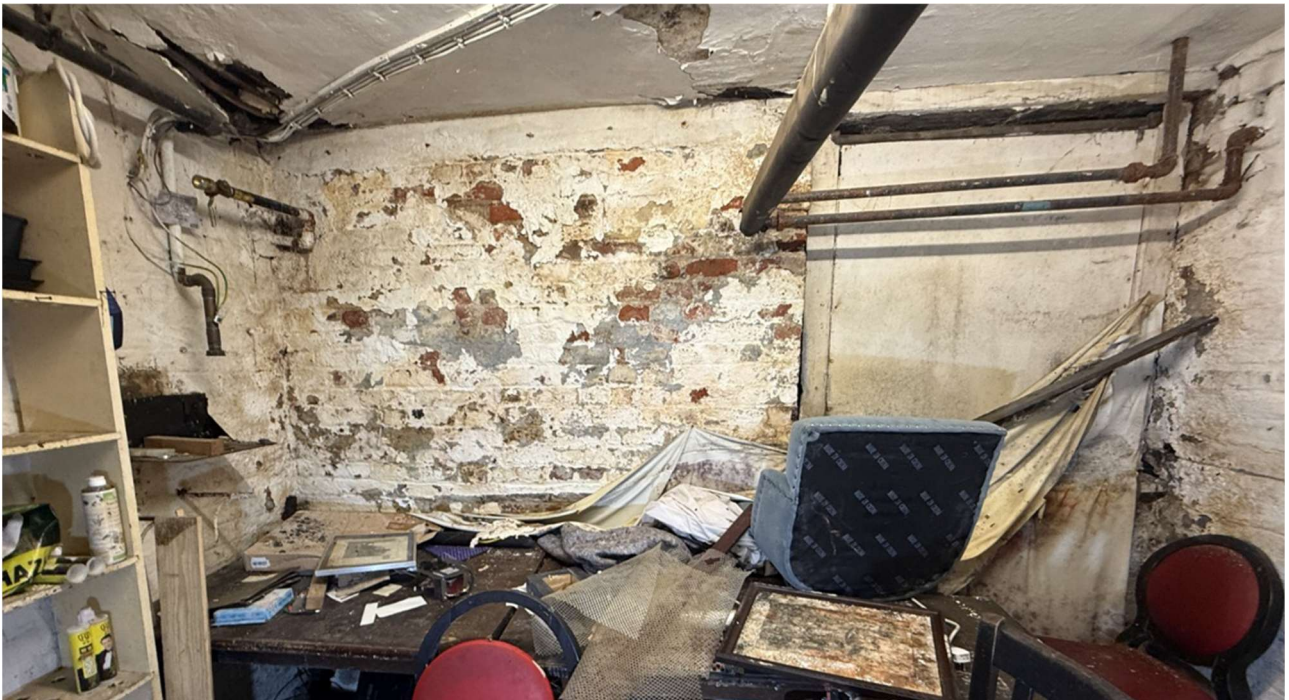
Continuation of the retaining wall condition, to the other wide of the internal pictured above, full height spalling paint:

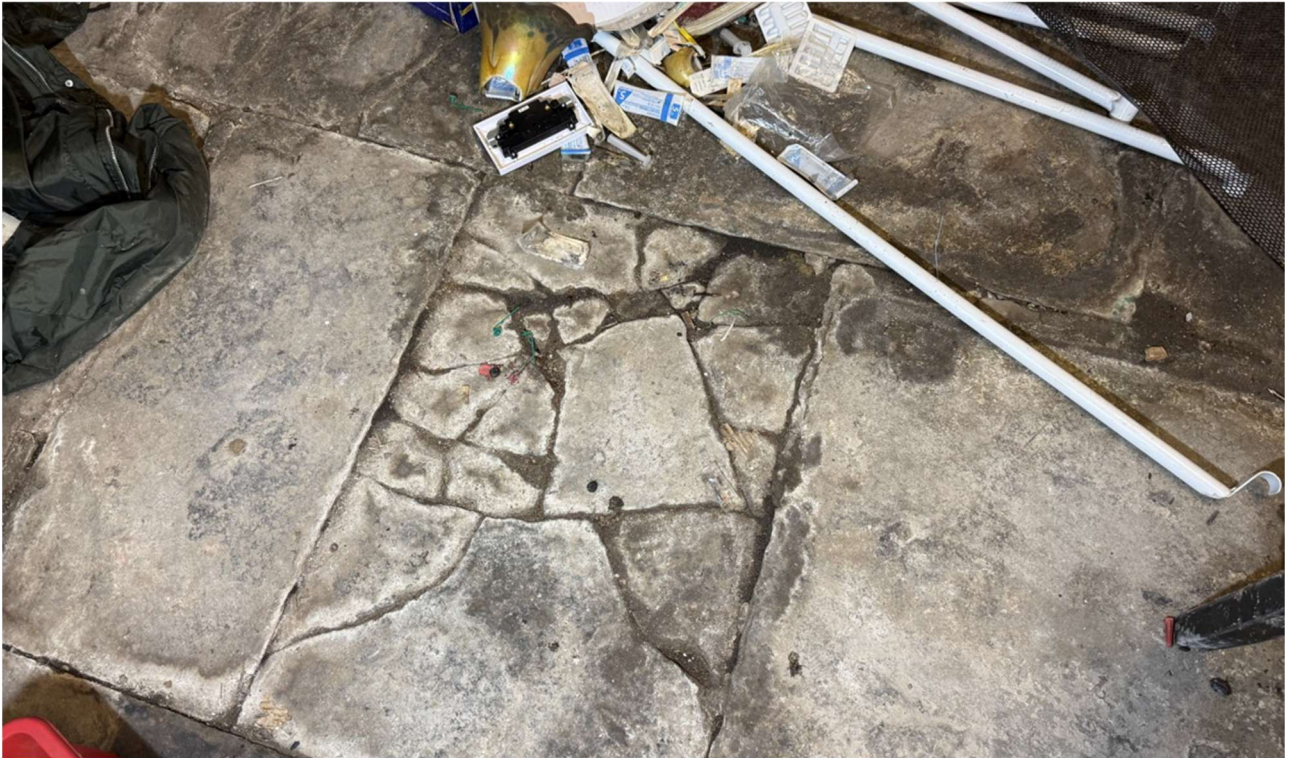
Visible capillary dampness to joints/cracks in stone flag floor:

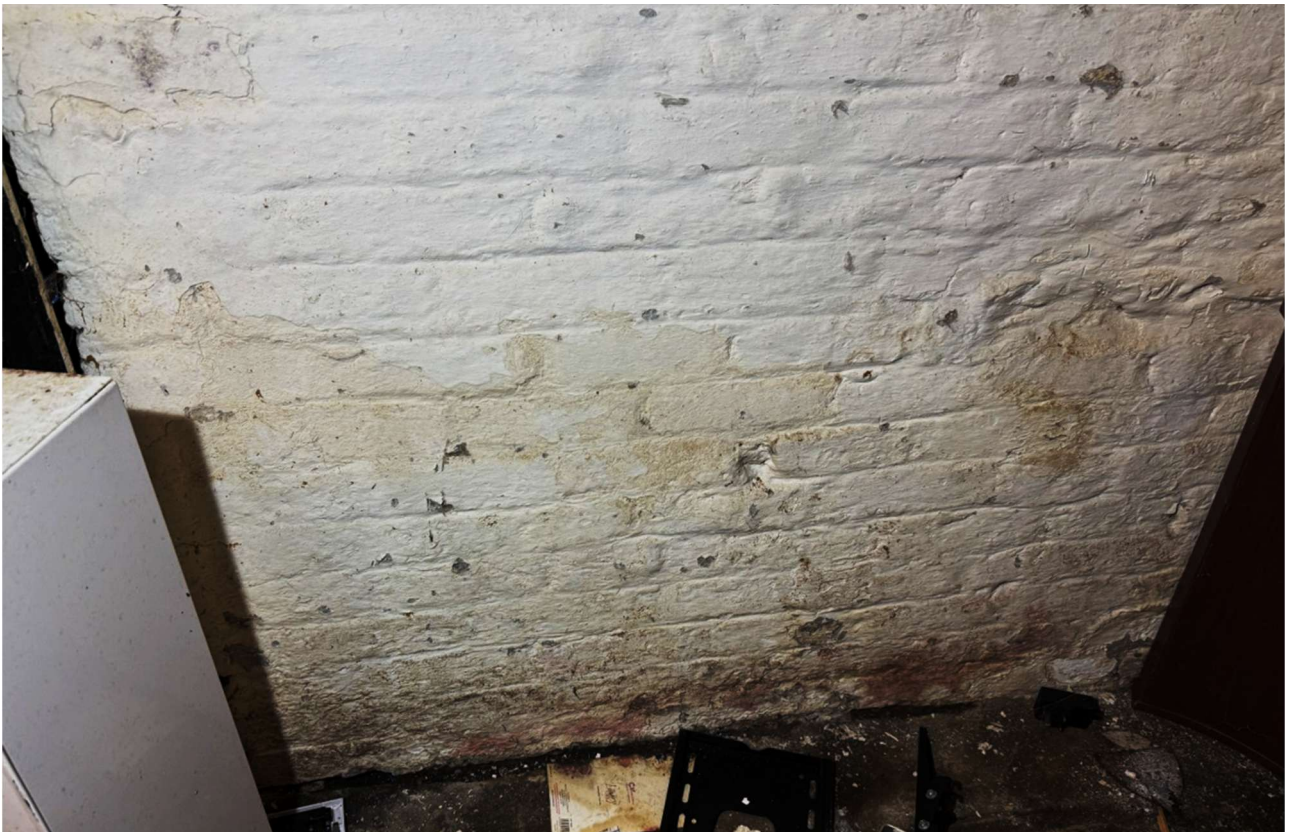
Contrast adjusted to highlight, but this is an internal wall (stairs are on the other side), note the discolouration at lower levels and spalling at the base of the wall, compared to higher level which is comparatively unaffected.

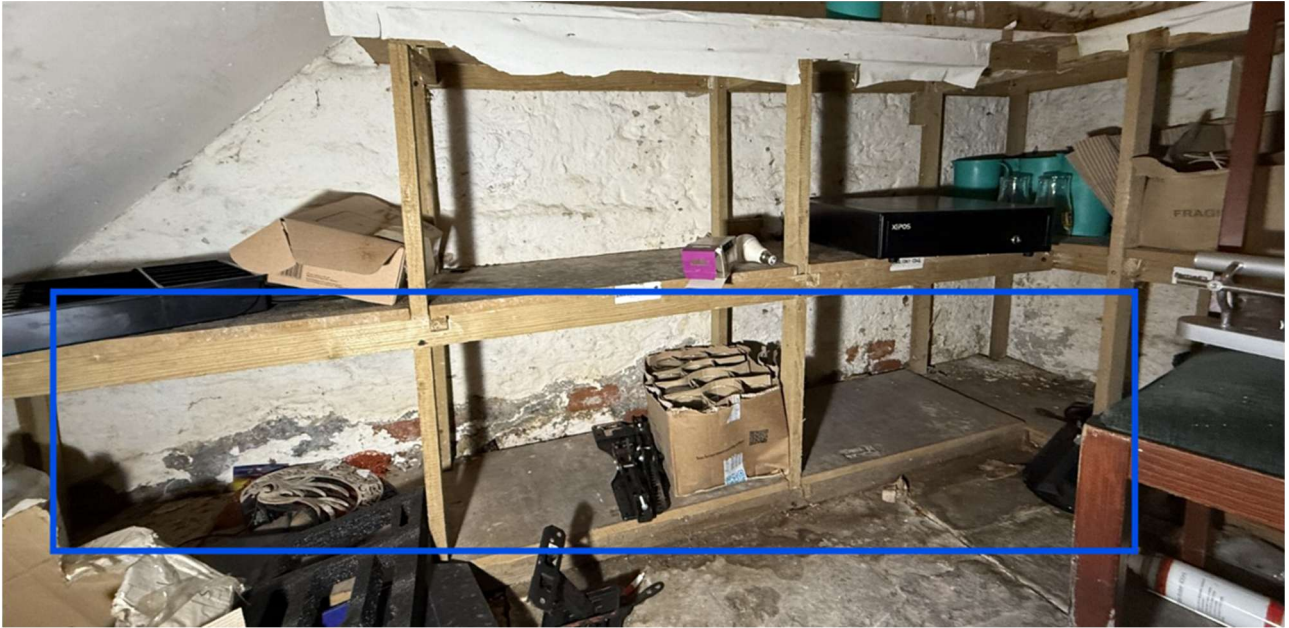
Low level spalling of applied coatings, again an internal wall.

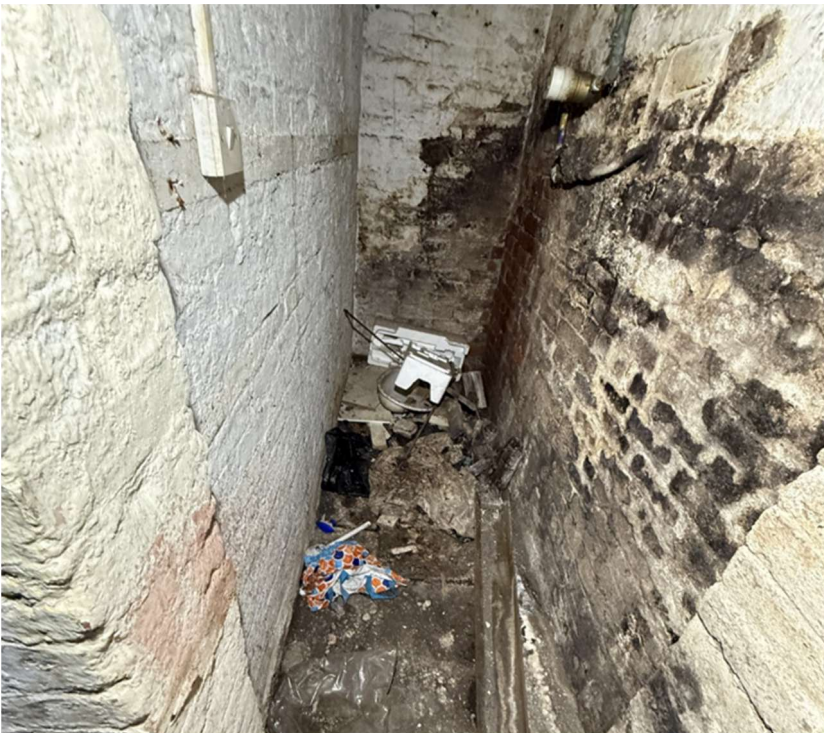
Retaining wall to right, internal wall to left:

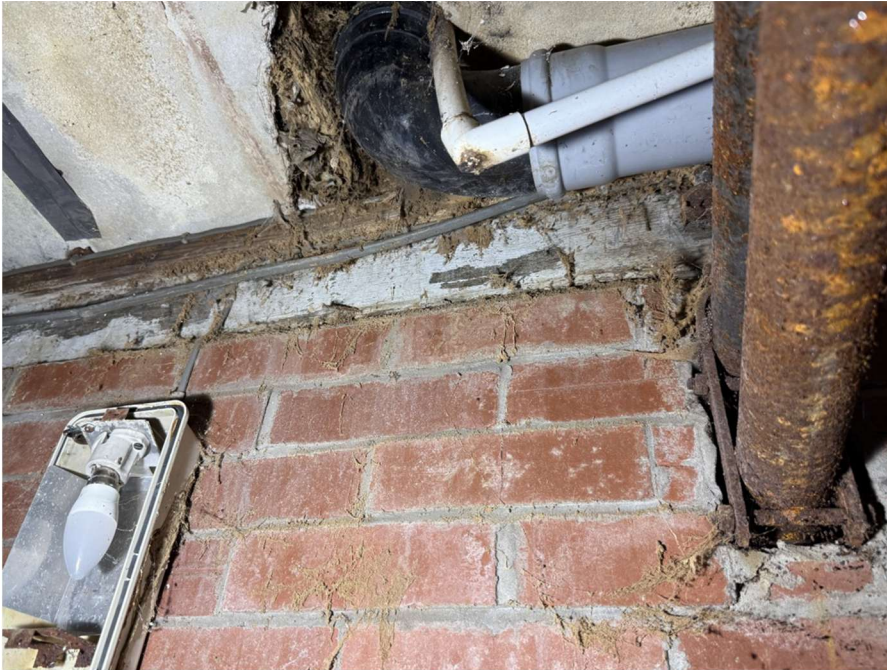
The brown powder caught in cobwebs is frass, which is waste from wood boring insects. This was the area where there was ingress from above, and this may have triggered the issue, but it is likely active given the conditions within the space and would benefit from closer inspection subject to works progressing.

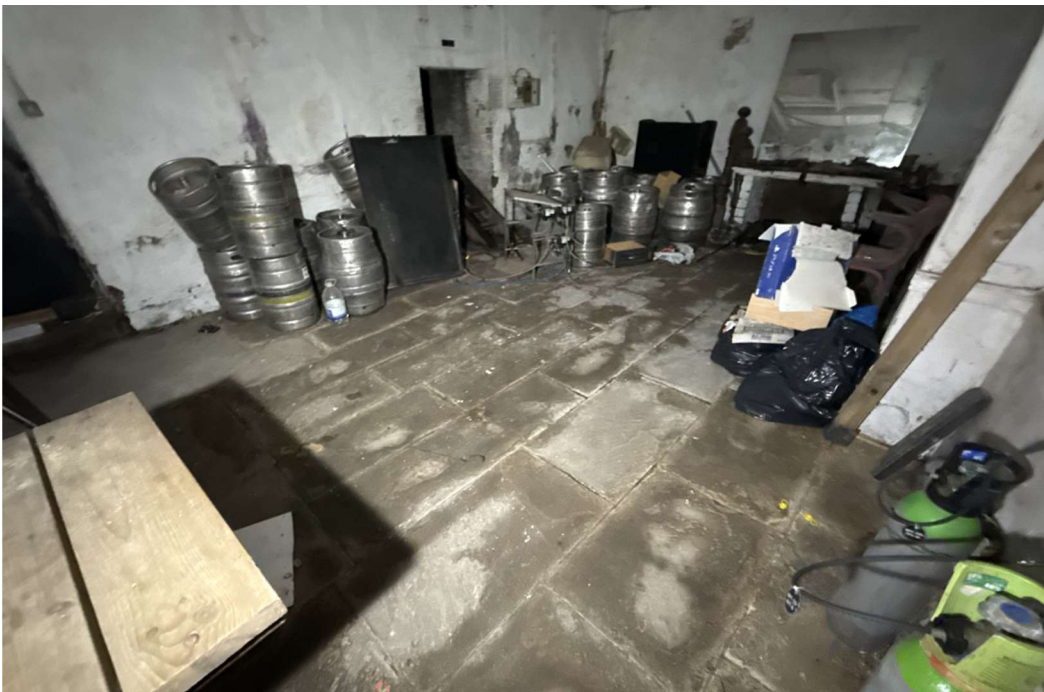
This room includes a barrel drop. These inevitably allow for some water ingress through the metal hatches above these, and there was some standing water beneath at the time of inspection.

This water likely causes or contributes to the capillary dampness evident within the flags in this area.

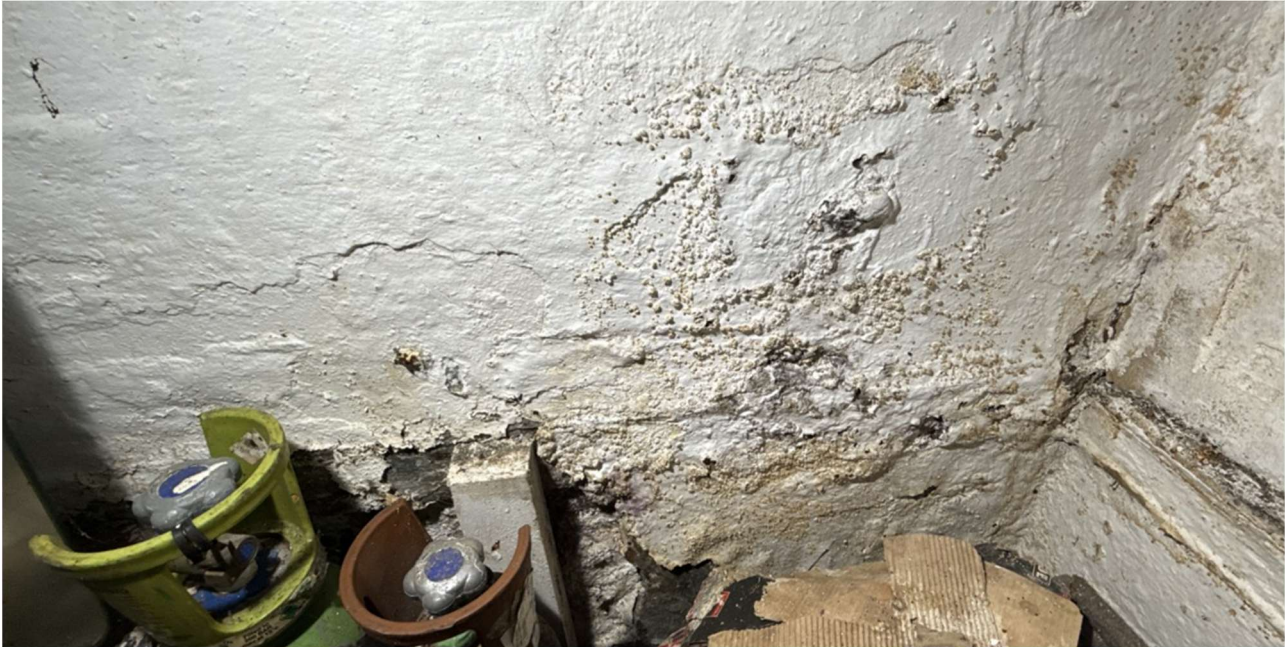
Walls here have received a direct applied coating, which has completely delaminated in areas and then has been painted over, with paint spanning to masonry where this has become exposed.

This is an example of efflorescence causing paint to bubble and spall, which as stated demonstrates evaporation from the face of the substrate.

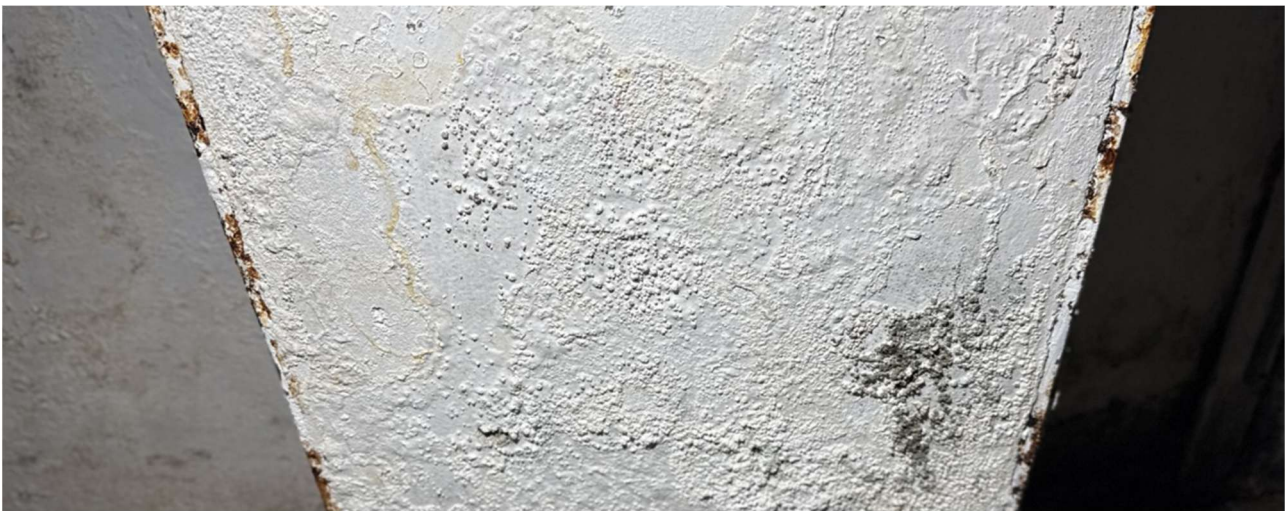
Similar within the beer cellar to rendered and painted walls:

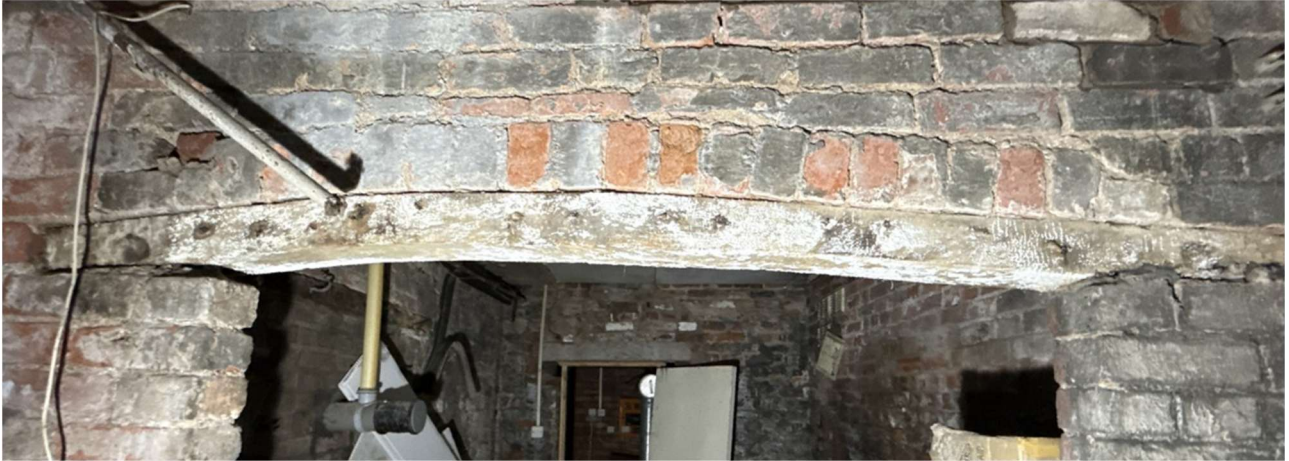
Brick arch with timber lintel (proposed B06 – dressing room):

The brick arch, we can potentially work around that and leave the timber and the arched header course directly above, to maintain the feature.

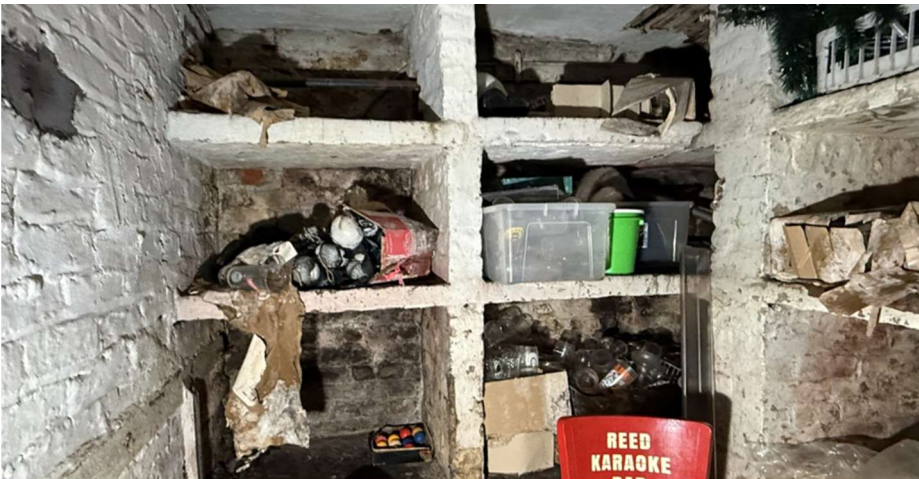
Brick/stone alcoves (B03 – kitchen):

The alcoves are designed for removal to allow formation of a kitchen.

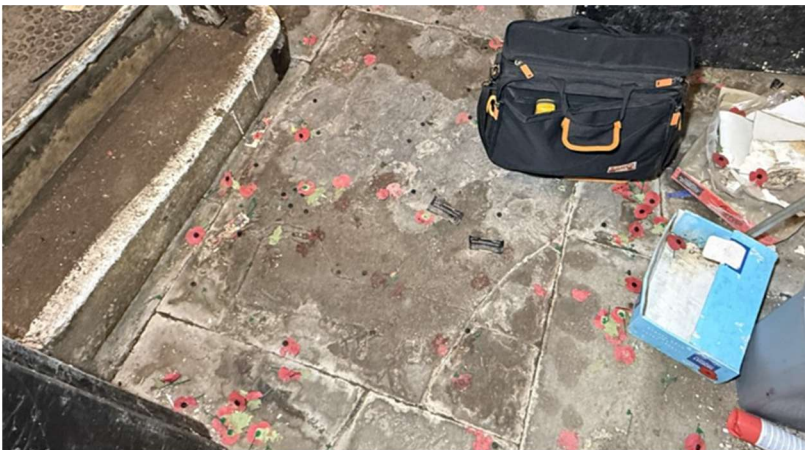
Stone flagged floor - :

With regard to the flagged floor, a dry floor is required in a habitable space, stored items, fitted kitchens and more will be placed upon the floor. If capillary dampness is present, that will detrimentally affect whatever is placed over, and therefore we would propose that the floor be protected.

It can be possible to lift a flagged floor and reinstate this above protection, but if proposing to fit typical floor finishes – carpets/tiles/lino etc., it's not a substantial gain for a significant outlay in respect of lifting and relaying, and my advice would be to replace the flags with a new floor construction.
